## PUBLIC UTILITIES COMMISSION

CPUC File No.: CIP200806

**SUBJECT:** Audit of Verizon's Novato District

# Audit Summary

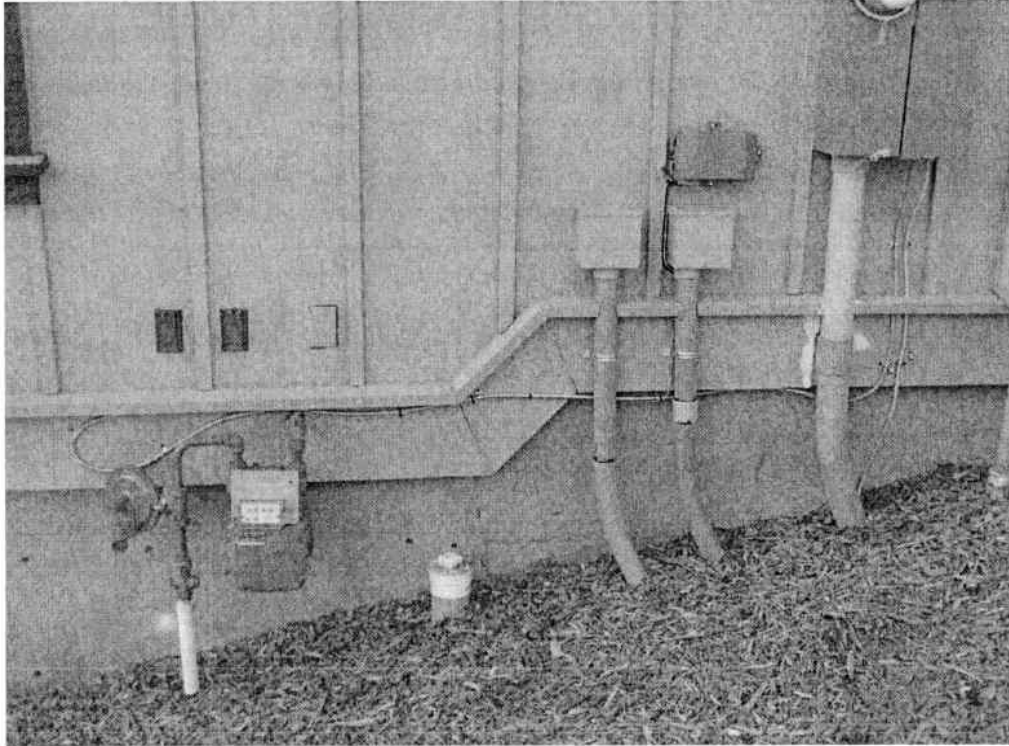
- (7) **10/29/08 – Field Location #13**  
**Job ID: T0463020, Completed 9/24/08**  
**2035 Laguna Vista Dr, Novato**

At the service entrance, we found that the Verizon ground wire had been clamped to the customer side of the gas meter. After speaking with Verizon staff, as well as the PG&E serviceman who happened to be in the neighborhood at the time of the inspection, we found this violation was not intentional, as the Verizon staff had intended to bond to the cold water service (the PG&E gas meter had not yet been installed at the time of job). However, we find this unintentional, yet careless act to be a safety hazard. It is certain that this safety hazard would have persisted indefinitely had we not visited this job. Please ensure that all ground wires are properly terminated per Verizon procedures and local ordinances. Note: The Verizon ground wire was removed from the gas service at the time of this inspection.
