## PUBLIC UTILITIES COMMISSION

**CPUC File No.: E2009-16**

**SUBJECT:** General Order (GO) 165 Compliance Audit of Southern California Edison's Orange District

## Compliance Audit Summary

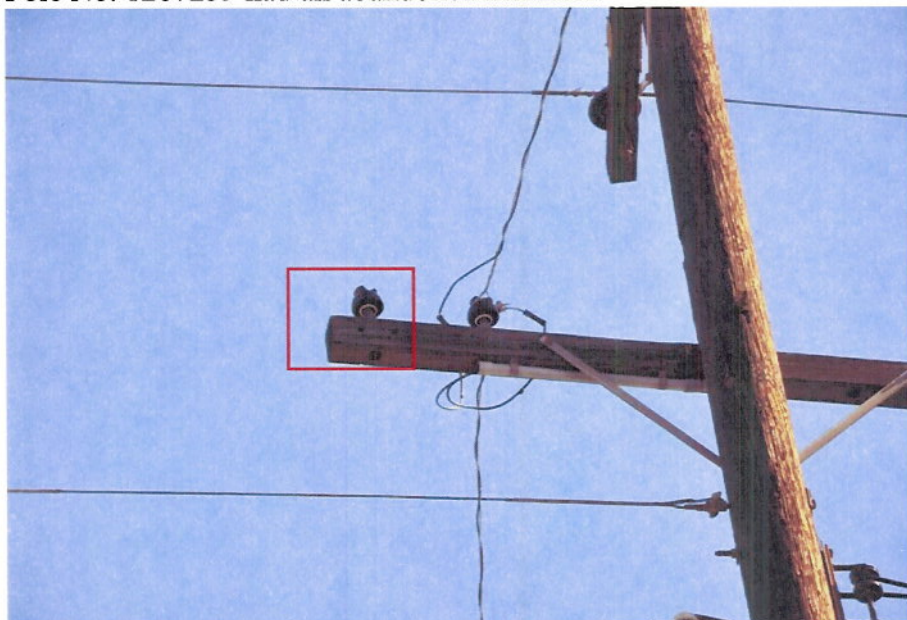
Picture 1

- a) Location: 7790 Pavonia Circle, Buena Park (**Picture 1**)  
Pole No. 1267259 had an abandoned insulator.

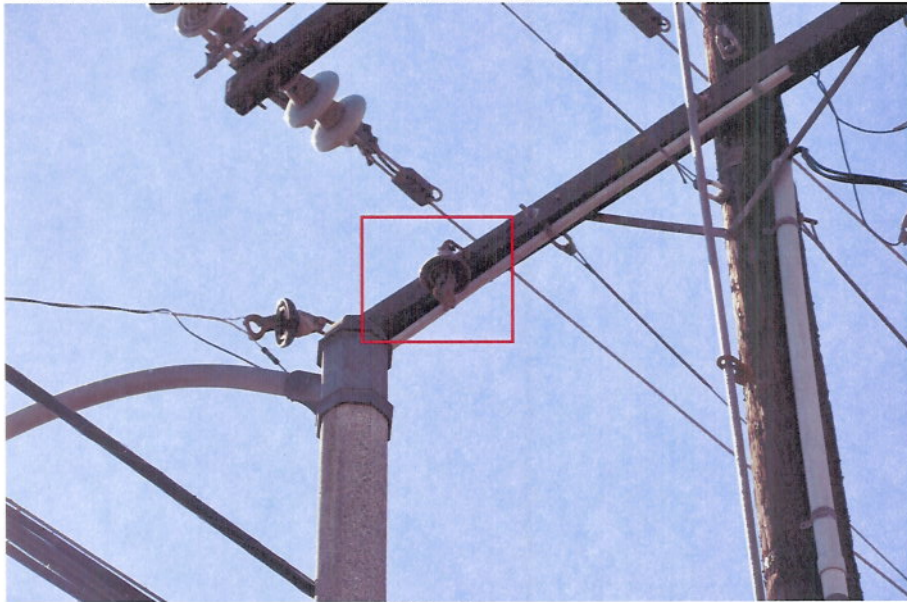
Picture 2

- b) Location: 8575 Knott Ave., Buena Park (**Picture 2**)  
Pole No. 1361764E had an abandoned insulator.

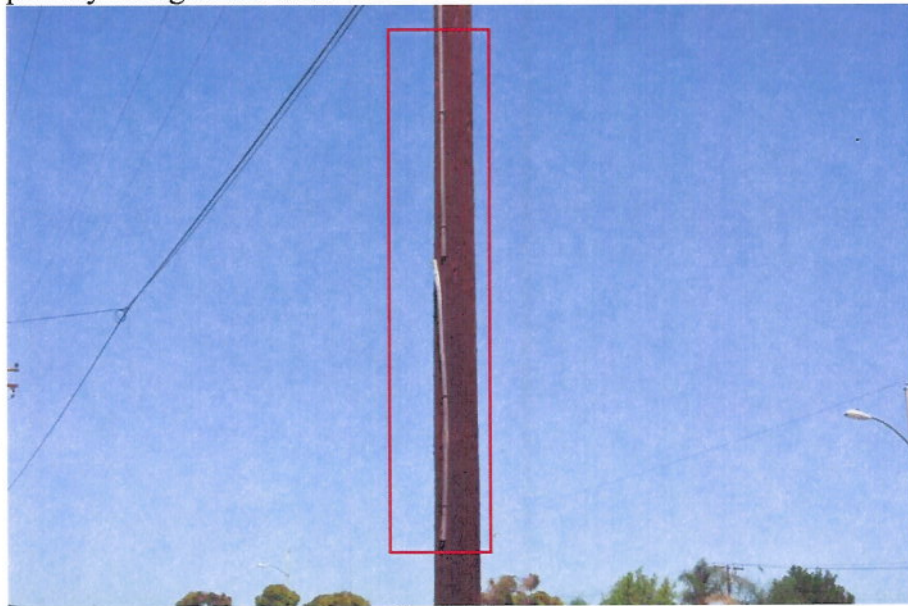
Picture 3

- c) Location: c/o Crescent Ave. and San Adriano St., Buena Park (**Picture 3**)  
Pole 1952404E had an abandoned ground moulding and was inspected on  
March 2, 2009. The work order was cancelled on June 17, 2009 and was not  
added to the new Distribution Inspection and Maintenance Program (DIMP).  
\*All violations found from the previous inspection program must be given a  
priority rating in the latest DIMP.\*

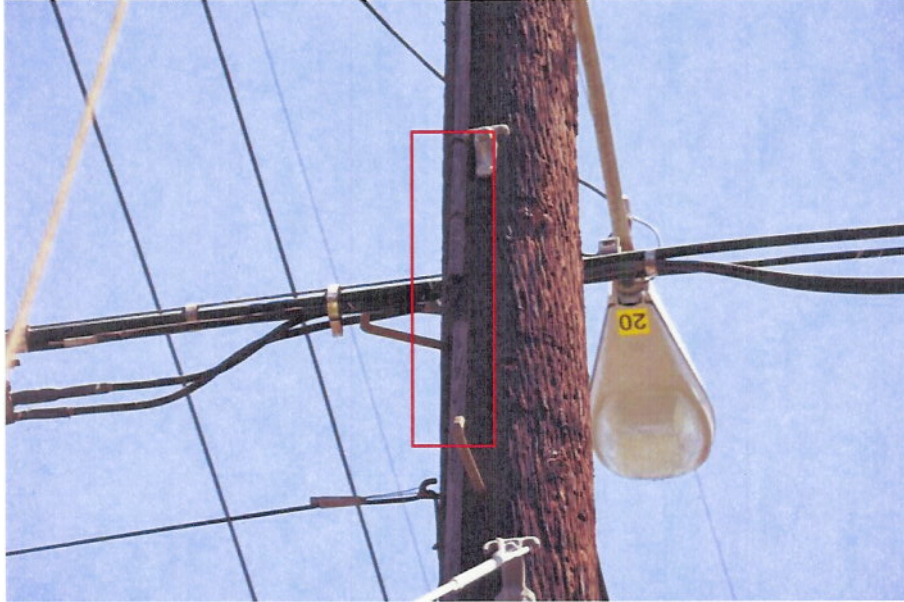
Picture 4

- d) Location: 8571 Western Ave., Buena Park (**Picture 4**)  
Pole No. 1592427E had an abandoned ground moulding and was inspected on March 2, 2009. The work order was cancelled on May 29, 2009 and was not added to the new Distribution Inspection and Maintenance Program (DIMP).  
\*All violations found from the previous inspection program must be given a priority rating in the latest DIMP.\*

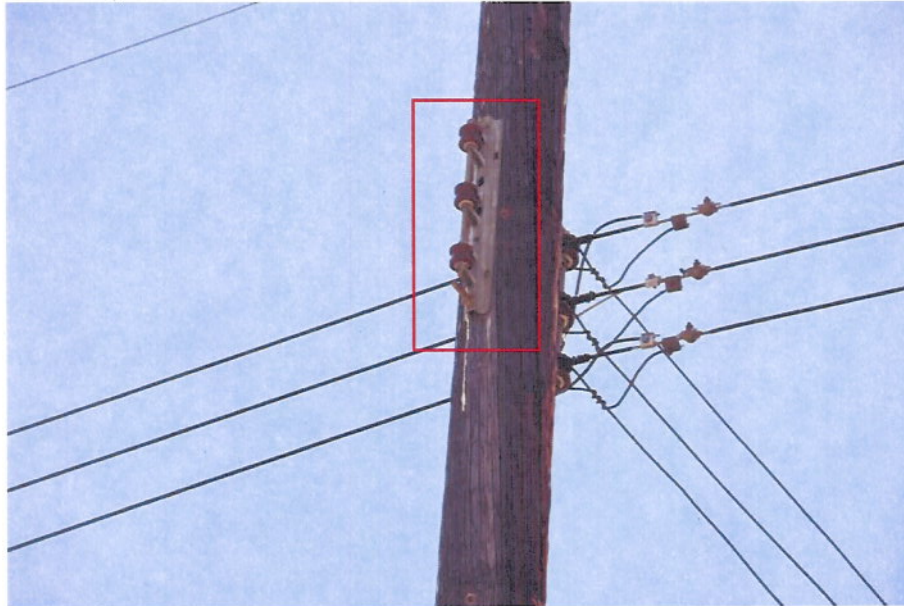
Picture 5

- e) Location: c/o Fillmore Drive and Madison Ave., Buena Park (**Picture 5**)  
Pole No. 110765 had an abandoned triplex rack. The pole was inspected on March 2, 2009.

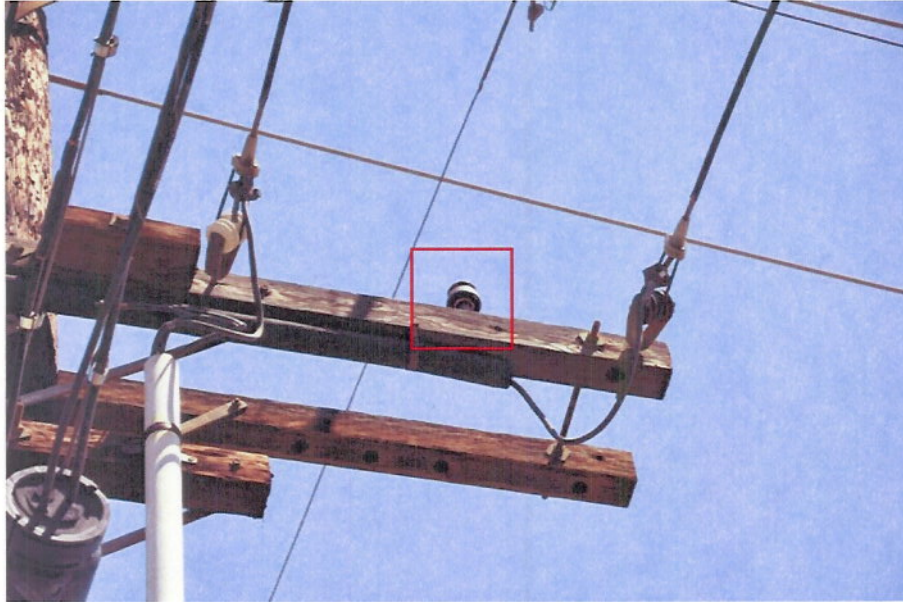
Picture 6

- f) Location: 111 Western Ave., Anaheim (**Picture 6**)  
Pole No. 1592427E had an abandoned insulator. The pole was inspected on March 2, 2009.

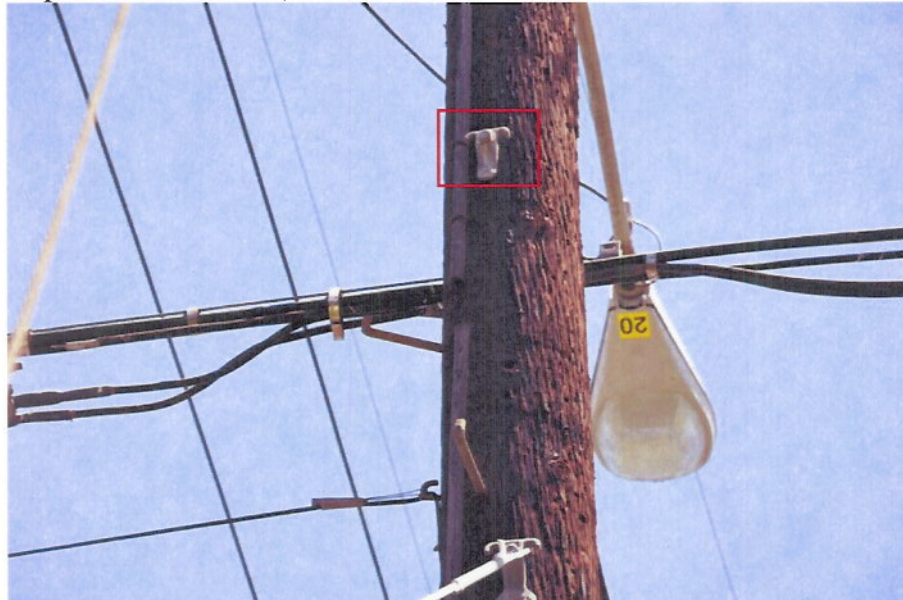
Picture 7

- g) Location: 8571 Western Ave., Buena Park (**Picture 7**)  
Pole No. 1592427E had an abandoned guy attachment. The pole was inspected on March 2, 2009.

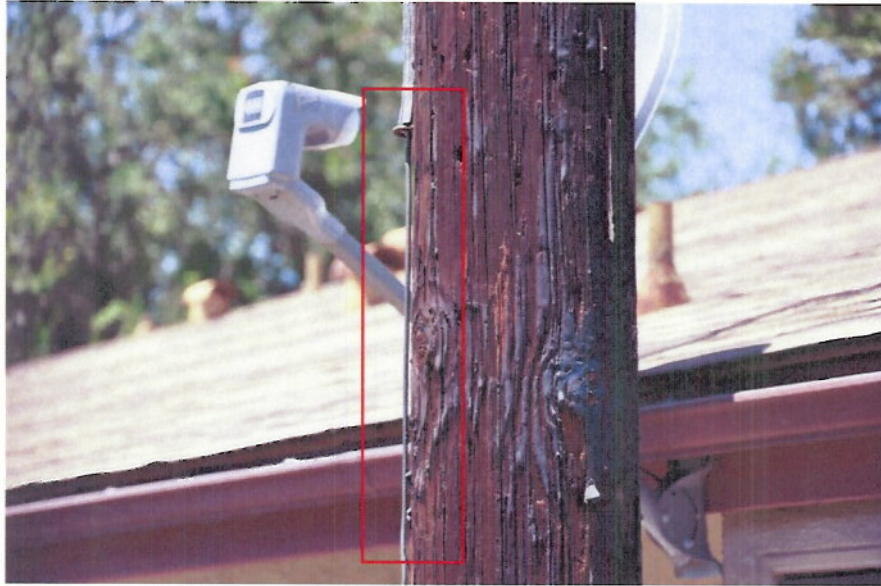
**Picture 8**

- a) Location: 8571 Western Ave., Buena Park (**Picture 8**)  
Pole No. 1628302E had an exposed ground moulding.

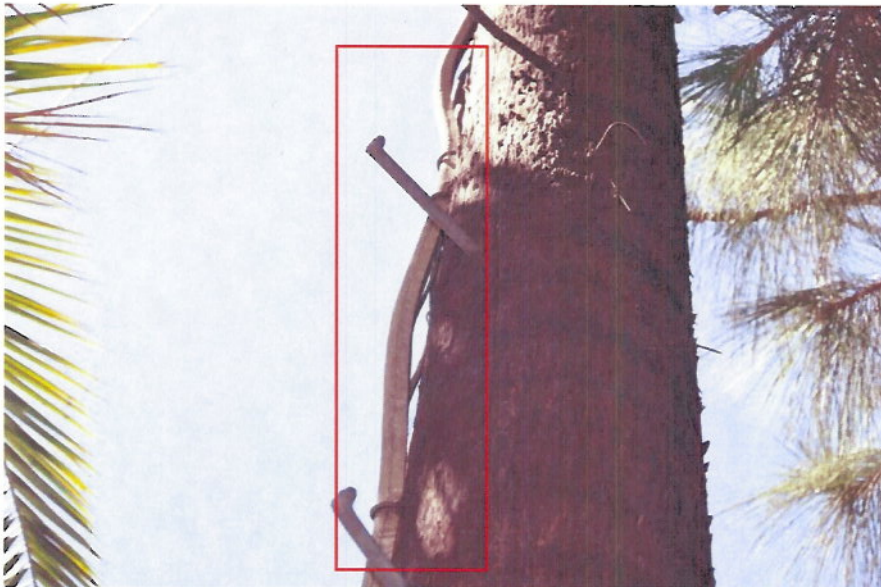
**Picture 9**

- b) Location: 801 Las Palmas Dr., Fullerton (**Picture 9**)  
Pole No. 1024036E had a damaged ground moulding.
