## PUBLIC UTILITIES COMMISSION

CPUC File No. EA2009-17

**SUBJECT:** Electric Audit of PG&E's North Yosemite Division, Merced and Los Banos

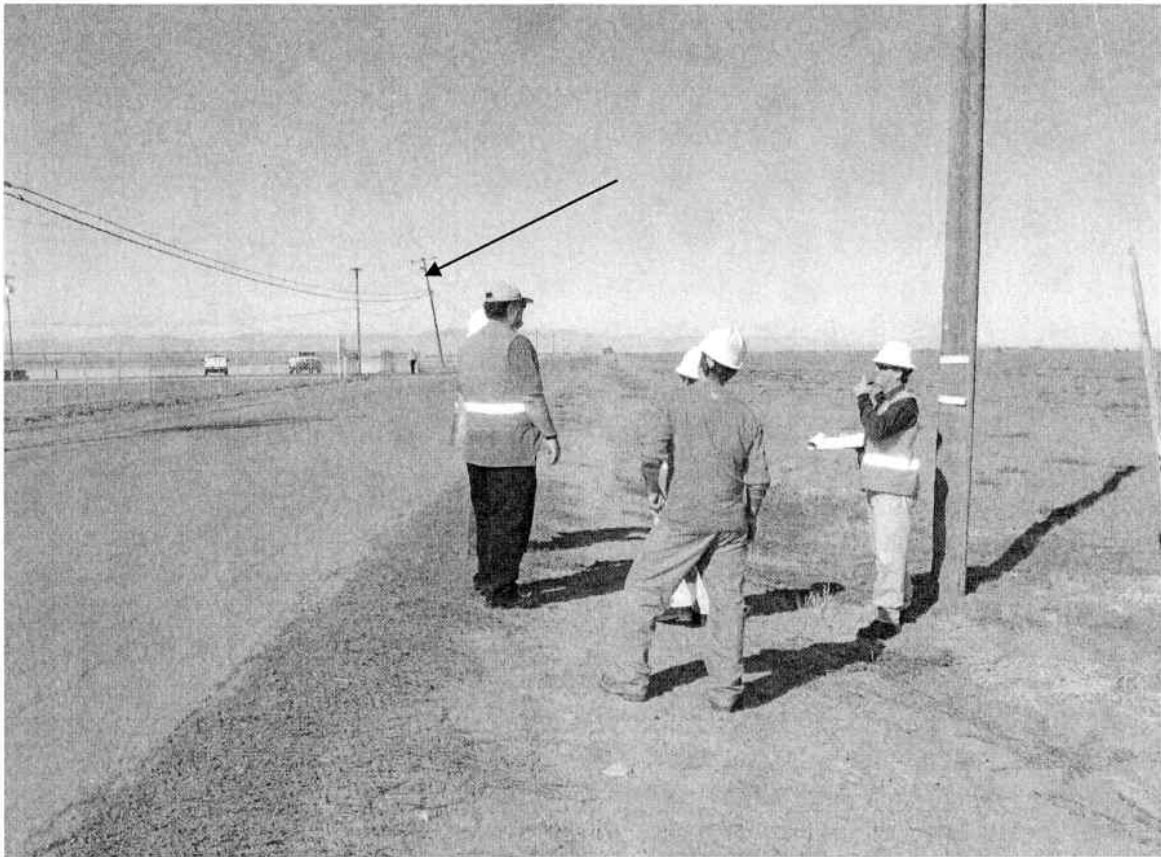
During our field review of closed tags, we noted a pole with a significant lean at 40109 W. Bullard Ave., in Firebaugh. The pole is on the right hand side of a gate leading into a business. See Figure 1 below. We are concerned that the pole may not have the required minimum safety factor as defined in GO95, Rule 44.3. Therefore, please provide PG&E's pole loading calculations.

**Figure 1**—a leaning pole in Firebaugh.

Also, in PG&E's pole loading calculations, does PG&E generally take into account pole lean? If not, please explain? For this particular pole, please take pole lean into account. In other words, in addition to the stress caused by the vertical loading, please include the stress due to bending moment at the base of the pole caused by the weight of the pole.
