**Moss Landing Tower Collapse
Root Cause Analysis**

Prepared for

Pacific Gas & Electric
6111 Bollinger Canyon Road
San Ramon, CA 94583

April 4, 2016

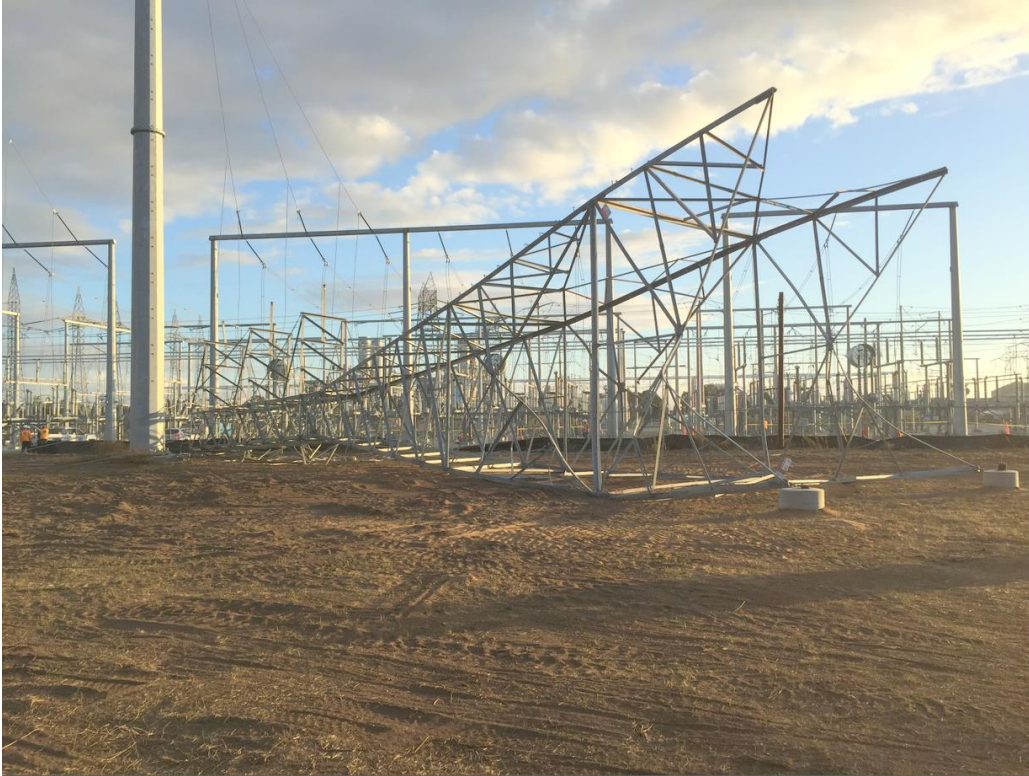
Figure 1: Moss Landing Tower Collapse Site Photo

The tower collapse occurred on October 15, 2015 and Figure 1 shows a photograph of the site shortly after the tower collapse.⁷

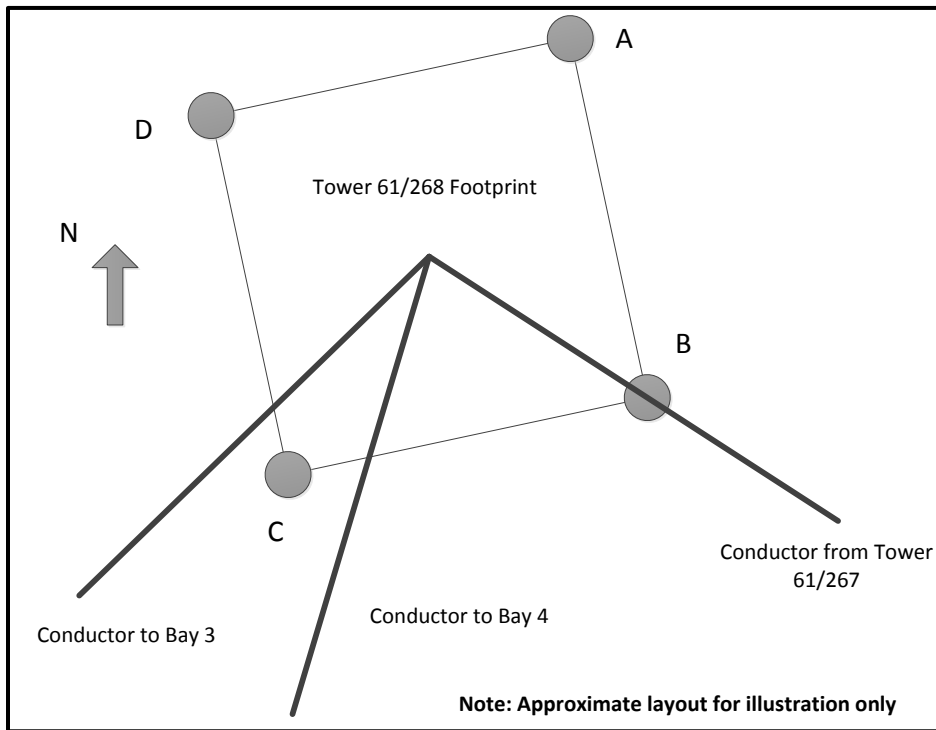
Figure 2: Tower Foundation Layout and Conductor Location

The subject tower supported two circuits designated as Metcalf – Moss Landing 1 and Metcalf – Moss Landing 2. Both circuits made an approximately 90 degree angle at the tower, resulting in a net overturning load to the southeast⁸. Figure 2 shows the foundation layout of the tower and the location of the conductors for illustrative purposes. The tower toppled to the southeast after failure of the stub angles. The stub angles at legs B and D exhibited corroded fracture surfaces at the time of collapse, indicating that these developed cracks prior to the tower collapse⁹. The stub angles at legs A and C showed no signs of corrosion, indicating that they most likely failed at the time of the collapse.

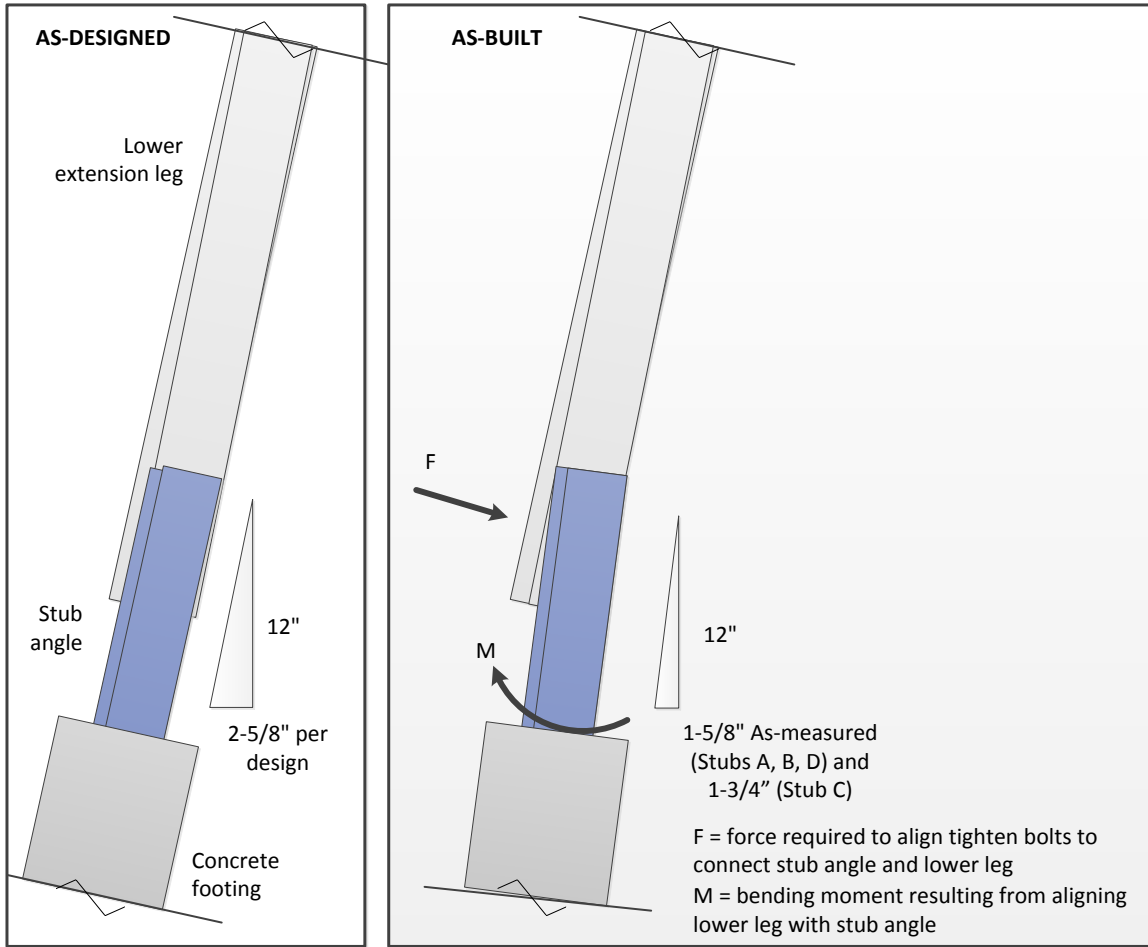
Figure 3: Stub Angle – Lower Tower Leg Orientation (for illustrative purposes only)

- Based on measurements made of the foundations after the accident, the stub angles were not oriented correctly at the time of construction. Rather than being tilted to match the sloped tower legs, the stub angles were installed with insufficient batter (angle). The correct heel batter angle is $2\text{-}5/8^{\circ}$ ¹¹. The as-built (as-measured) heel batter of the foundation stub angles was too steep relative to the design drawings, and as such, the top of any tower leg bolted to them would have been significantly outboard of its intended position.¹² Figure 3 provides an illustration of this condition.

The “as-designed” requirements for the stub angles is that the lower legs and stub angles are parallel (as shown in the left graphic in Figure 3) such that there is no lateral force (F) or bending moment (M) on the stub angle. The “as-built” configuration measured in the field after the tower failure showed that the stub angle and lower leg were out-of-alignment (as shown in the right graphic in Figure 3). When the bolts were tightened to

¹² Reference 1: Exponent Failure Analysis Report. The as-measured heel batter was $1\text{-}5/8^{\circ}$ for three of the stub angles. The fourth stub angle was measured at $1\text{-}3/4^{\circ}$.

bring these components together, this produced bending moments in the stub angles which exceeded the stress limits in the stub angle material and resulted in the failure as identified in Reference 1.

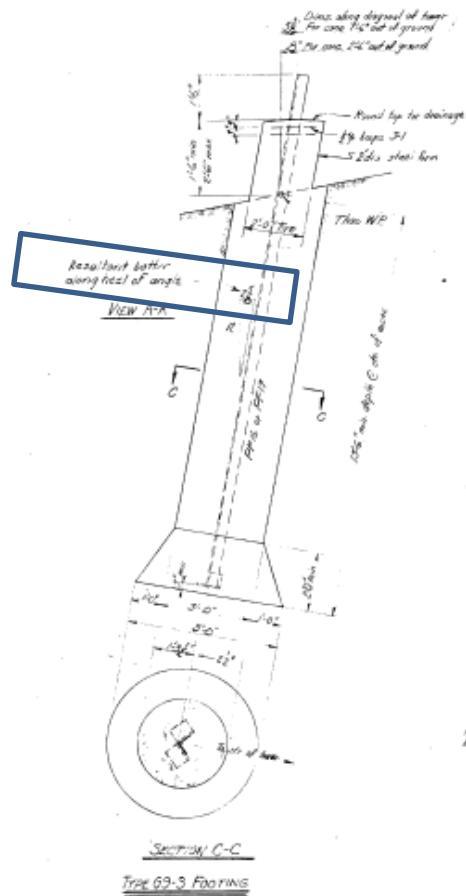
Figure 5: Heel Batter Designation from Drawing 313438

The structural data sheet references structural drawing 403912 for the G95 tower. This drawing and the structural data sheet references drawing 309933 for the foundations. This drawing references drawing 313438 and Rec. 621915 for additional foundation and stub angle details. The correct heel batter is indicated in Section C-C of drawing 313438. The heel batter is indicated as 2-5/8" per 12". The crew foreman indicated that he did not use this drawing for determination of the heel batter, but used the referenced Rec. 621915 for the heel batter determination. Figure 5 below shows the heel batter designation from drawing 313438.

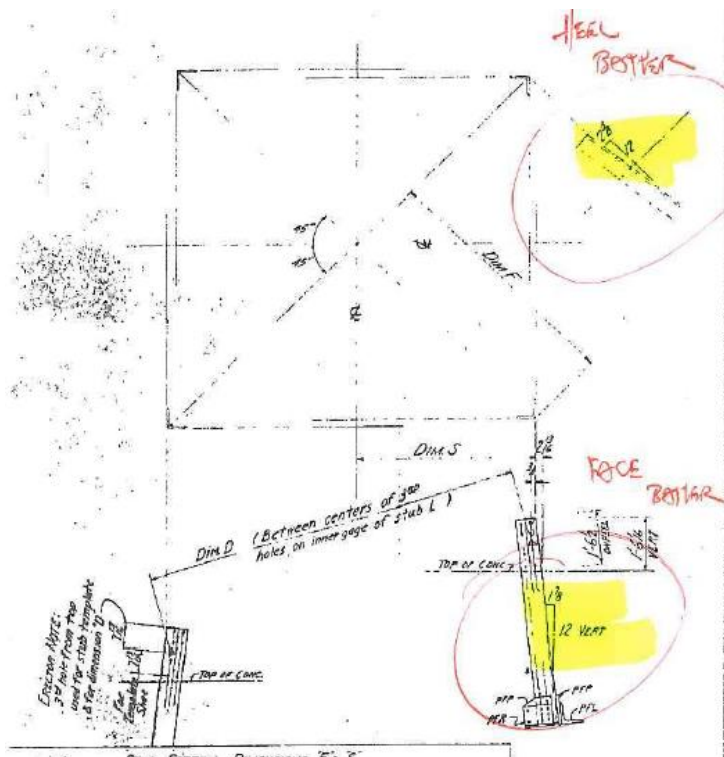
Figure 6: Stub Batter Angles from Rec. 621915

Note 4: (Finding) Misread required batter from Rec. 621915 and miscommunicated to crew

Rec. 621915 is provided for additional foundation and stub angle details. The correct heel batter is indicated in Section C-C of drawing 313438 and also in the diagram in the top right of Rec. 621915. The heel batter is indicated as 2-5/8” per 12”. There is additional information in the diagram in the top right of Rec. 621915 that shows both a face batter and a heel batter, but with no specific identifier (“heel” or “face”) next to the values. Discussions with the crew indicated that the foreman miscommunicated the heel batter to the crew for use in setting the footings and stub angle.^{29,30} The information from Rec. 621915 is shown in Figure 6 below. This incorrect heel batter angle led to a condition which introduced excessive stress on the stub angle (see Note 8 later).

- During the review of the job package, the foreman indicated that he misread the heel batter inclination on Rec 621915. Additionally, drawing 313438 was not used to determine the heel batter. These actions for ineffective review were caused by inadequate training, relative to transferring design information into the construction plan for the footing set-up. The inadequate training is caused because there is no formal training program for the construction crews on interpreting the design-related information to construction. Currently, on-the-job training is relied upon for transferring knowledge to the crew. This approach may have been effective in the past, but there are fewer towers being constructed today, and the on-the-job training approach may no longer be sufficient. The lack of a formal training program is caused by inadequate program design to identify the need for formal training of the crew, relative to understanding and interpreting the design drawings for construction.

- A lack of clarity and confusing information in the construction drawing (Rec. 621915) also resulted in the misreading of the tower design drawing³⁹. This is caused by the use of legacy drawings (dating from the 1960's). The legacy tower drawings may not reflect the current needs of crews who perform the tower installations on an infrequent basis. The lack of drawing clarity results from

| Cause | Recommended Corrective Action |
|--|--|
| CC2: Inadequate maintenance (update) of drawings relative to legacy tower drawings may not reflect the current needs of crews who perform the tower installations on an infrequent basis | <p>Update tower drawings to ensure legibility and more accurate information (especially related to stub angle measurements)</p> <p>Evaluate the need to create project specific drawings relative to current generic drawing approach</p> |
