# **FINAL REPORT ON THE AUDIT OF THE ALAMITOS POWER PLANT**

**CONDUCTED UNDER GENERAL ORDER 167  
TO DETERMINE COMPLIANCE WITH  
OPERATION, MAINTENANCE, AND LOGBOOK STANDARDS**

ELECTRIC GENERATION PERFORMANCE BRANCH  
CONSUMER PROTECTION AND SAFETY DIVISION  
CALIFORNIA PUBLIC UTILITIES COMMISSION  
505 VAN NESS AVENUE  
SAN FRANCISCO, CA 94102

October 10, 2008

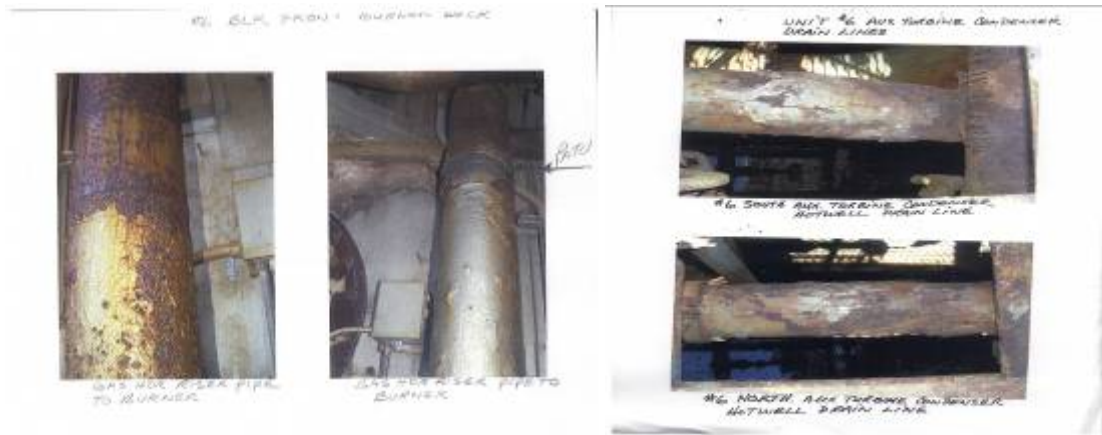
Figure 1. Corrosion on Unit 6 gas system and auxiliary turbine condenser hotwell drain lines.

Since the initial audit visit, the plant has undertaken certain corrosion protective measures, including adding leak detectors, repairing some piping, repainting other pipes, and submitting some inspection procedures and records. However, the plant's response remained piecemeal. Below are some examples of the improvements at Alamitos, along with examples of specific deficiencies that a comprehensive corrosion control program should address.

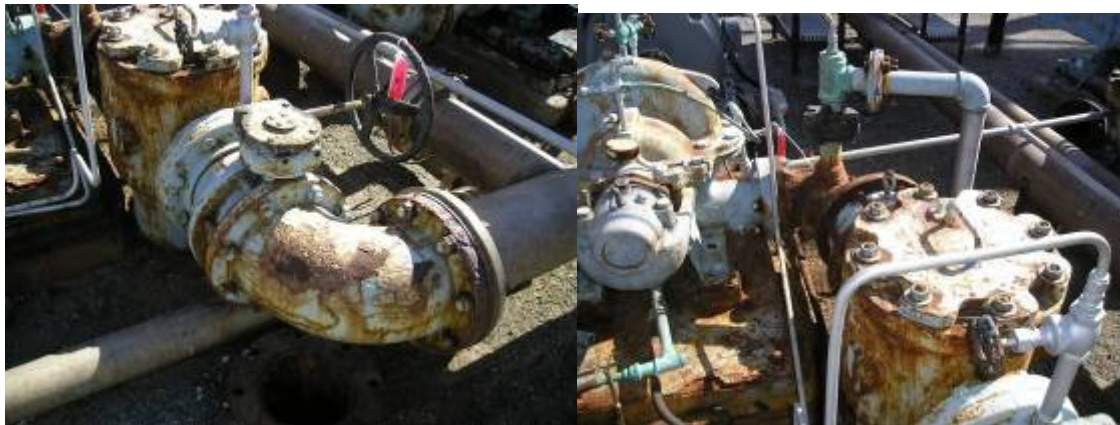
Figure 2. Corrosion at the plant.

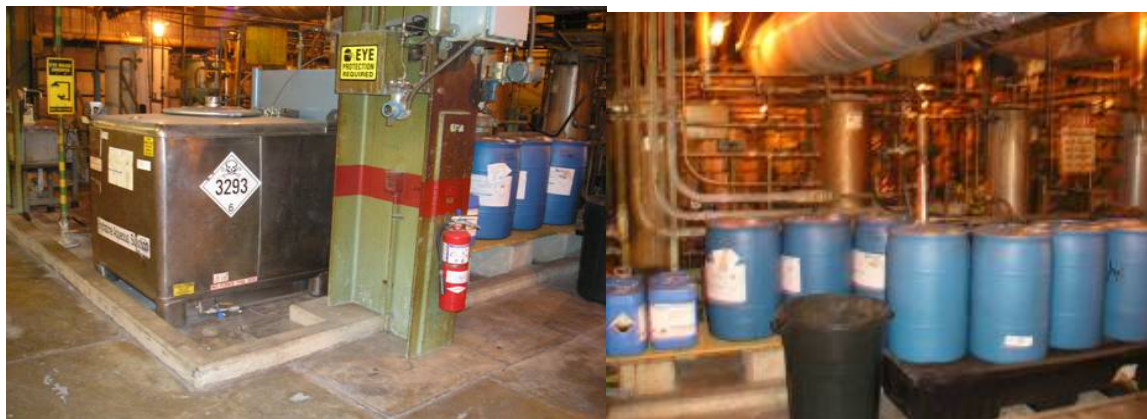
The plant lacked proper handling, storage, and monitoring processes and procedures for hydrazine. The plant lacked the Material Safety Data Sheet (MSDS sheet) that prescribes proper handling, storage, and exposure controls for hydrazine. This sheet is a prerequisite to adoption and implementation of an adequate hydrazine management program.

The plant had not reported the chemical to the appropriate local agencies, which need the information to review emergency response, preparedness, and contingency plans in the event of hazardous materials release. State law requires the plant to complete a separate Hazardous Materials Inventory – Chemical Description (form 2731) for each hazardous material handled at the facility exceeding specific threshold quantities. For liquids, this threshold is 55 gallons. At the request of CPSD, Alamitos provided the form, listing the average daily amount of hydrazine at the site as 0.5 gallons. However, auditors believe that the plant maintains an inventory clearly larger than 0.5 gallons and very likely larger than 55 gallons. Figure 3 shows a hydrazine mixing tank well over 100 gallons, as well as several 55 gallon drums some of which appear to contain hydrazine. Power plants typically carry inventories of hydrazine in the hundreds of gallons.

**Figure 3. Hydrazine mixing and storage area appears capable of storing over 100 gallons of hydrazine.**

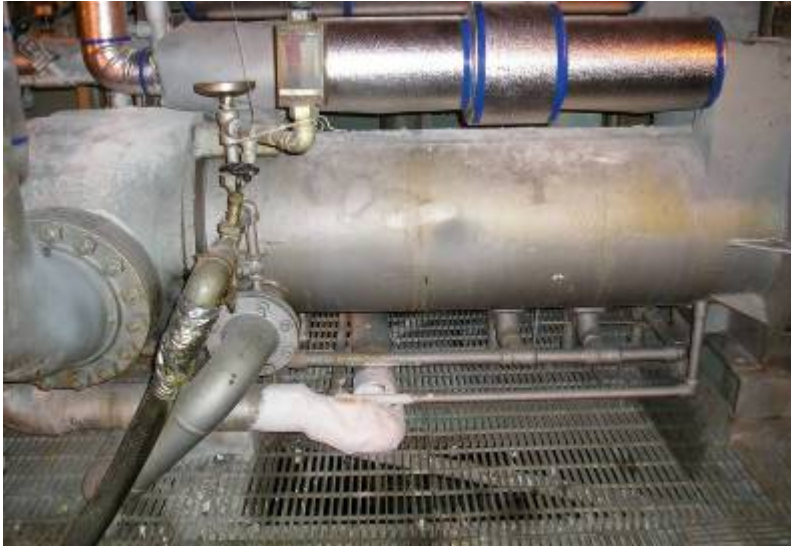
traveled from the steam jet air ejector in the auxiliary bay into other areas of the plant, including the control room. After workers reported the fumes, Alamitos taped a long hose onto the exhaust of the steam jet air ejector to route the fumes to the outside of the building (Figures 4 and 5). Alamitos installed a large fan at the doorway of the building to exhaust fumes that had already been released inside the building.

**Figure 4. The plant taped a hose to the steam jet air ejector to exhaust fumes.**

After discussion with CPSD, Alamitos vented both steam air ejectors to the outside. In particular the plant installed permanent piping starting at the exhaust, passing through grating in the auxiliary bay, and ending in a vent at the building's side wall.

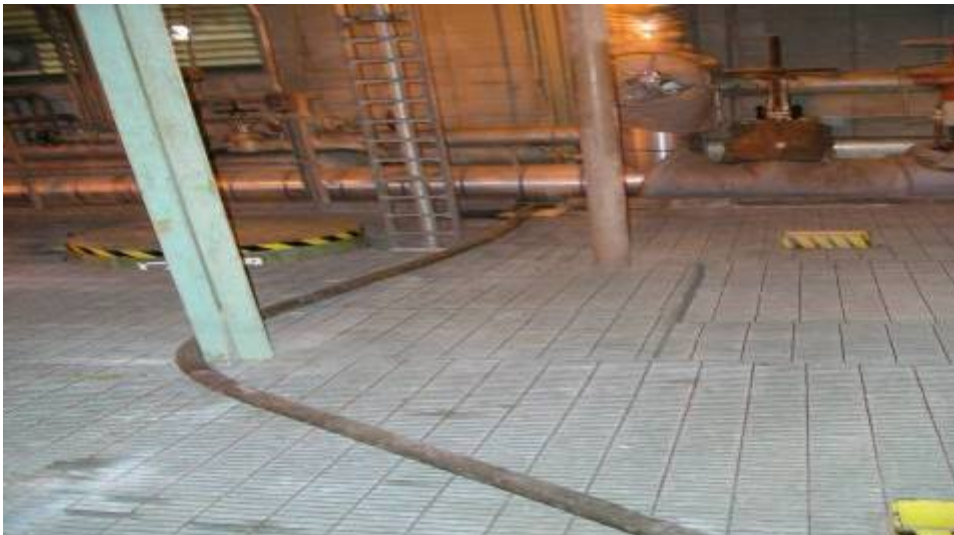
**Figure 5. The hose from the steam jet air ejector extends through the auxiliary bay.**

Temporary installation of a hose and fan to disperse hydrazine fumes release is inadequate to meet exposure controls prescribed in the hydrazine Material Safety Data Sheet (MSDS). Furthermore, there is evidence that fumes may have been released in the past. The auditor saw tape around the exhaust port of the steam jet air ejector for Unit 4 (see Figure 6).

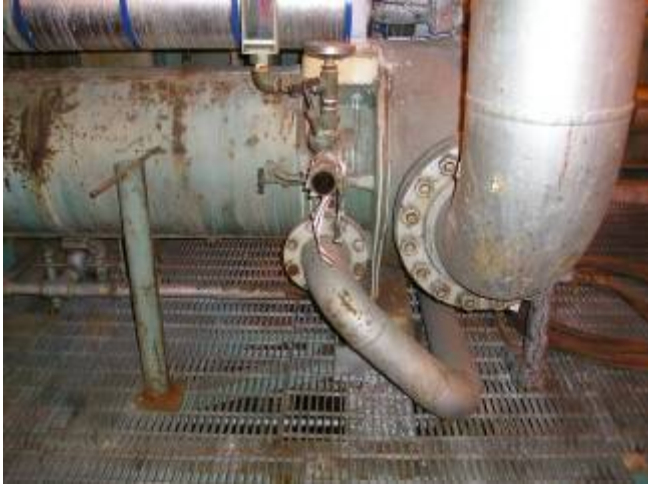
**Figure 6. Tape wrapped around exhaust port of Unit 4 steam jet air ejector may indicate prior release of fumes.**

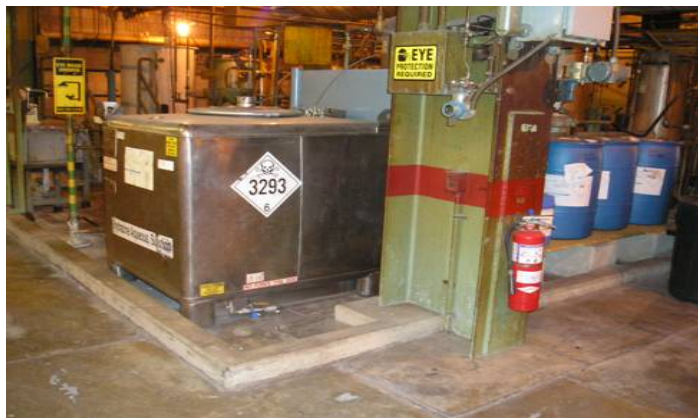
**Figure 7. Hydrazine area at the time of the initial audit visit. The metal tote is on the left.**

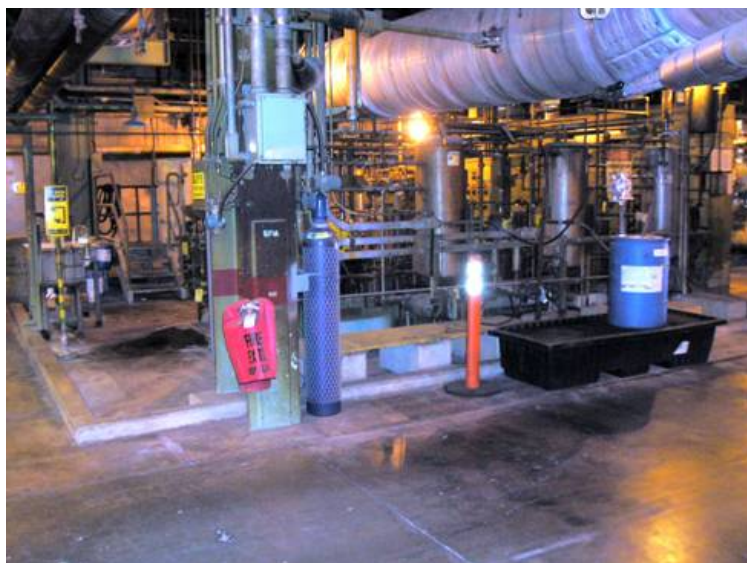
**Figure 8. Hydrazine area after the metal tote and excess (blue) hydrazine drums were removed.**

Second, after considering a less dangerous oxygen scavenger, as well as a tote system for handling hydrazine, Alamitos instead decided to reduce the quantity of hydrazine on the site. Before the audit, Alamitos installed a large tote. Tote systems generally reduce handling of and exposure to hydrazine, among other things, because staff no longer needs to clean drums, and can reuse the tote. Alamitos also considered switching from hydrazine to Eliminox, a less dangerous oxygen scavenger. Alamitos instead decided to continue using hydrazine drums, but in reduced quantities.

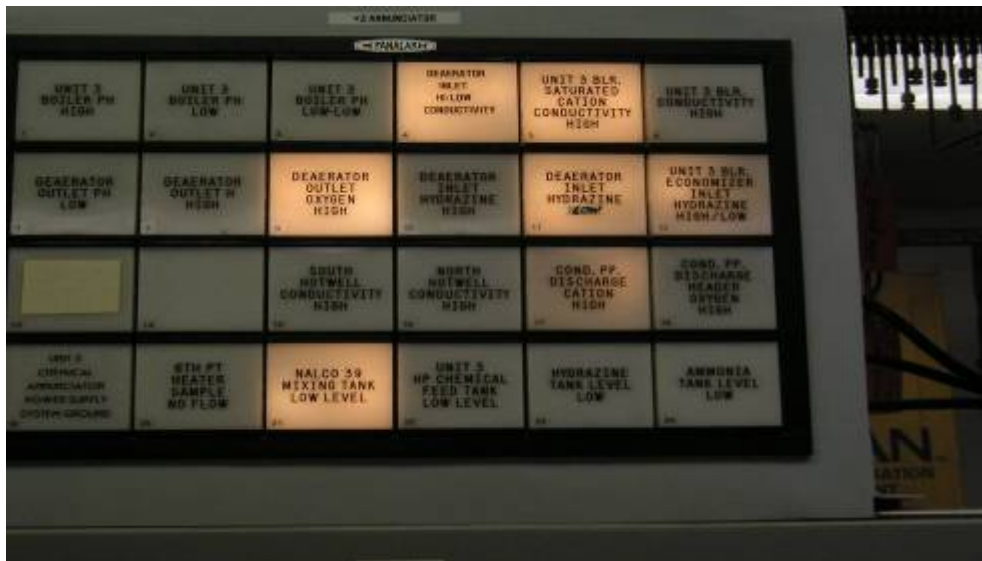
Figure 9. Hydrazine and conductivity alarms activated in the chemical lab.

CPSD is concerned for two reasons. First, if alarms are false, or improperly tuned, the alarms will unnecessarily distract plant staff. Plant staff may become desensitized to and ignore alarms that require action, causing equipment damage and safety risks. On the other hand, to the extent alarms are real; the plant fails to control water chemistry and/or the condition of equipment.

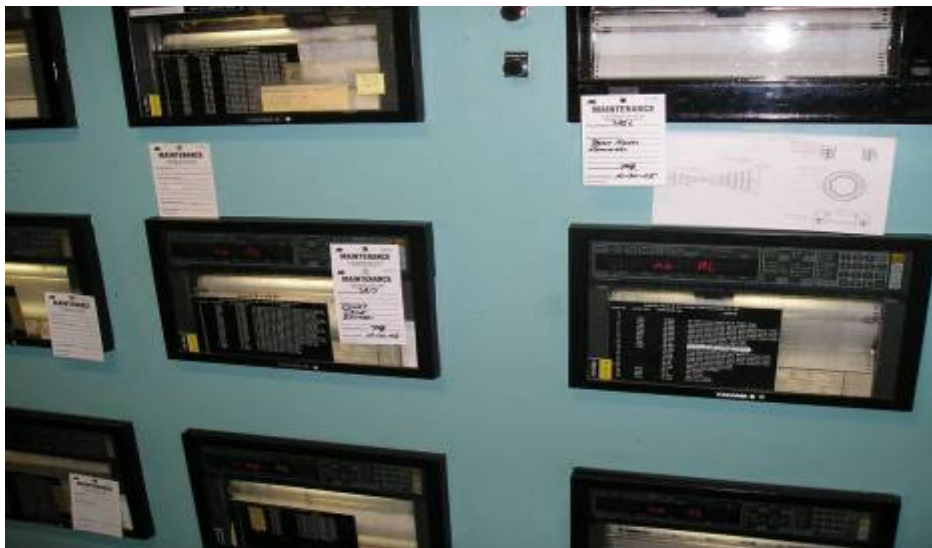
The plant does not trend or otherwise analyze the number of outstanding maintenance tasks over time. The plant cannot therefore track its effectiveness in making timely repairs, nor determine whether the backlog of maintenance items is growing. Auditors saw many maintenance tags on equipment in the plant's control rooms (Figure 10).

**Figure 10. Chart recorders in control room need repairs.**

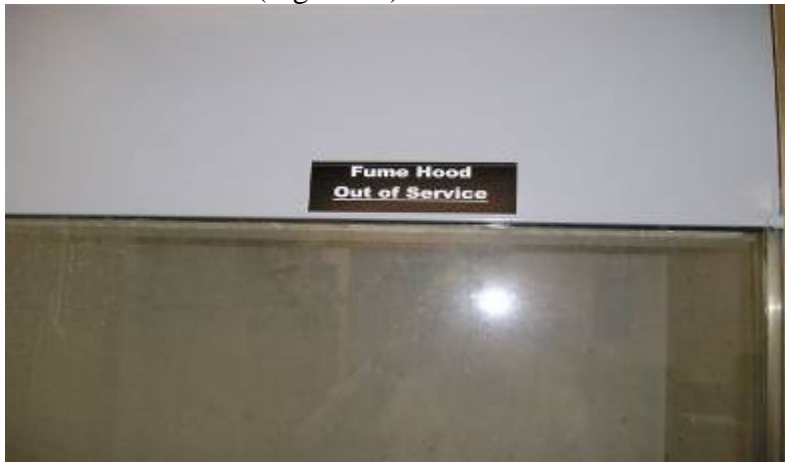
According to plant personnel the fume hood for Units 1 and 2 is no longer needed, because the mixing of chemicals for the entire plant now takes place in the chemistry laboratory at Units 3 and 4. The auditor visited the chemistry laboratory for Units 3 and 4, and found that the ventilation system for the fume hood works properly. The plant submitted a copy of the latest certification for the hood, dated June 6, 2007. The plant placed a warning sign in the disused fume hood (Figure 11).

**Figure 11. The plant labeled the disused fume hood.**

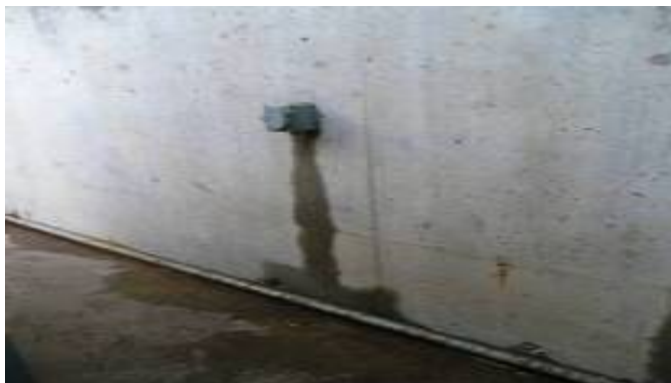
Auditors noted multiple potential problems during a plant tour. Figure 12 shows water, which leaked, through an electrical box. Figure 13 shows fallen concrete resting on a pipe. Figure 14 shows a pipe that appears to be missing some insulation.

**Figure 12. Water leaked through an electrical box.**

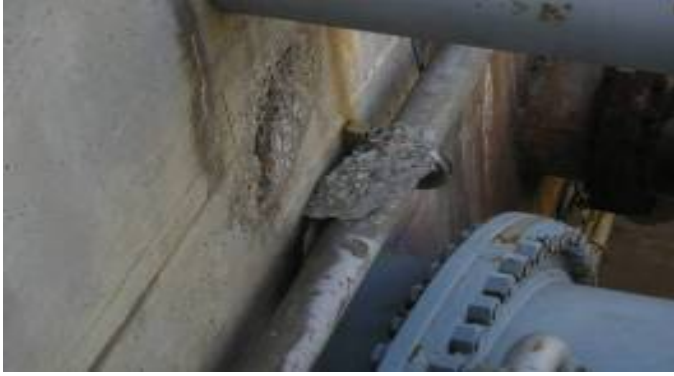
**Figure 13. Fallen concrete rests on a pipe.**

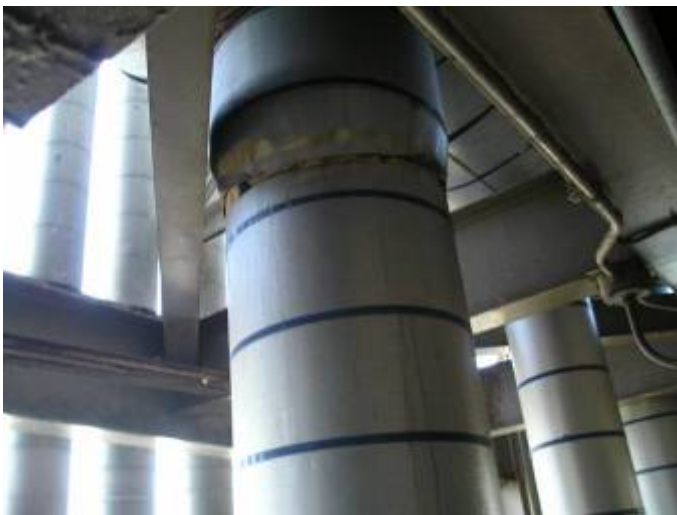
**Figure 14. Pipe missing insulation.**
