**Root Cause Analysis Report:
Worker Fatality
PG&E - Kern Power Plant Demolition
Bakersfield, CA**

Location of Incident: Kern Power Plant, Bakersfield, California
Date of Incident: Tuesday, June 19, 2012, approximately 9:20 a.m.
Type of Incident: Worker fatality; struck by collapsing tank wall

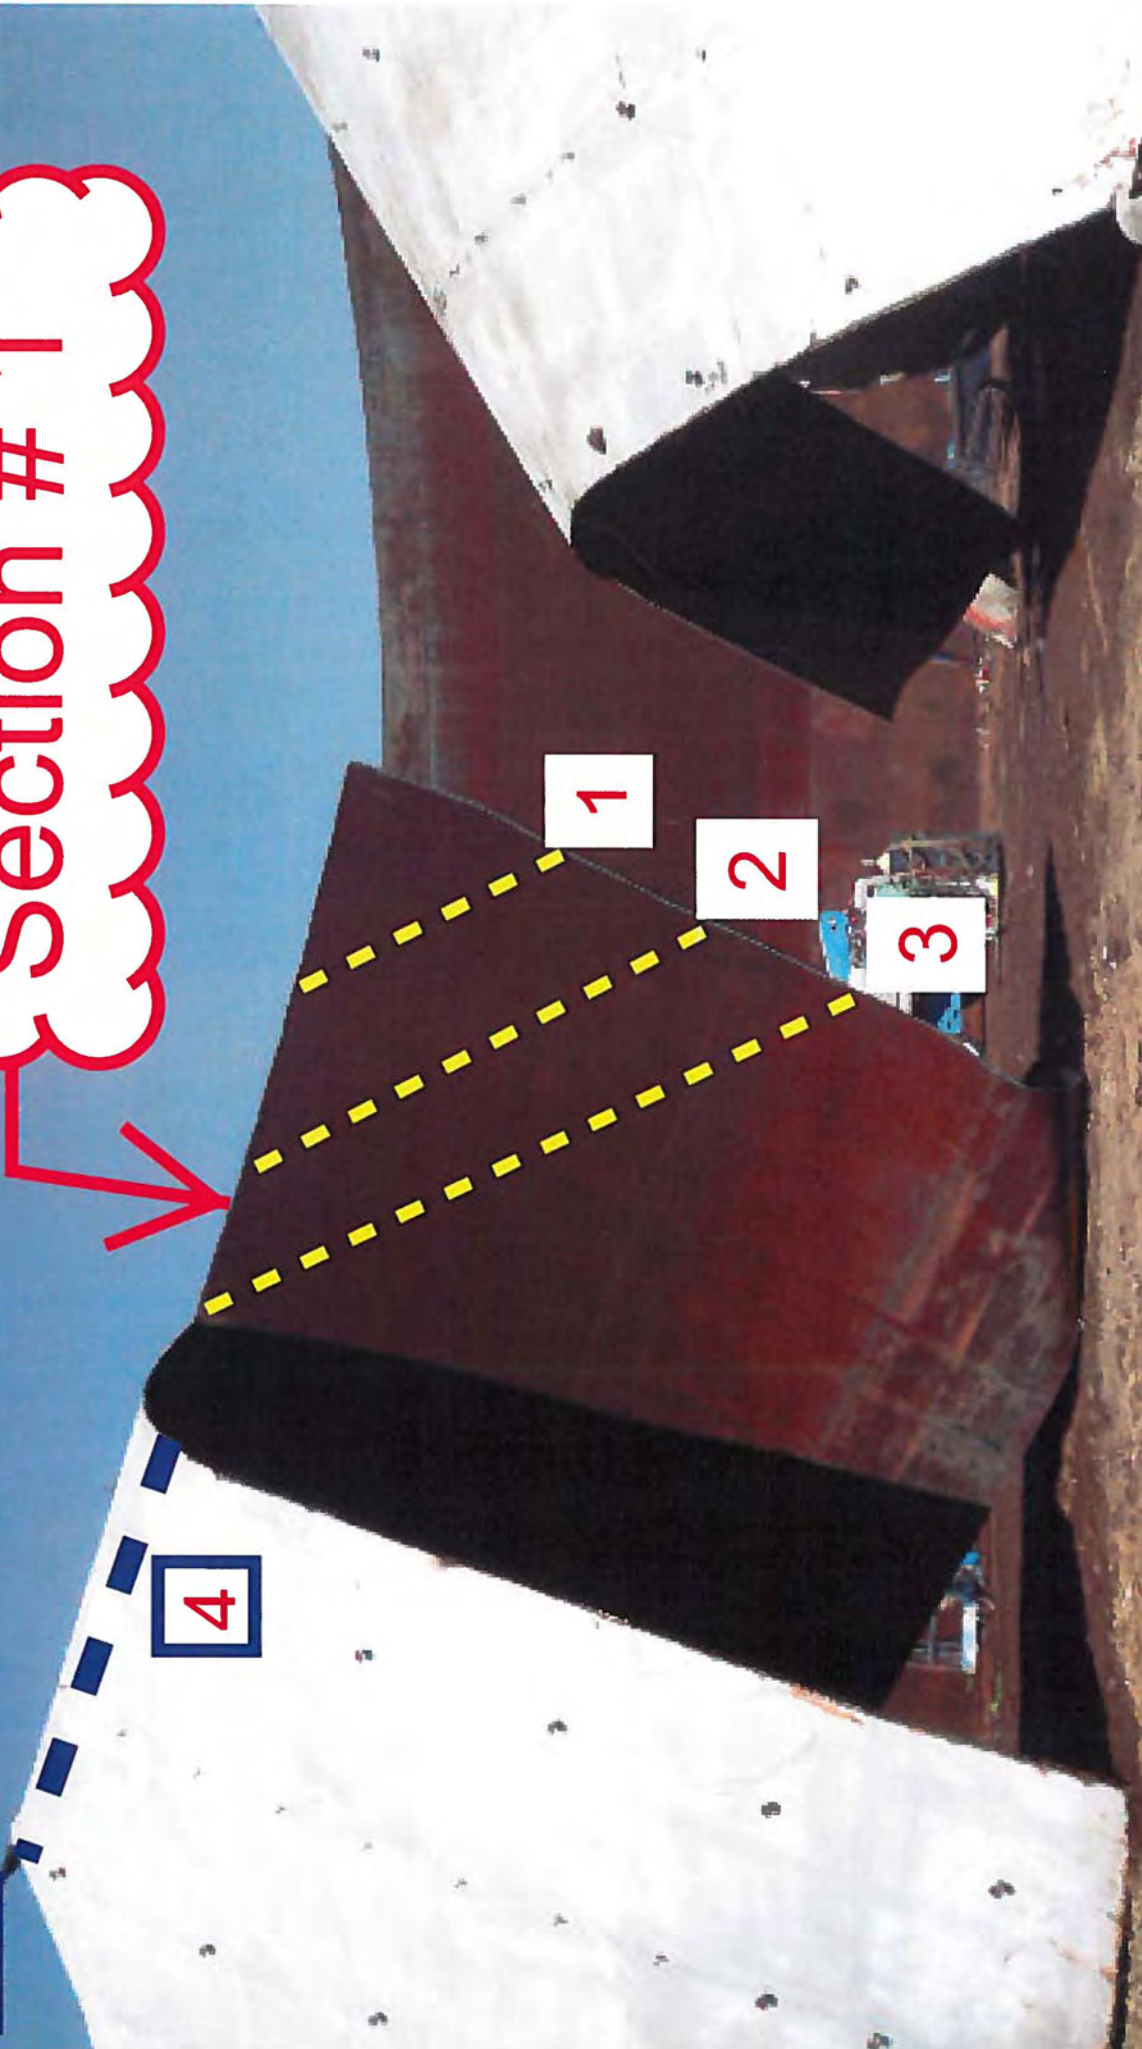
1. Back drag and level tank perimeter areas for boom lift operations using a track loader
2. Torch man will work from a boom lift positioned outside the tank cutting 3 strips of the cantilevered portion of section #1 of the tank finishing with cut #4, felling the section within the tank(see photo #1)

Section # 1

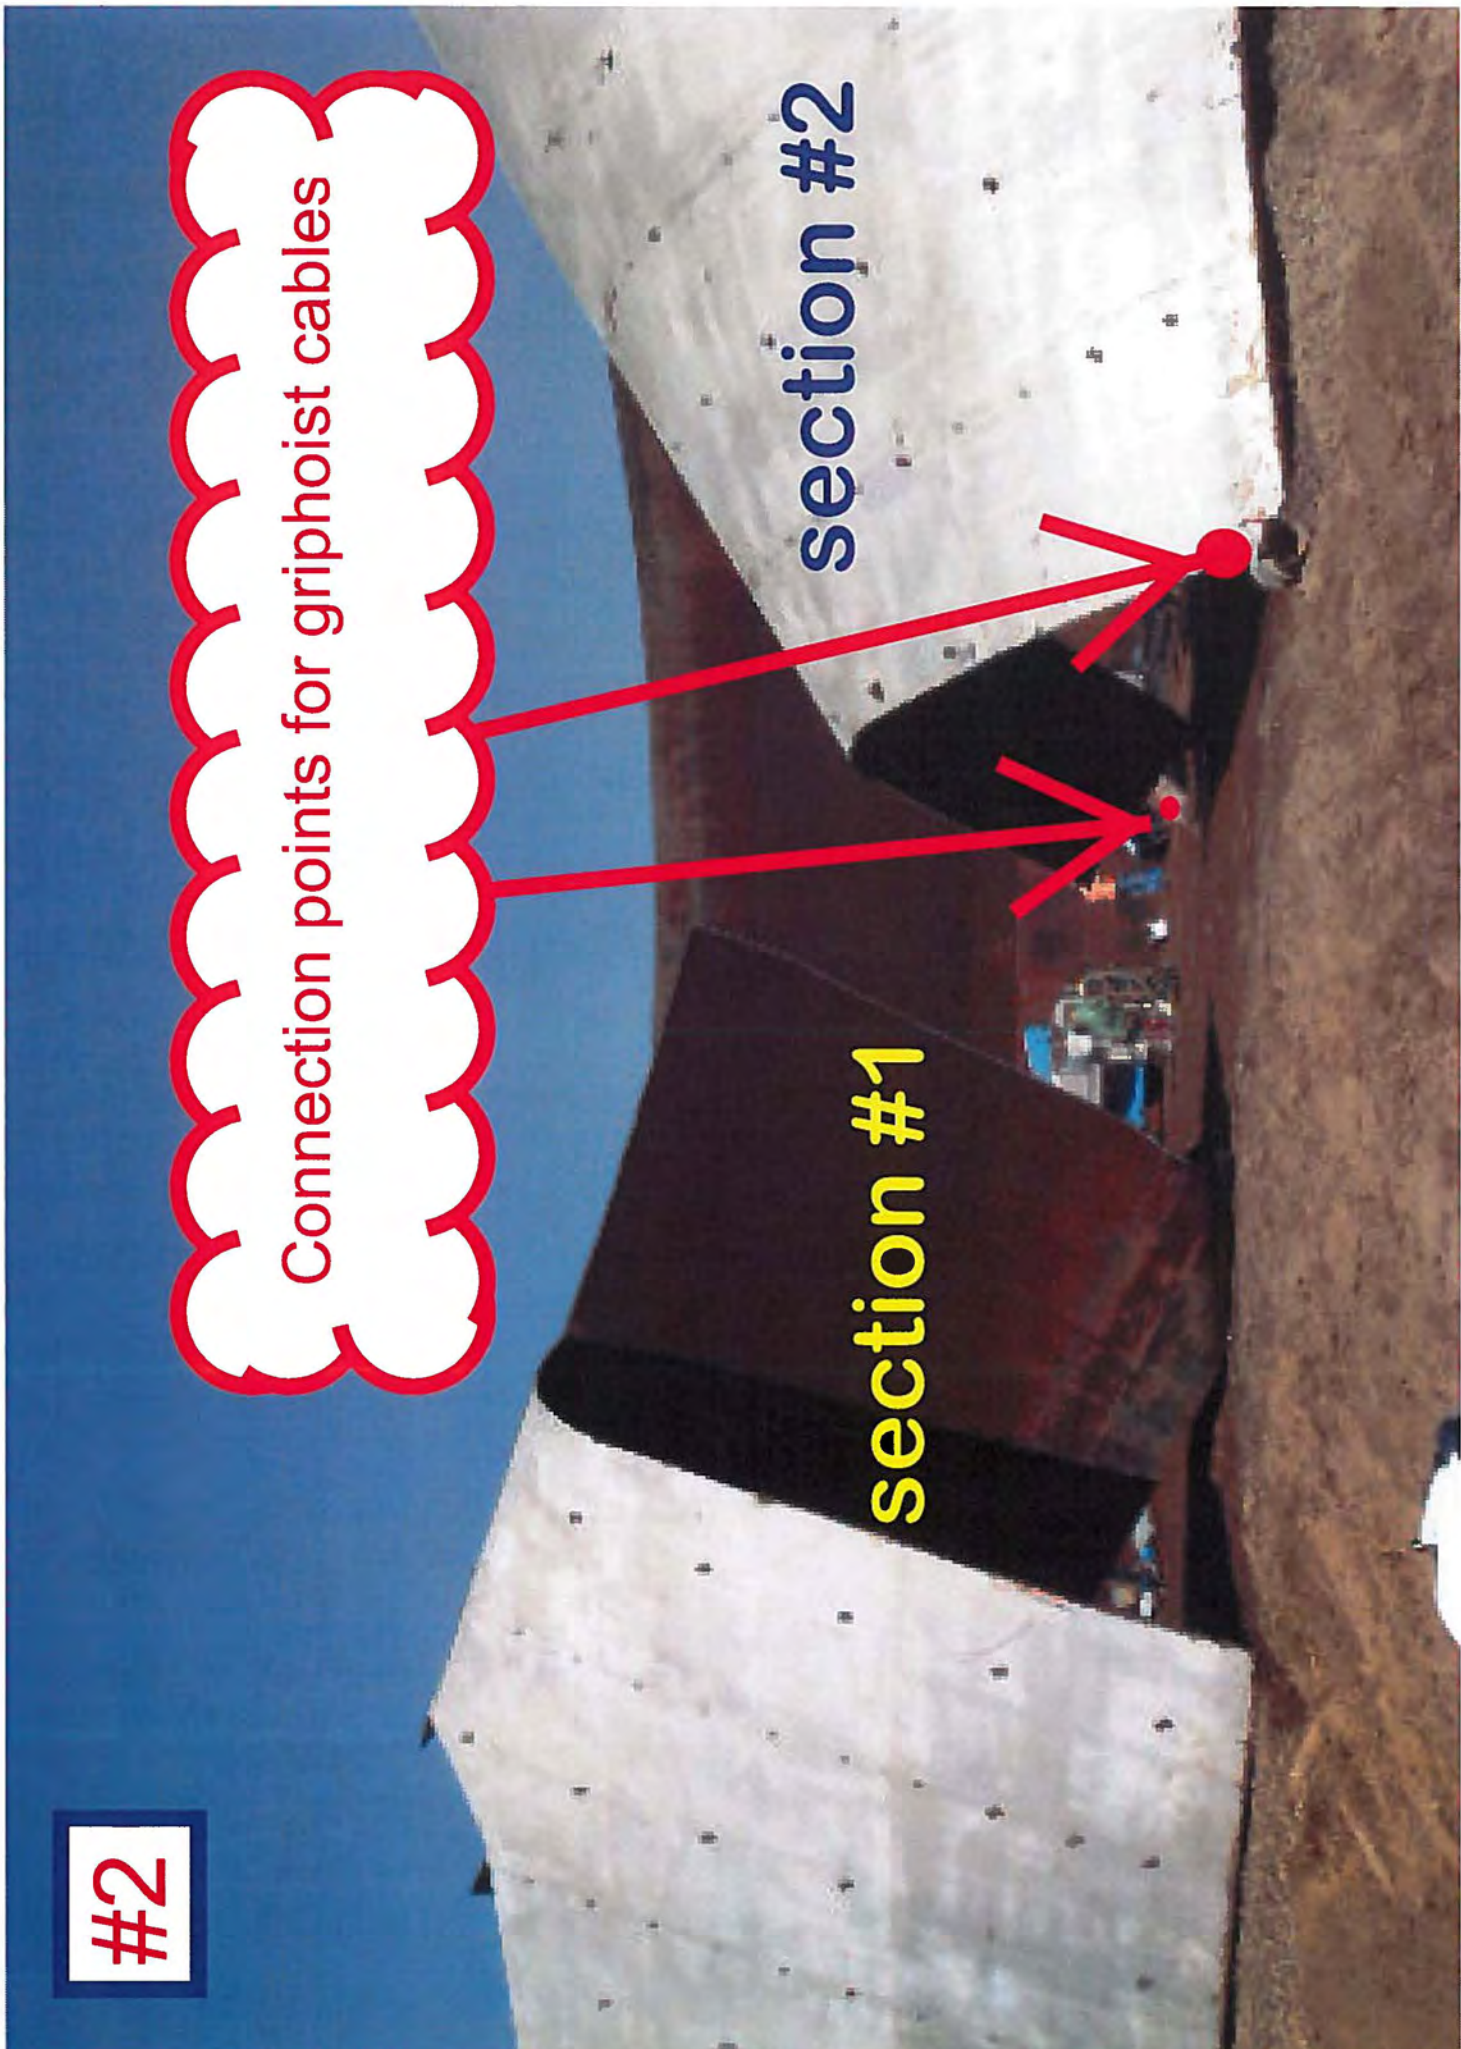
#2

Connection points for griphoist cables

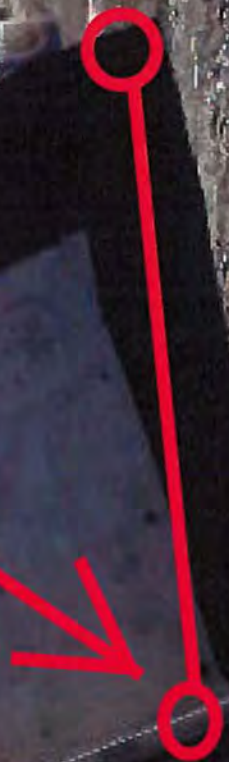
#3

griphoist cable connection point to failed section @ stiffener plate

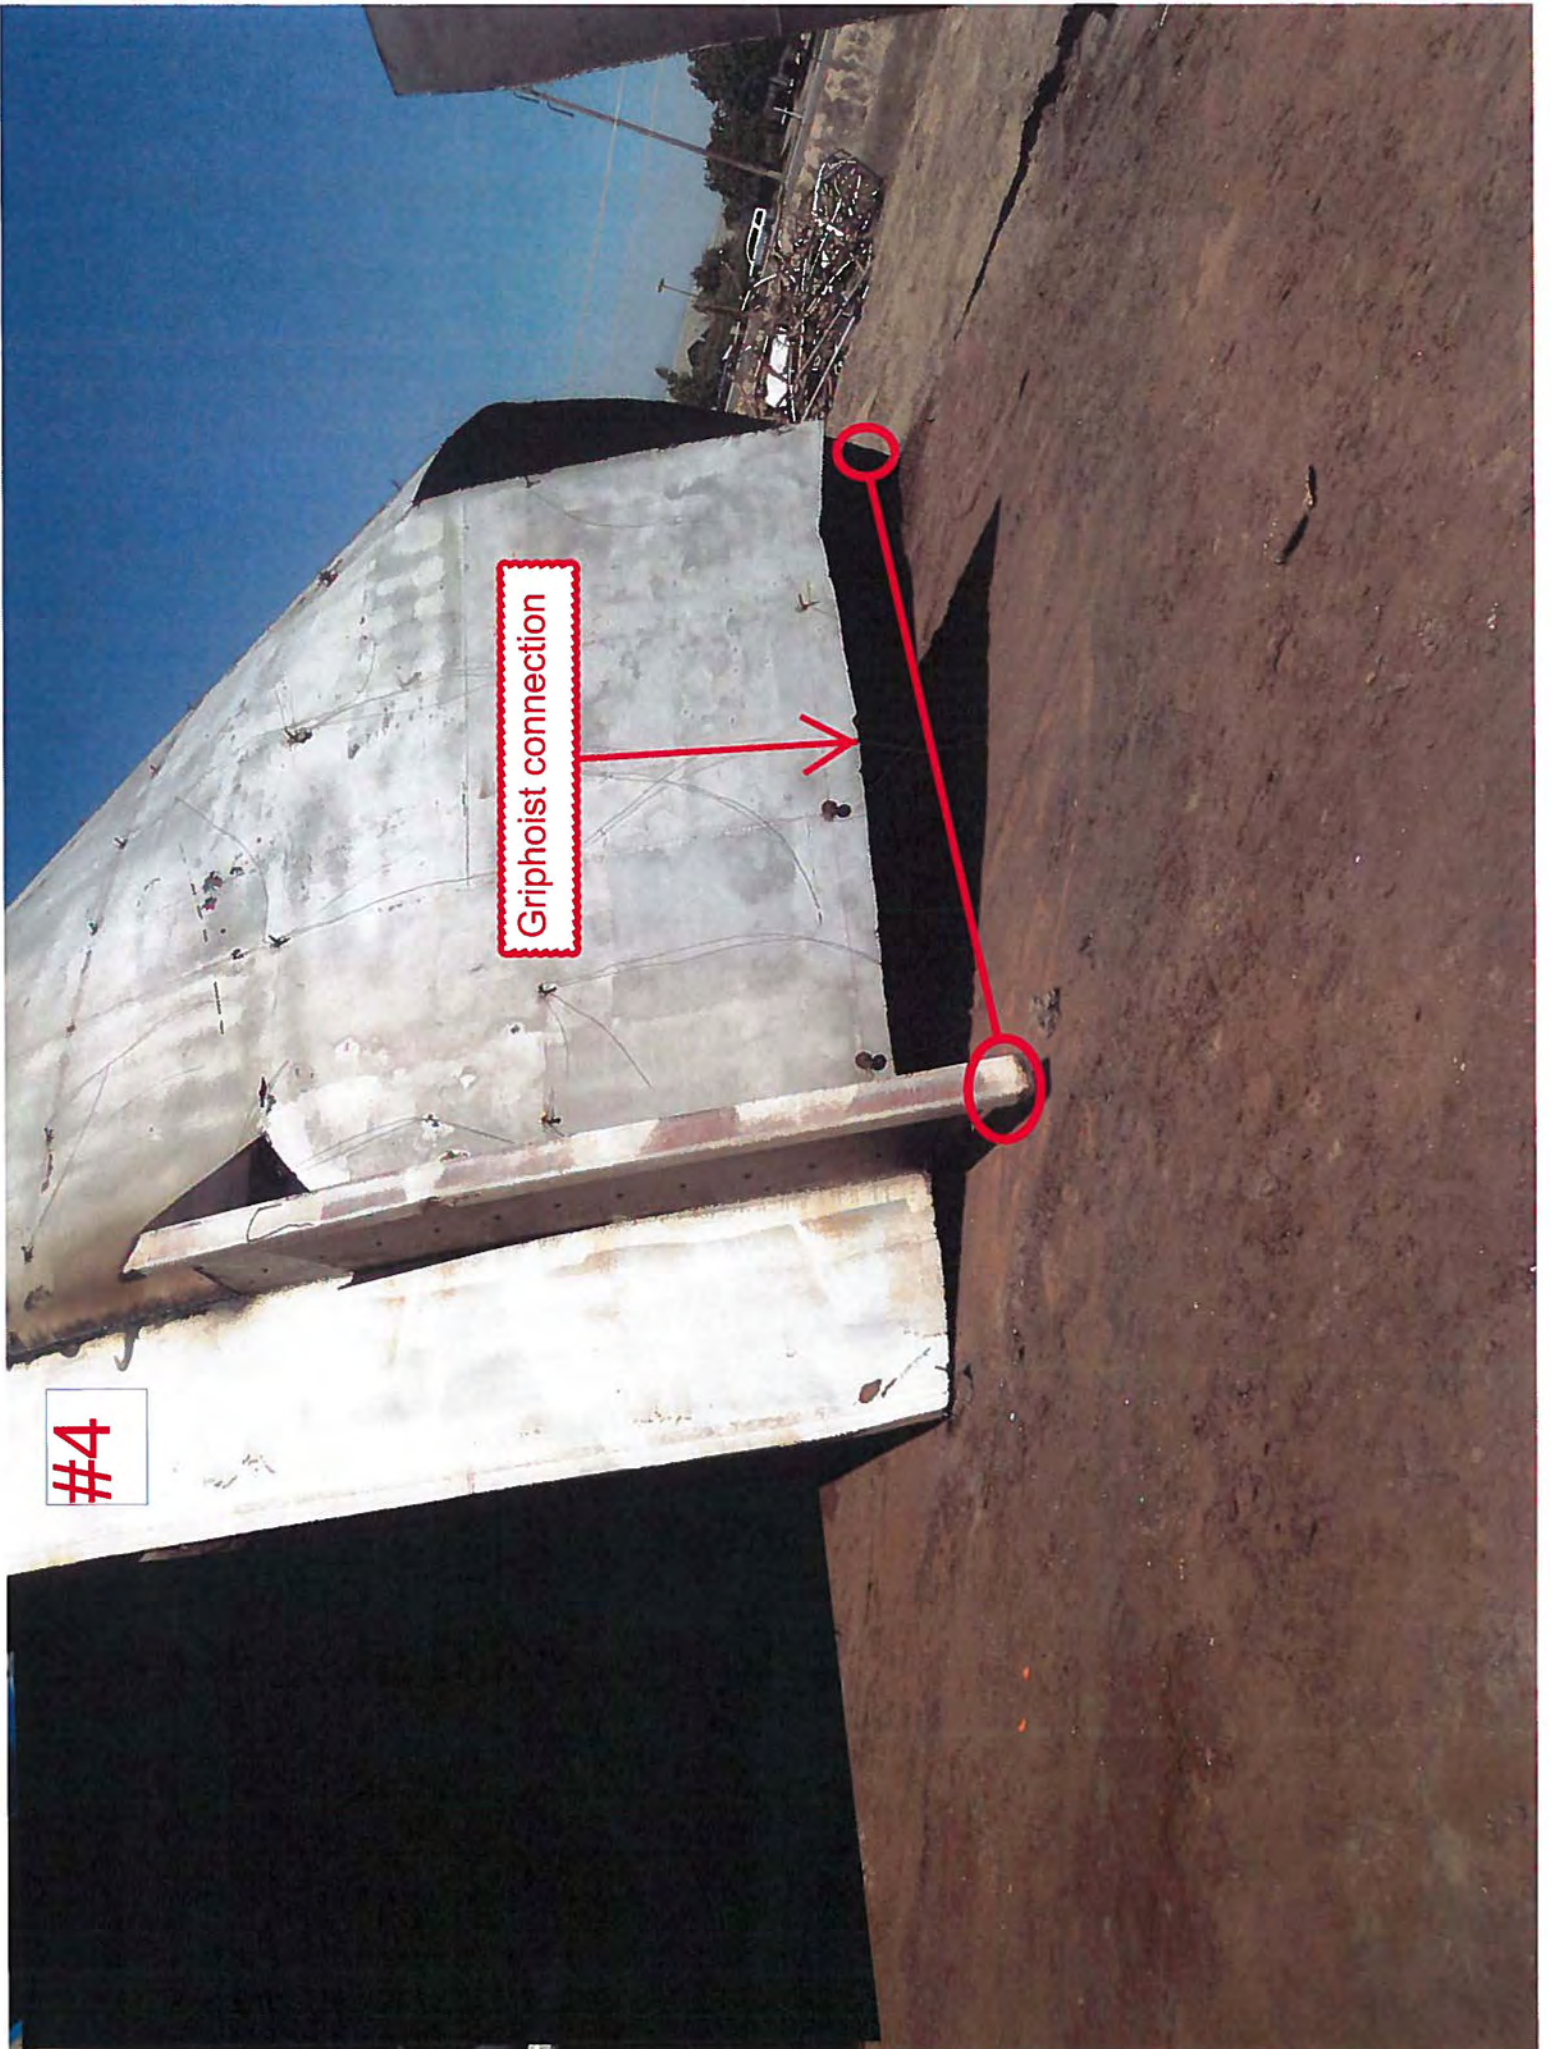
#4

Griphoist connection

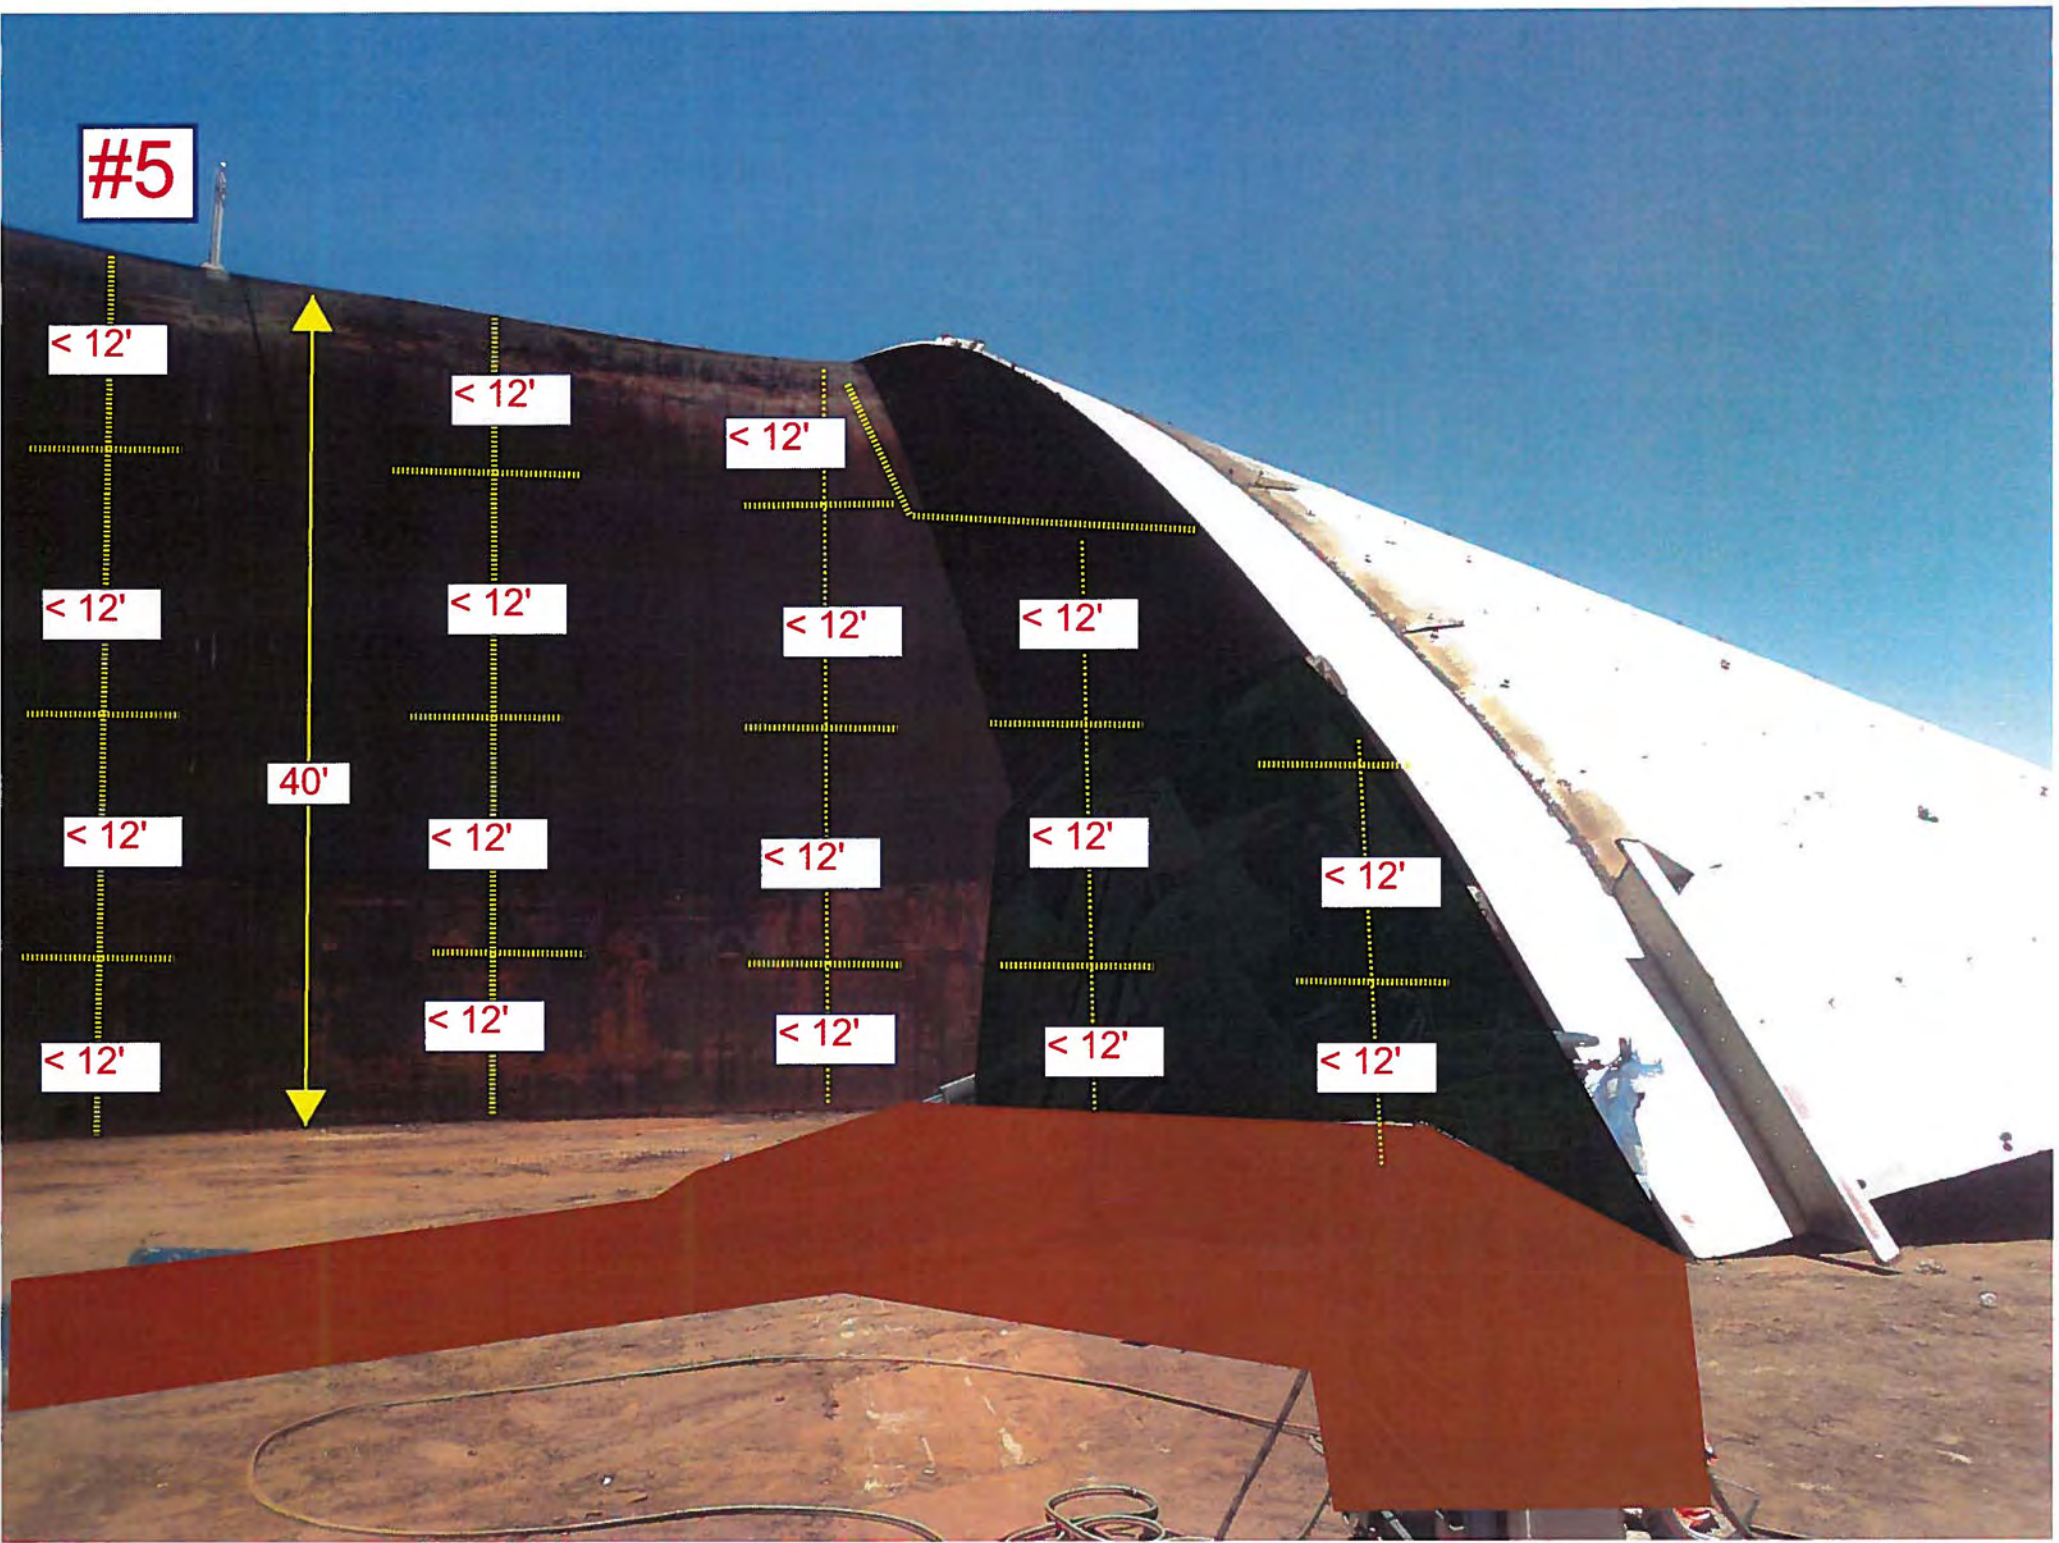
Normal tank removal activities will resume working from the outside of the tank as detailed in photo #5 and the tank removal plan enclosed

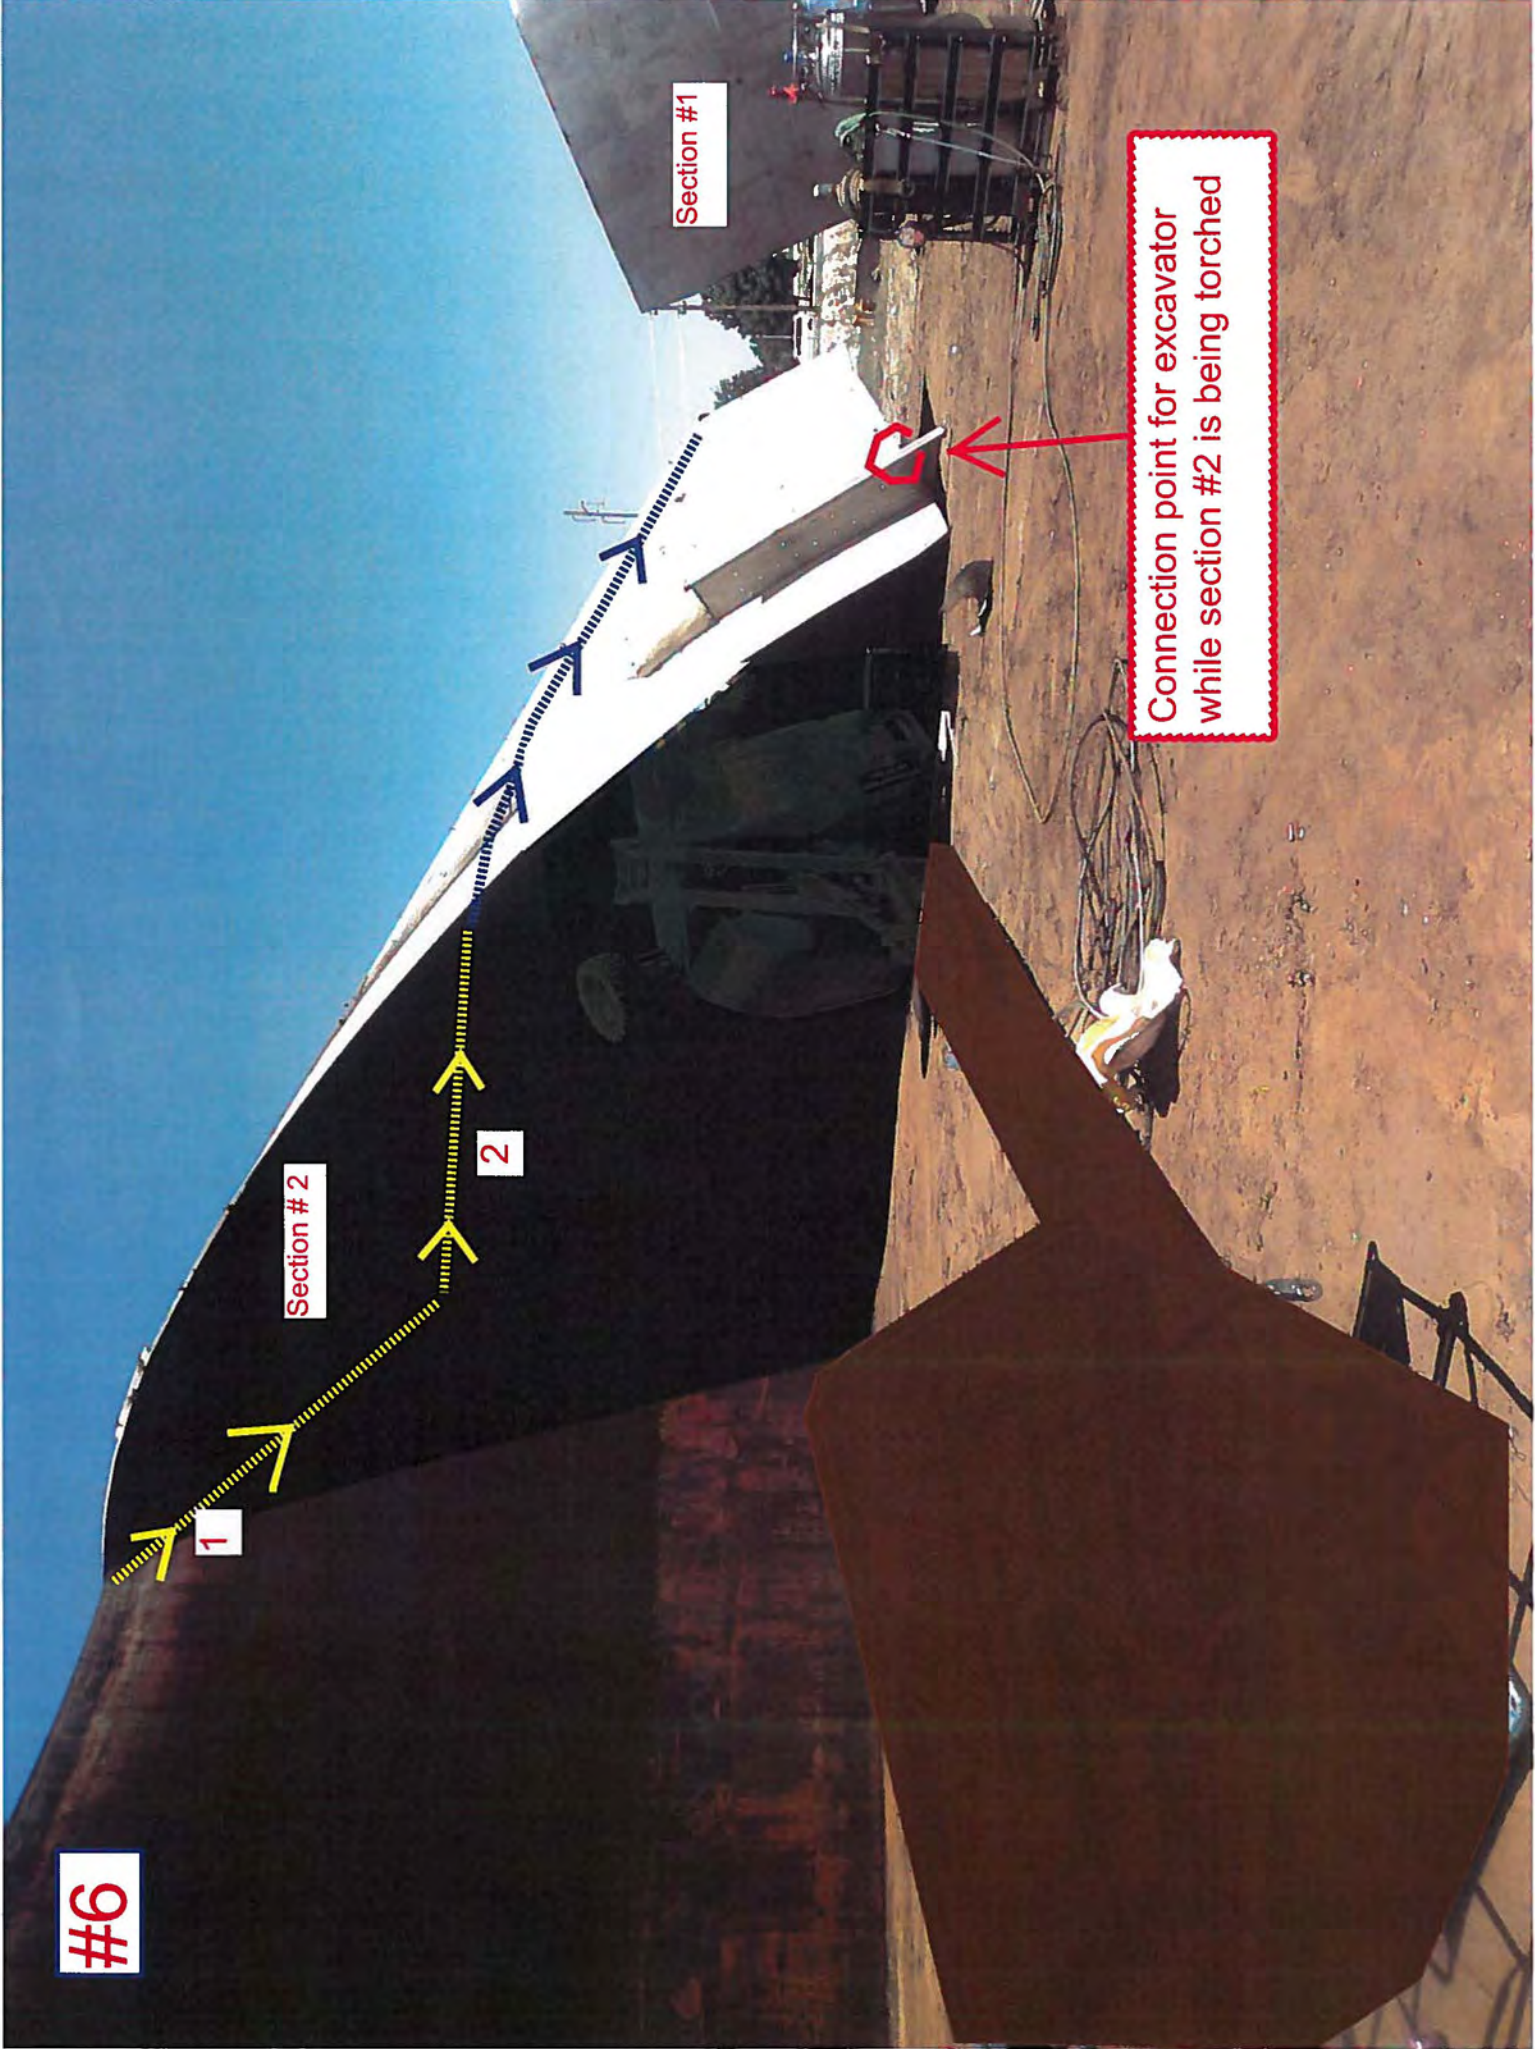
3. A grapple mounted excavator will remove fallen section #1 to a processing area.
4. The excavator will then re-position to the interior of the tank and secure the grapple to the stiffener plate as indicated in photo #6. This will stabilize section #2 while the curvature is removed by torching.

5. Torch man will work from boom lift positioned outside section #2 of the tank and begin torch cutting along cut line 1 down to ring #3 of the tank.
6. Torching will continue laterally along ring #3 as illustrated with line 2 of photo #6 through to the north end of the section.

Connection point for excavator while section #2 is being torched
