California Public Utilities Commission

**INVESTIGATION REPORT  
OF THE  
JUNE 19, 2012 FATALITY AT THE  
KERN POWER PLANT OWNED BY  
PACIFIC GAS AND ELECTRIC COMPANY**

**PUBLIC REPORT**

**PREPARED BY THE SAFETY AND ENFORCEMENT DIVISION  
ELECTRIC SAFETY AND RELIABILITY BRANCH**

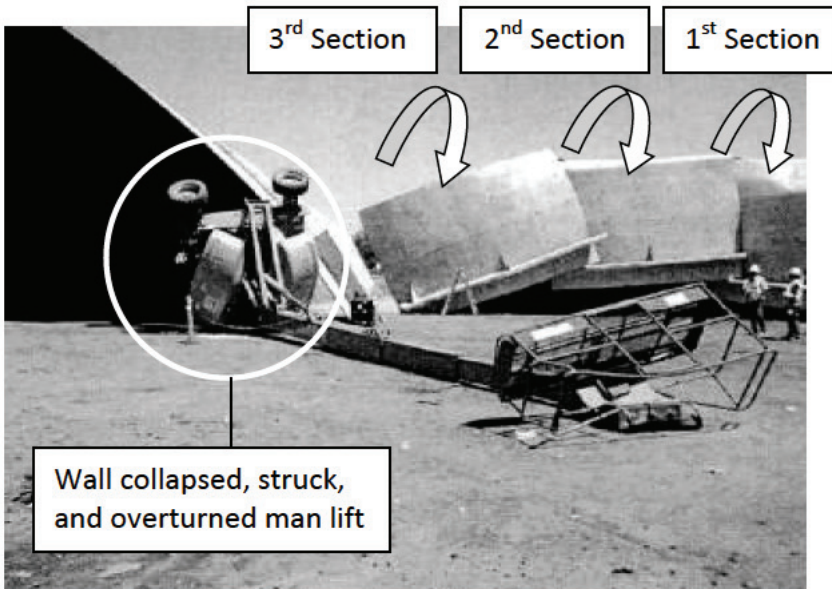
Figure 5: Overturned man lift inside Fuel Oil Tank #1.

The crew used this method to cut down three sections. On the fourth section, the superintendent stepped away and told the torch cutters to rest, expecting the crew would not resume work until his return. The crew resumed work before the superintendent returned. The torch cutter who sustained the fatal injuries made a vertical cut just above the rectangular tank access opening cut the previous day. The torch cutter signaled completion of the cut, and the excavator pushed in. But this time, not only did the newly cut section fold in, but the portion of the tank wall from which the section was

cut collapsed inward as well. The collapsing wall struck the man lift carrying the torch cutter. The lift overturned and fell to the ground. The other workers stopped the project immediately. An ambulance transported the worker to a local hospital. The worker did not survive the injuries.<sup>2</sup> PG&E reported the incident to ESRB on June 19, 2012, at 5:35 pm.<sup>3</sup>
