SCE VALLEY SOUTH SUBTRANSMISSION PROJECT

Date: November 14, 2019
To: Eric Chiang, Project Manager, CPUC
From: Vida Strong, Aspen Project Manager
Subject: Monitoring Report #15: October 27, 2019 to November 9, 2019

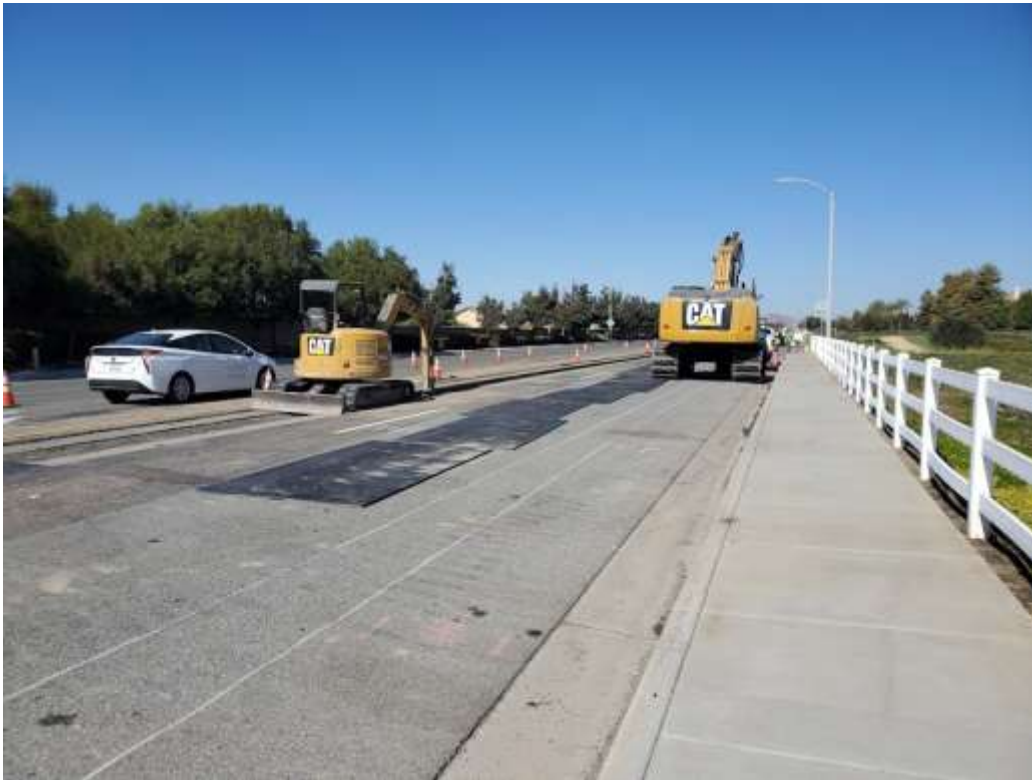
2. BMP inspections and maintenance occurred at TSP foundation locations in Segment 1.
3. Cattrac continued cutting asphalt and trenching and installing conduit in the duct bank trench between Vault 2B and Vault 3B, as well as excavation between Vault 1 and Vault 2B for the southern underground section on Leon Road (Construction Areas UNK207 through UNK222)(see Photo 1).

Photo 1 – Construction activities on the southern underground (November 6, 2019).

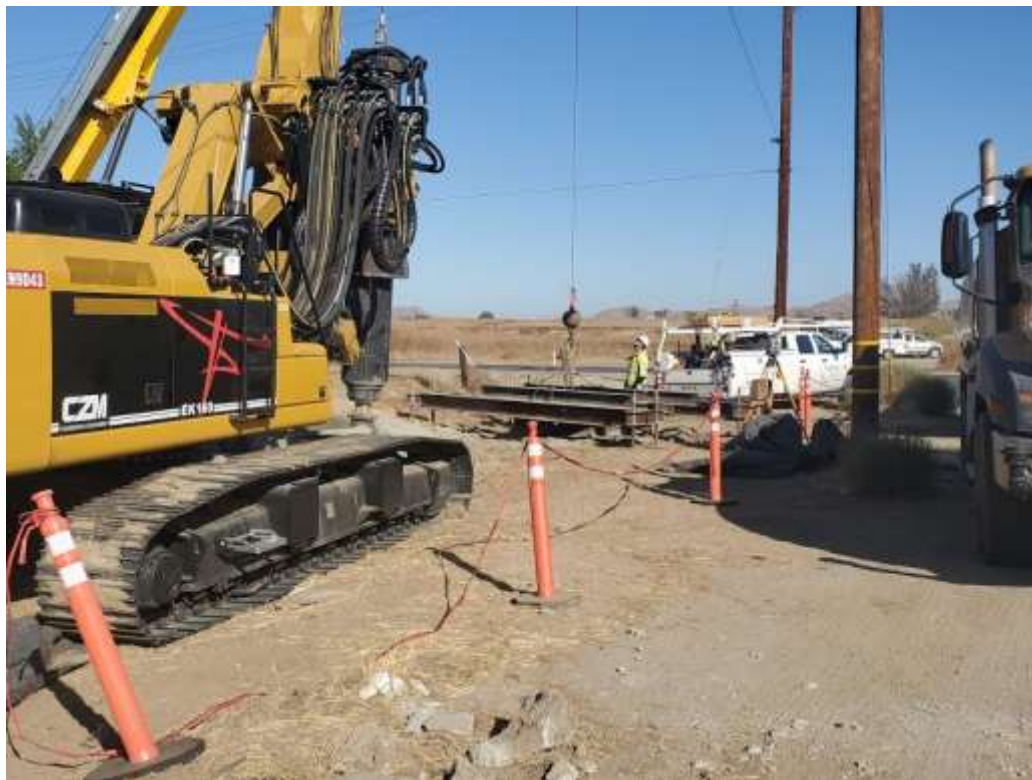
5. KV Structures construction activities included foundation activities at Construction Areas UNK19, UNK41, UNK42, UNK115, and UNK155 on Segment 1 (see Photo 2).

Photo 2 – Foundation activities at Construction Area UNK155 (October 28, 2019).

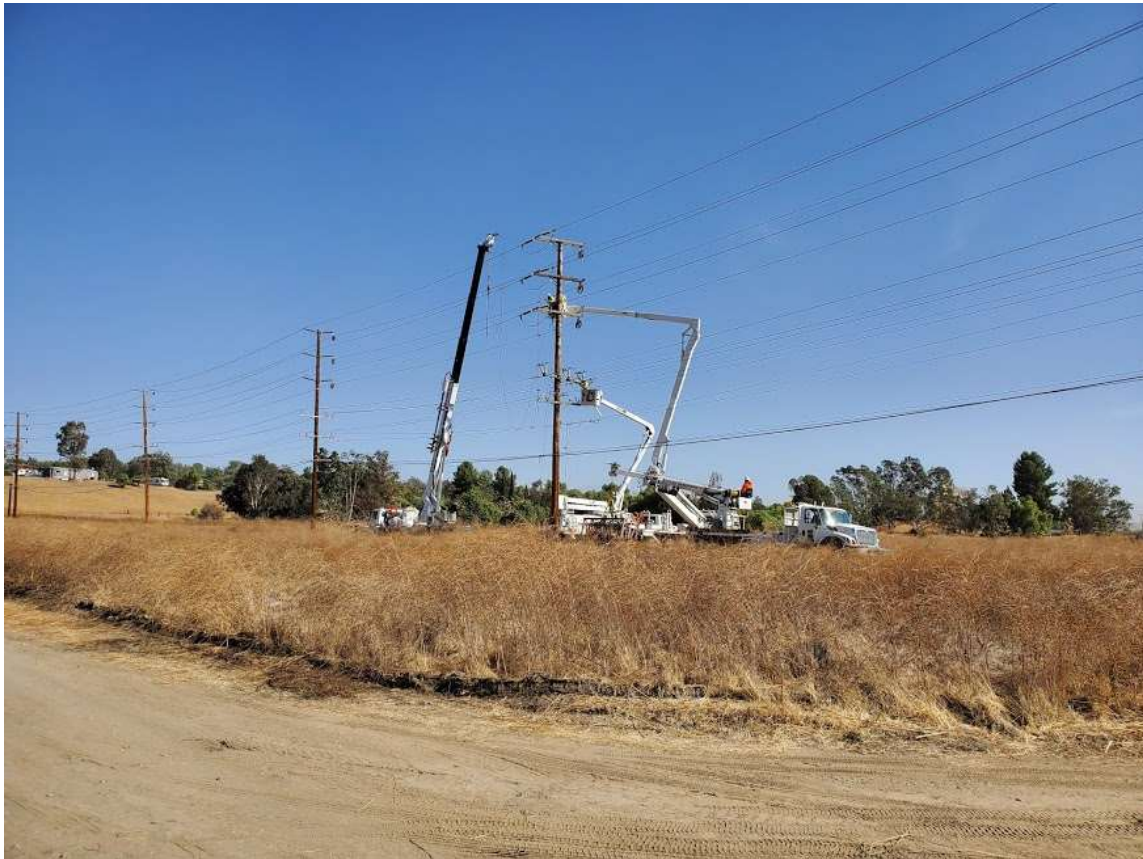
6. Wilson construction activities on Segment 2 included: prepping, declipping, and replacing pole 4402074E; reconductoring the Morris 12 kV line on poles 4402061E through 4402075E and 4402033E through 4402061E (see Photo 3); lowered distribution arms at poles 4402059E and 4402063E; worked on jumpers at poles 4402074E and 2202075E; and completed installation of stabilized entrances for right-of-way roads at the southern end of Segment 2 starting at Nicolas Road and moving north towards Benton Road.

Photo 3 – Reconducting activities on Segment 2 (October 30, 2019).
