SCE VALLEY SOUTH SUBTRANSMISSION PROJECT

Date: April 30, 2020
To: Eric Chiang, Project Manager, CPUC
From: Vida Strong, Aspen Project Manager
Subject: Monitoring Report #26: April 12 to April 25, 2020

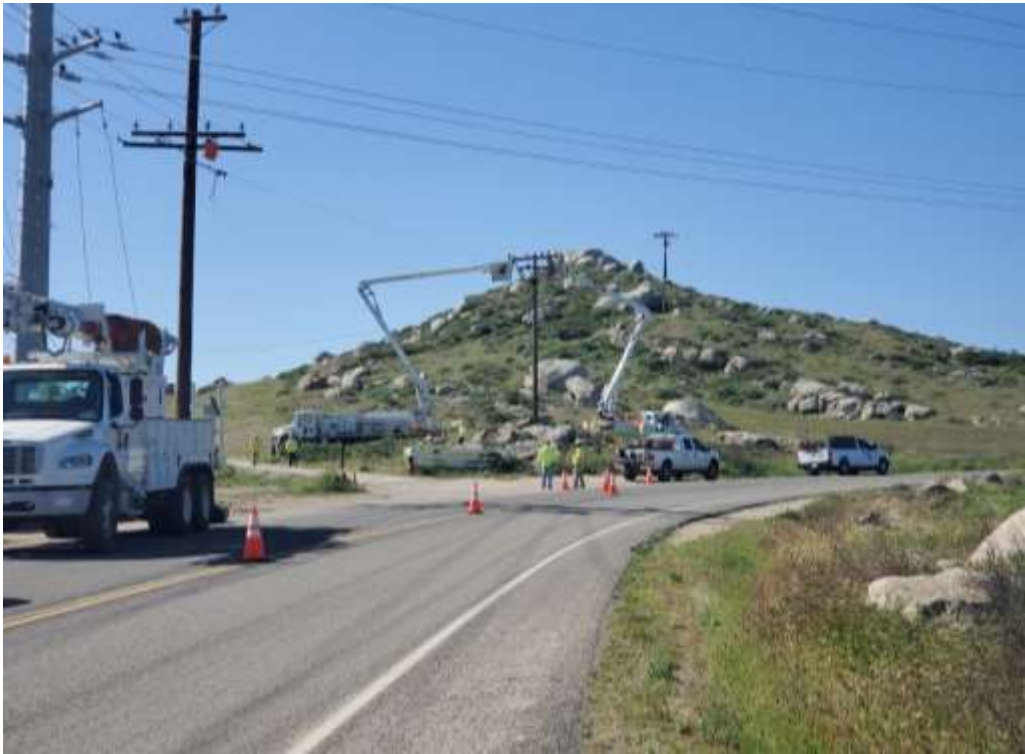
2. BMP inspections and maintenance occurred at TSP foundation locations in Segment 1.
3. Wilson Construction activities on Segment 1 included: Hauling, framing, and setting wood poles at Construction Areas UNK48, UNK56, UNK57, UNK59, UNK71, UNK73, UNK75, and UNK77 through UNK80; installing transformers at Construction Areas UNK145, UNK107 through UNK112 and pole 4032038E; switch installation at pole 4606518E and Construction Area UNK38; guy wire work at Construction Areas UNK141 and UNK62; anchor and crossarm work at pole 2091014E; installing rock anchors at Construction Areas UNK84, UNK85, UNK86, and UNK96; preparation for shoofly at pole UNK39 to pole 4606541E; preparation for reconductoring activities at poles 4606518E through 4606520E; replacing distribution poles 4782356E, 4782358E and 4393118E; distribution cutover activities at Construction Areas UNK20 through UNK46, and UNK138 through UNK154; installing distribution arms at pole 4393118E; reconductoring activities at Construction Areas UNK126, poles 4032041E through Construction Area UNK 140, UNK253 through UNK141, and UNK147 to 4058629E; changing arms at poles 4058629E and 4937058E; lowering arms at pole 4726838E; installing underground risers at UNK21 and UNK27; tapline work at pole 4032039E; installing arms and wire at Construction Areas UNK32 through UNK37; wreck-out of distribution poles and wire at Construction Areas UNK95 through UNK115 and UNK154 through 4937061E; lowering phases at poles 4726838E, 4726839E, and 4605894E; reconductoring and energization at Construction Areas UNK118 to 20901014E, UNK115 to 2105782E, UNK114 to 2113203E, UNK20 to 4532622E, and 4606541E (see Photo 1); and removing jumpers at poles 4606520E through 4606518E.

Photo 1 – Reconductoring activities at Construction Area UNK115 to pole 2105782E (April 22, 2020).

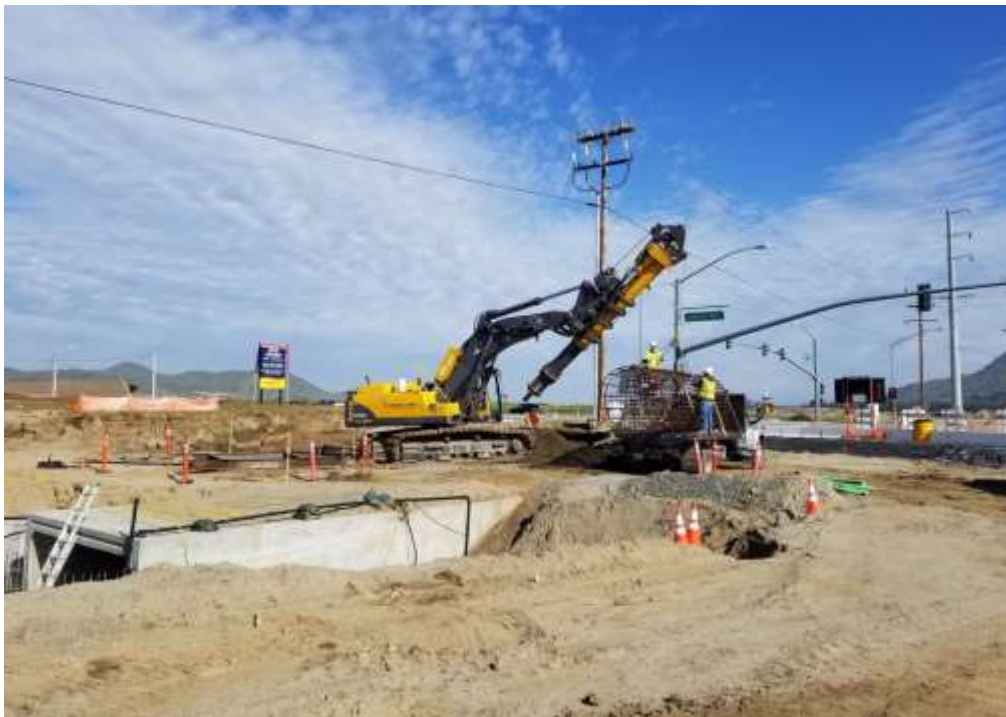
4. KV Structures completed the last foundation at UNK47 (see Photo 2).
5. Wilson Construction activities on Segment 2 included watering restoration sites at poles 4402023E, 4402024E, 4402027E, 4402028E, 4402043E, 4402061E, and 4402062E.

Photo 2 – KV Structures foundation activities at UNK47 (April 17, 2020) (Photo courtesy of SCE).

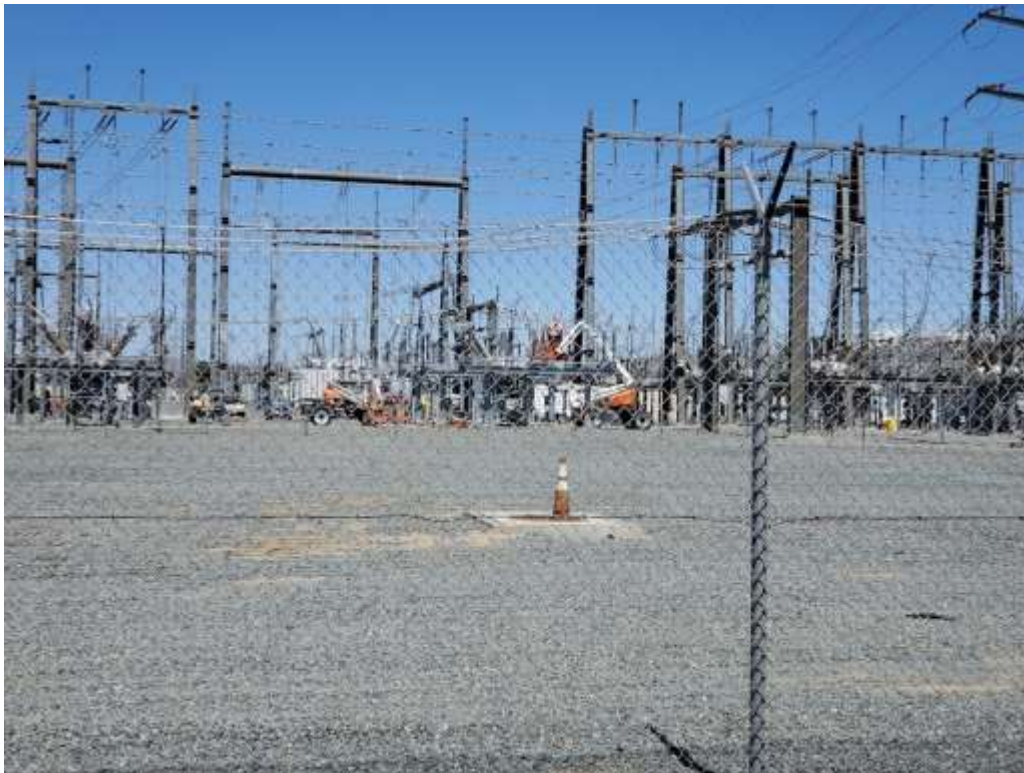
6. SCE self-perform construction activities within the Valley Substation included wiring within the MEER building and the 115 kV rack (see Photo 3).

Photo 3 – Construction activities on the 115 kV rack within the Valley Substation (April 15, 2020).

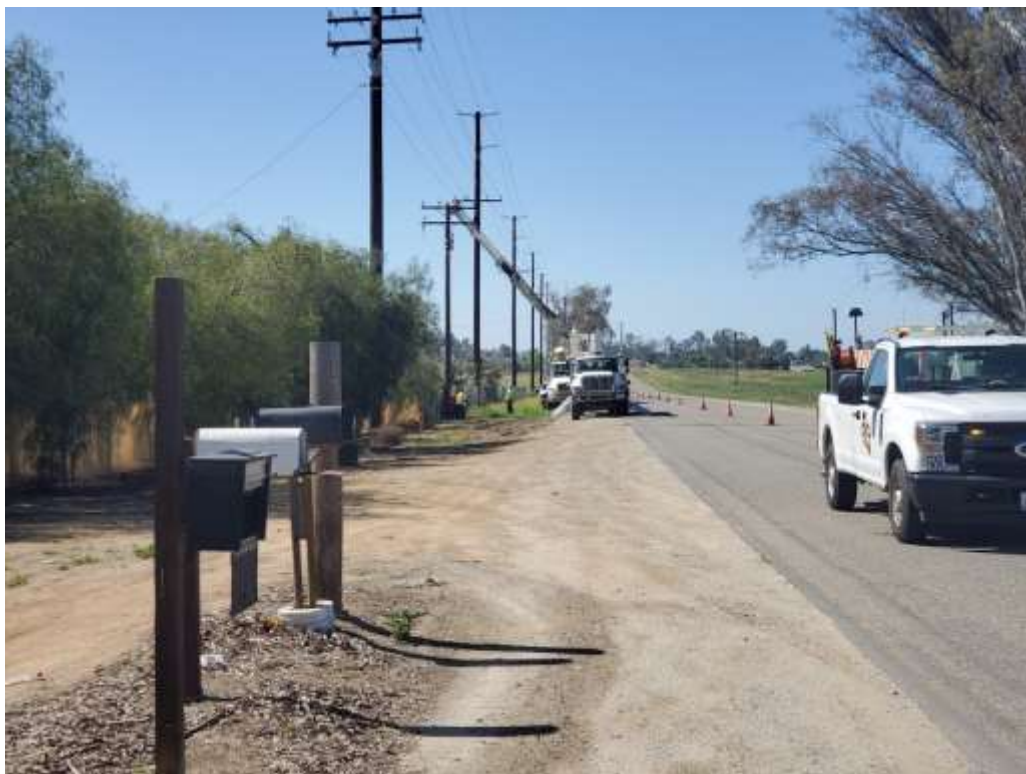
1. Biological, cultural, paleontological, and Native American monitoring occurred during construction activities.
2. On April 22, the CPUC EM observed existing pole wreck-out construction activities, including traffic control on Leon Road, within 300 feet of an active red-tailed hawk nest near UNK142 (see Photo 4). Upon review of Collector data, the red-tailed hawk nest showed a buffer of only 100 feet. A nest buffer reduction had been previously submitted by SCE for this nest on January 28, 2020. The reduction was from 300 feet to 100 feet for pole installation and wire stringing activities with a duration of 60 days. The request did not include pole wreck-out activities and expired on March 28, 2020. SCE was notified of the CPUC EM's observations at 10:12am. SCE stated the crew would move out of the nest buffer when it was safe to do so, and SCE would submit a nest buffer reduction. The nest buffer reduction was received at 11:21am and the CPUC EM issued a Level 1 incident report for non-compliance the Nesting Bird Management Plan which states, "Once the project activity is complete, the buffer will revert back to the original established buffer". SCE responded on April 28, stating Wilson's environ-

3. There was one SCE self-reported incident documented throughout the monitoring period that was in response to the CPUC Level 1 incident documented on April 22, 2020 and described above. Additionally, SCE included in their weekly report a Level 1 incident on March 5, 2020 for the Level 1 incident report documented by the CPUC EM for weekly reporting issues. The incident was discussed in the VSSP Monitoring Report #23 (also see Table 3 below).

Photo 4 – Pole wreck-out activities and traffic control within active red-tailed hawk buffer at UNK142 (April 22, 2020).

mental manager and field lead will review buffers in FRED bi-weekly to review status of active nests, upcoming expirations of requested reductions, and checking upcoming work activities with the approved activities listed in FRED. Additionally, as work activities are completed, reduced buffers will be set back to the default buffer size in FRED and re-staked in the field accordingly.
