SCE VALLEY SOUTH SUBTRANSMISSION PROJECT

Date: May 14, 2020
To: Eric Chiang, Project Manager, CPUC
From: Vida Strong, Aspen Project Manager
Subject: Monitoring Report #27: April 26 to May 9, 2020

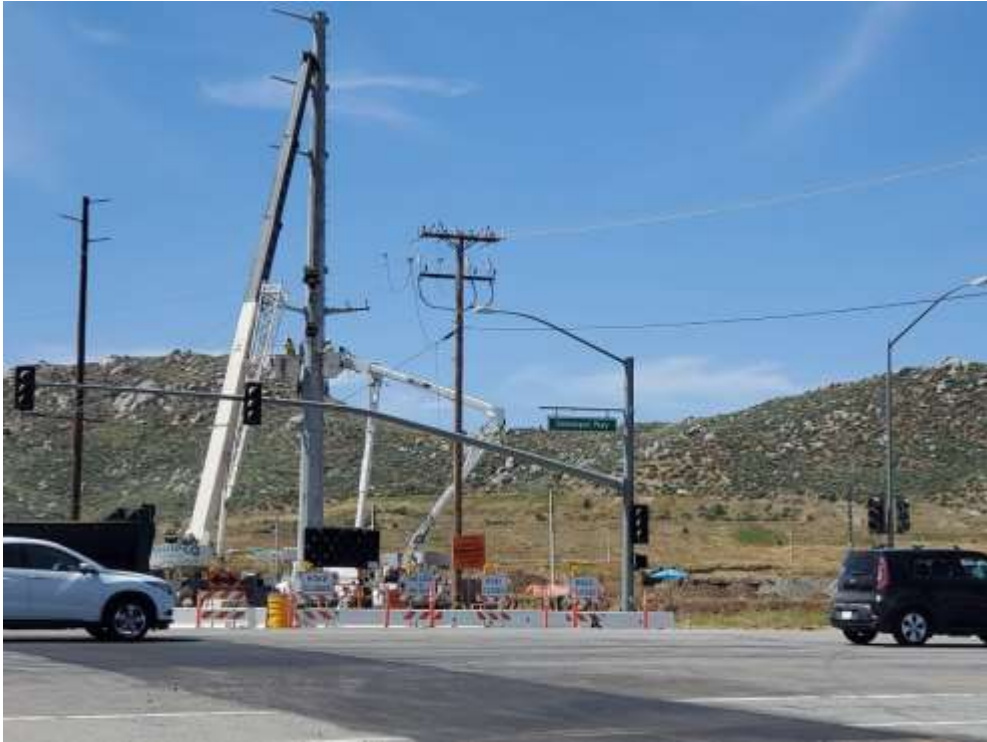
Photo 1 – Setting TSP at Construction Area UNK47 (May 6, 2020).

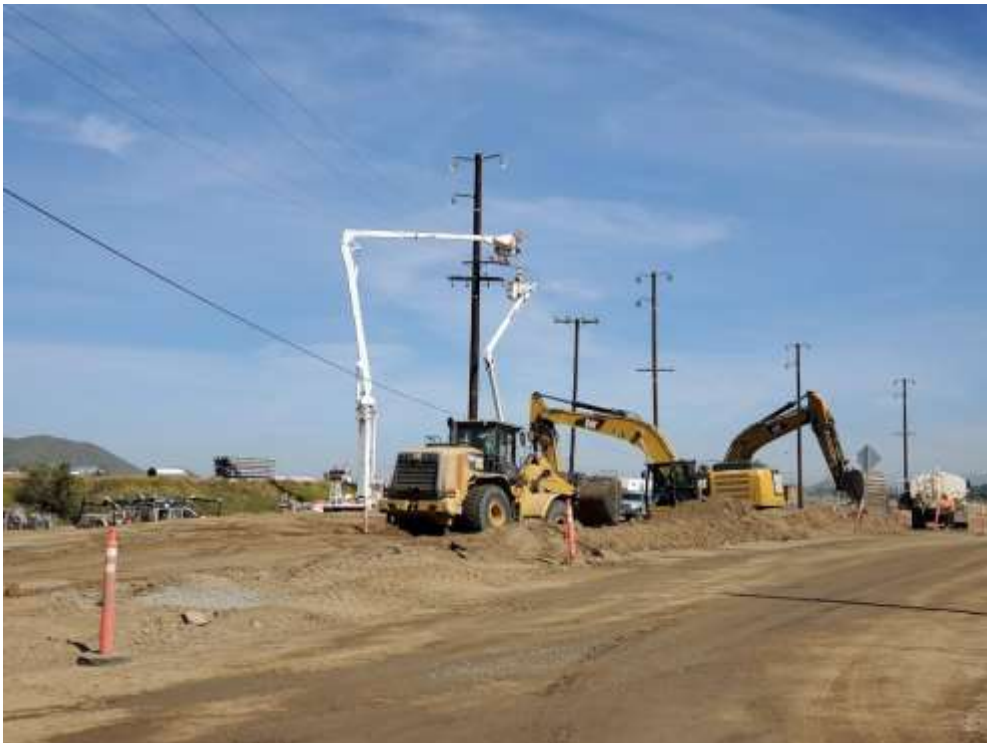
1. Biological, cultural, paleontological, and Native American monitoring occurred during construction activities.
2. There were no SCE self-reported incidents and one observation during the monitoring period. The observation was for non-project related construction activities on the right-of-way.

Photo 2 – Wire stringing activities at Construction Area UNK54. Please note that ground disturbing construction activities in the foreground of photo is non-project related. (May 6, 2020).

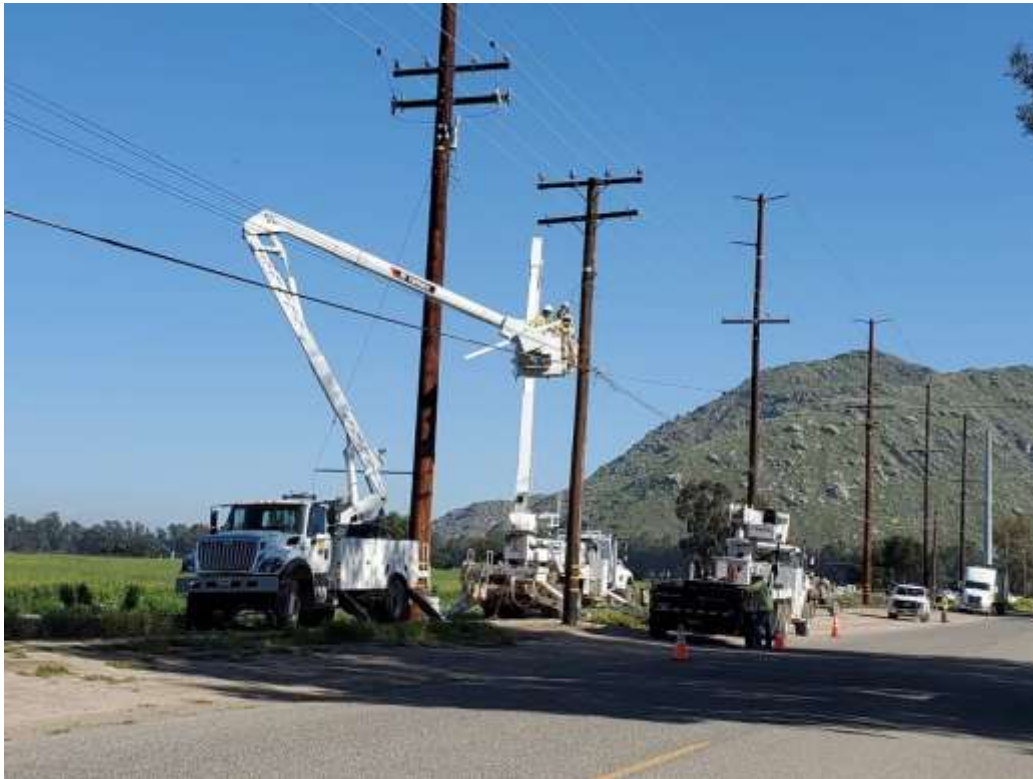
Photo 3 – Distribution cutover activities at Construction Area UNK25 (April 28, 2020).

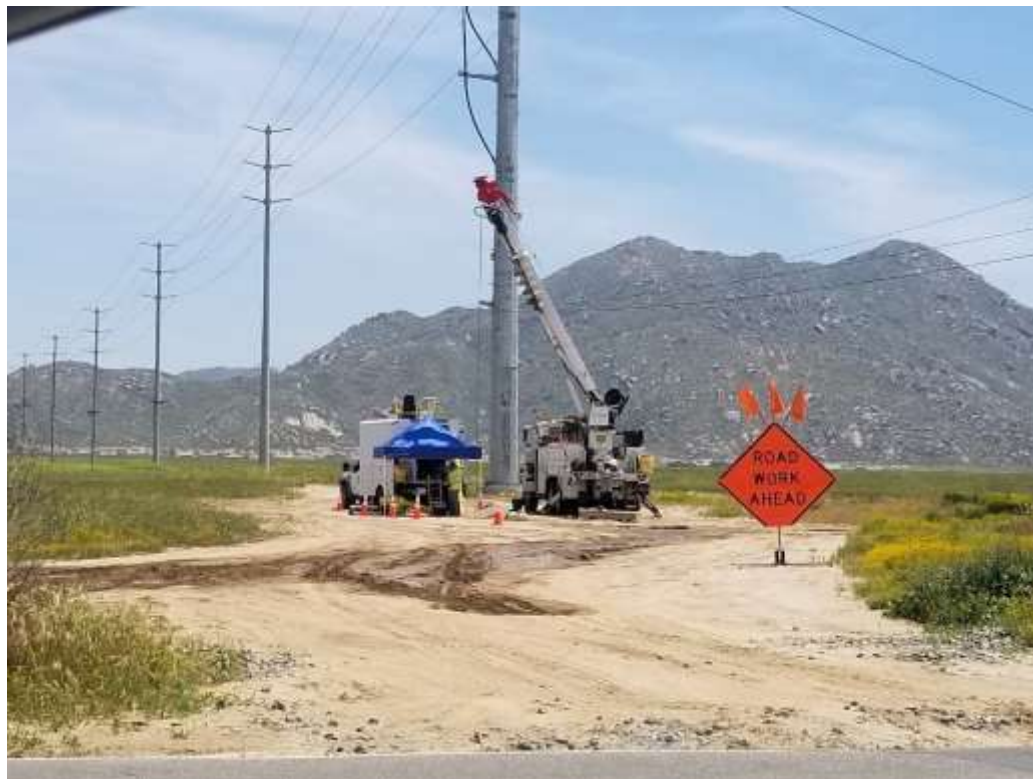
5. SCE self-perform construction activities within the Valley Substation included wiring inside the Meer building, 115 kV rack, and at vaults in the substation and Construction Area UNK250 (see Photo 4).

Photo 4 – SCE crews working in vault at Construction Area UNK250 (April 29, 2020)
(Photo courtesy of SCE).
