**SCE VALLEY SOUTH SUBTRANSMISSION PROJECT**

**Date:** November 12, 2020  
**To:** Eric Chiang, Project Manager, CPUC  
**From:** Vida Strong, Aspen Project Manager  
**Subject:** Monitoring Report #37: October 4 to November 7, 2020

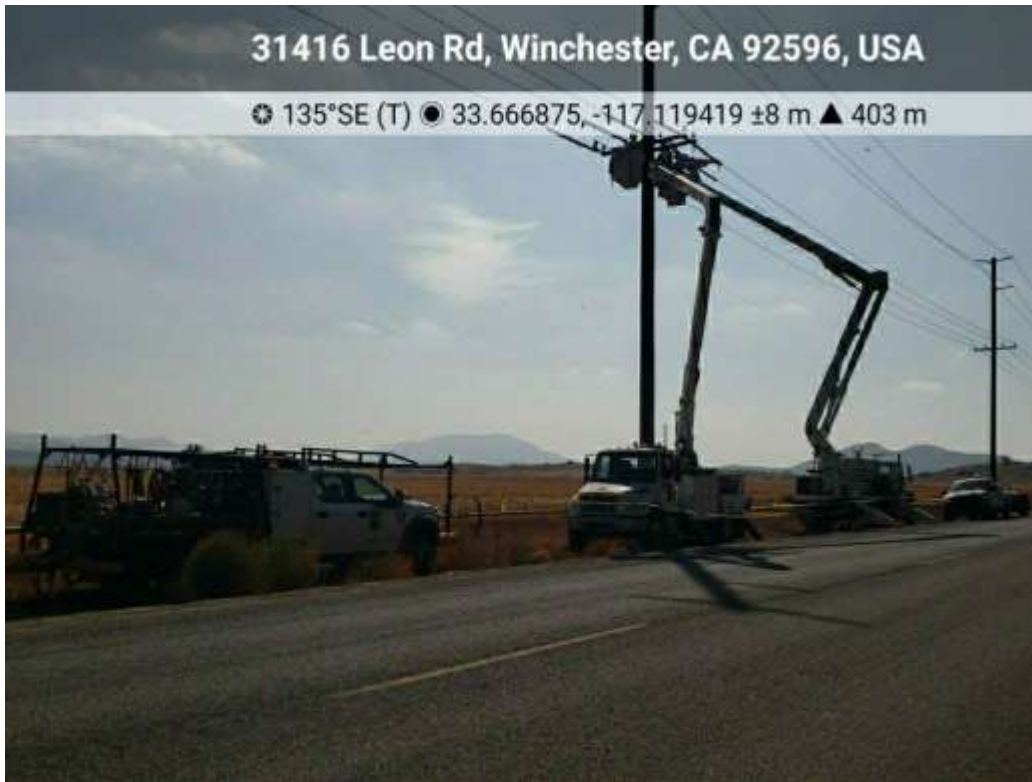
Photo 1 – Dead end installation at Distribution Pole 4936675E (October 22, 2020)  
(Photo courtesy of SCE).

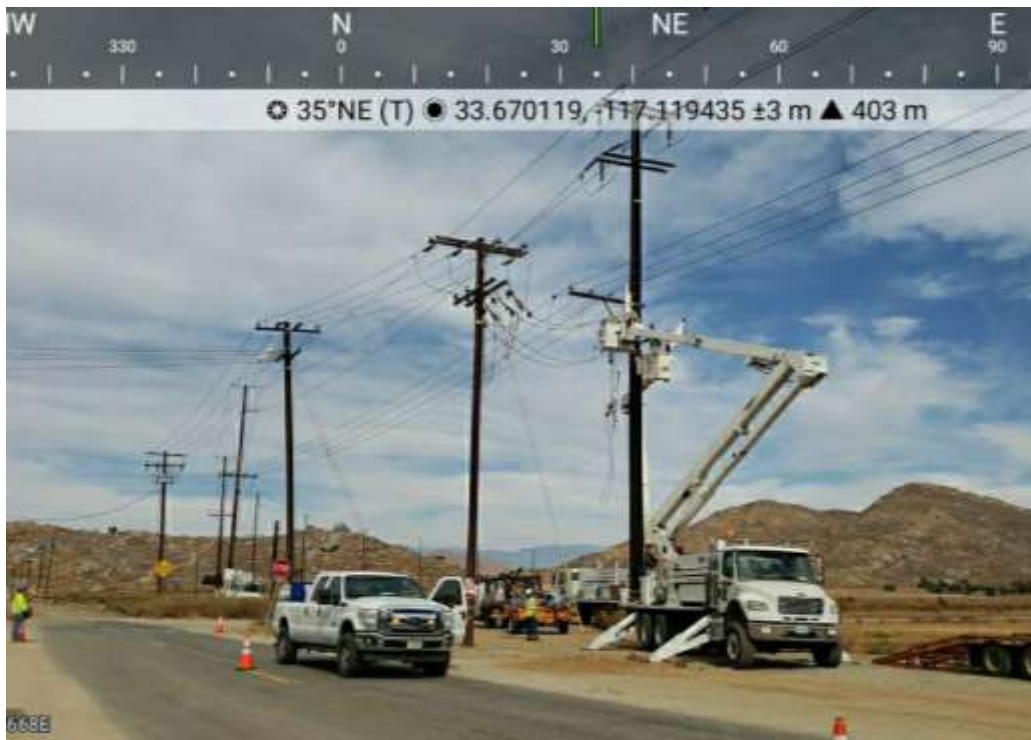
Photo 2 – Engineering fix at UNK98 (November 5, 2020) (Photo courtesy of SCE).
