PROJECT MEMORANDUM

DOWNS SUBSTATION EXPANSION PROJECT

To: Eric Chiang, Project Manager, CPUC
From: Vida Strong, Aspen Project Manager
Date: January 30, 2015
Subject: Monitoring Report #9: January 19 to 25, 2015

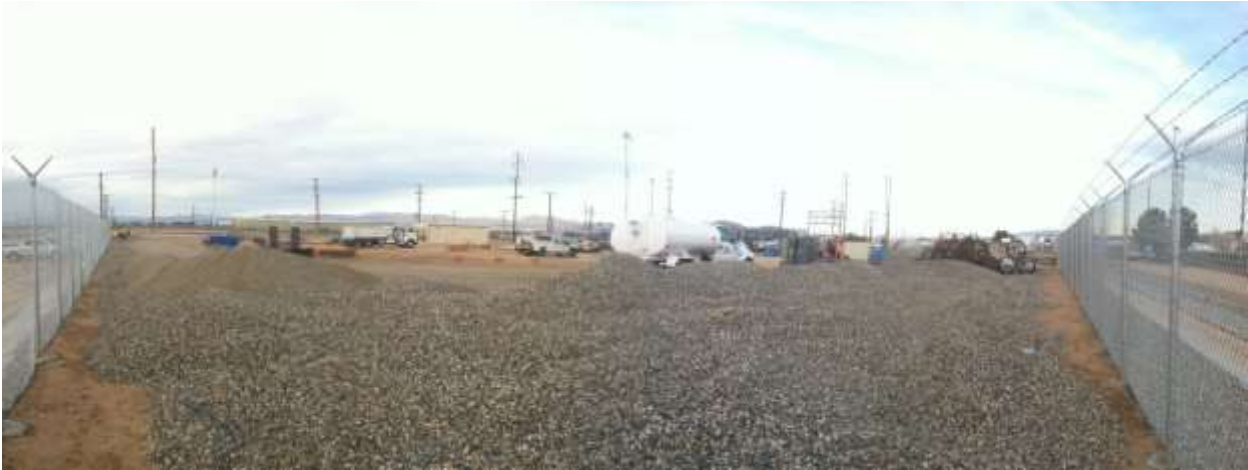
Figure 1 – Gravel continues to be stored on the substation pad. View northeast, January 22, 2015.

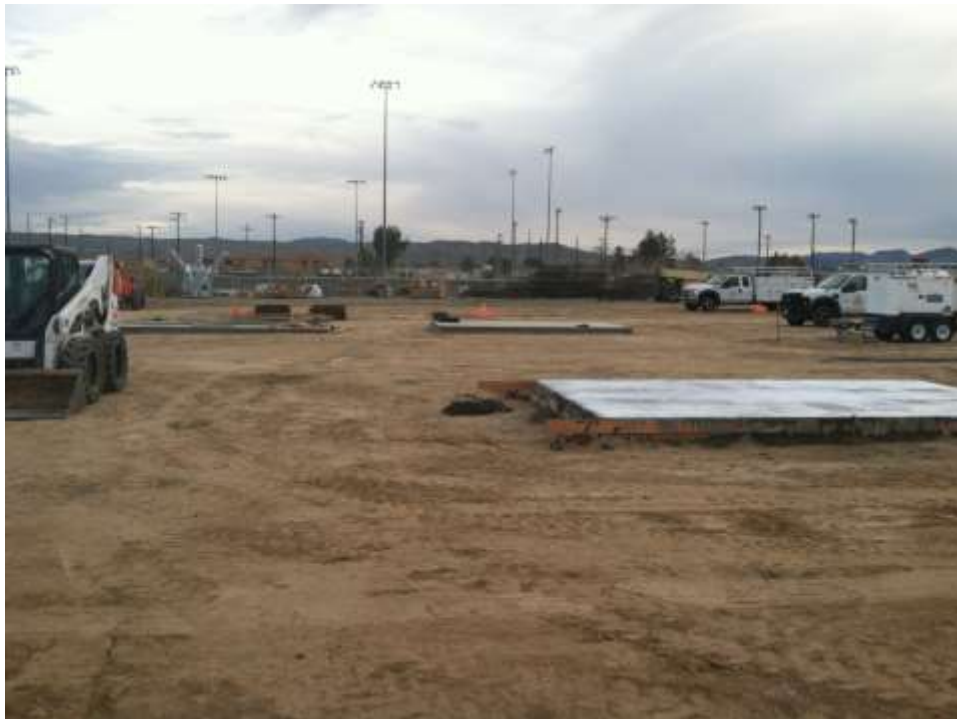
Figure 2 – Foundations were installed during the subject period. View south, January 22, 2015.

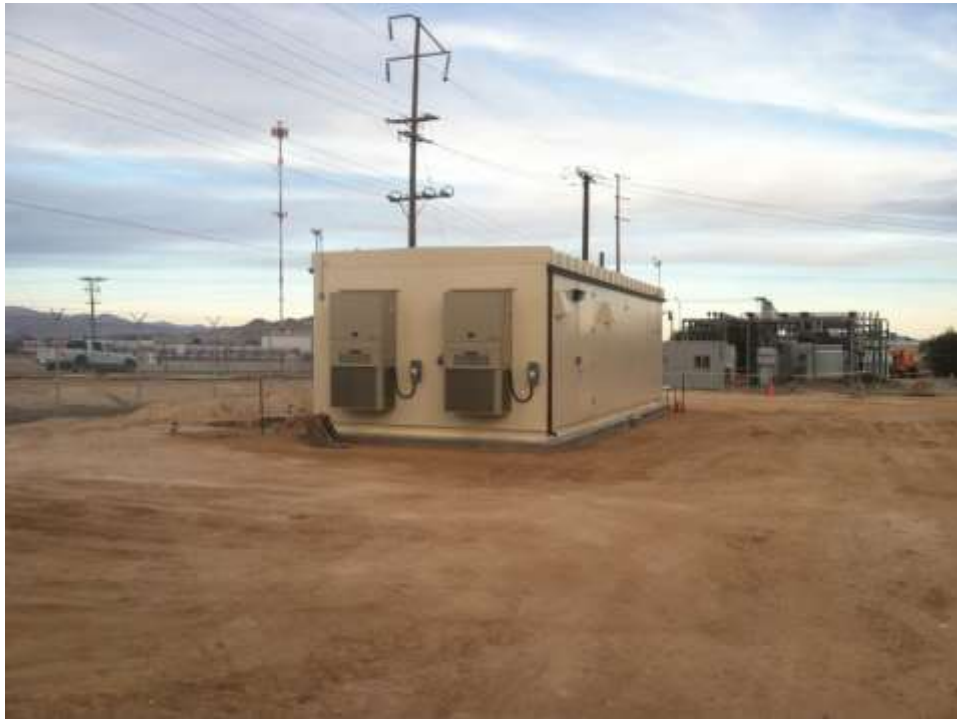
Figure 3 – Installation of the MEER building occurred during the subject period. View northeast, January 22, 2015.

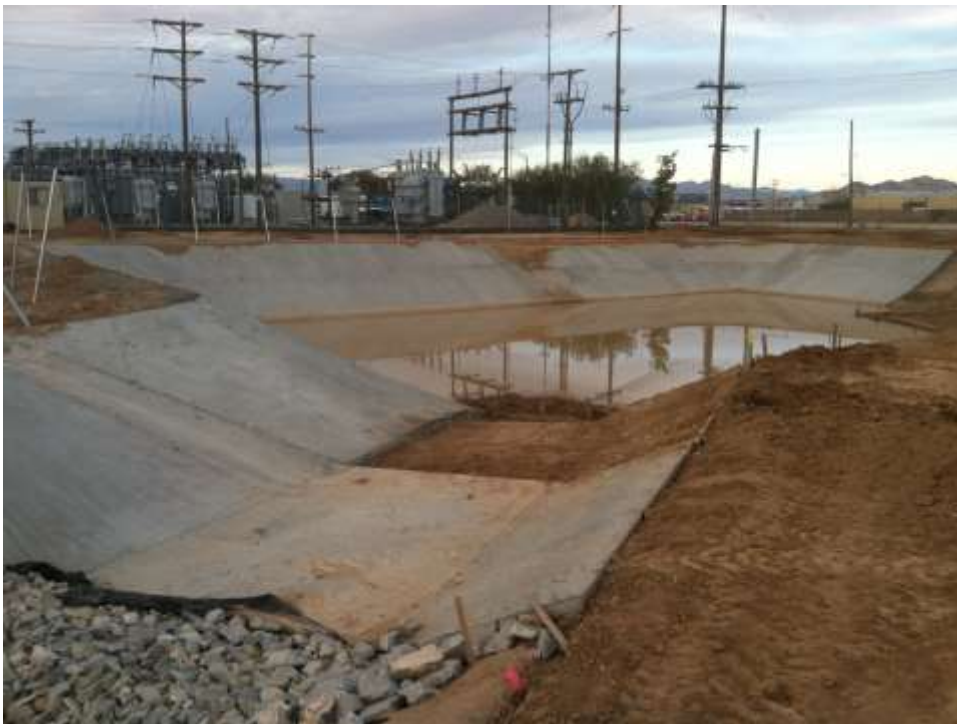
Figure 4 – Pooled water has delayed completion of the site's detention basin. View northeast, January 22, 2015.

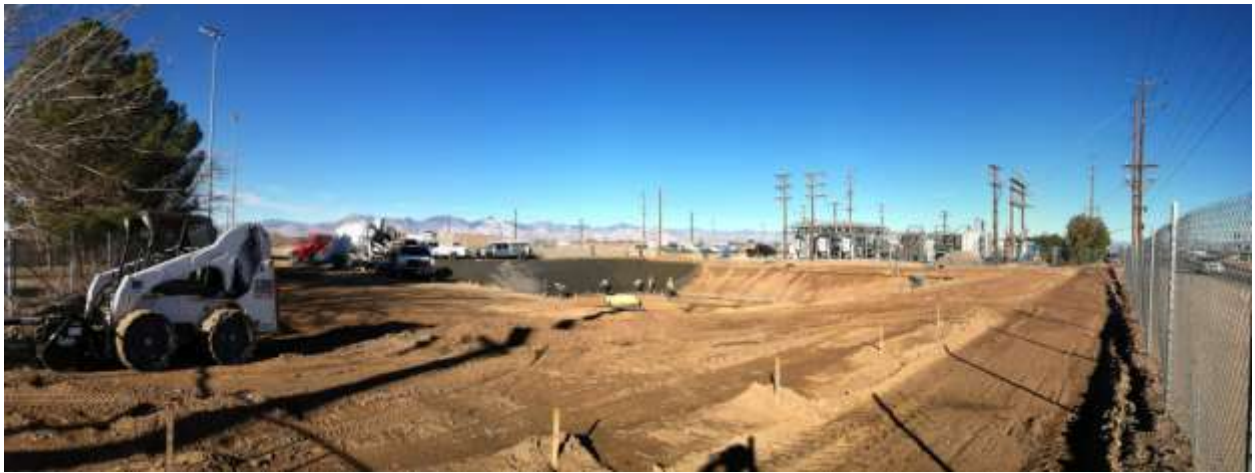
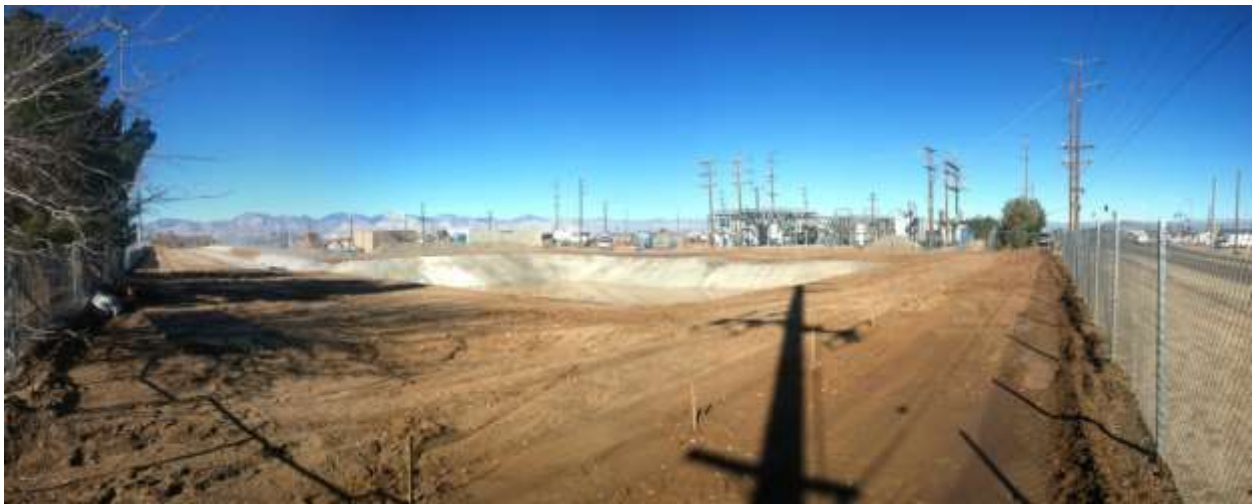
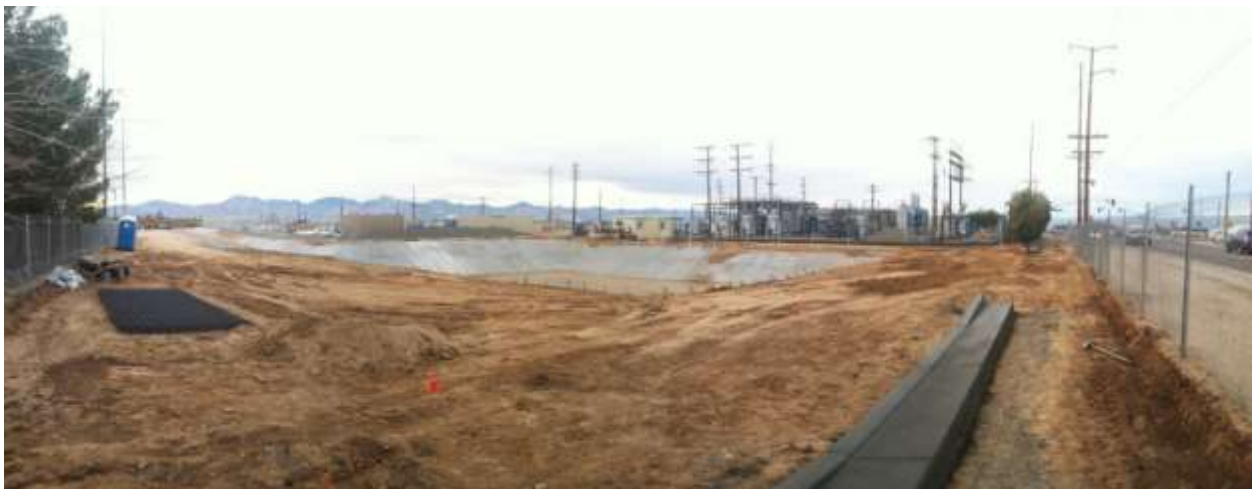
Figure 5 – Panoramic view of detention basin grading progress, from southeast corner of site. View northwest, 01/08/15 above, 01/13/14 middle, and 01/22/14 below.

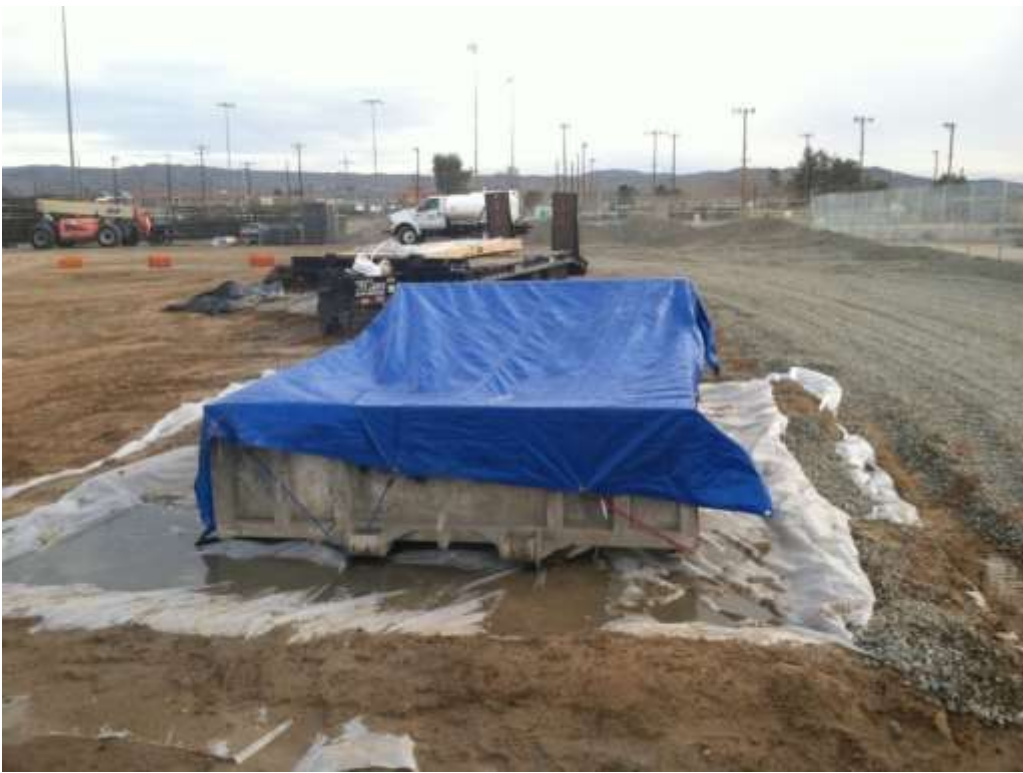
7. Concrete wash-outs are properly contained (see Figure 6).
8. The CPUC EM observed a trench without escape ramps. Construction personnel were notified and escape ramps were installed prior to closing the work site for the day (see Figure 7).

Figure 6 – Concrete washout is properly contained at the end of the work day. View south, January 22, 2015.

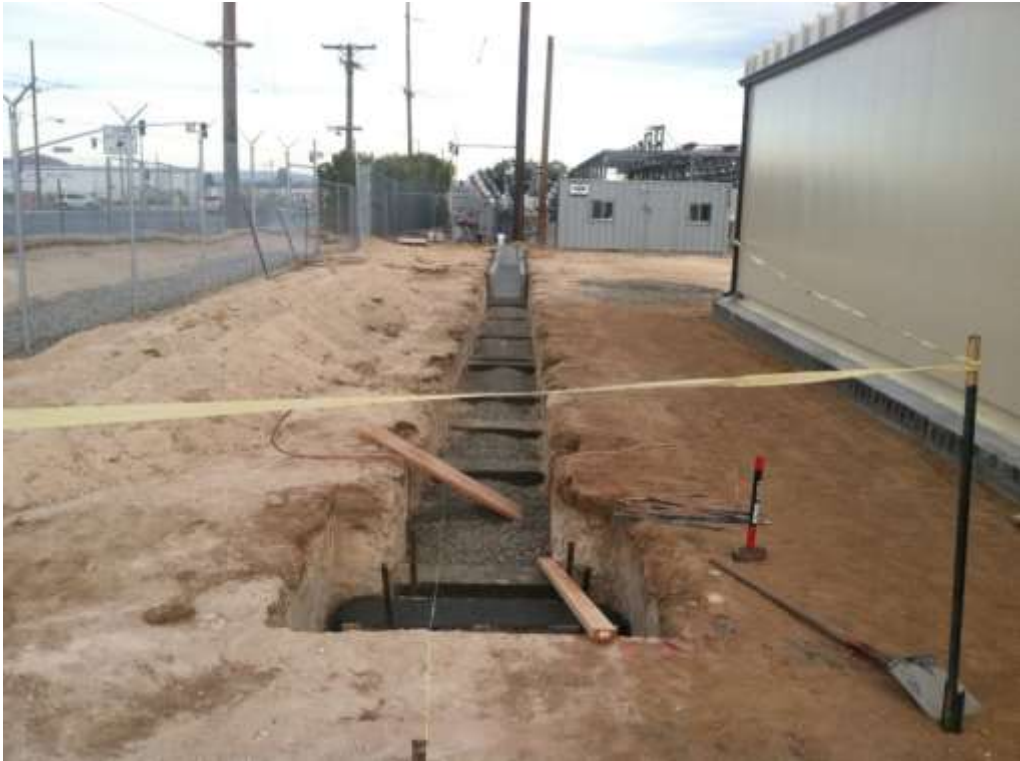
Figure 7 – A trench was equipped with escape ramps to help prevent animal entrapment. View east, January 22, 2015.
