PROJECT MEMORANDUM PG&E JEFFERSON-MARTIN 230KV TRANSMISSION PROJECT

To: Billie Blanchard, CPUC
From: Vida Strong, Aspen Project Manager
Date: March 22, 2005
Subject: Weekly Report #9: March 13, 2005 – March 19, 2005
CPUC Environmental Monitor (EM): Jody Fessler

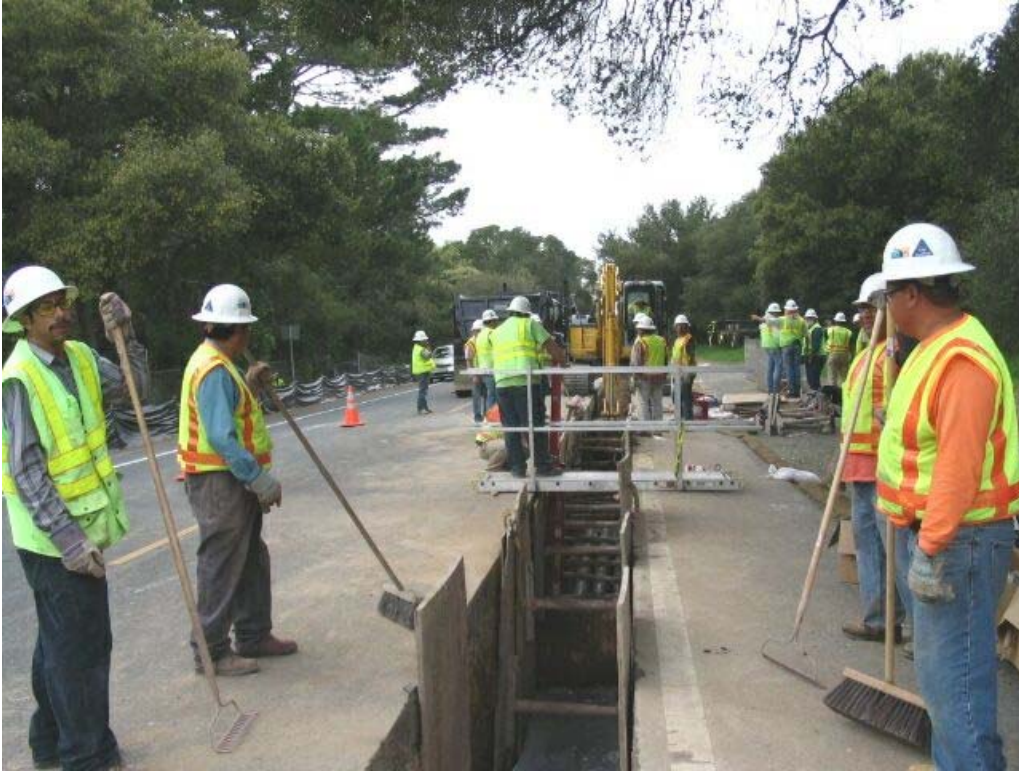
2. On March 14, crews started excavating trench between Manhole #4 and Manhole #5 on Cañada Road (Figure 1). The soil from the trenching activities was transported to Ox Mountain landfill in Half Moon Bay (Class 3 facility). Crews shored the trench as they excavated. Excavation of new trench was halted on Tuesday because of the San Francisco garter snake find. Conduit was installed in the trench as the excavation progressed, and cement slurry was poured around the conduit as it was installed. Crews worked through the night shift installing conduit in the trench. A biological monitor

Figure 1 – Crews installing conduit on Cañada Road North of Edgewood intersection, Segment 1, March 16, 2005.

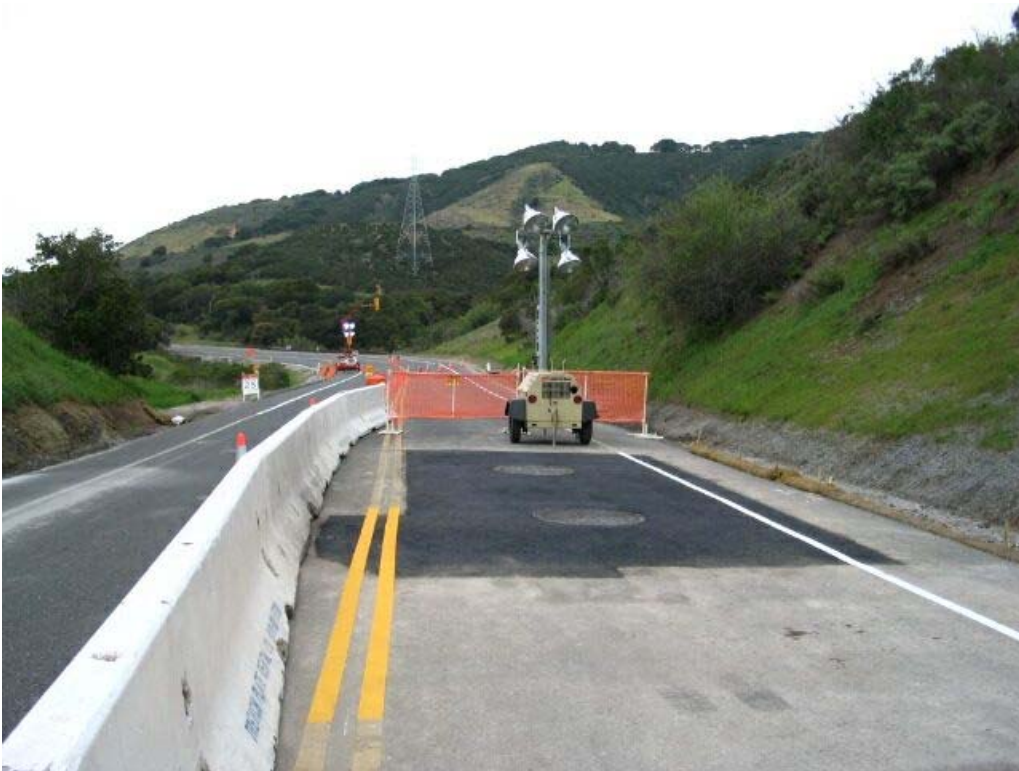
3. On Monday, March 14, excavation of Manhole #12 on Cañada Road began. Excavation was completed on Monday and shoring was installed in the pit. The manhole vault arrived on Tuesday morning and cement slurry was poured around and over the vault. Paving was done on Wednesday (see Figure 2) and traffic controls were removed from the site on Thursday.

Figure 2 – Manhole #12 paved over, Cañada Road, Segment 1, March 16, 2005.

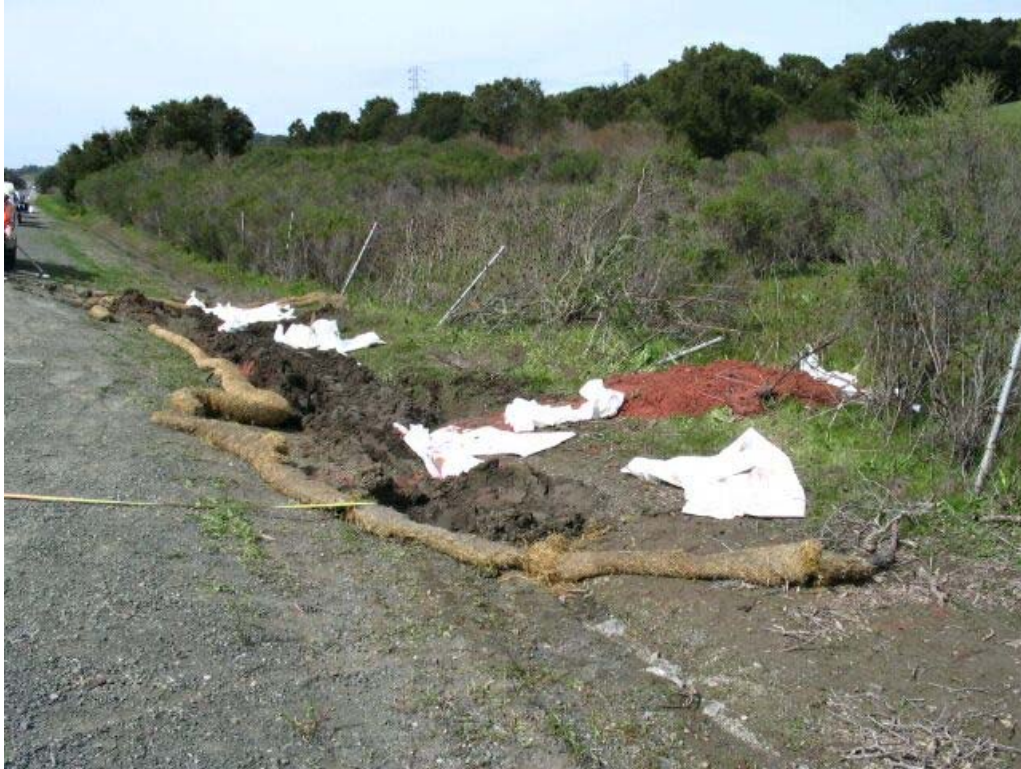
4. On Wednesday, March 16, the CPUC EM was informed that a full cement truck operated by RMC had tipped over on its side along the east side of Cañada Road at approximately Station #93+00 (Figure 3). The truck landed in the middle of a roadside drainage that had standing water. The truck was partly in the SFPUC watershed lands and partly in the San Mateo County right-of-way. The truck spilled about 1 cubic yard of red concrete slurry over a sparsely vegetated area. Some hydraulic fluid also leaked out of the truck and onto the ground. The CPUC EM observed the cement truck being towed away and the cleanup effort that ensued. RMC sent out their environmental representative, Robert Aldenhuisen, to assess the situation and take water and soil samples. Absorbent material was placed over the hydraulic spills. Crews shoveled concrete into two trucks as the CPUC EM inspected each shovel of concrete and soil for amphibians and reptiles. None were spotted. The concrete supplier took the spilled concrete back to their yard for disposal. Sheila Byrne of PG&E was out at the site doing snake surveys south of the cement spill, and came by the spill site in the late afternoon to do an assessment of the damage to the habitat at that location. The RMC cement truck driver had not been through the B&V Safety training or PG&E's Environmental Training for the project. RMC was removed from the project and a new cement supplier will be used for Segment 1.

On Wednesday, March 16, a full cement truck operated by RMC flipped over on its side on the east side of Cañada Road at approximately Station #93+00. RMC was removed from the project because they continued to send drivers out to the site, after they had been instructed not to, that had not been safety or environmentally trained. Appropriate action was taken by PG&E.

Figure 3 – Area where concrete truck flipped over and spilled concrete (red material) and hydraulic fluid along side of Cañada Road, Segment 1, March 16, 2005.

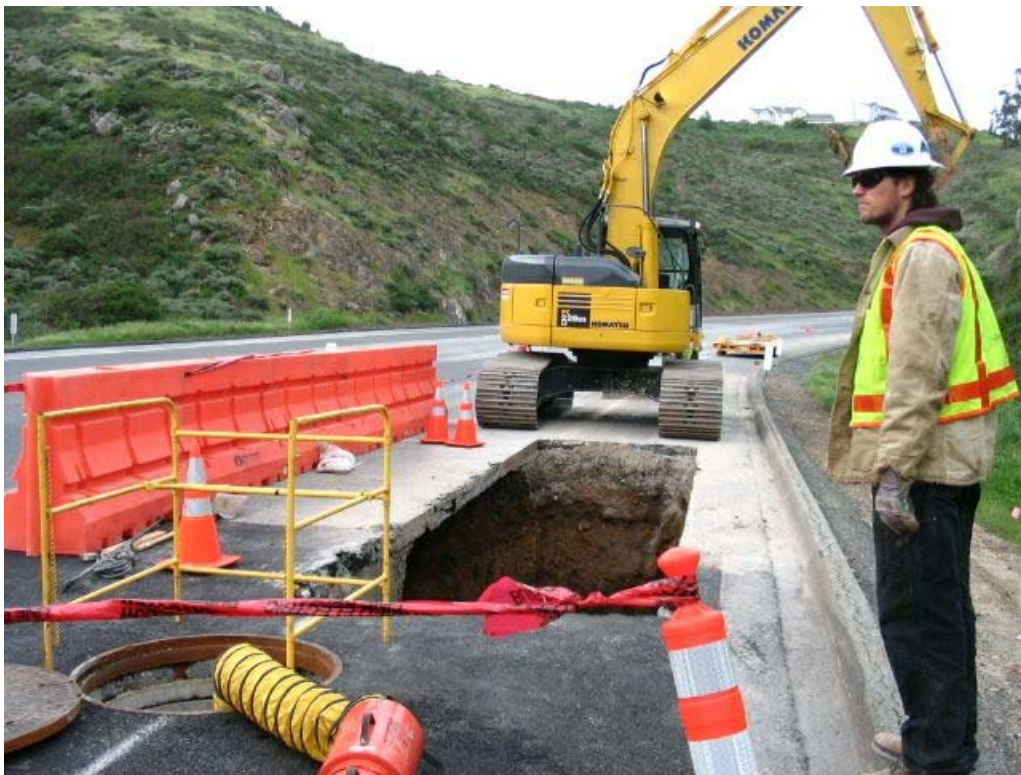
2. Crews worked on the stub-outs at Manhole #67, Manhole #69, and Manhole #70 throughout the week (Figure 4). Conduit was installed on either side of the manhole, cement slurry poured, and the areas paved over on Friday.

Figure 4 – Crews working at stub-outs on east side of Manhole #67 on Guadalupe Canyon Parkway, Segment 5, March 16, 2005.

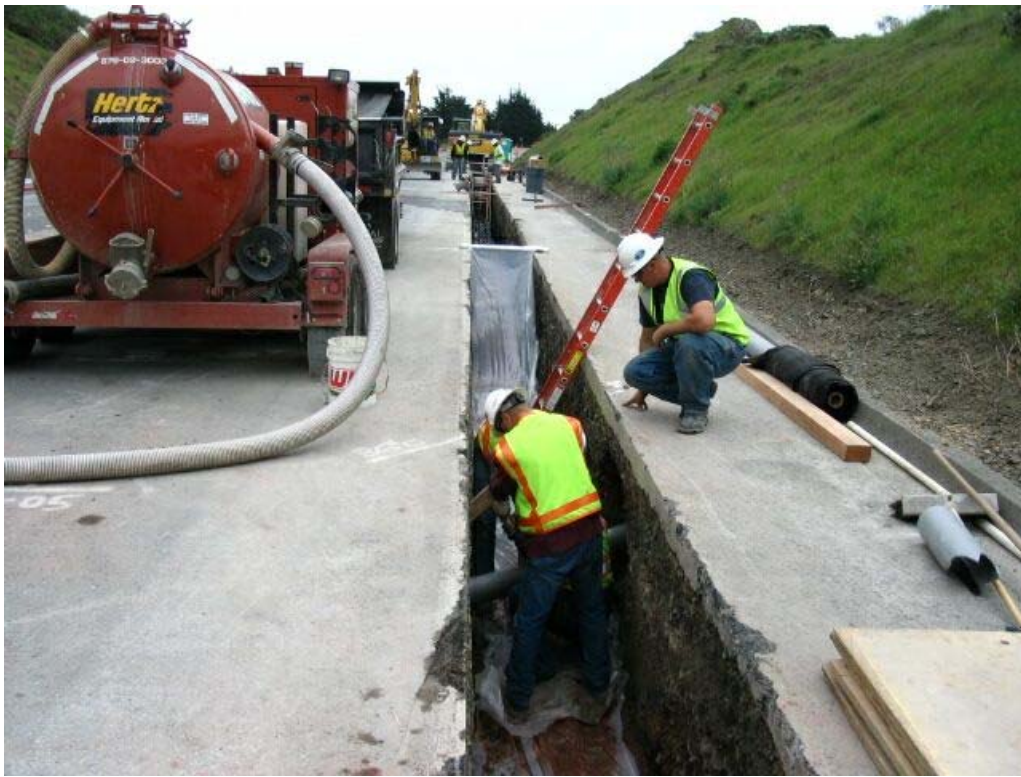
3. Culverts under Guadalupe Canyon Parkway that had been damaged by trenching activities were repaired per San Mateo County requirements (Figure 5).
4. Traffic controls (signs, cones, and lights) were set up on Guadalupe Canyon Parkway. Traffic control flaggers were in place at the active construction areas. Traffic cones were left in place blocking off the southern lane. Bright lights were set up on either end of the project at night. A small night crew stayed on-site at night and did some light work.

Figure 5 – Crews fixing culvert in trench east of Manhole #68 on Guadalupe Canyon Parkway, Segment 5, March 17, 2005.
