PROJECT MEMORANDUM
SDG&E OCEAN RANCH SUBSTATION PROJECT

To: Eric Chiang, Project Manager, CPUC
From: Vida Strong, Aspen Project Manager
Date: February 6, 2018
Subject: Monitoring Report #1: January 22 to January 28, 2018

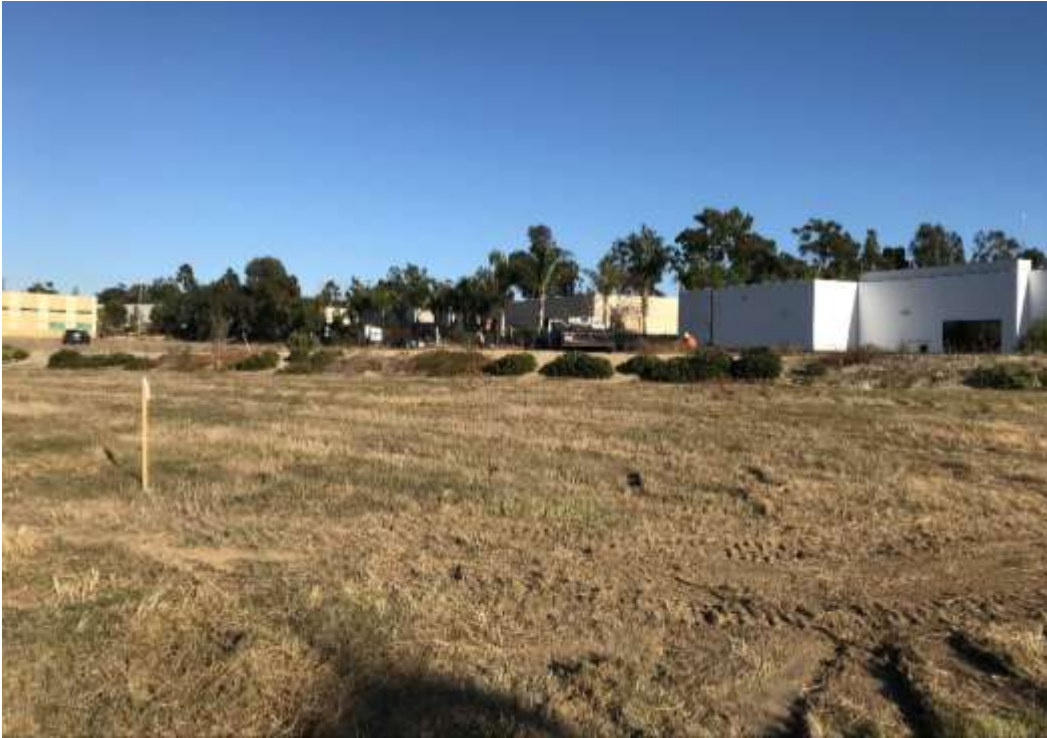
Figure 1 – AM Ortega crews conducted vegetation mowing and tree removal at the Ocean Ranch Substation site.

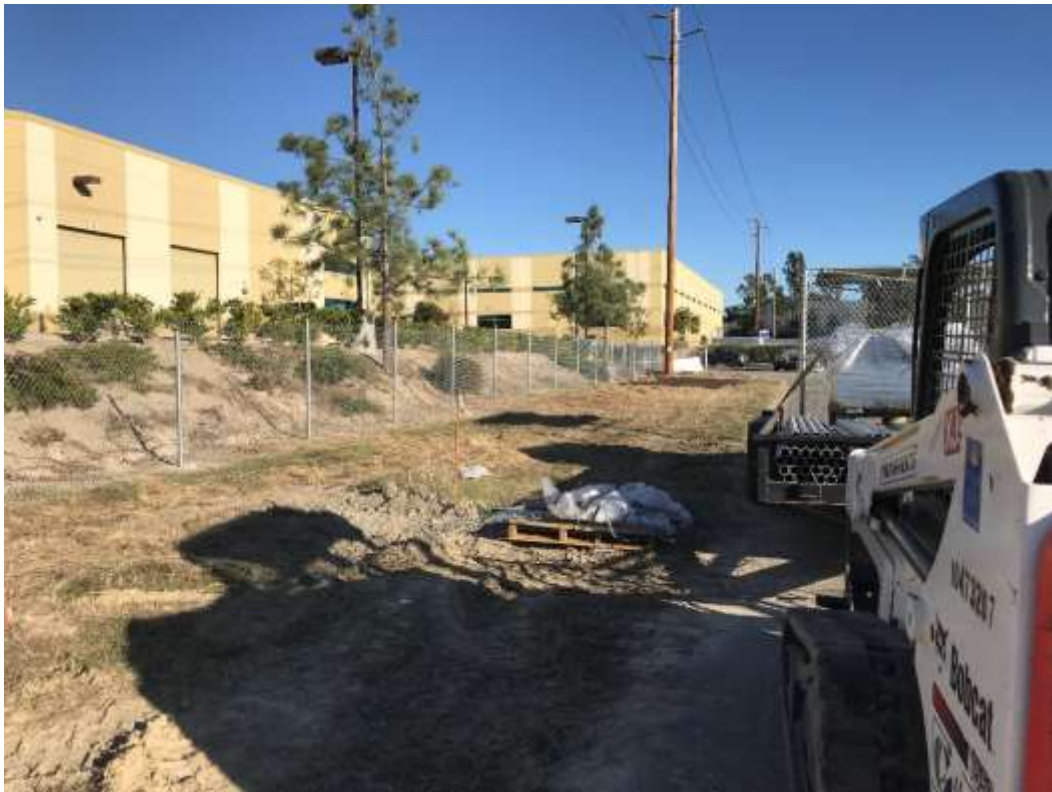
Figure 2 – Chain link perimeter fencing was installed at the Ocean Ranch Substation site.

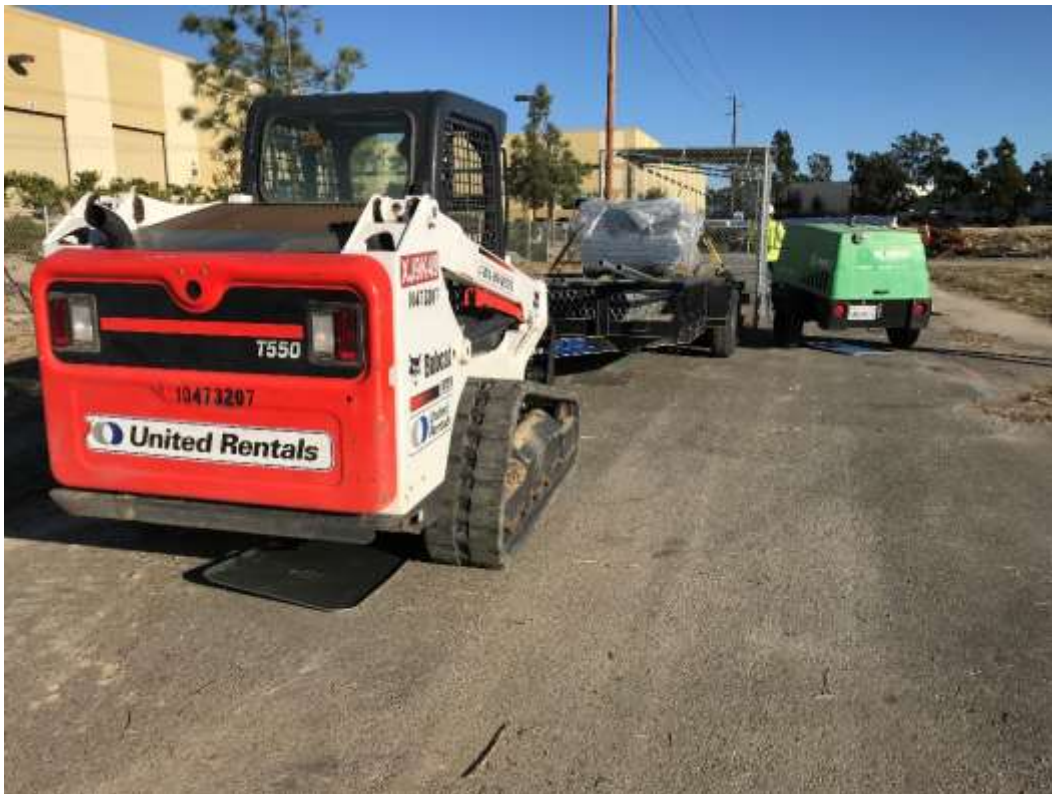
1. No non-compliances were observed or reported during the reporting period.
2. Nesting bird surveys are being conducted on a weekly basis and a biological monitor is onsite during construction. Environmental trainings are held on an as needed basis when new crewmembers join the project.
3. During mowing operations, a hose broke on the mower causing a hydrocarbon spill. The contaminated soil was bagged up and removed from the site.
4. Drip pans were placed underneath staged equipment (see Figure 3).
5. SWPPP inspections are occurring on a weekly basis or more often if rain is forecasted.

Figure 3 – Equipment staged at the Ocean Ranch site with dip pans placed underneath.
