**PROJECT MEMORANDUM
PG&E SEVENTH STANDARD SUBSTATION PROJECT**

To: Monisha Gangopadhyay, CEQA Project Manager, CPUC
From: Vida Strong, Aspen Project Manager
Date: June 16, 2010
Subject: Report #7: May 30, 2010 – June 12, 2010

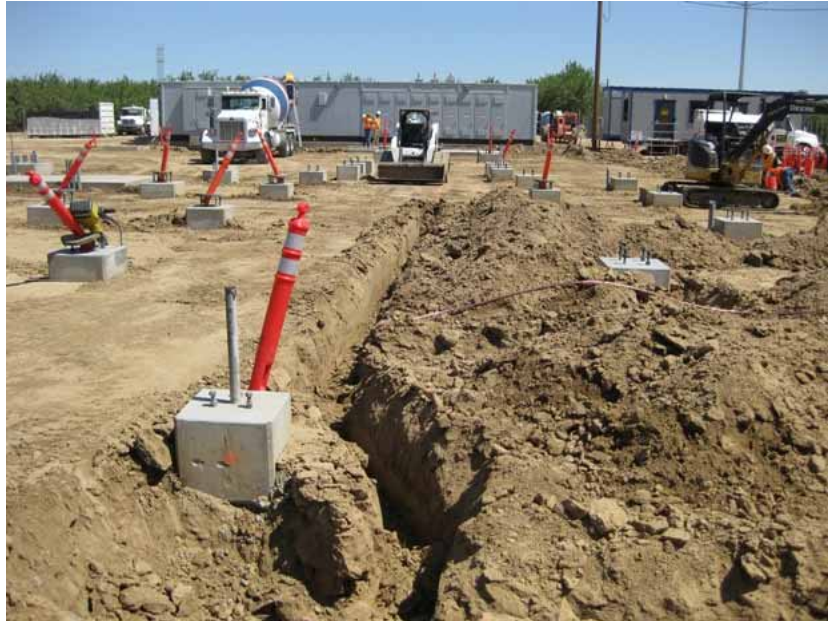
During the subject period, construction of structure foundations, below-ground conduit trenches, and the ground grid system continued (see Figure 1). The structures will begin to be erected during the following week. The concrete pad for the transformer was placed.

Figure 1: Construction of structure foundations, below-ground conduit trenches, and the ground grid system continued during the subject period. The concrete pad for the transformer was placed (see concrete truck in front of the electrical controls enclosure in the distance). The photograph faces northward.

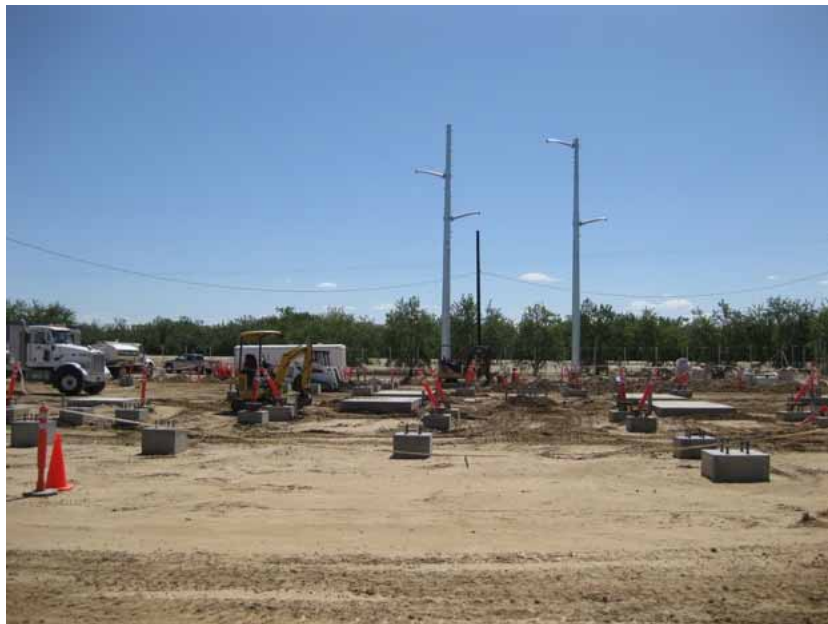
The tubular steel poles were installed near the eastern edge of the site (see Figure 2).

Figure 2: The tubular steel poles were installed near the eastern edge of the site. The photograph faces eastward.

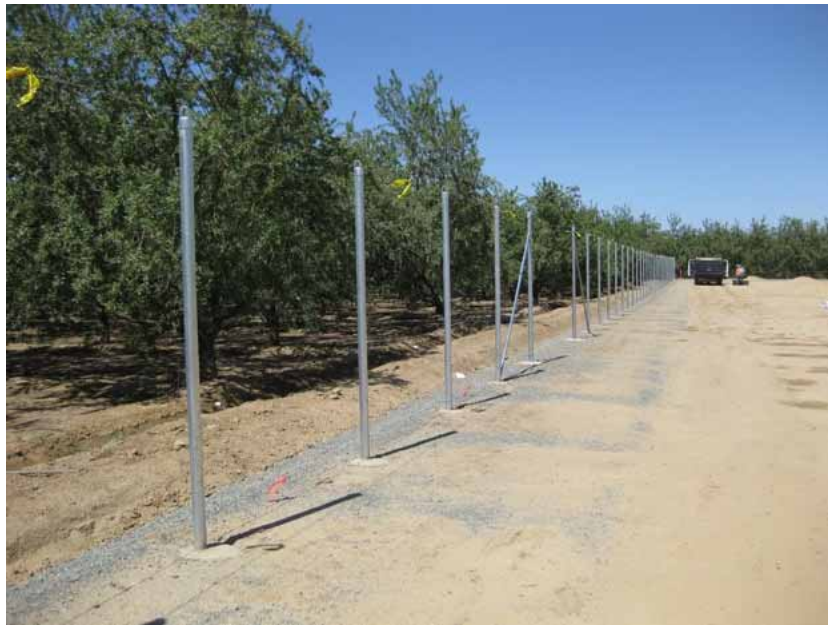
Work on the perimeter chain link fencing continued during the subject period (see Figure 3). The eight-foot high chain link fencing is expected to arrive at the site during the following week. Chain link perimeter fence will be placed on both sides of the access road and along the south, north and east boundaries of the substation. A concrete paneled wall will be placed along the perimeter of the west edge of the substation site in anticipation of future home development in that area. Supports for the concrete wall paneling have been placed (see Figure 4). The prefab concrete panels for the wall will be arriving on site within the next few weeks.

The chain link perimeter fence under construction was fitted with temporary supporting wiring between the poles during the subject period. The wires were festooned with flagging to prevent bird collision events (see Figure 3).

Figure 3: Work on the perimeter chain link fencing continued during the subject period. While under construction the fence was fitted with temporary supporting wiring between the poles. The wires were festooned with yellow flagging to prevent bird collision events. The photograph faces southwestward.

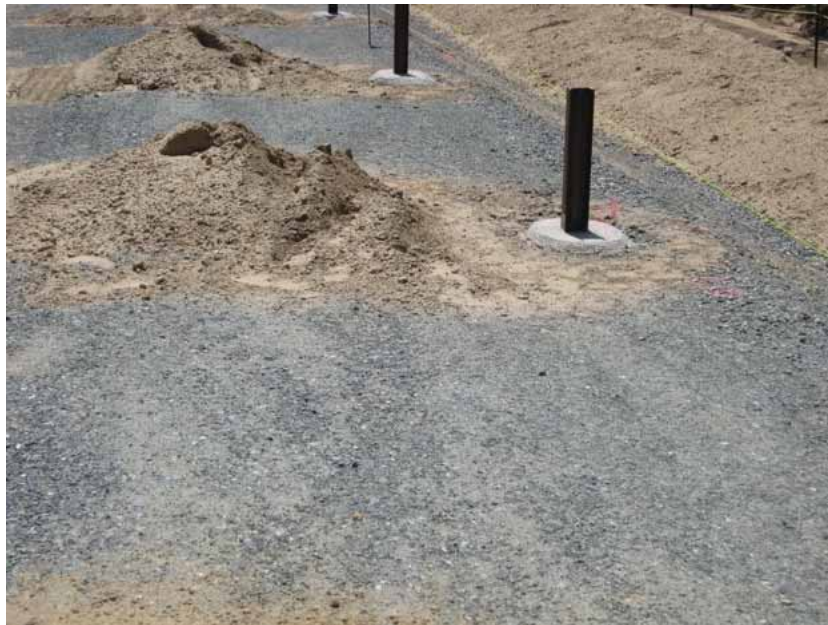
Figure 4: A concrete paneled wall will be placed along the perimeter of the west edge of the substation site in anticipation of future home development in that area. Supports for the concrete wall paneling have been placed. The wall panels are scheduled to arrive in a few weeks.

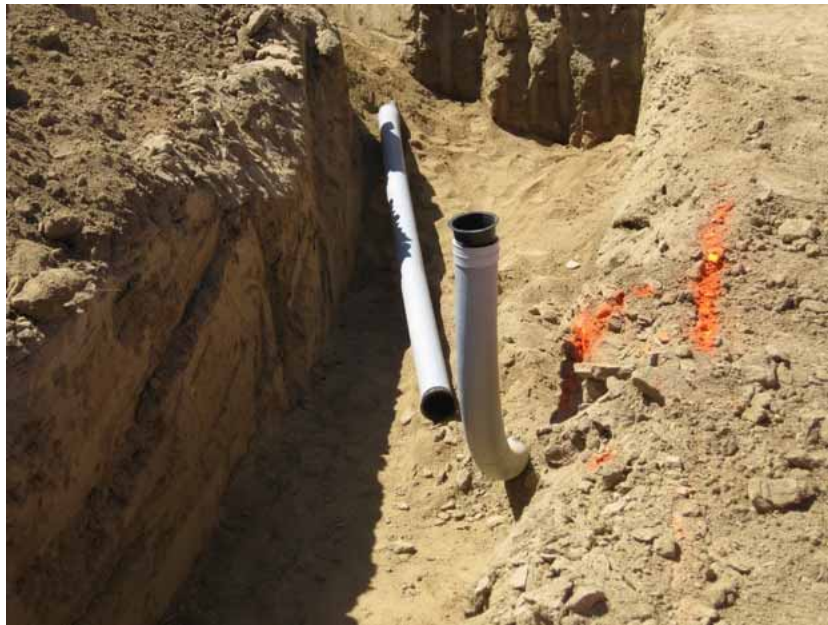
During the subject period, open trenches were less than two feet deep and were sloped enough to allow escape by animals. One partially buried pipe with a diameter of six inches was left open over night accidentally (see Figure 5). A plug was pushed gently through the pipe to the other open end to ensure no animal was present. The pipe then was closed.

Figure 5: One partially buried pipe with a diameter of six inches (similar to, but with larger diameter than the one photographed) was left open over night accidentally. A plug was gently pushed through the pipe to the other open end, under supervision by the biological monitor, to ensure no animal was present. The pipe then was closed.

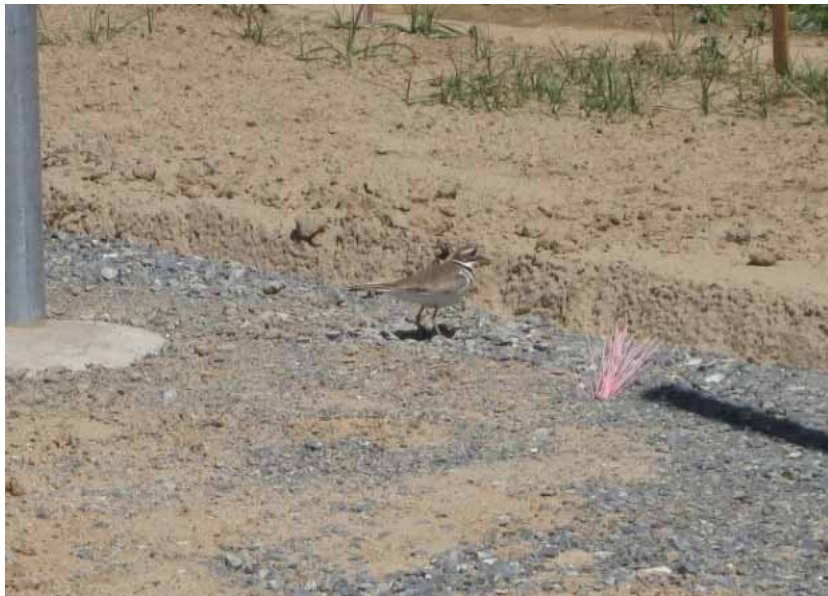
No fox or other mammal tracks or other evidence was found within the substation site during the subject period. The surface of the soil on the site is crusty and non conducive to track formation at this time. Several bird species have been observed in the area. One active Killdeer nest was present on site during the subject week (see Figure 6). The area surrounding the nest was roped off (see Figure 7). No other birds were nesting in the immediate vicinity of the Project during the subject period.

Figure 6: One active Killdeer nest was present on site during the subject week. One parent is in the middle of the photograph straddling the eggs.

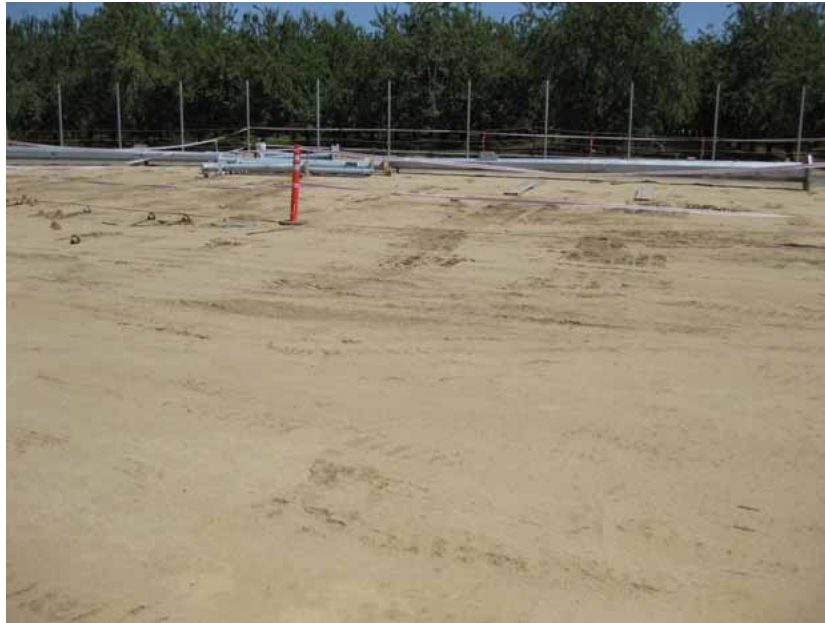
Figure 7: The area surrounding the nest was roped off for protection. The photograph faces northward within the western storage and staging area of the site. The nest is located in the middle of the photograph beyond the pipe, and below the fence line.
