PROJECT MEMORANDUM
PG&E SEVENTH STANDARD SUBSTATION PROJECT

To: Monisha Gangopadhyay, CEQA Project Manager, CPUC
From: Vida Strong, Aspen Project Manager
Date: July 30, 2010
Subject: Report #9: June 27, 2010 – July 24, 2010

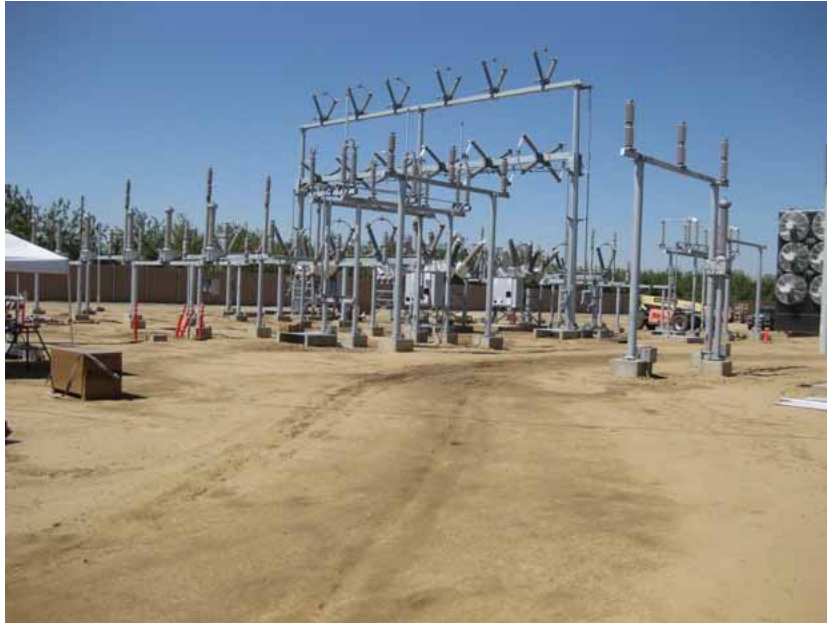
During the subject period, erection of structures continued (see Figure 1). Construction of below-ground conduit trenches and the ground grid system also continued (see Figure 2).

Figure 1: During the subject period, erection of structures continued. The photograph faces southwestward.

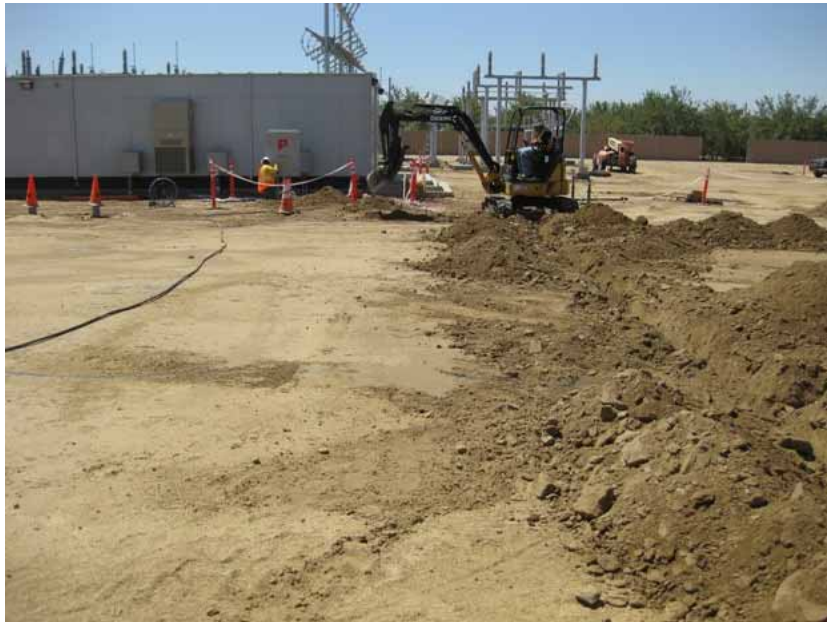
Figure 2: Below-ground conduit trenches were being excavated leading to the electrical controls enclosure in the middle distance. The photograph faces southward.

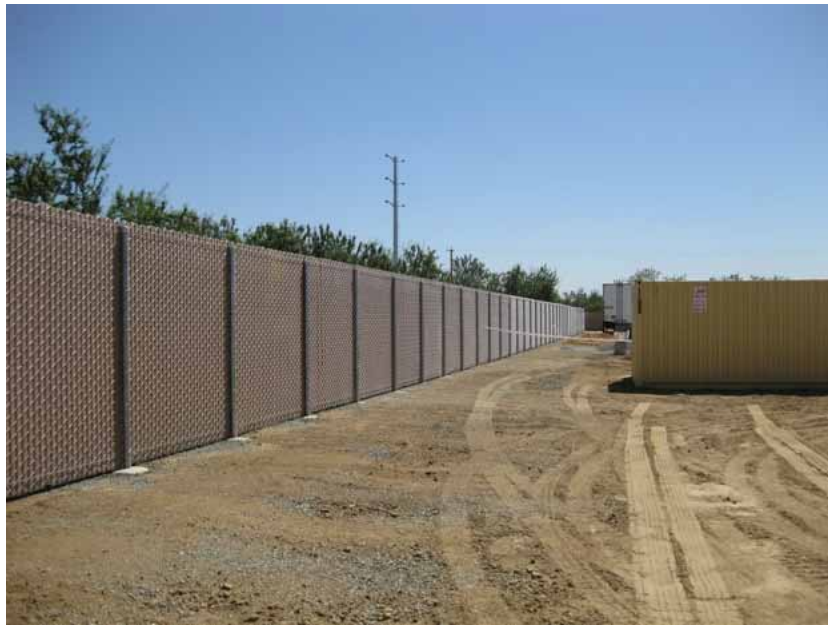
Work on the perimeter chain link fencing was mostly completed during the subject period (see Figure 3). The eight-foot high chain link fencing is being installed on both sides of the access road and along the south, north and east boundaries of the substation. A concrete paneled wall was placed along the perimeter of the west edge of the substation site in anticipation of future home development in that area. An access gate will be placed in the middle of the wall (see Figure 4).

Figure 3: Work on the perimeter chain link fencing has been mostly completed. The eight-foot high chain link fencing is being installed on both sides of the access road and along the south, north and east boundaries of the substation. The photograph shows the north side fence, and faces northeastward.

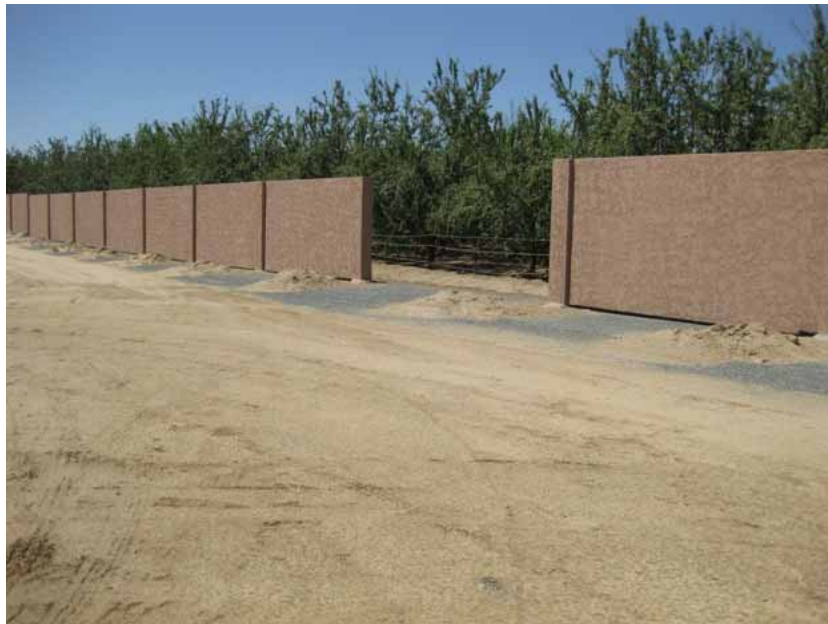
Figure 4: A concrete paneled wall was placed along the perimeter of the west edge of the substation site in anticipation of future home development in that area. An access gate will be placed in the middle of the wall. The photograph faces southwestward.

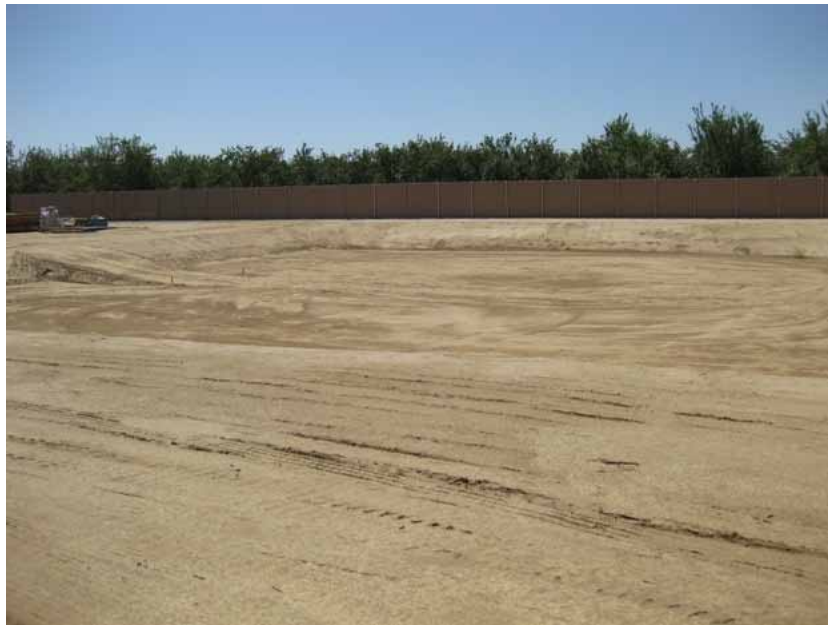
The western portion of the site will not be used for the current substation. This portion will contain the retention basin (see Figure 5). During construction, part of the western portion is being utilized for vehicle and equipment parking, and for materials storage. This section may be used for future substation expansion.

Figure 5: The contouring for the retention basin has been started in the western portion of the site. Some of the remainder of the western portion of the site is being utilized for vehicle and equipment parking, and for materials storage. This section may be used for future substation expansion. The photograph faces southeastward.

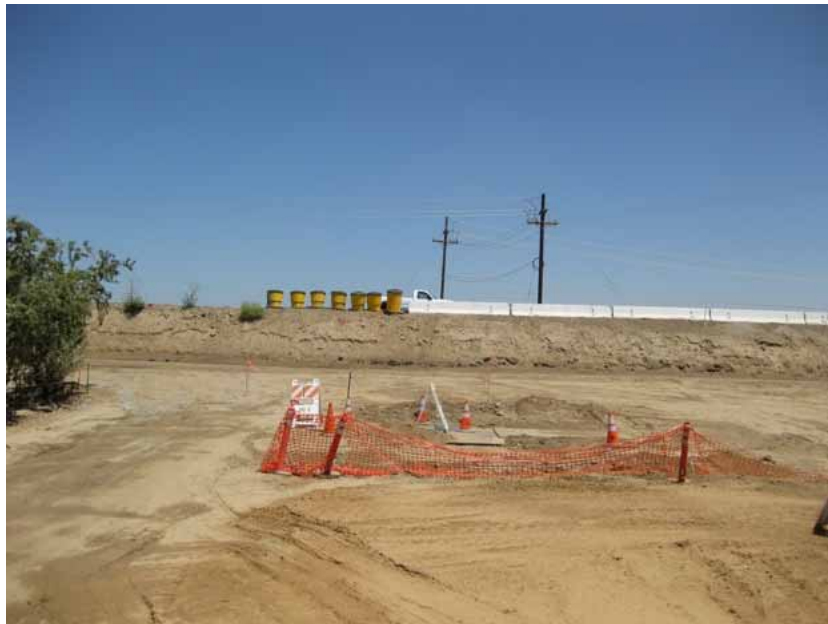
Final grading has not occurred on the access road, and will not be completed until the City of Bakersfield road work is completed on Seventh Standard Road at the entrance to the access road (see Figure 6)

Figure 6: Final grading of the access road (in the foreground) is awaiting the completion of the rebuilding work on Seventh Standard Road at the entrance to the access road. The former two-lane roadway has been removed, and will be replaced with two new eastbound lanes. The new westbound lanes have been completed (beyond the K-rails), and are currently carrying both directions of traffic. The photograph faces northward.

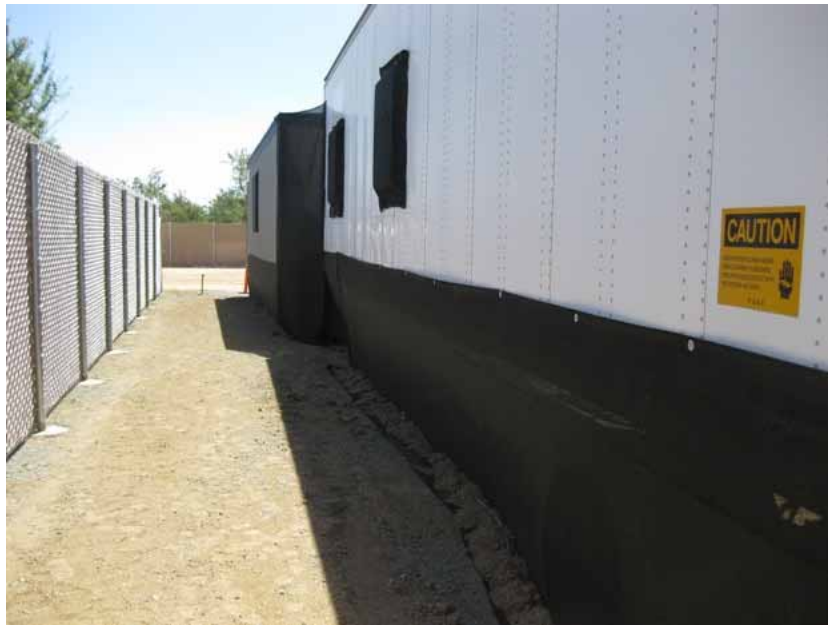
Figure 7: Black netting has been placed around the opening under trailers to discourage nesting by birds such as the black phoebe. The photograph was taken near the northern perimeter fence, and faces eastward towards the access road in the distance.
