Subject: Rock Fall Hazard Evaluations
Sunrise Powerlink Project
San Diego and Imperial Counties, California
URS Project No. 27661033.00010

**Subject: Sunrise Mountain Springs Grade
Rockfall Hazard Evaluation:
Towers 261A, 263A-2, 263B-2, 266-2, and 272-3**

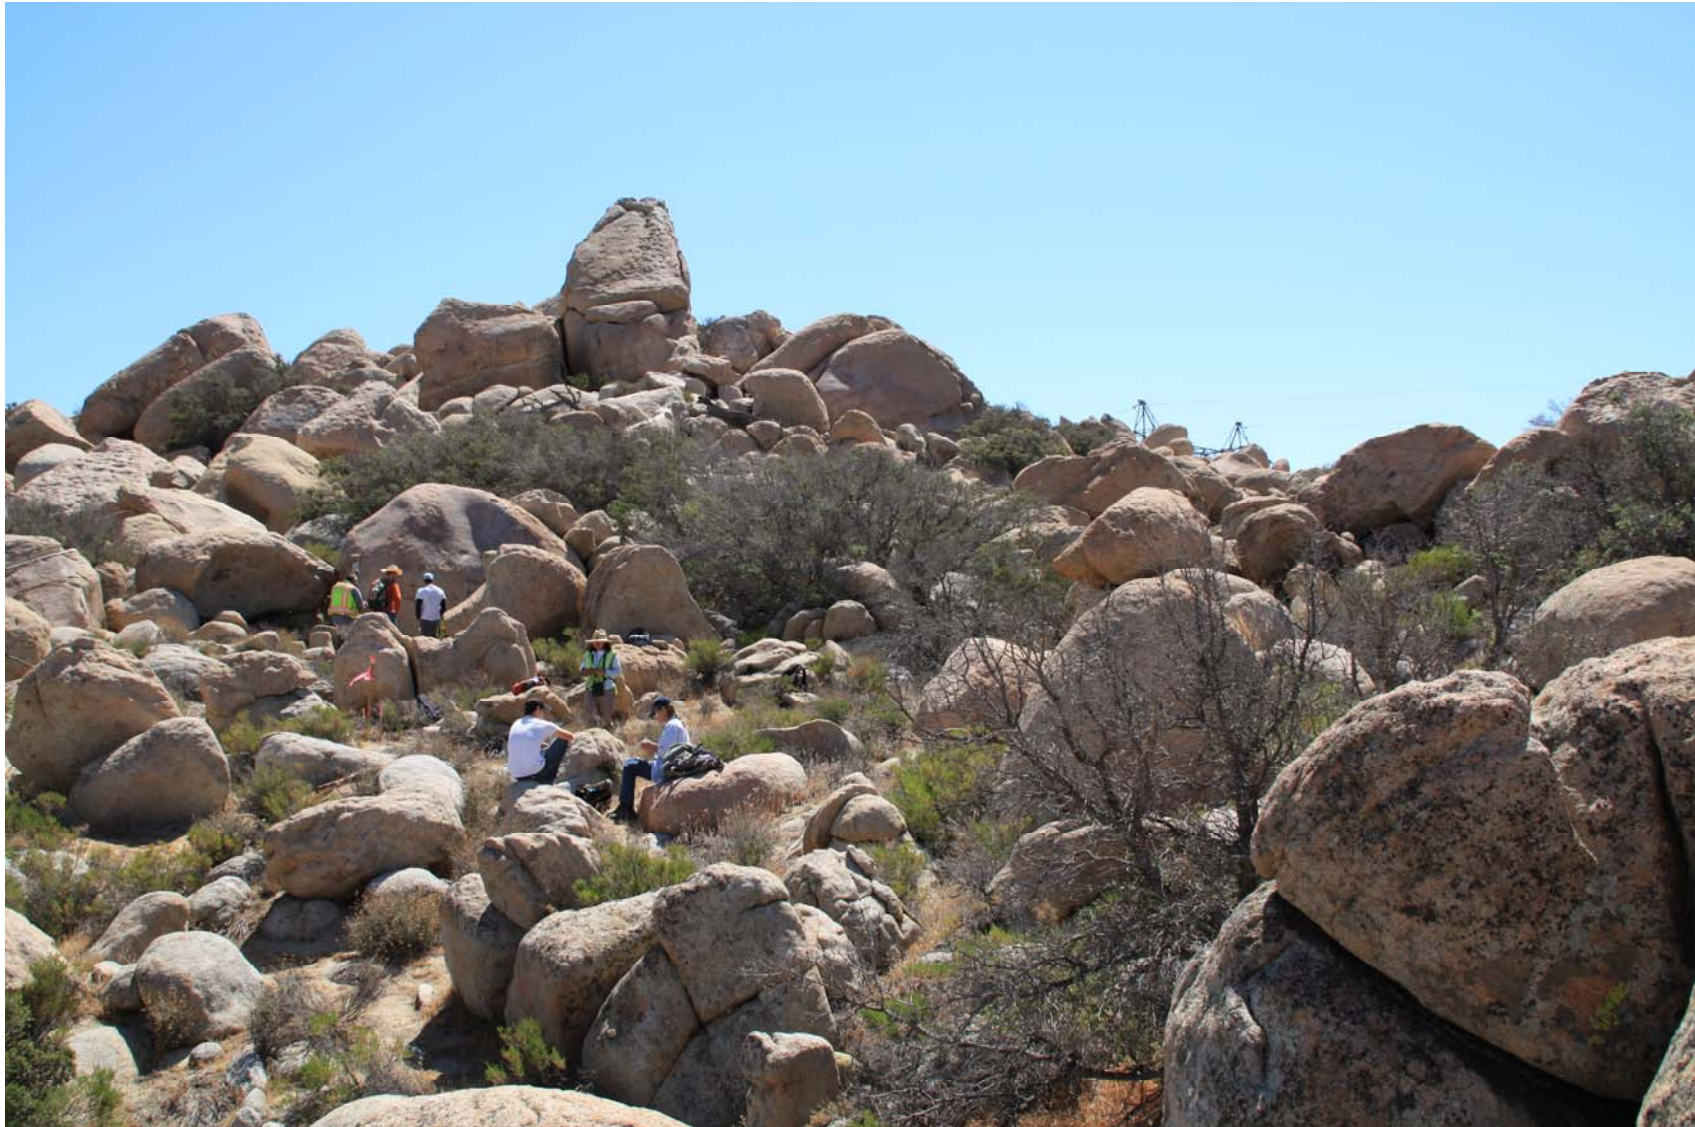
Figure 1
Hillside located southeast of Tower 261A

The local topography at Tower 261A is gently-sloping with a steeper slope located southeast of the tower. While in the field, Dr. Fisher and Mr. Hatch judged that the hillside presents a low rockfall hazard to the tower. This conclusion was reached after careful review of the topography and aerial photographs and an assessment of the general rock block geometries on the hillside. Below is a bulleted list of our observations. Figure C-1 is annotated with the items below.

Overall, the rockfall hazard at this location is judged low with a probability of impact over the design life of the structure of less than 0.5 percent.

Note: Flag shows one of the tower leg locations. Up slope of the tower is a natural rockfall barrier consisting of large boulders.

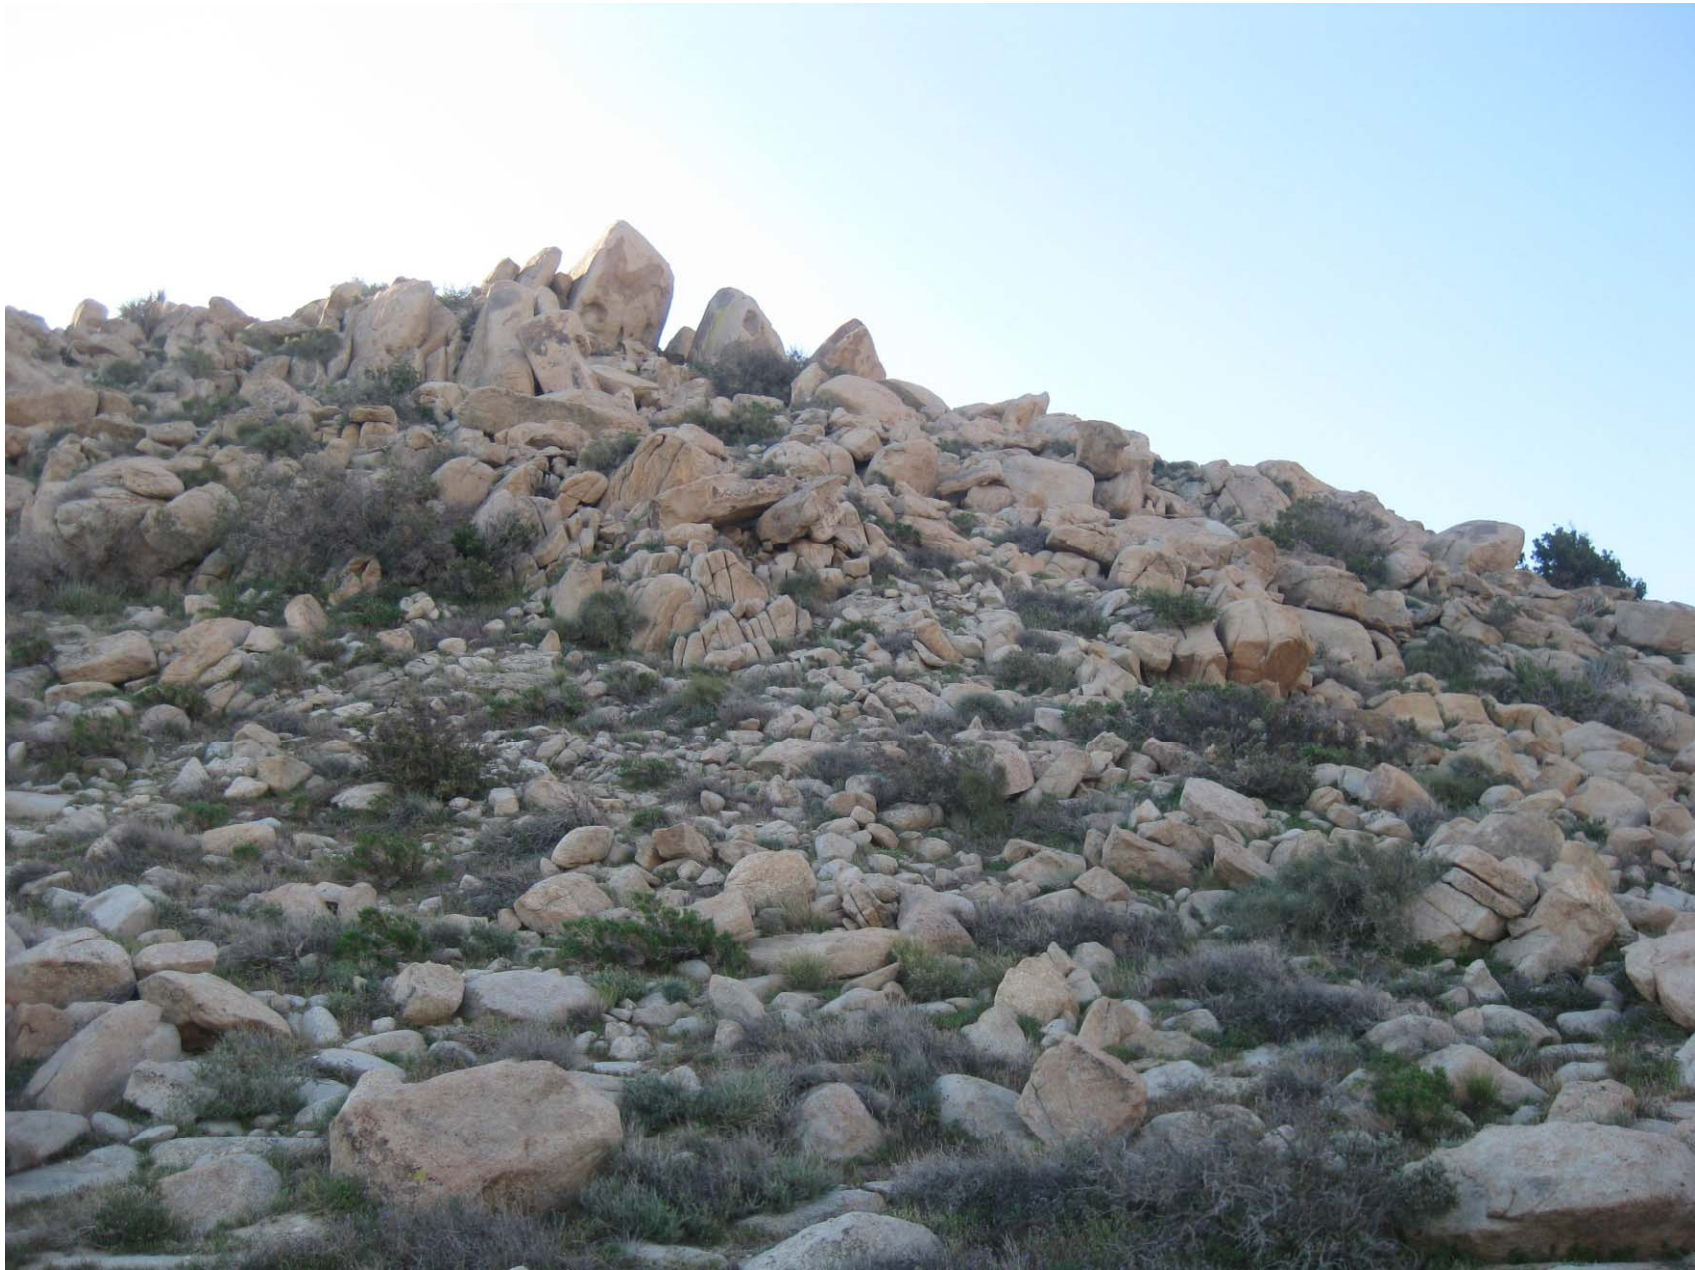
Figure 2

Overall, the rockfall hazard at this location is judged low with a probability of impact over the design life of the structure of less than 0.5 percent.

Hillside located southeast of Tower 263A-2

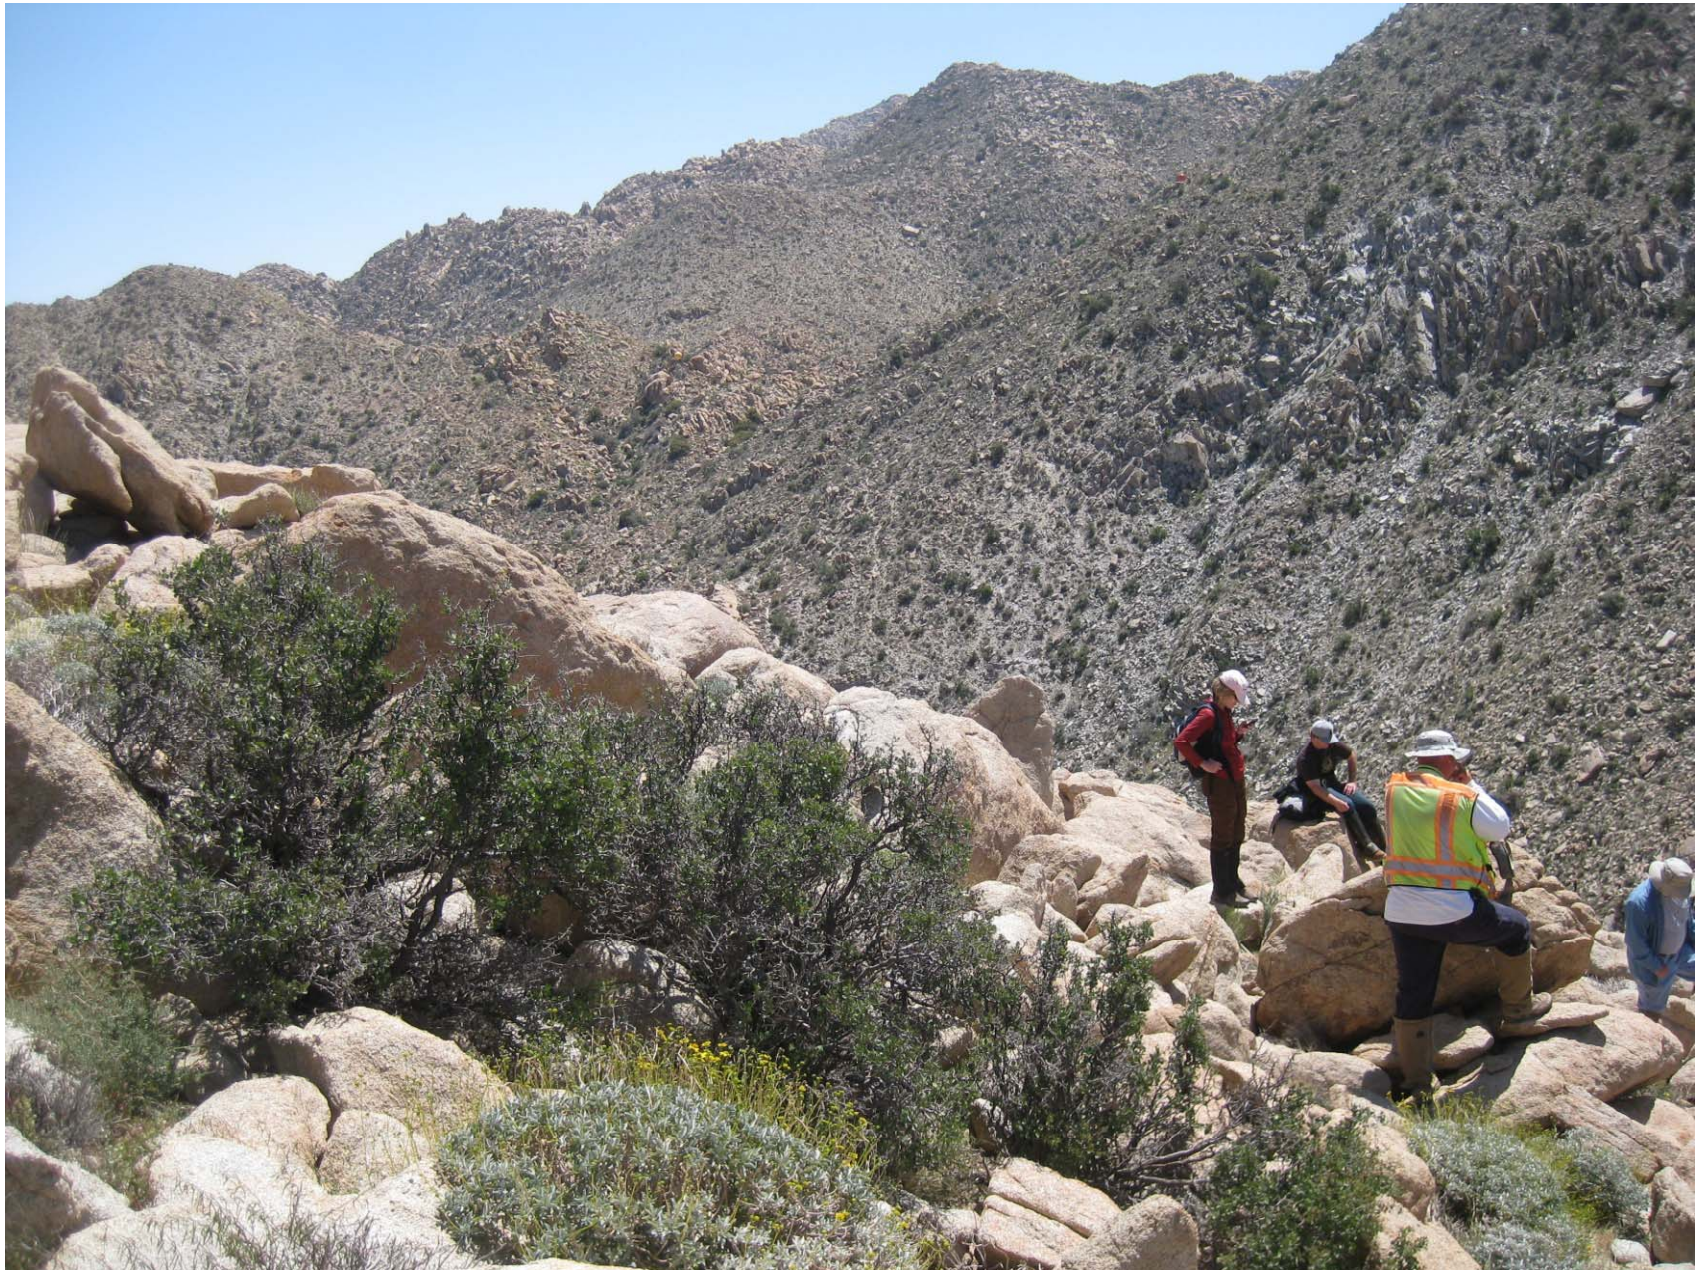
Figure 3

Note that mitigation measures for rocks located directly adjacent to the towers were presented in our report dated May 6, 2010. For example, Tower 263B-2 is located adjacent to a talus slope consisting of boulders that have weathered in place from bedrock. Rock anchors and high tensile strength wire mesh are recommended to help stabilize the toe of the talus pile north

Slope profile of steep slope located north of Tower 263B-2

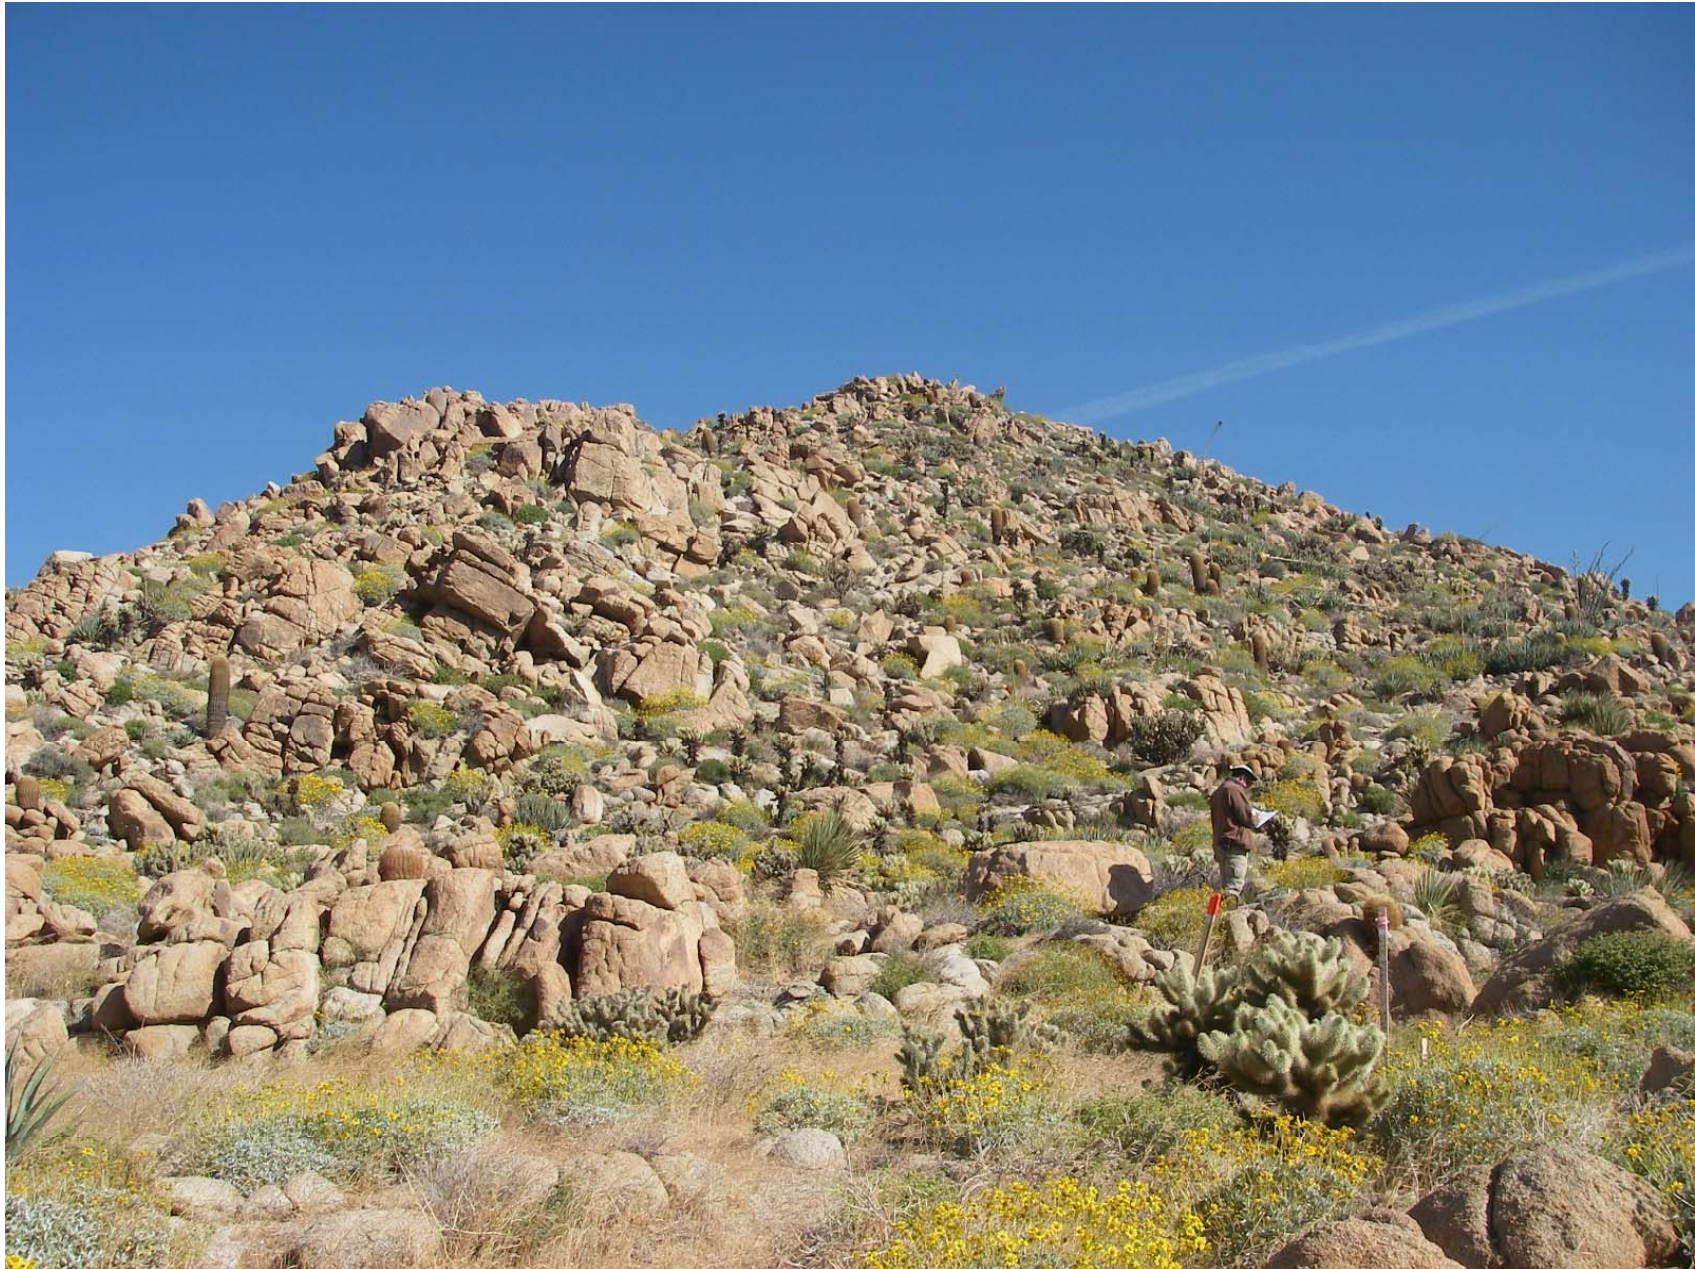
Figure 4

Hillside located north of Tower 266-2

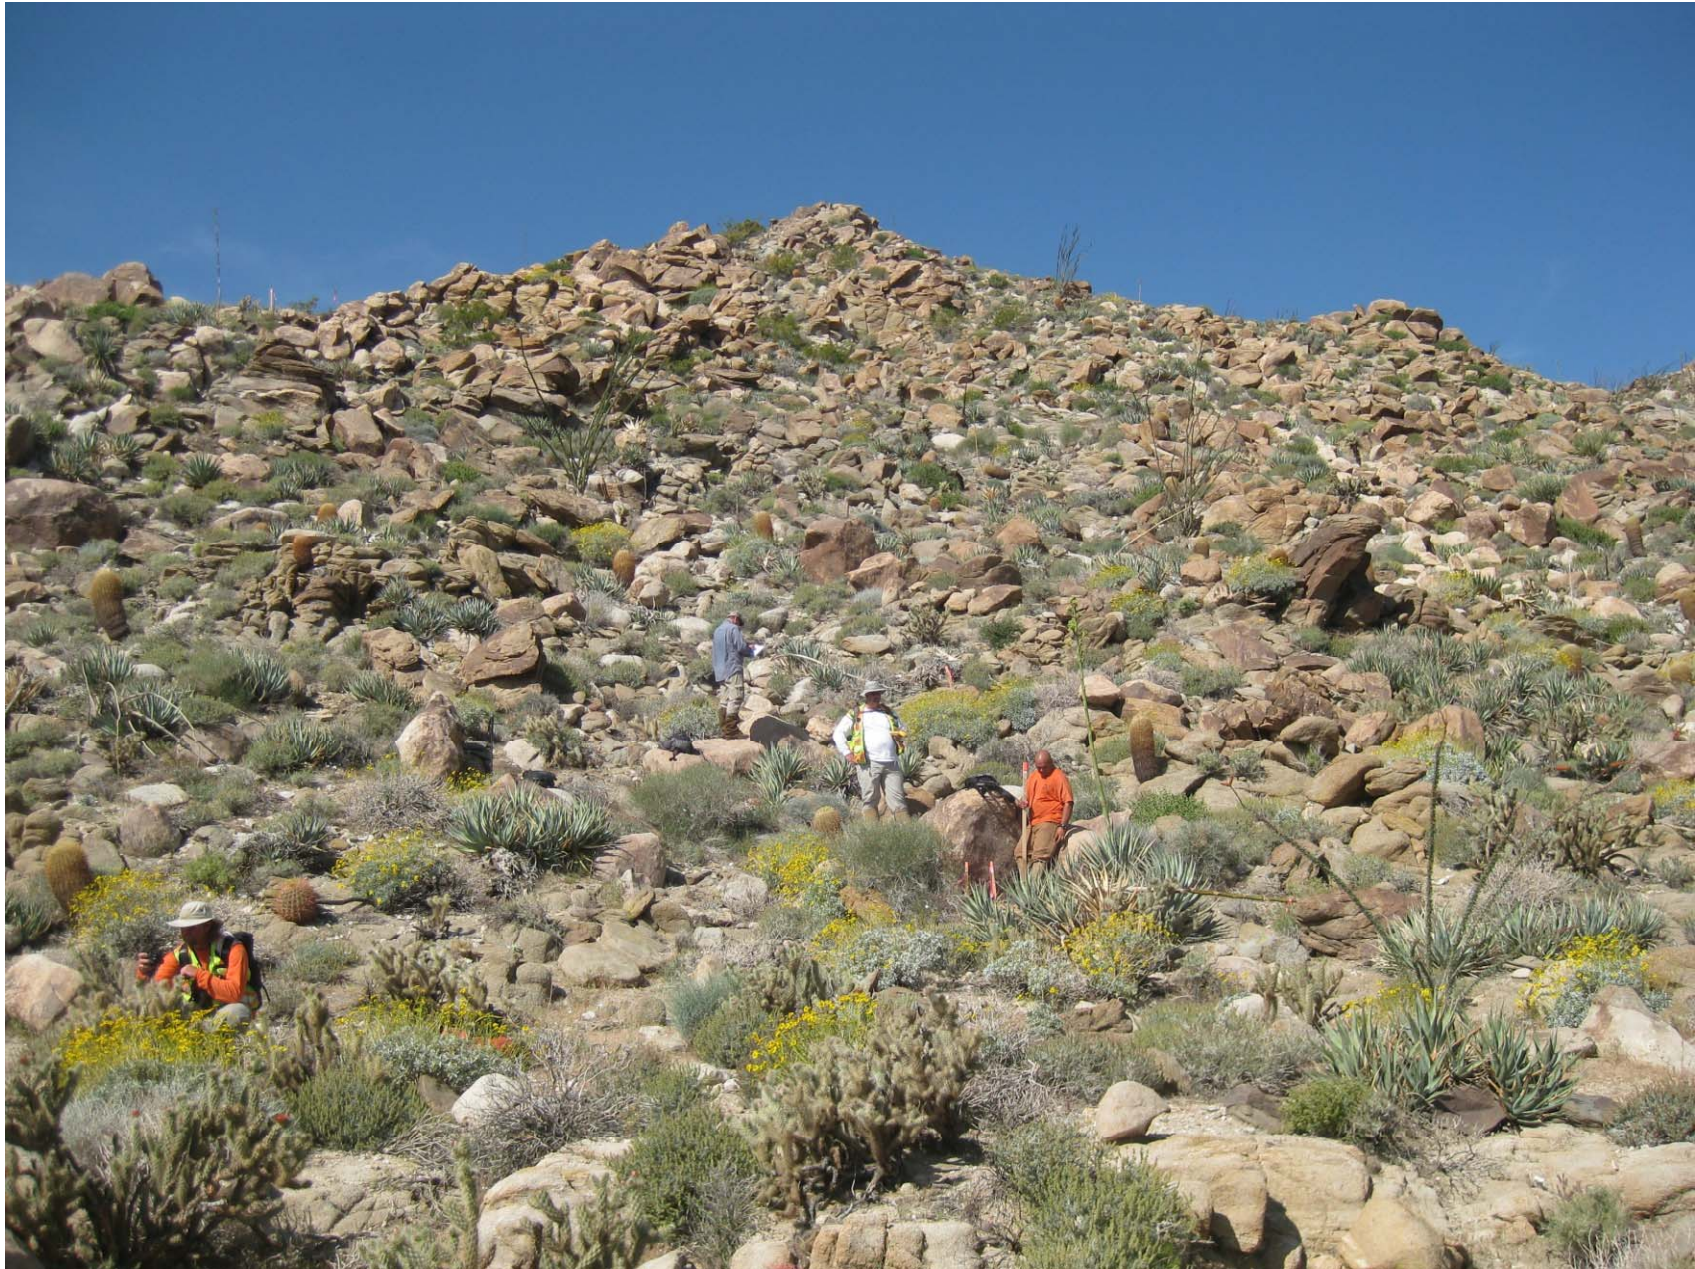
Figure 5

Overall, the rockfall hazard at this location is judged low with a probability of impact over the design life of the structure of less than 0.5 percent.

Hillside located west of Tower 272-3

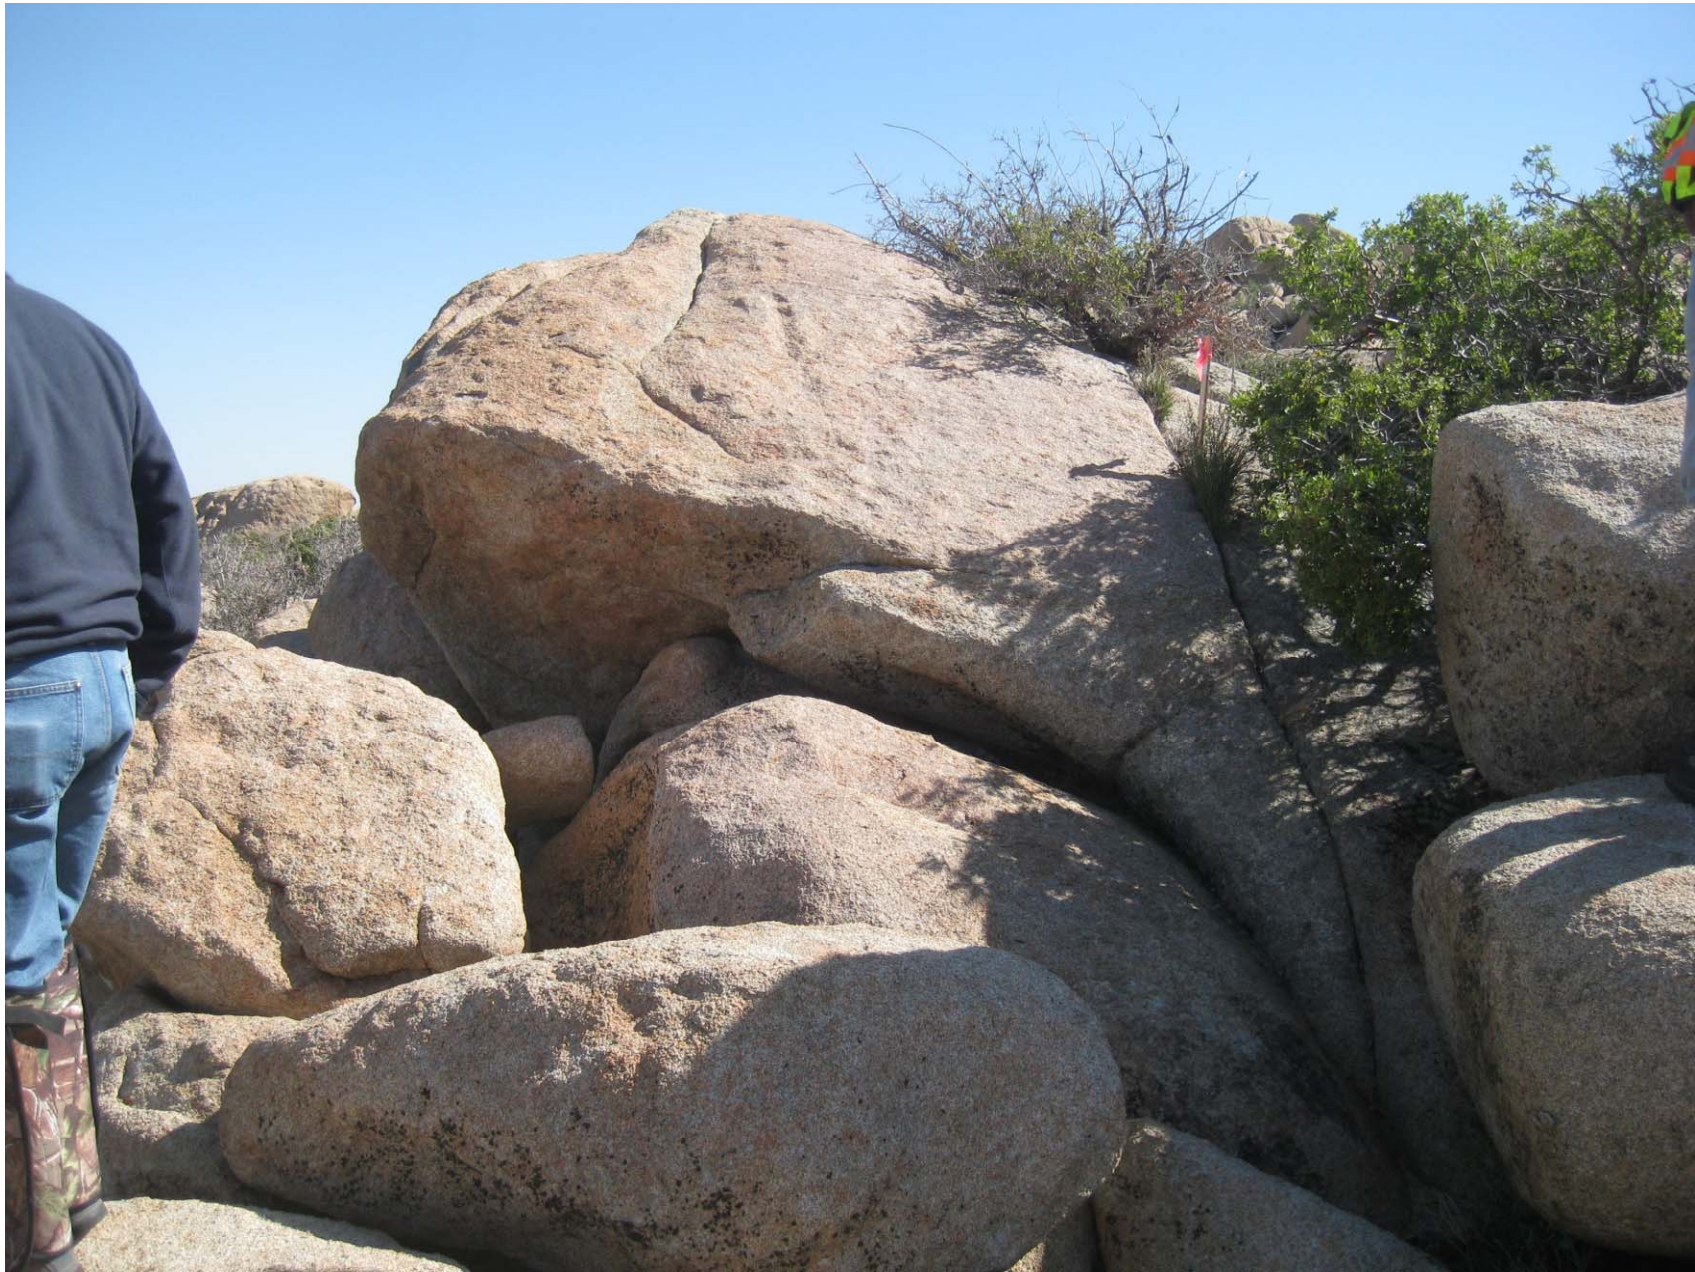
Figure 1

Tower 261-A: Large block situated below planned location for Leg C

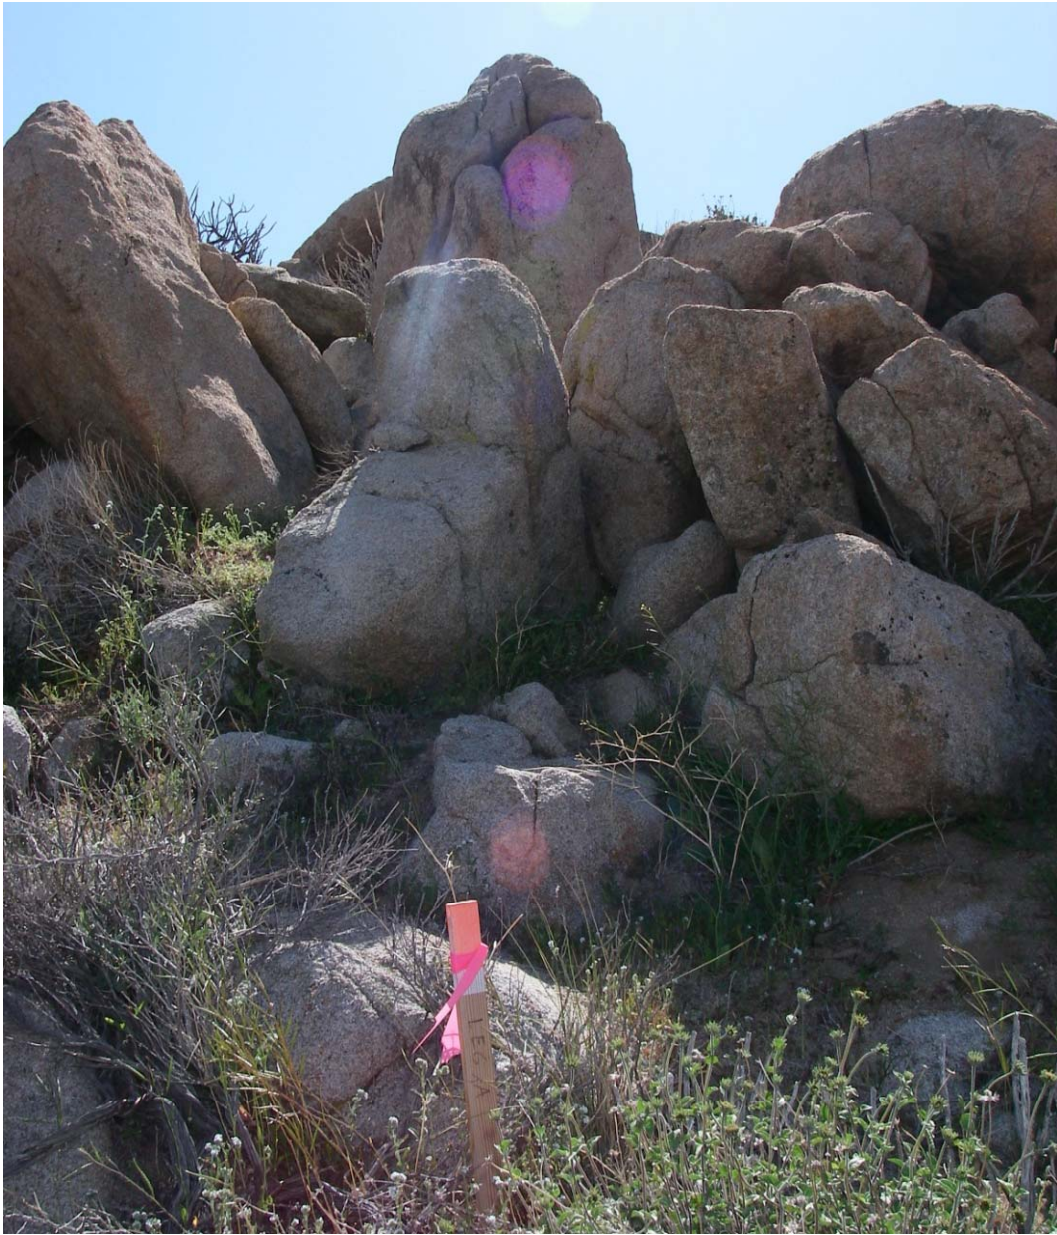
Figure 2

Tower 261-2: Location for Tecco® mesh at Leg A

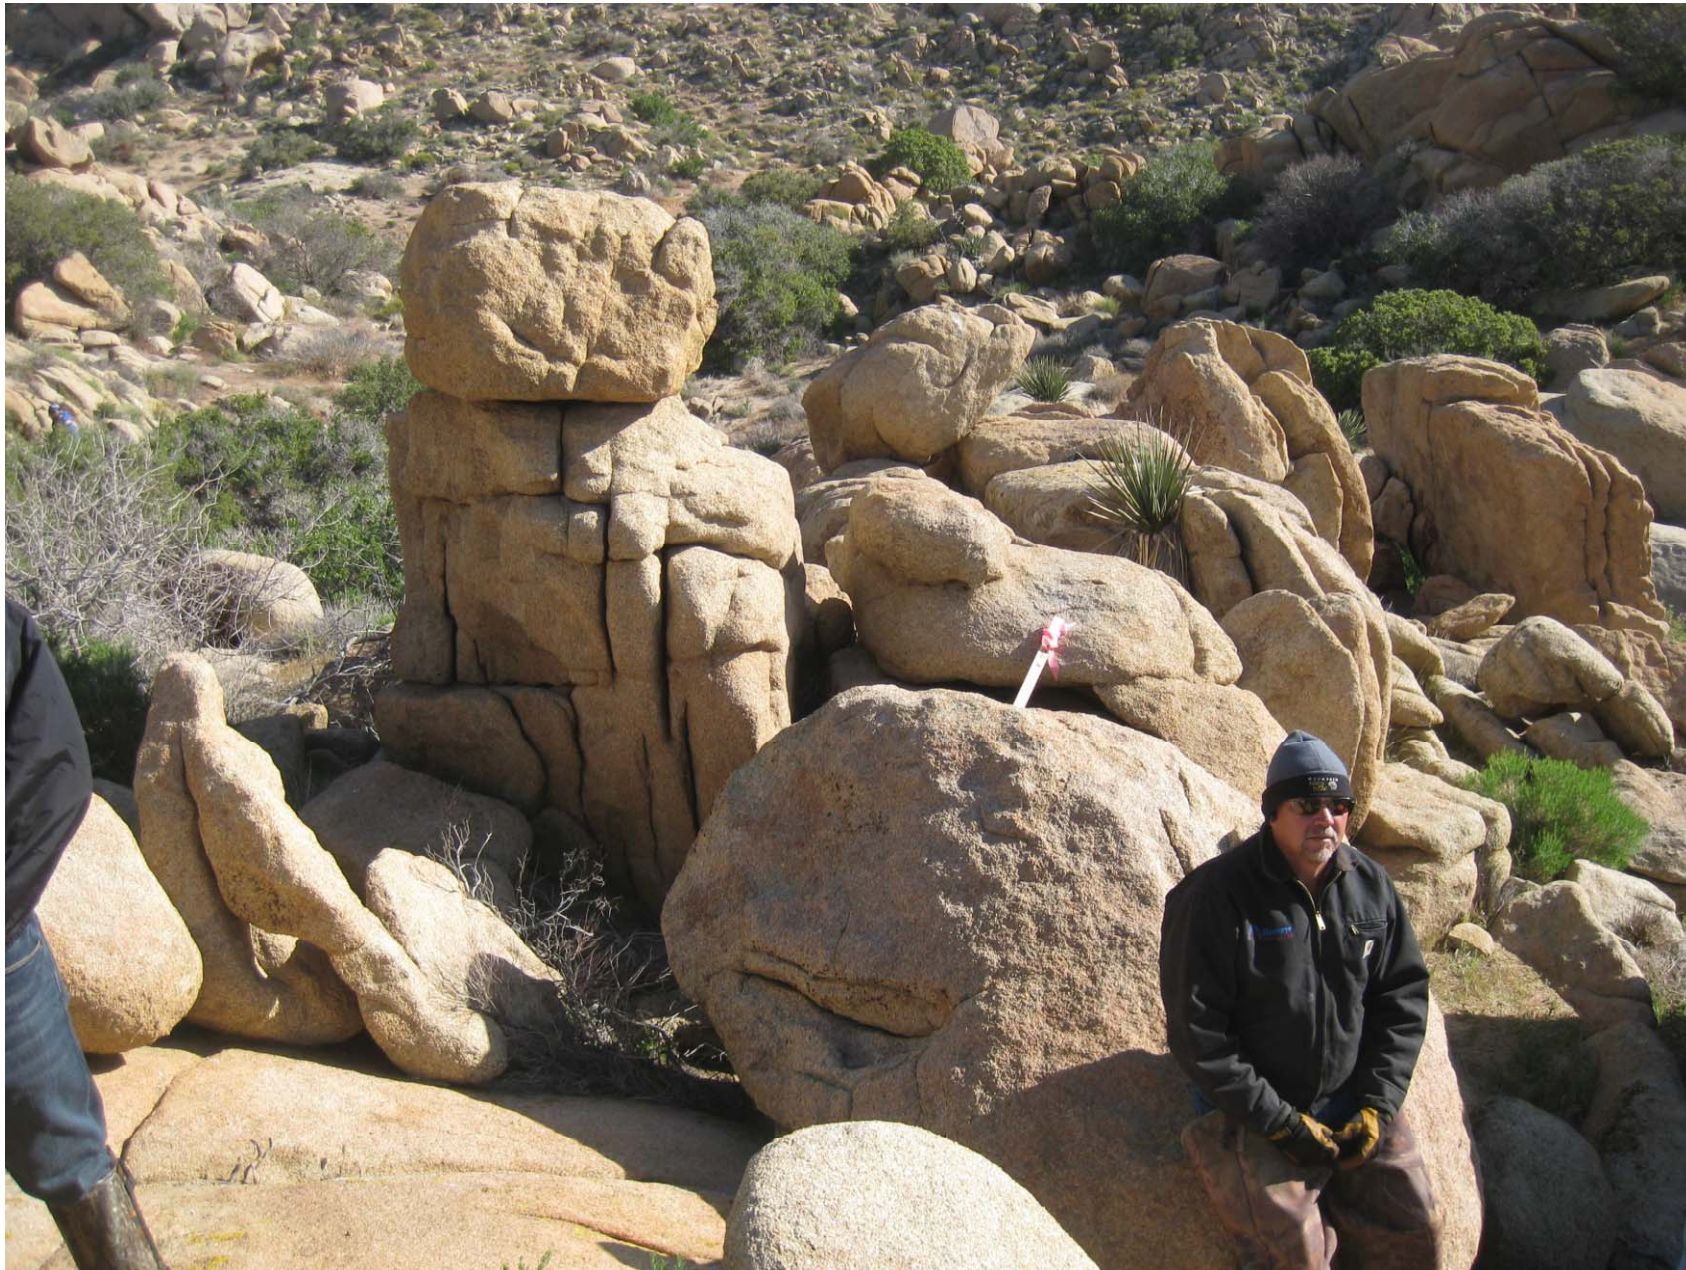
Figure 3

Tower 262-4: Precariously balanced rocks to be removed

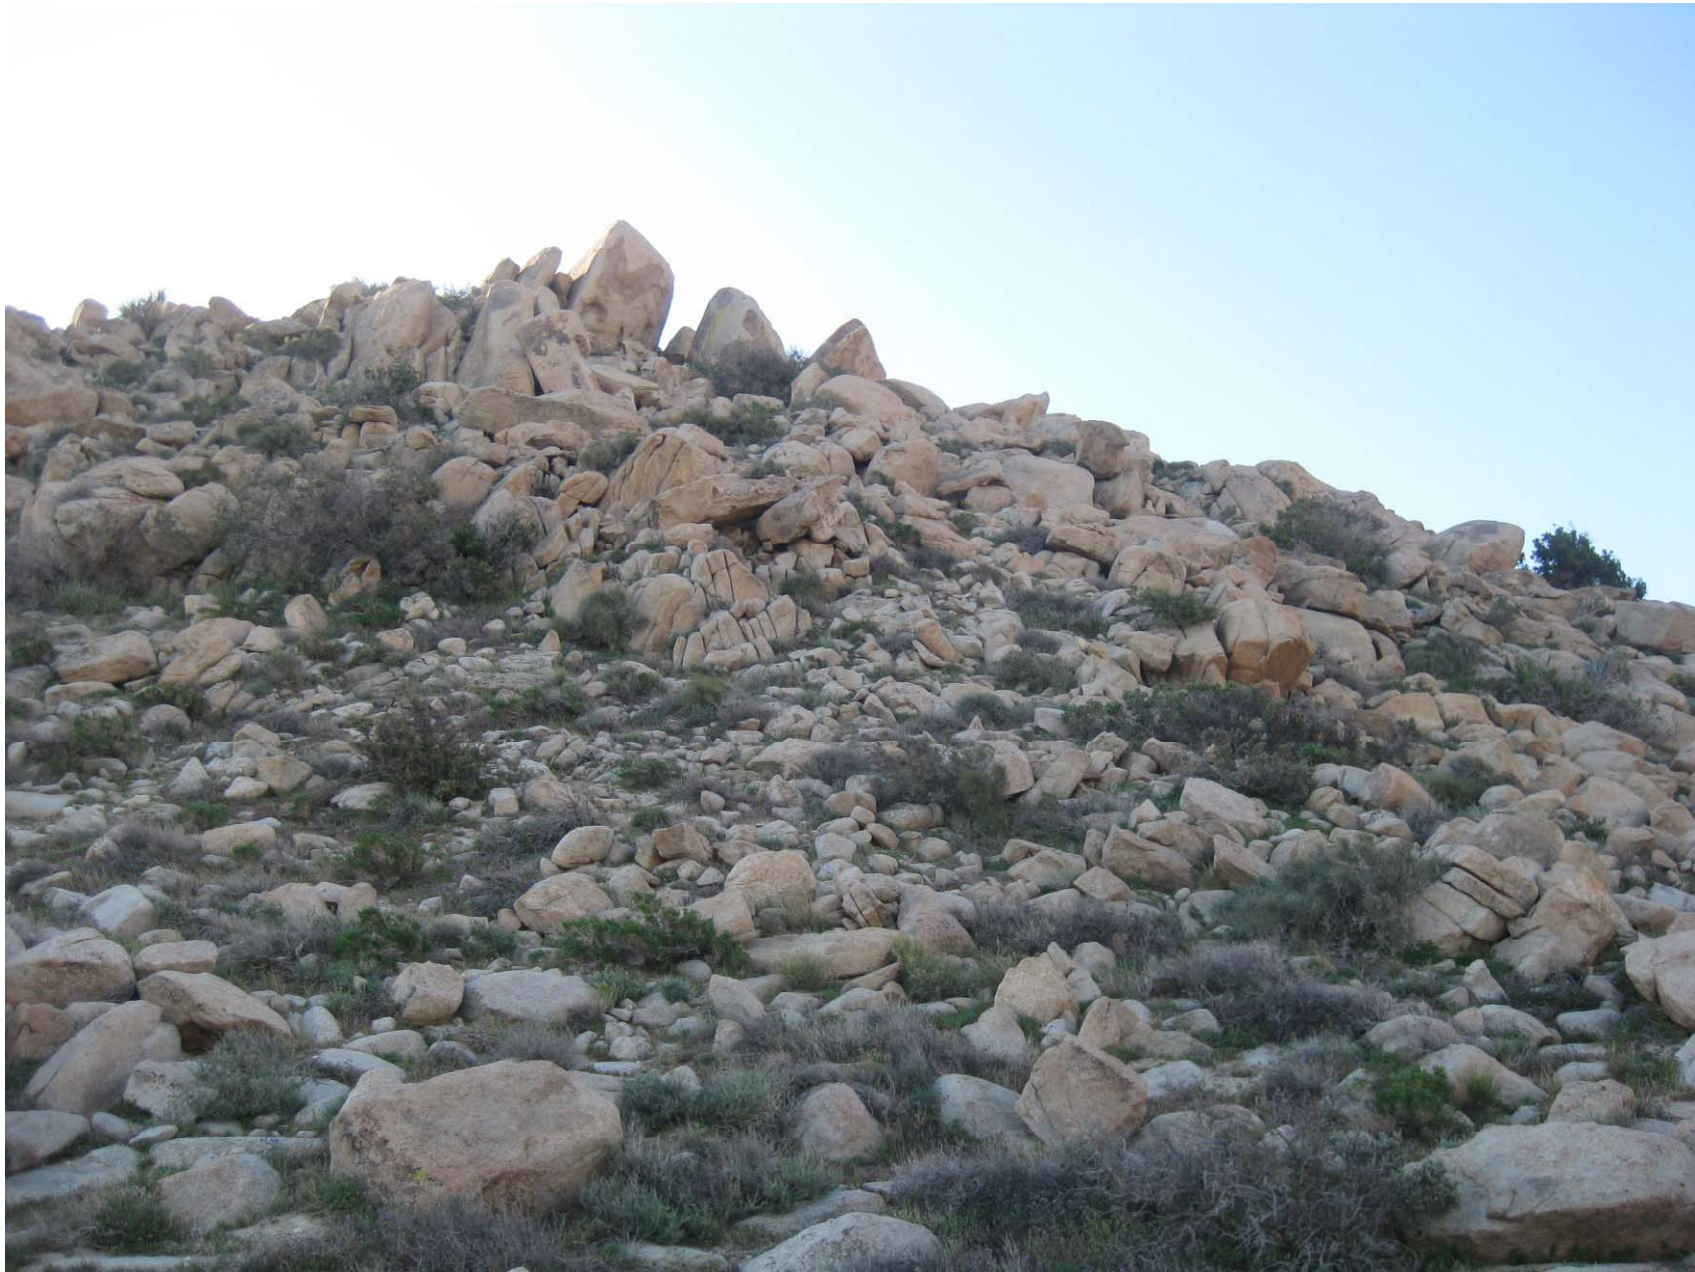
Figure 4

Tower 263A-2: Slope located to the southeast of tower

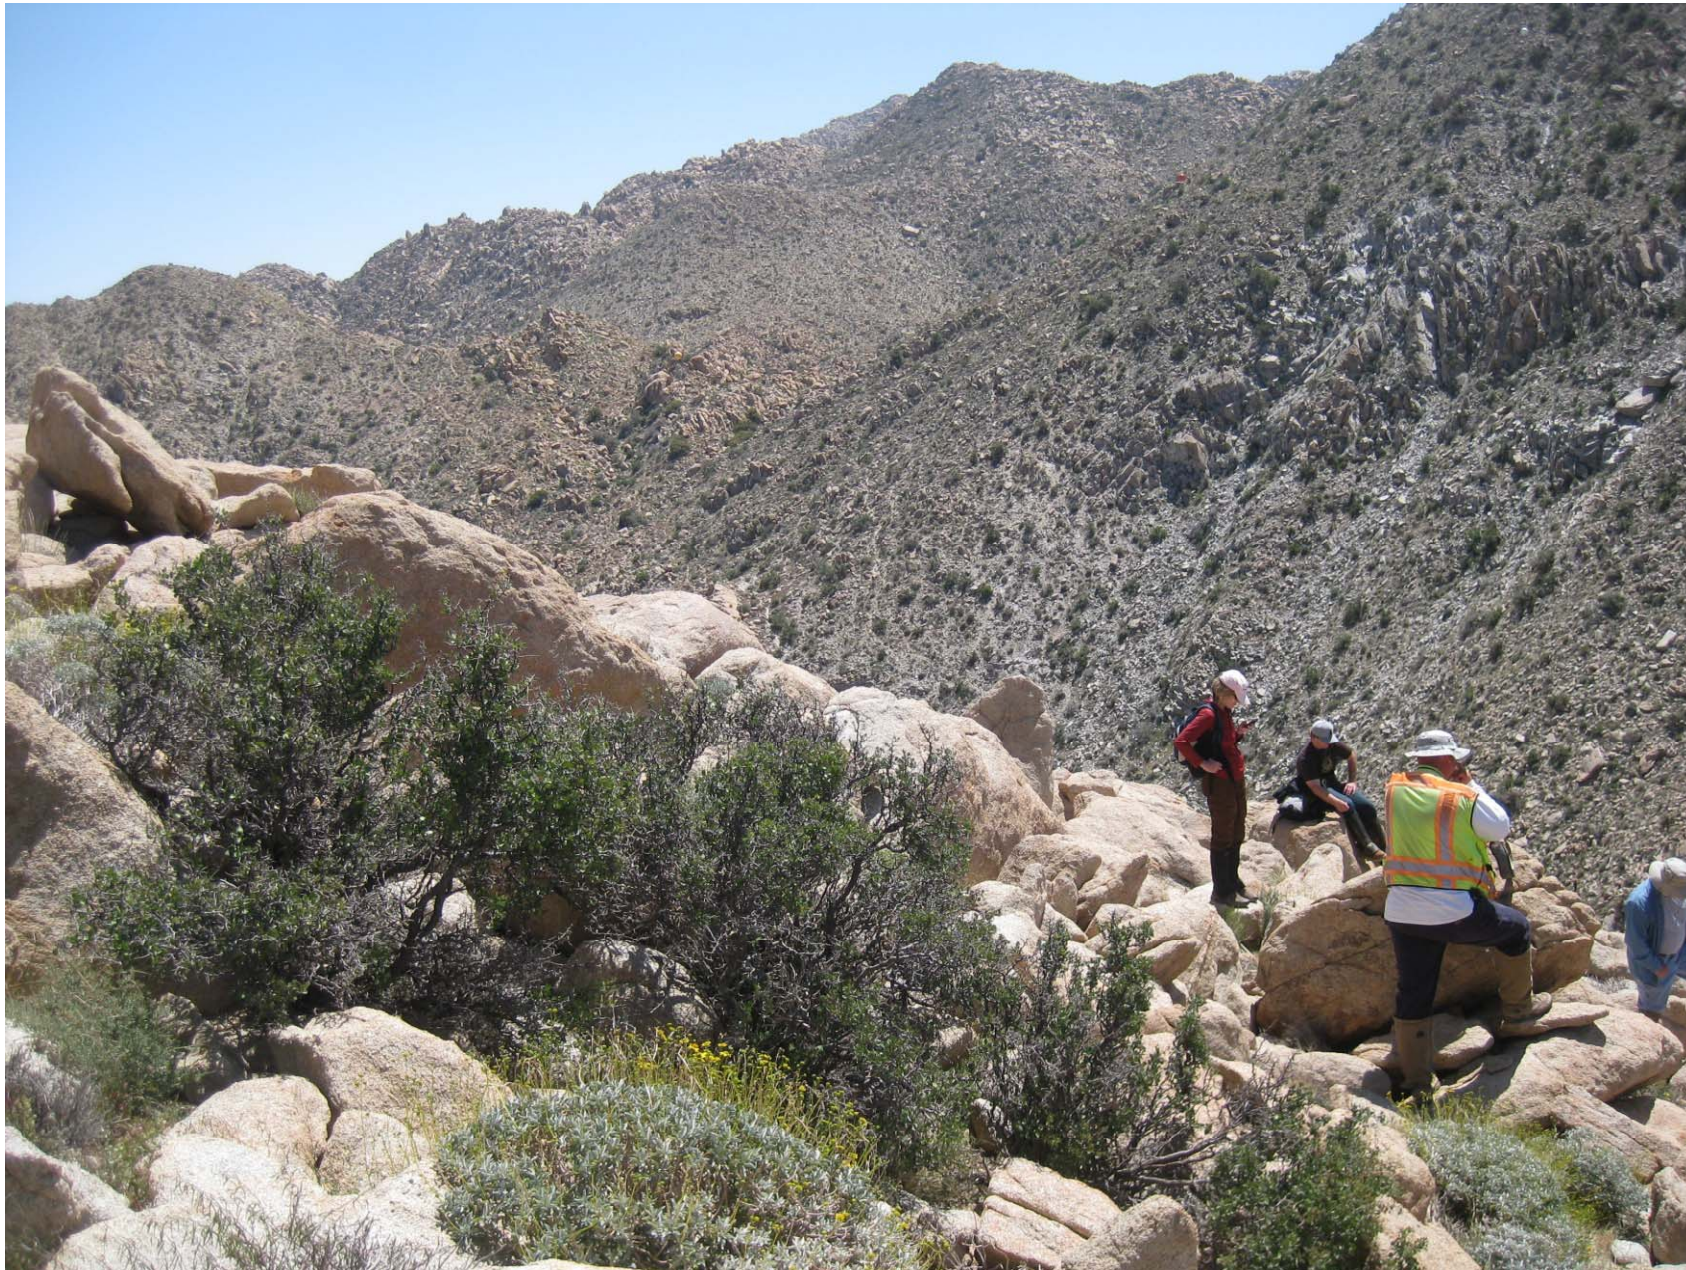
Figure 5

Tower 263B-2: Rock talus pile located above Leg D

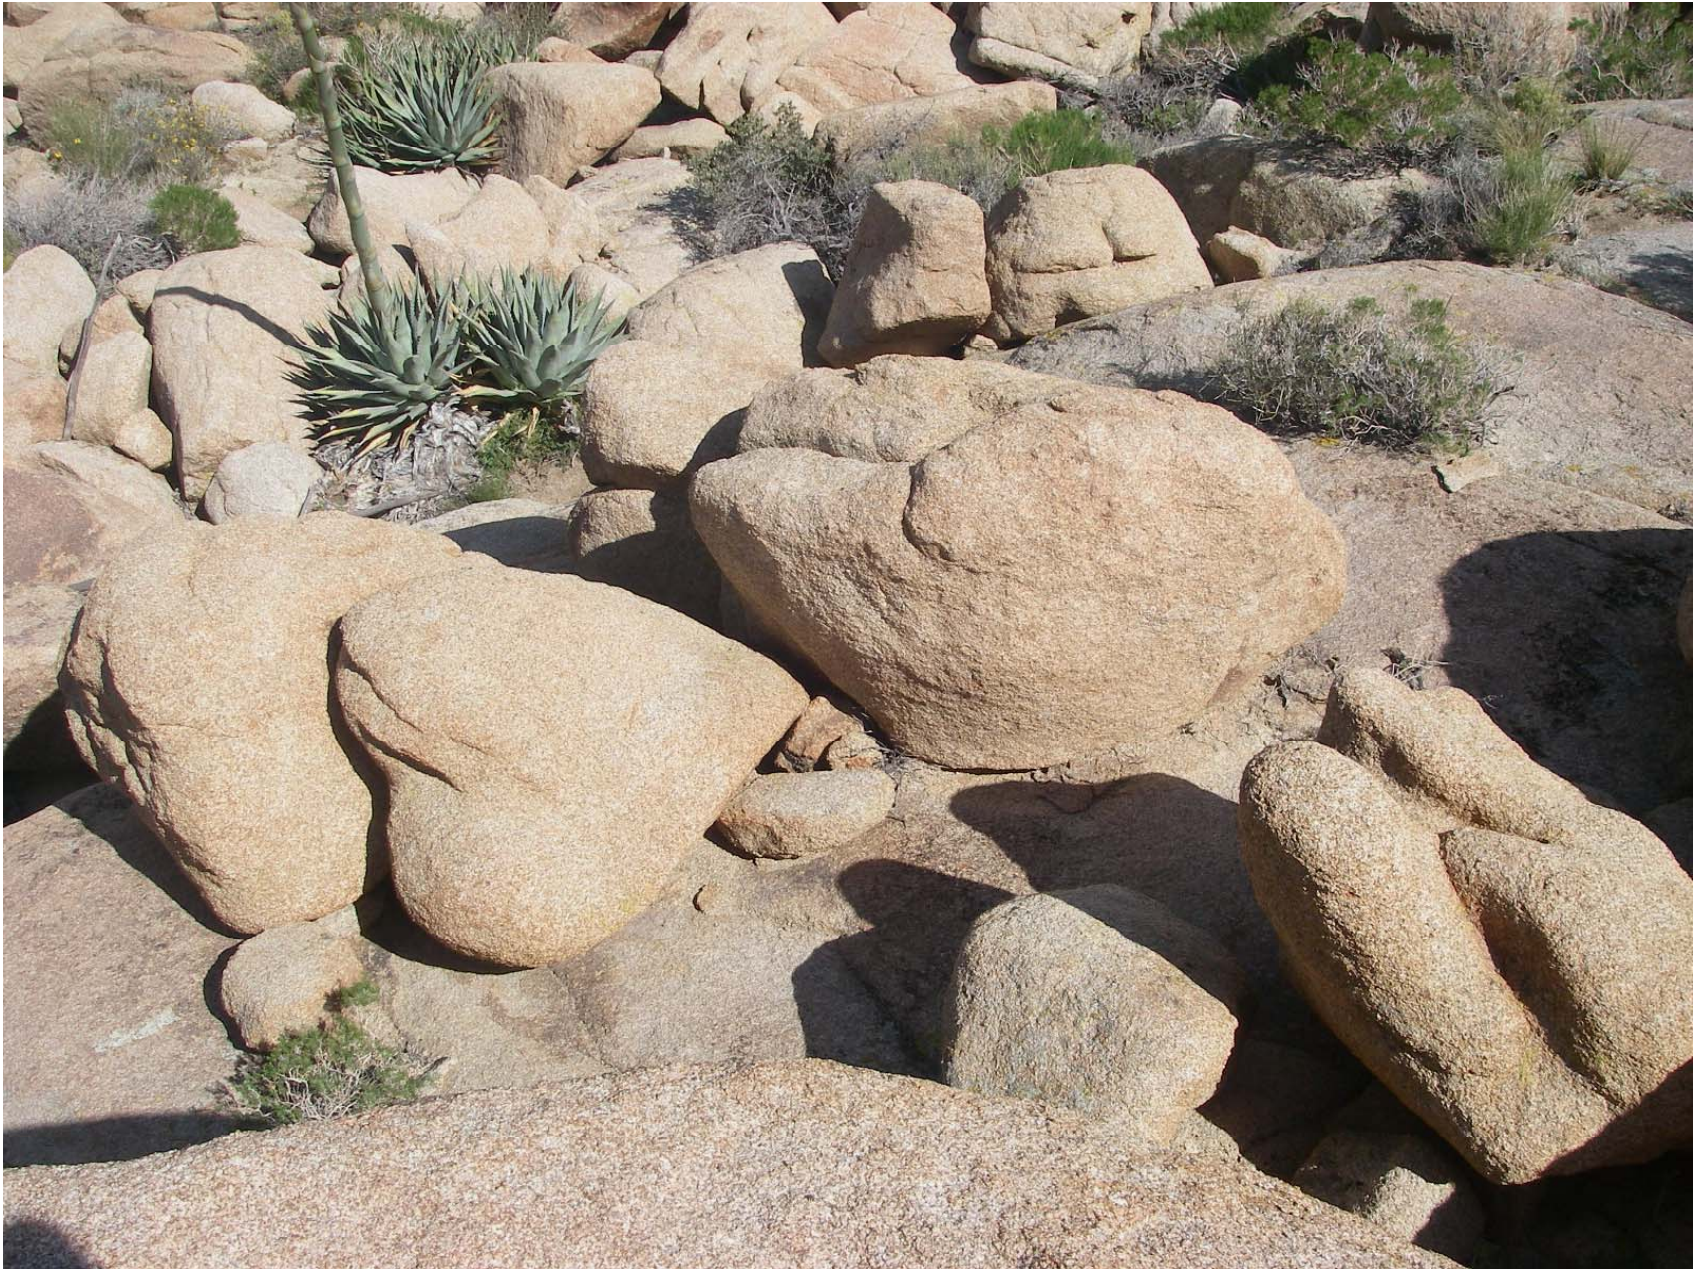
Figure 6

Tower 265-2: Blocks resting on a 35 degree slope above Leg A
