Subject: Rock Fall Hazard Evaluations
Sunrise Powerlink Project
San Diego and Imperial Counties, California
URS Project No. 27661033.00010

**Subject: Sunrise Mountain Springs Grade
Rockfall Hazard Evaluation:
Towers 261A, 263A-2, 263B-2, 266-2, and 272-3**

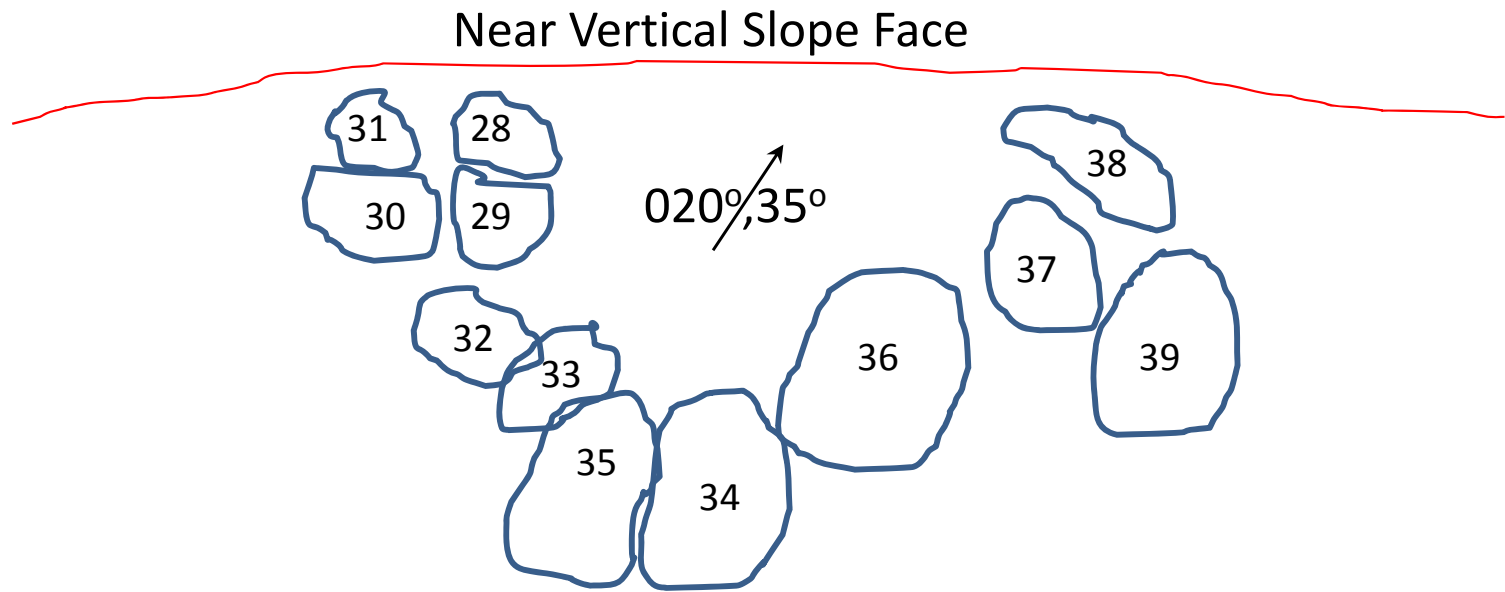
Figure 7

Note: Number in blocks are the 'boulder' numbers recorded by the surveyors.

Tower 265-2: Blocks located on 35 degree dip slope

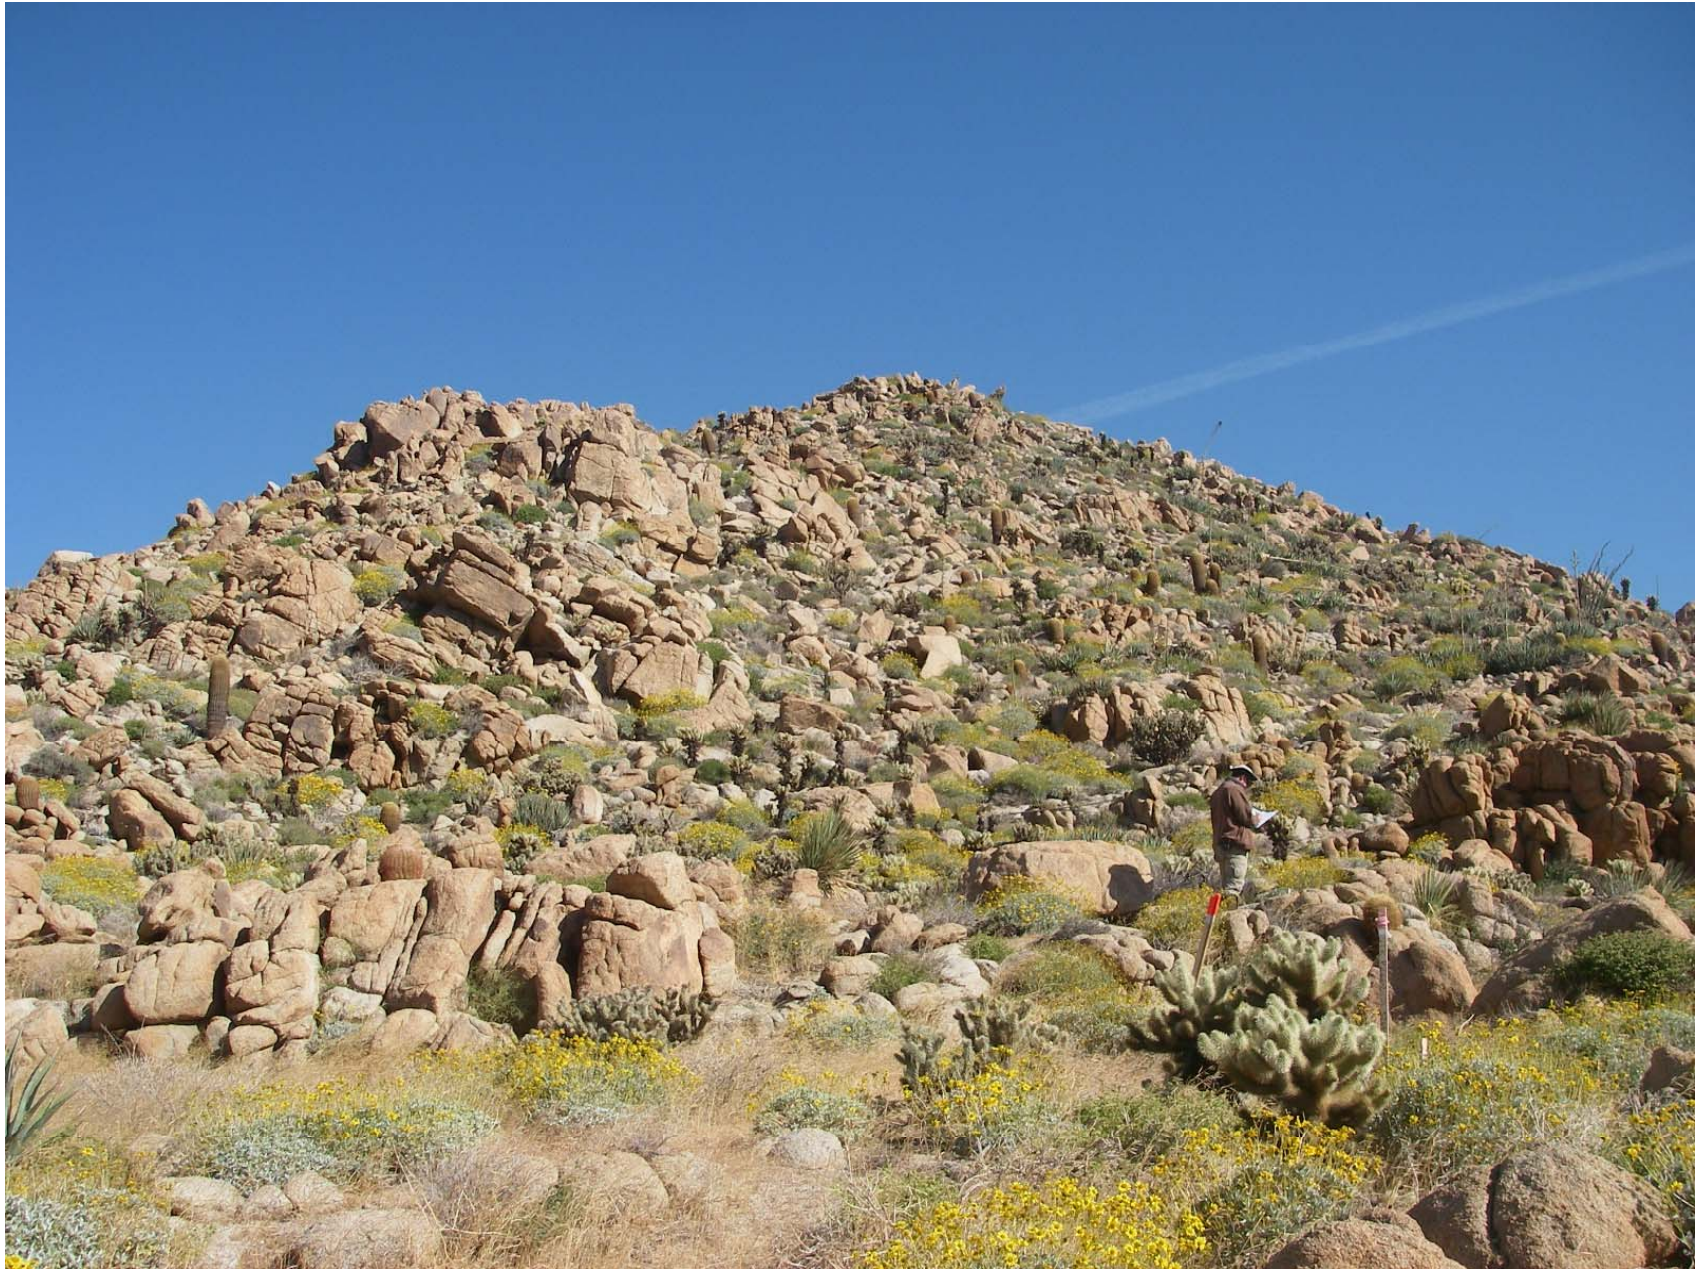
Figure 8

Tower 266-2: Slope located north of the tower

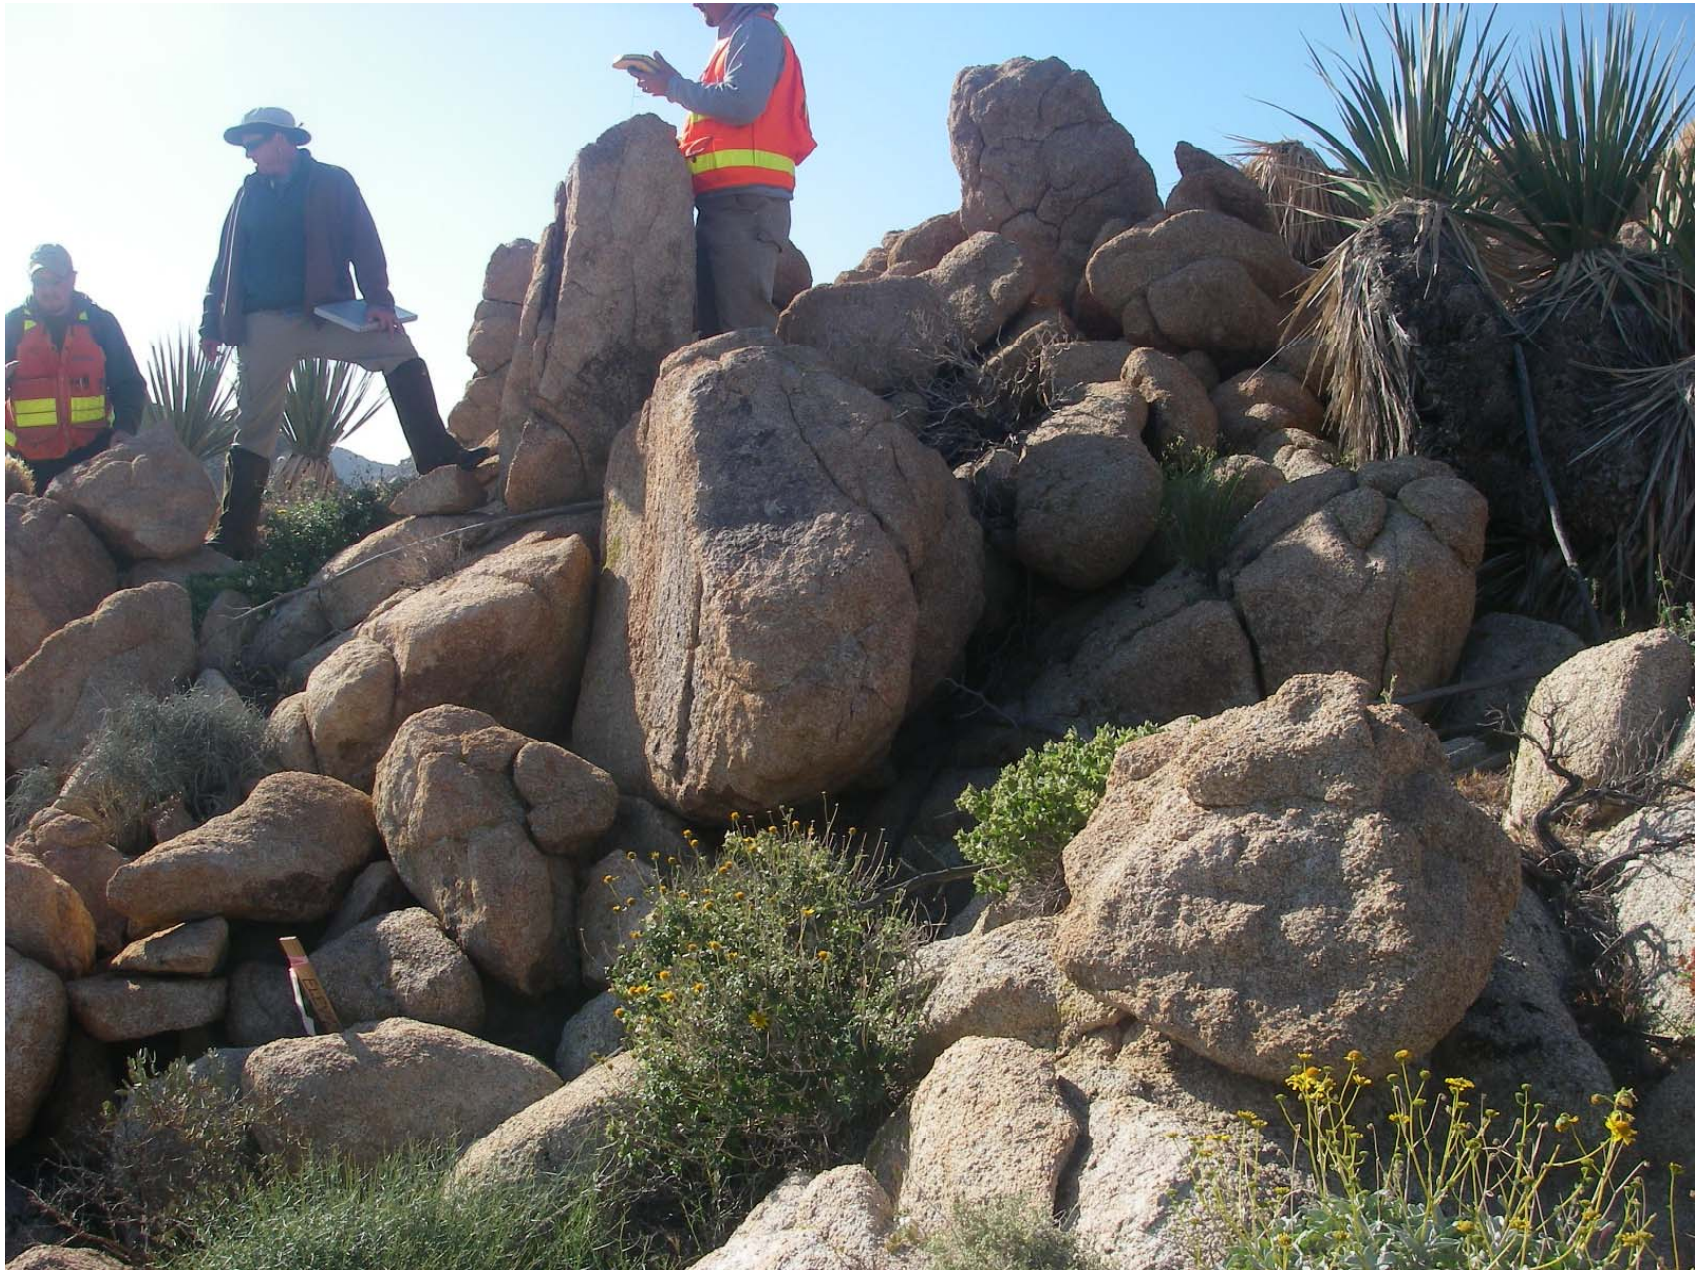
Figure 9

Tower 267-2: Rock fall hazard at Leg D

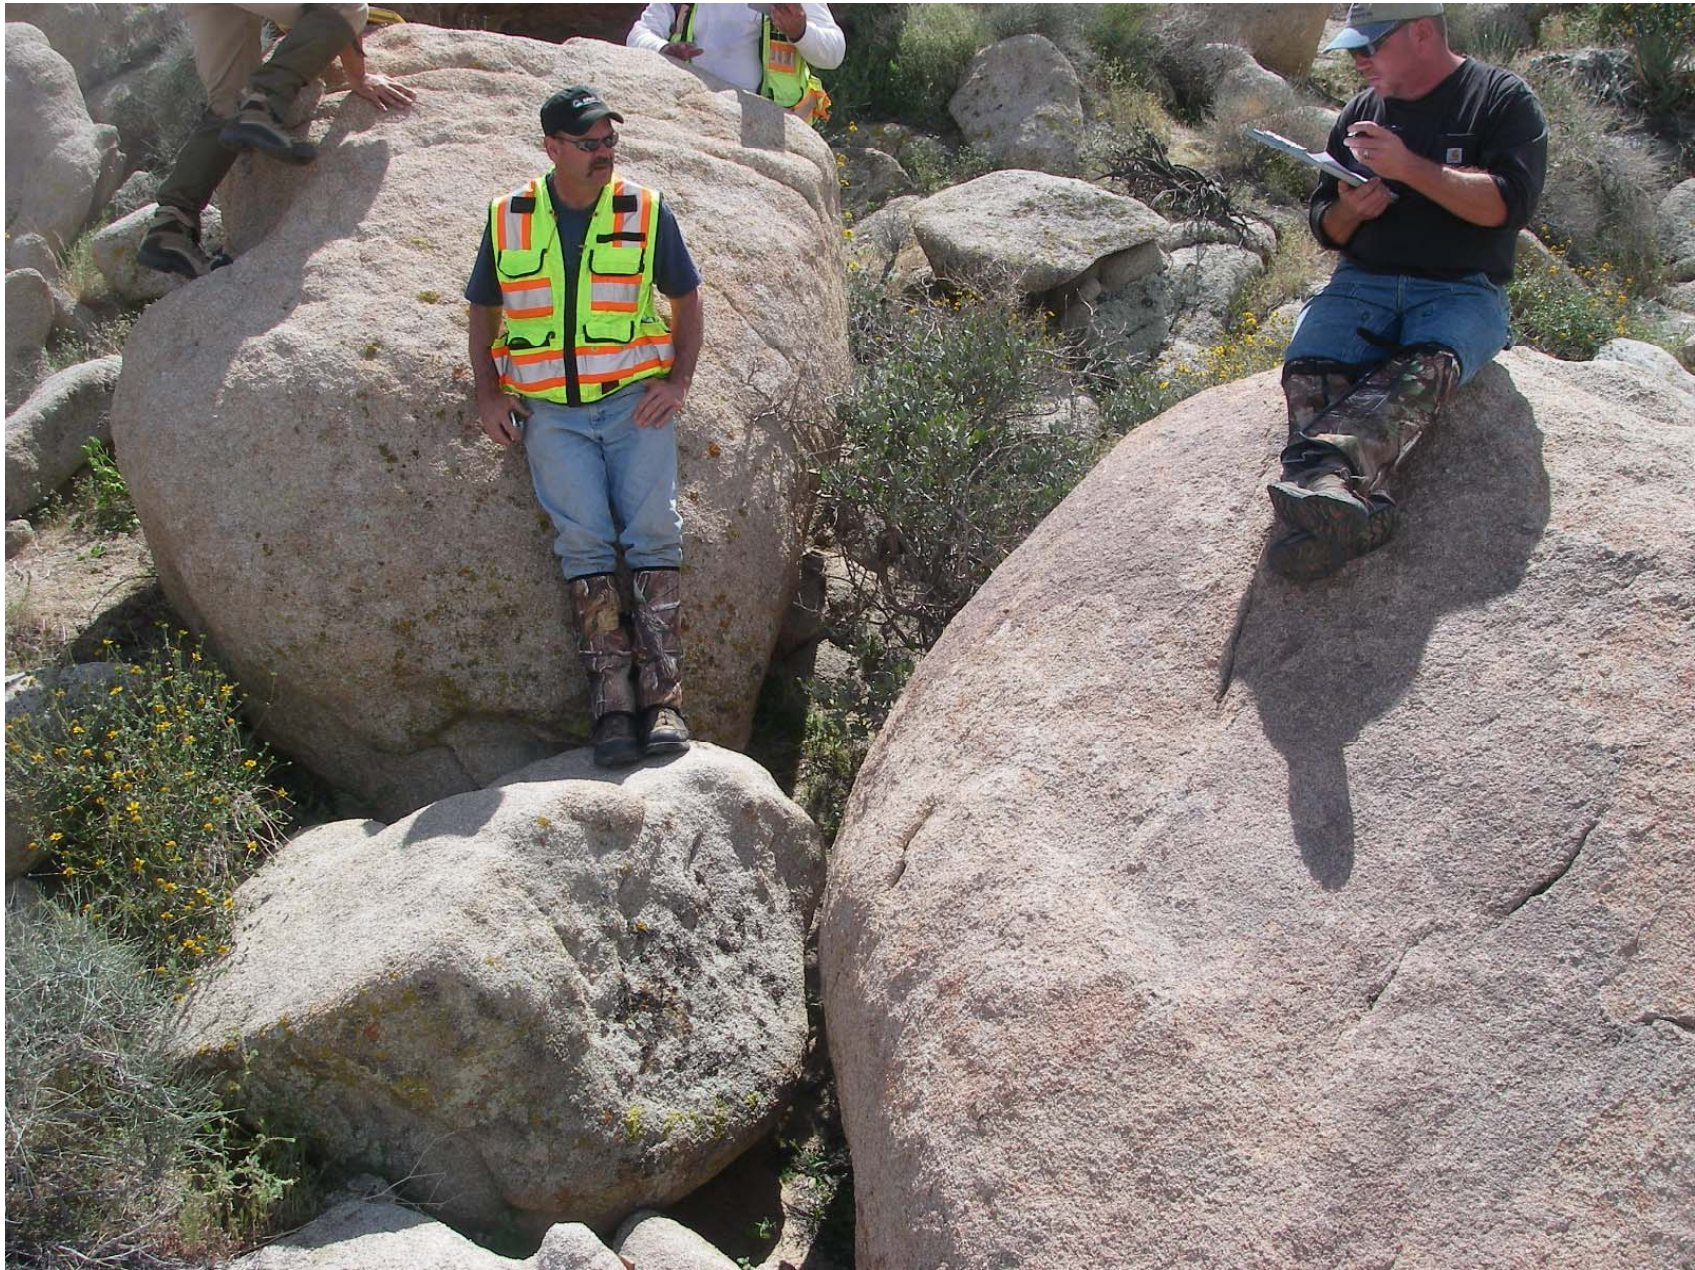
Figure 10

Tower 270-2: Unstable blocks at Leg D

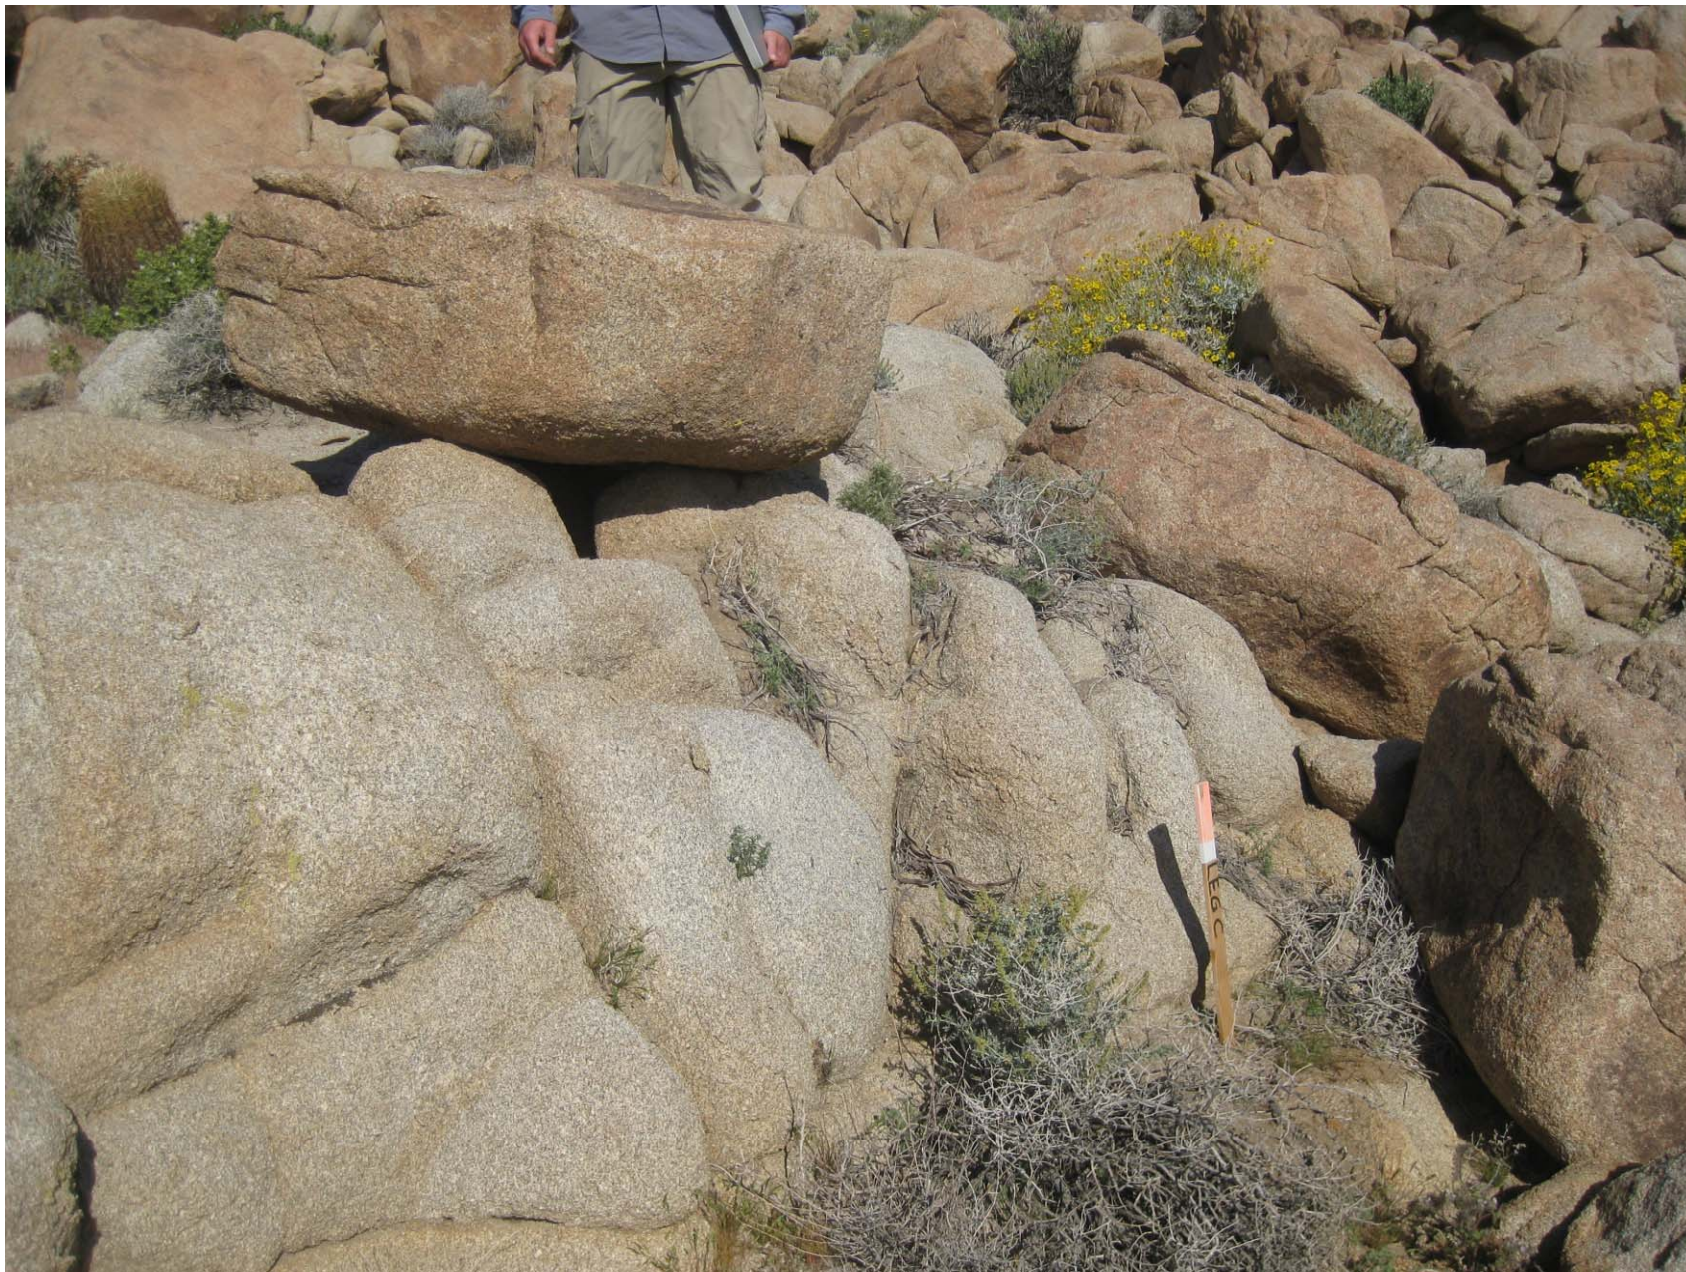
Figure 11

Tower 271-2: PBR that may be a threat after removal of rocks for drill rig

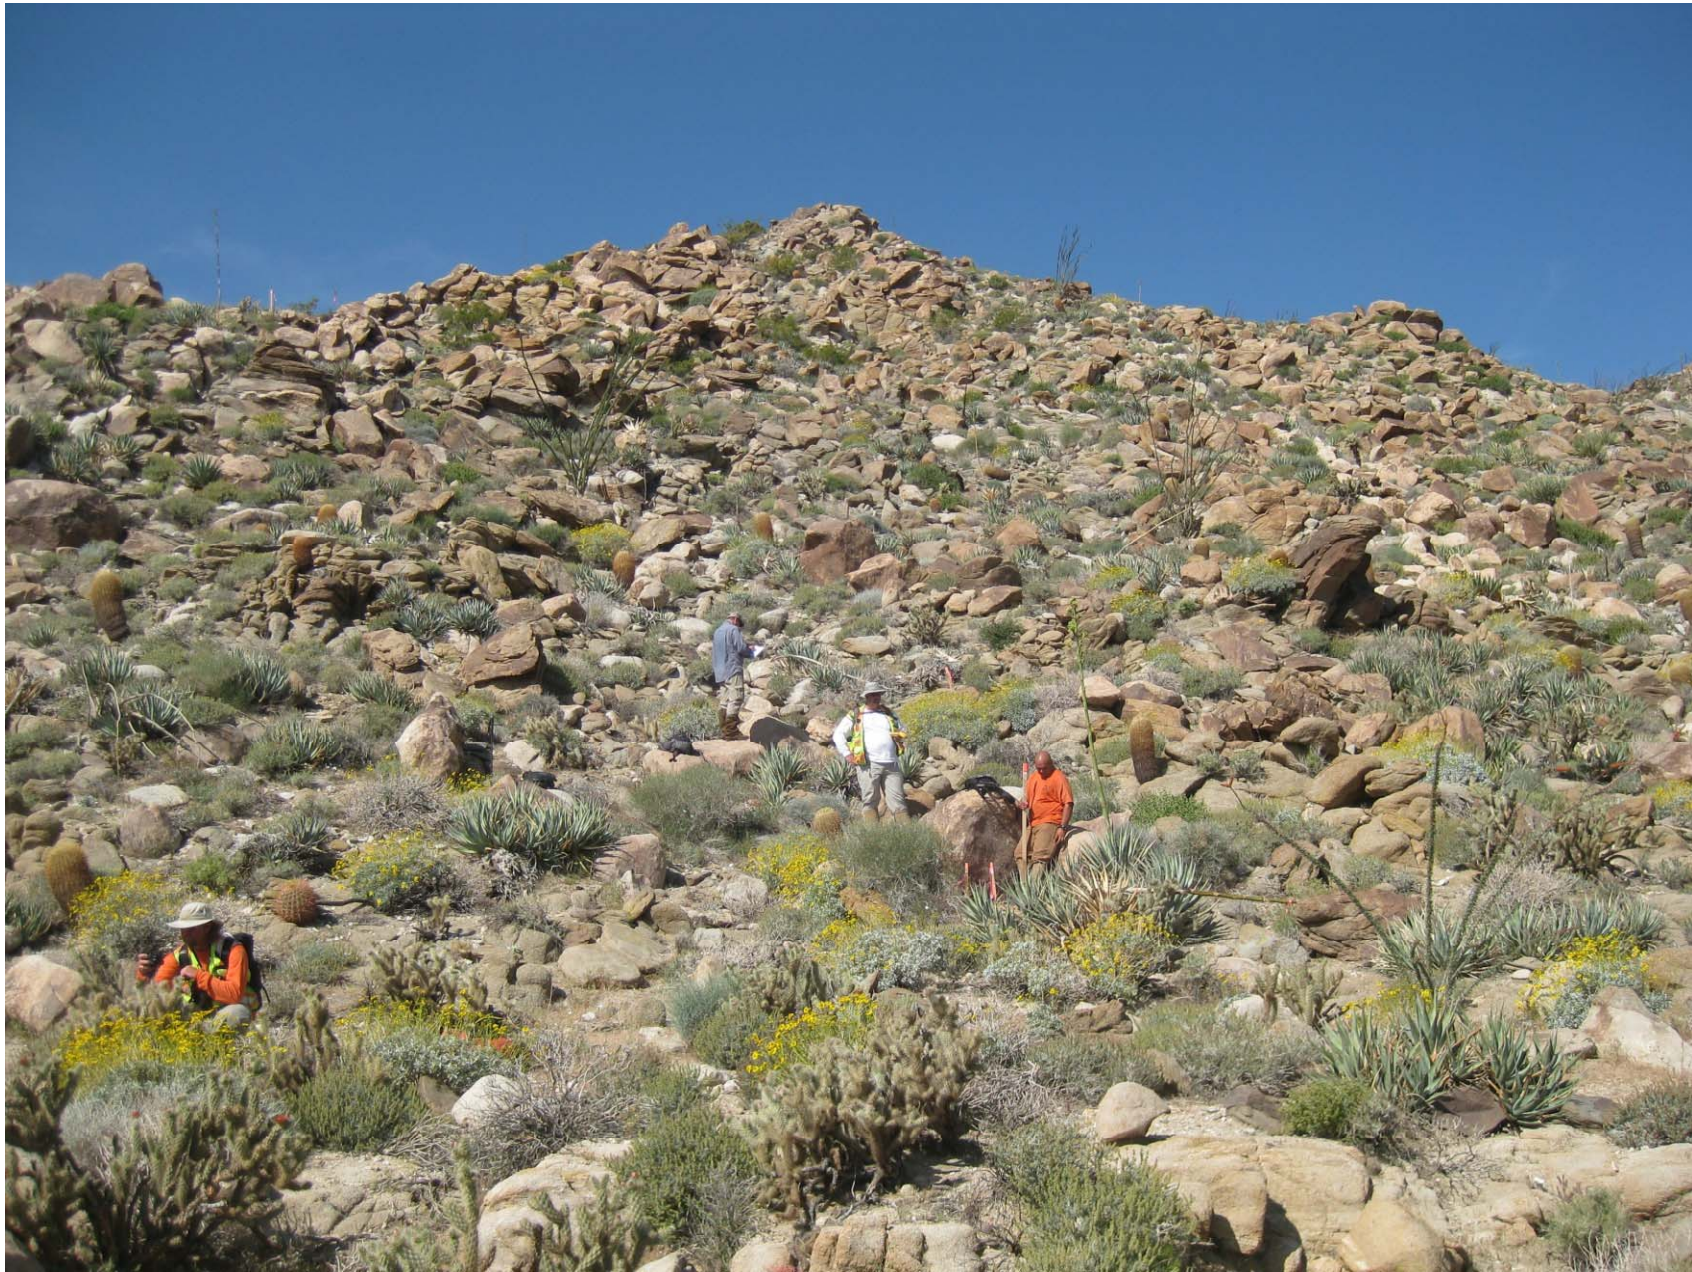
Figure 12

Tower 272-3: Slope located to the southwest of the tower

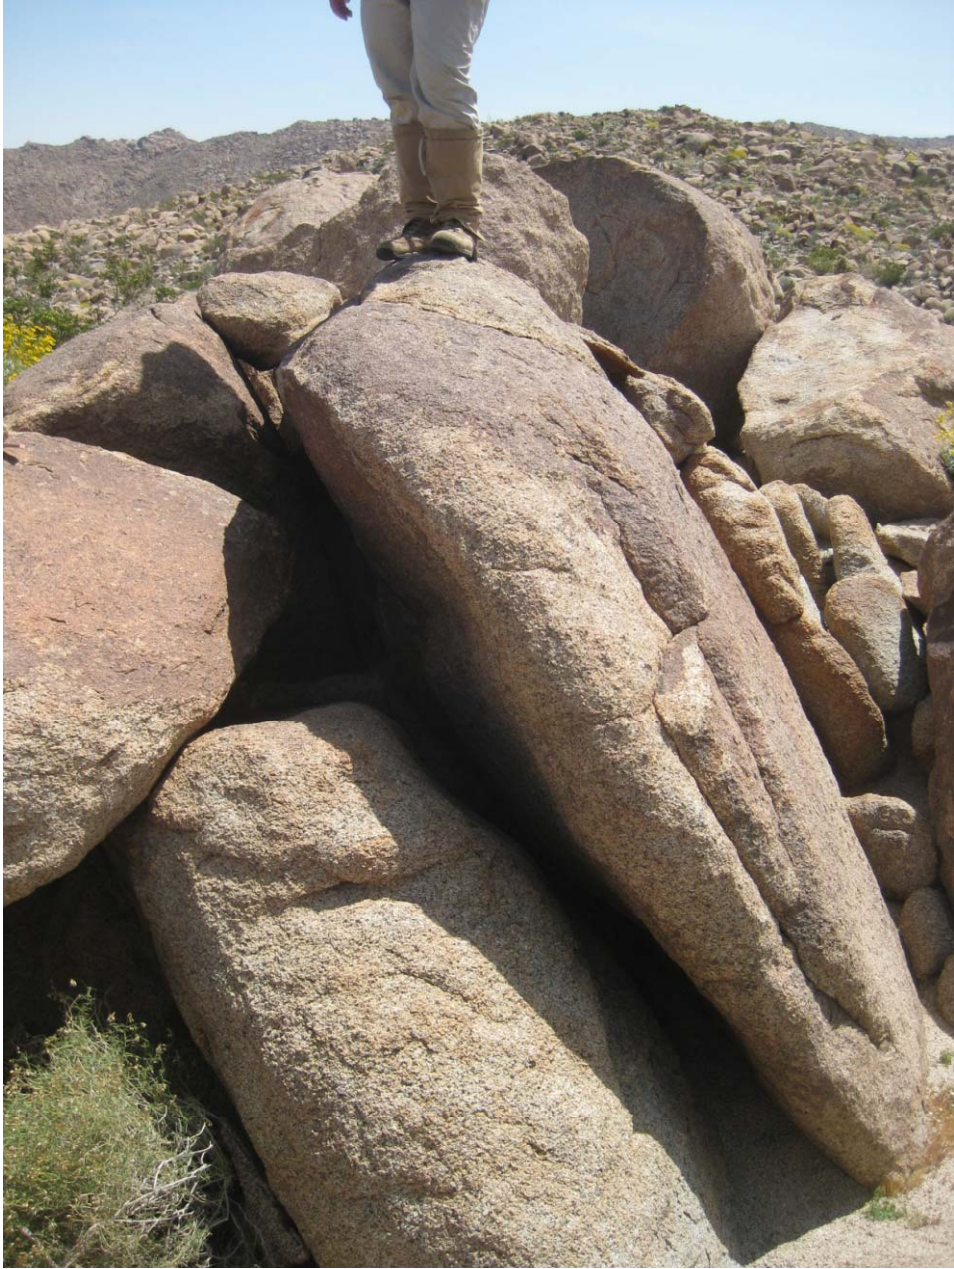
Figure 13

Note: Block is not a hazard until other rock blocks are removed for drill rig access.

Tower 276-1: Potential rockfall hazard

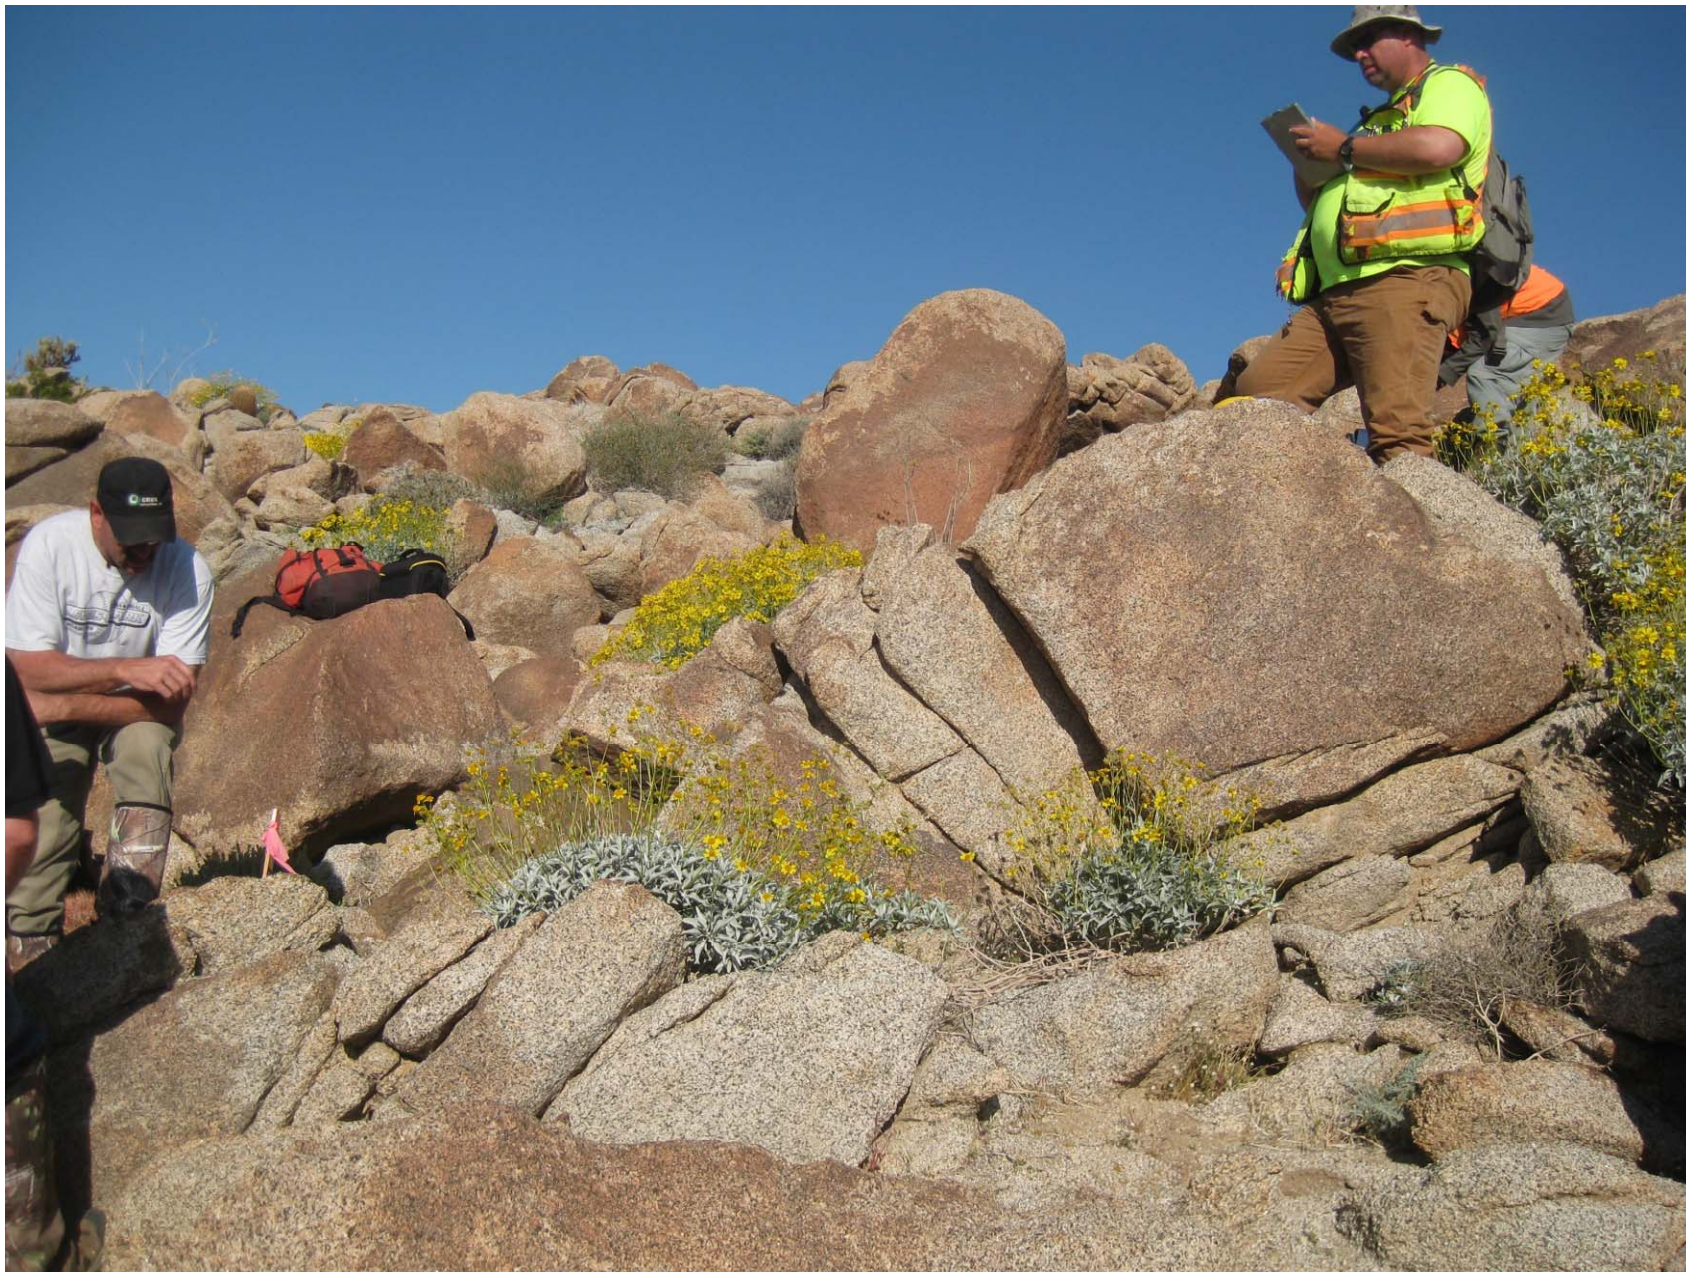
Figure 14

Tower 277-1: Photograph at Leg D

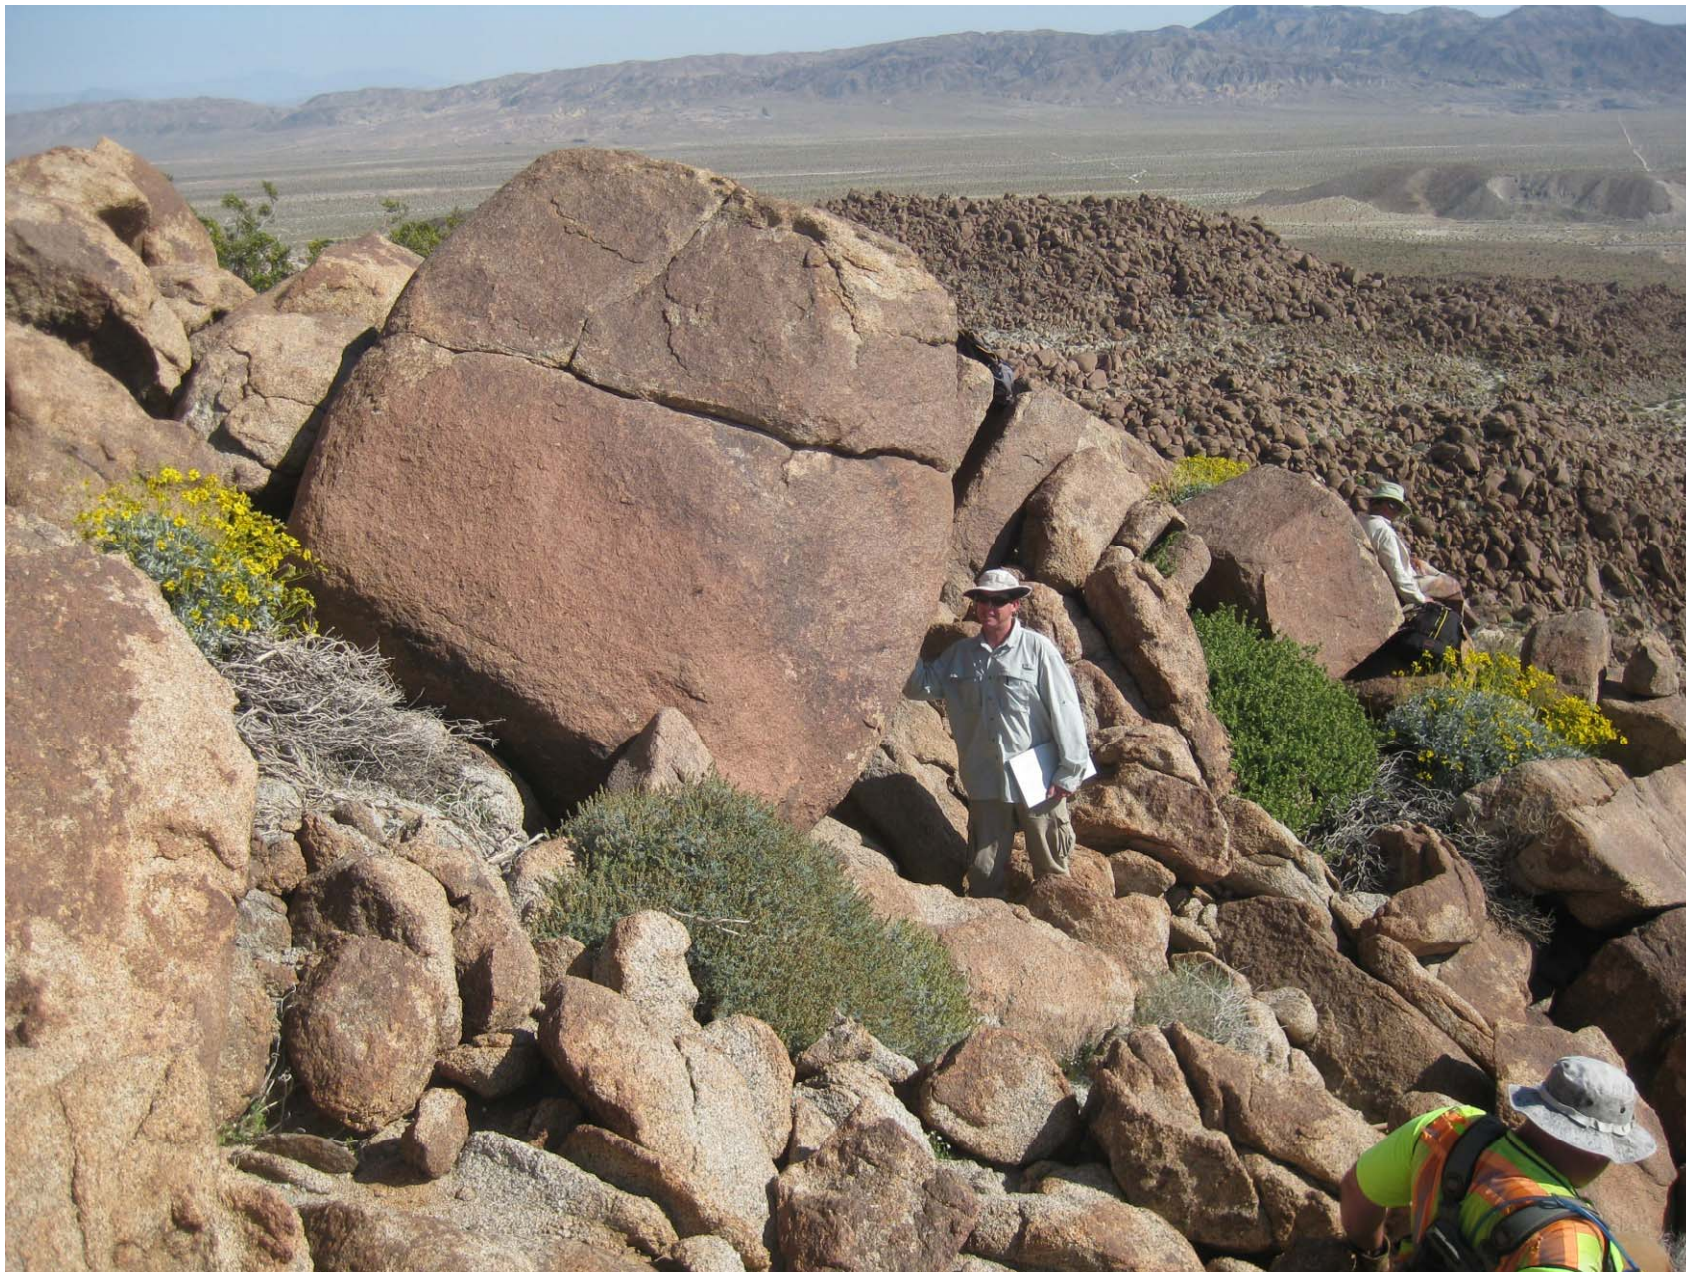
Figure 15

Tower 278-1: Large block that should be broken to mitigate toppling

Section	Tower	Seismic induced-Rock Fall Hazard ¹	Slope ² (inclination degrees from horizontal)	Comments
10a (Cont'd)	EP278-1	Low	25 to 37	Break and remove boulders adjacent to Legs C and D, bolt boulder adjacent to Leg C per FSR.
	EP279-1	Low	15 to 25	Break and remove boulders at all legs per FSR.
	EP280-1	None	< 10

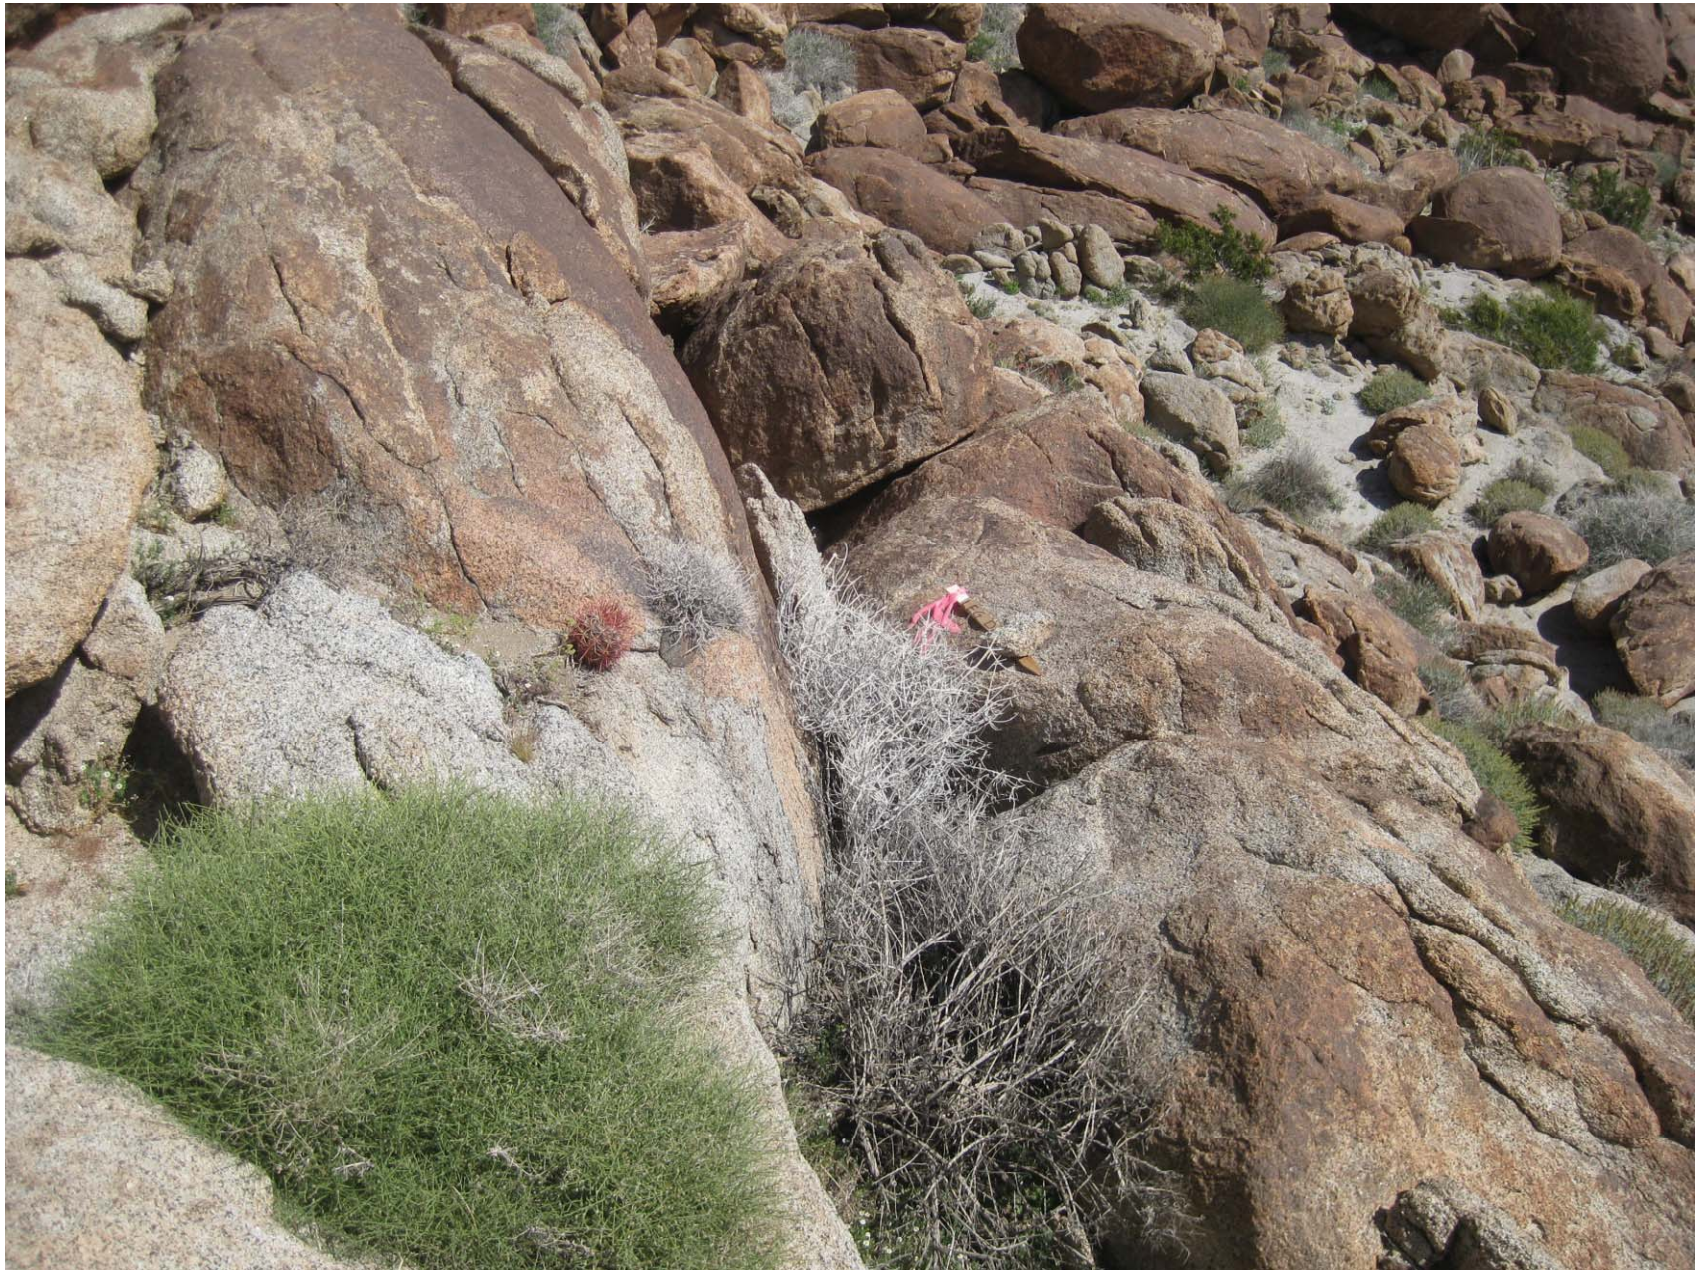
Figure 16

Tower 279-1: Leg D will require decreasing the foundation elevation

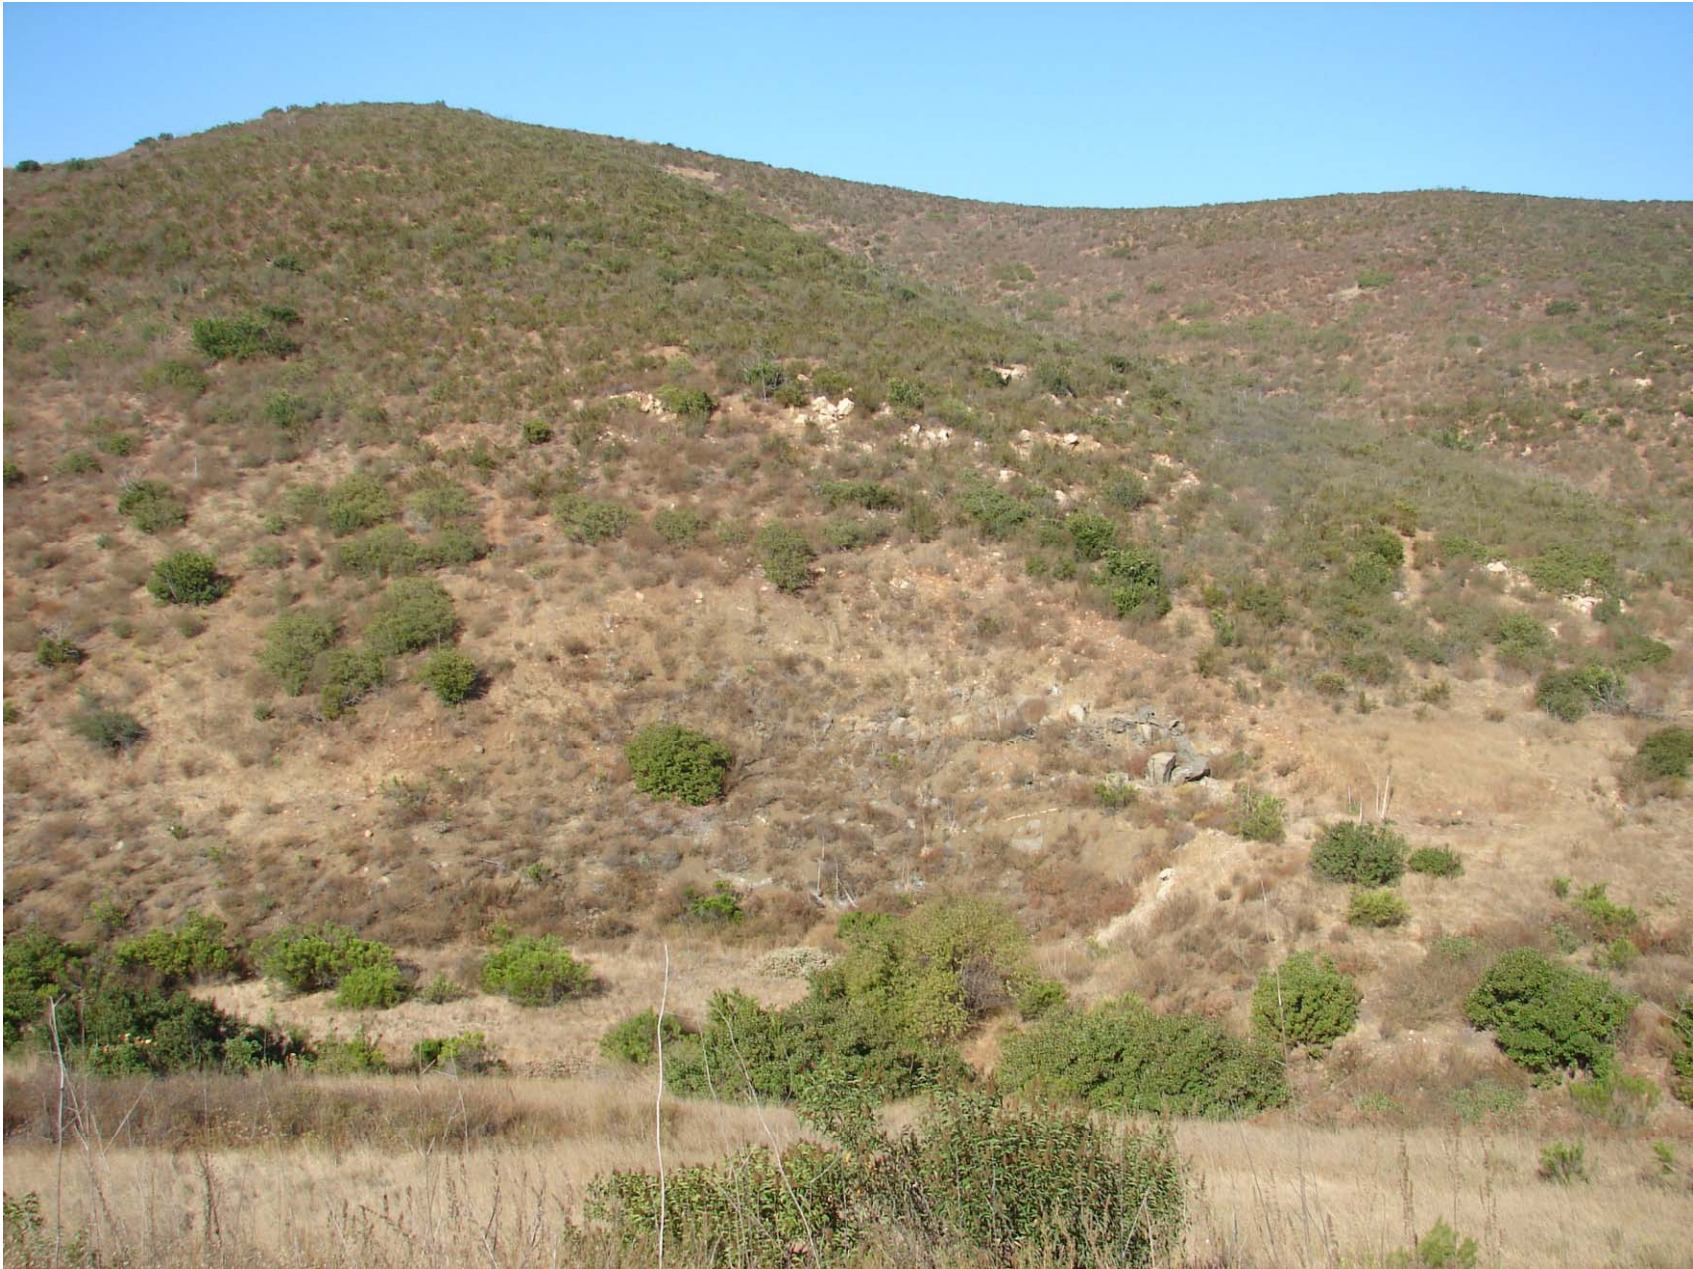
Figure 17

Tower CP20: Colluvium at tower location
