Subject: Rock Fall Hazard Evaluations
Sunrise Powerlink Project
San Diego and Imperial Counties, California
URS Project No. 27661033.00010

**Subject: Sunrise Mountain Springs Grade
Rockfall Hazard Evaluation:
Towers 261A, 263A-2, 263B-2, 266-2, and 272-3**

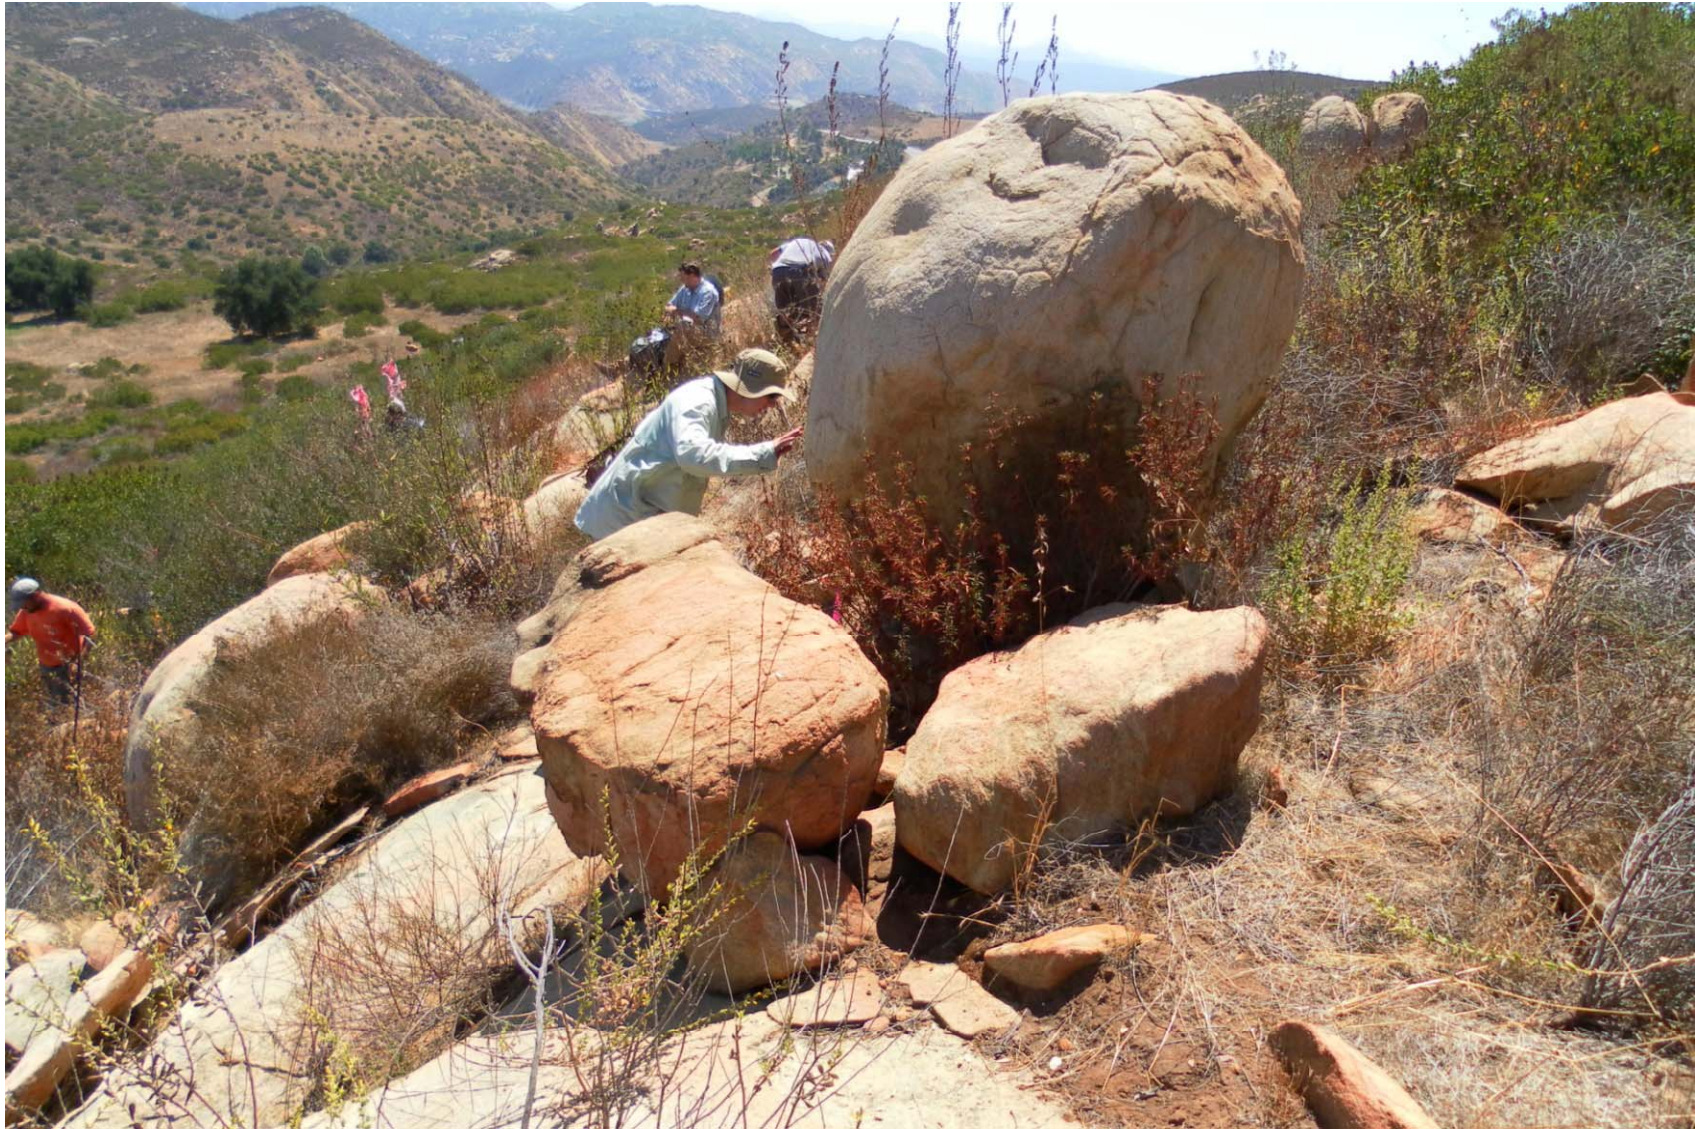
Figure 18

Tower CP 33-2: Three rock blocks that should be removed at leg B

Section	Tower	Seismic induced-Rock Fall Hazard ¹	Slope ² (inclination degrees from horizontal)	Comments
5	CP33-2	Low	15 to 27	Break and removal of boulders immediately upslope of Leg C per FSR.
	CP34-2	Low	20 to 26	
	CP35-2	None	18 to 24	
	CP45-1	None	15 to 19	
	CP47-2	Low	15 to 30, locally	Rock bolting during construction to stabilize boulder outcrop 60 feet upslope per FSR.
	CP47A-1	Low**	20 to 27	Rock bolting during construction to stabilize boulder outcrop 60 feet upslope per FSR. Low potential for boulders to impact structure based on rock fall analysis.
	CP48-2	None	10 to 15 locally; 30 upslope	
	CP49-1	Low**	15 to 20 locally; 30 upslope	Low potential for boulders to impact structure based on rock fall analysis.
	CP53-1	Low	15 to 27	
	CP54-1	Low	~15, (~30, upslope)	
	CP55	Low**	15 to 30	Low potential for boulders to impact structure based on rock fall analysis.
	CP61-1	None	~30	
7	CP108	Low	25 to 27 (20 upslope)

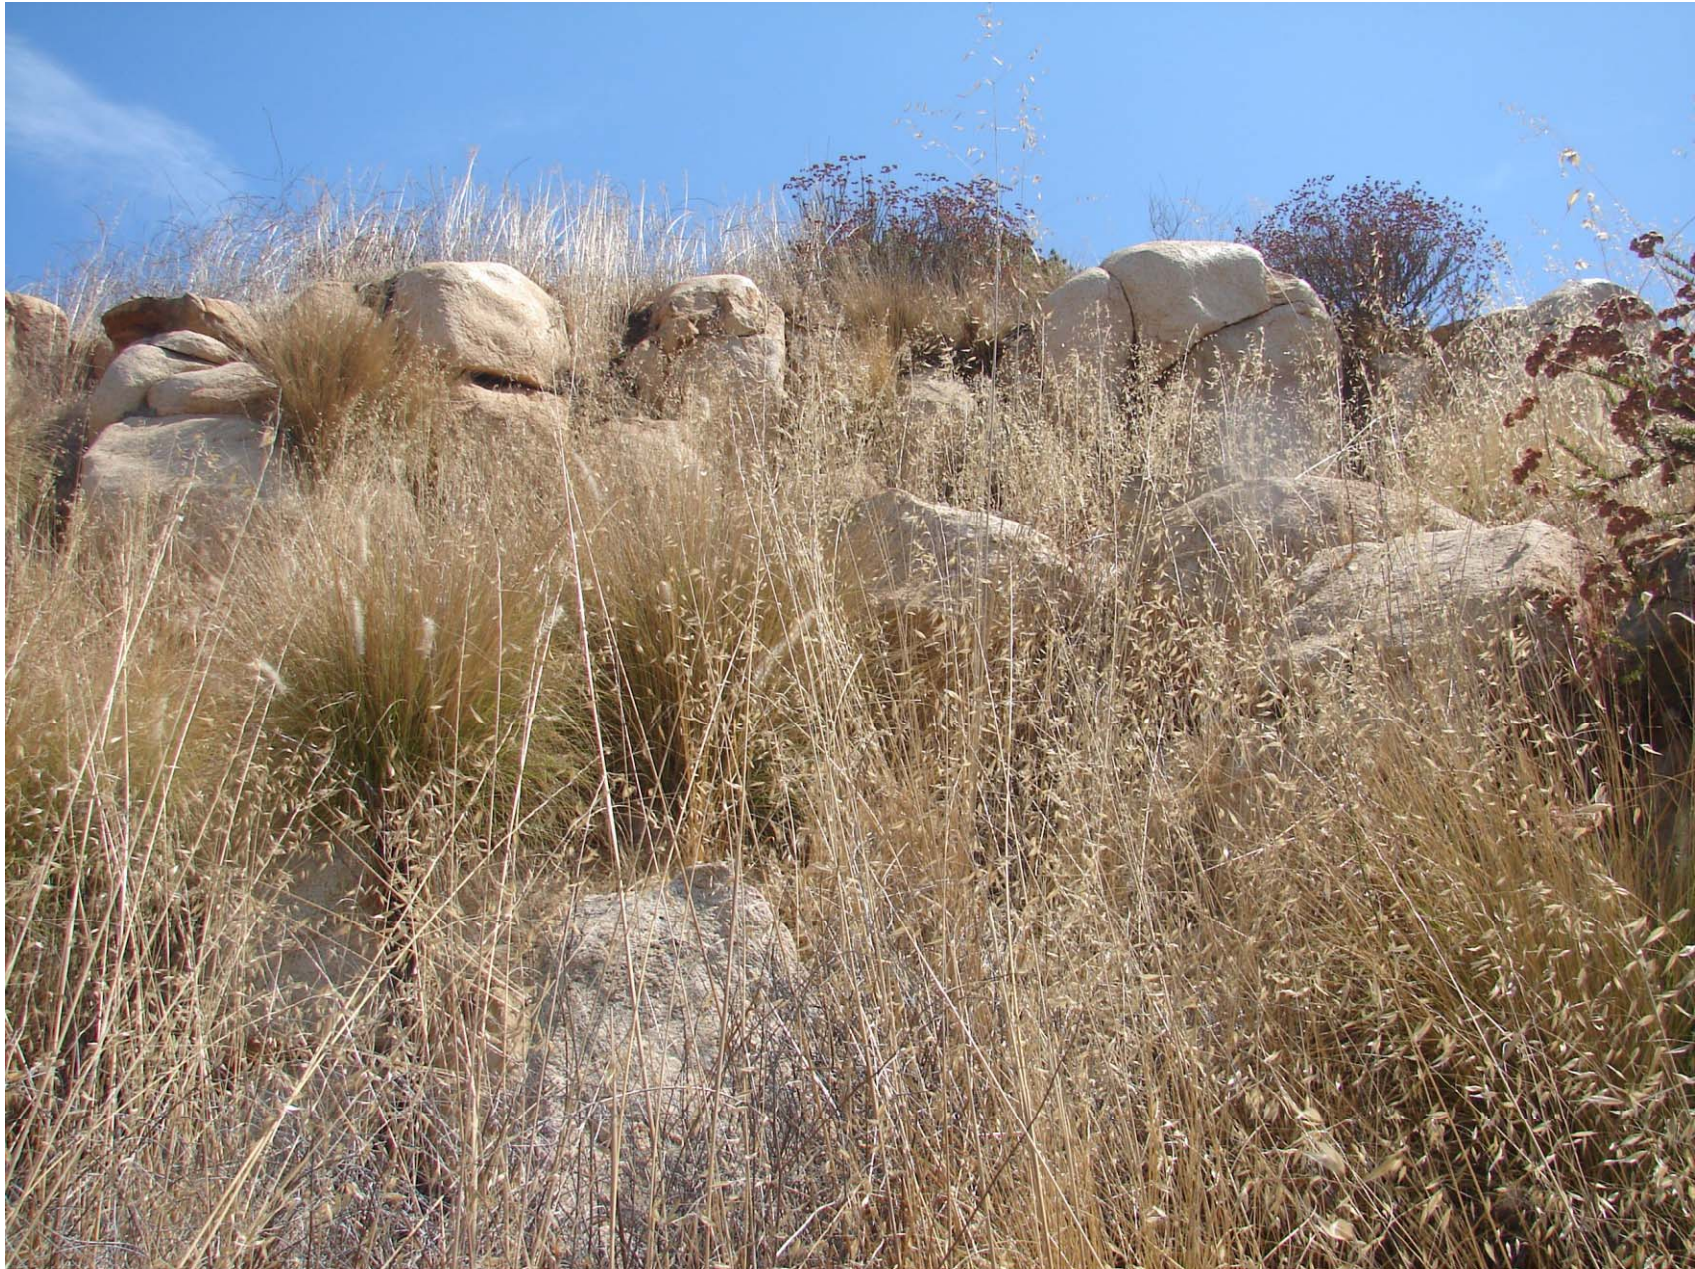
Figure 19

Tower CP 47A-1: outcrop located up slope of tower

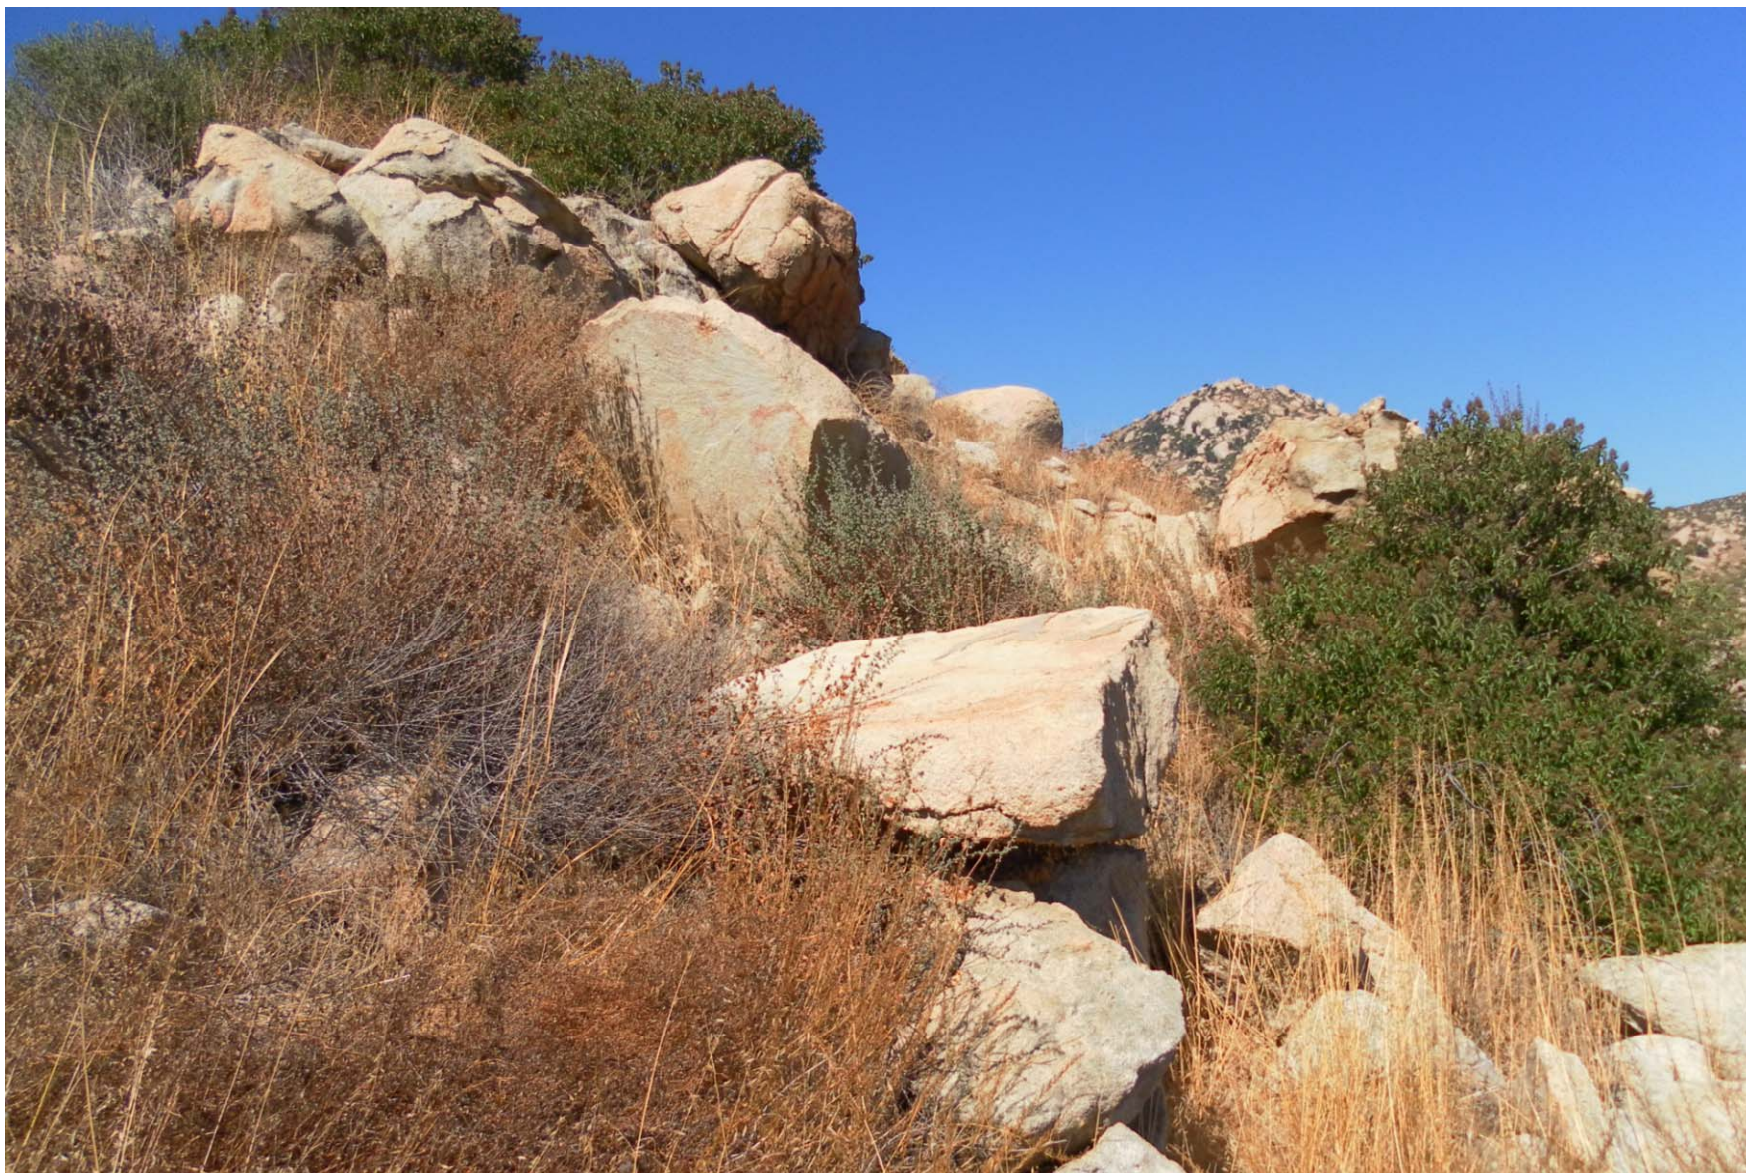
Figure 20

Tower CP 53-1: Unstable block located above the tower location

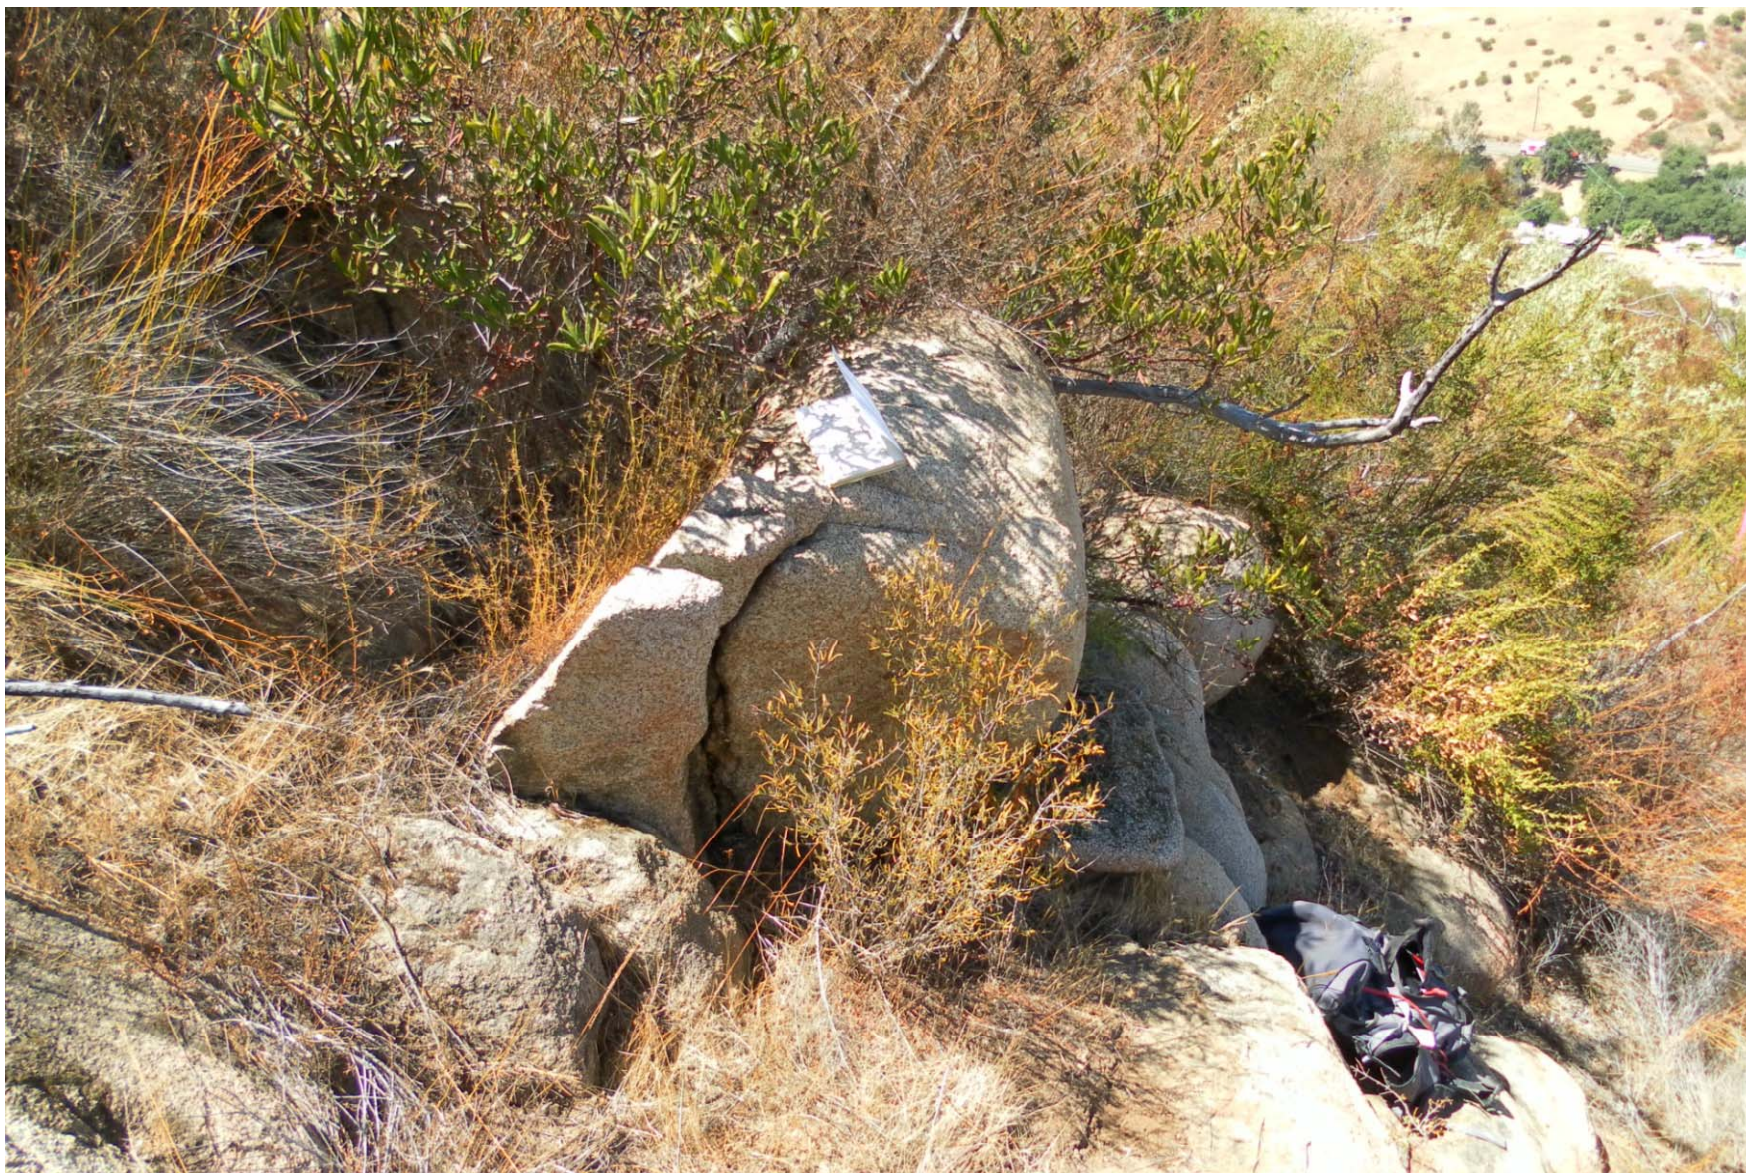
Figure 21

Tower CP55: Structurally-controlled block located above tower location

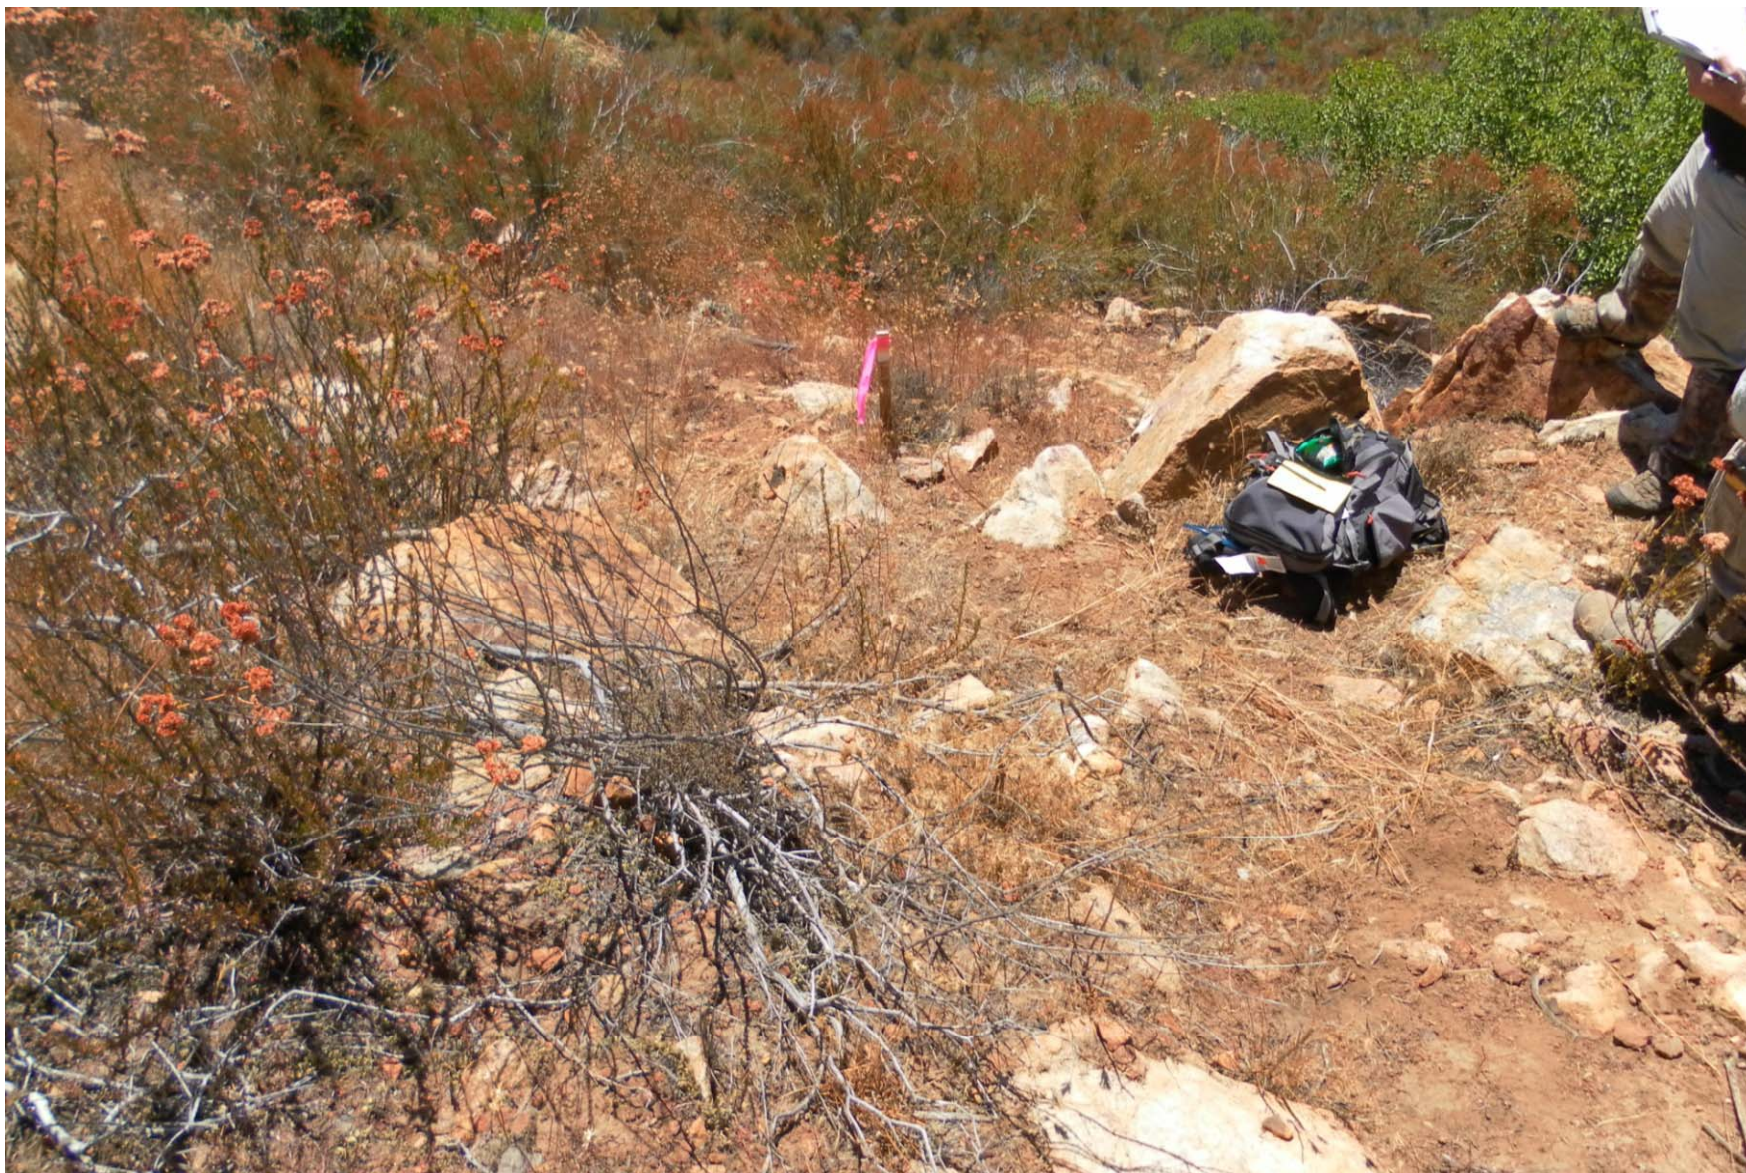
Figure 22

Tower CP108: Colluvium of unknown thickness at tower Leg A

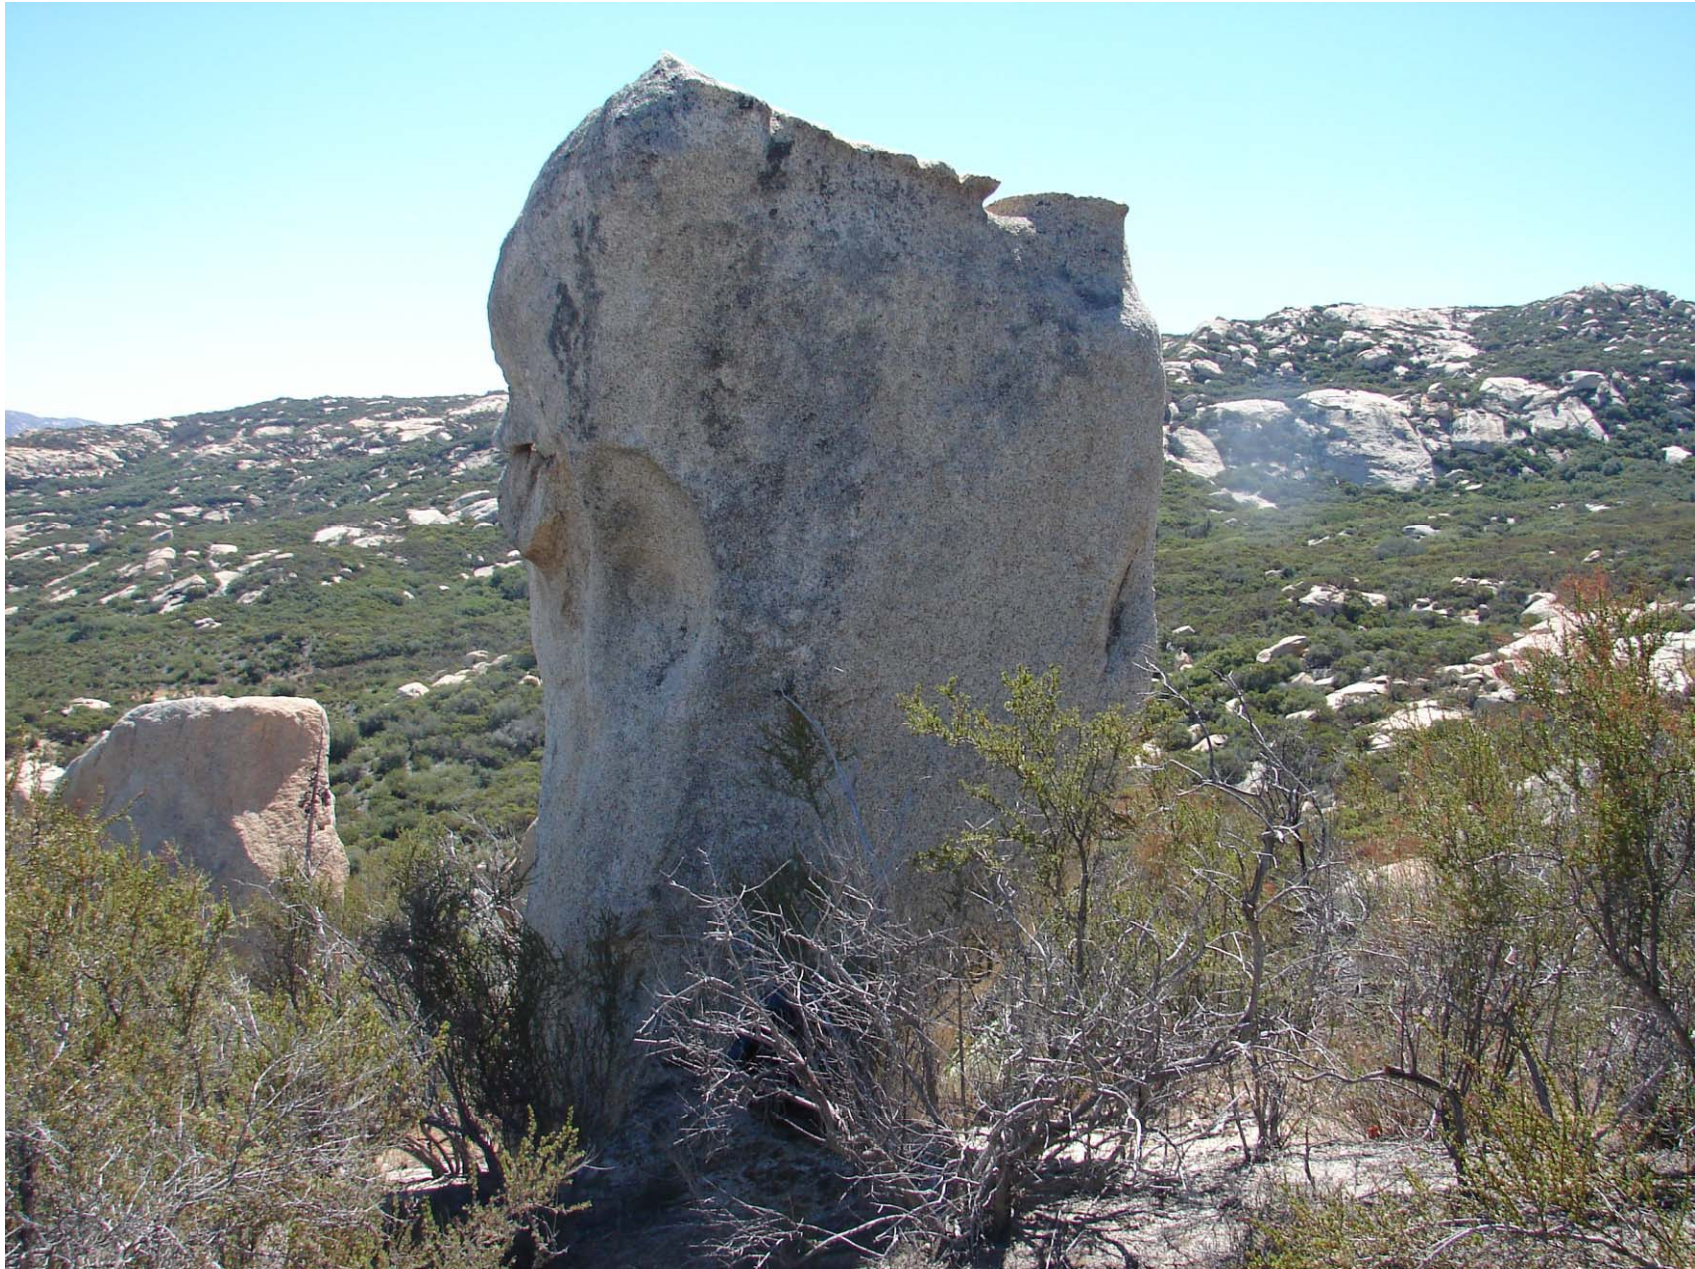
Figure 23

Tower EP17: Block located between tower legs A and B

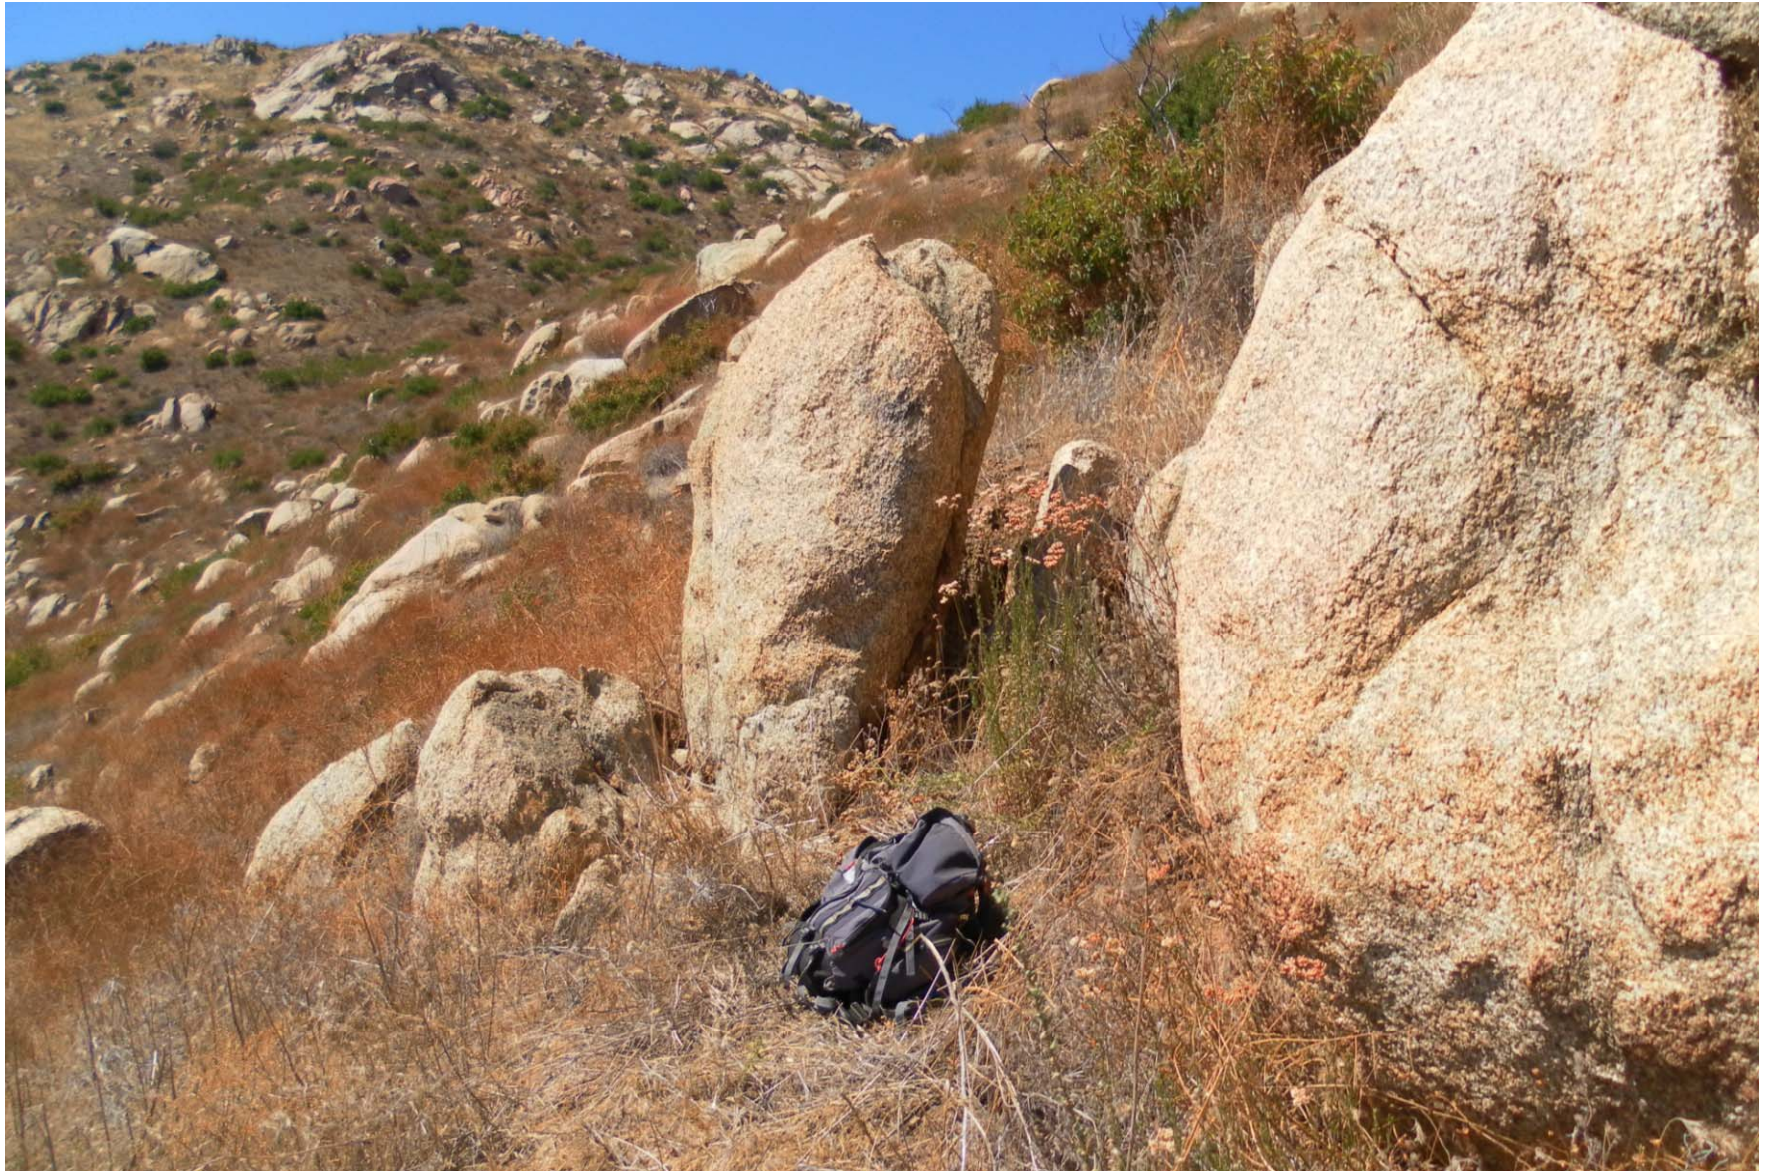
Figure 24

Tower EP45-1: Block to remove located upslope of tower

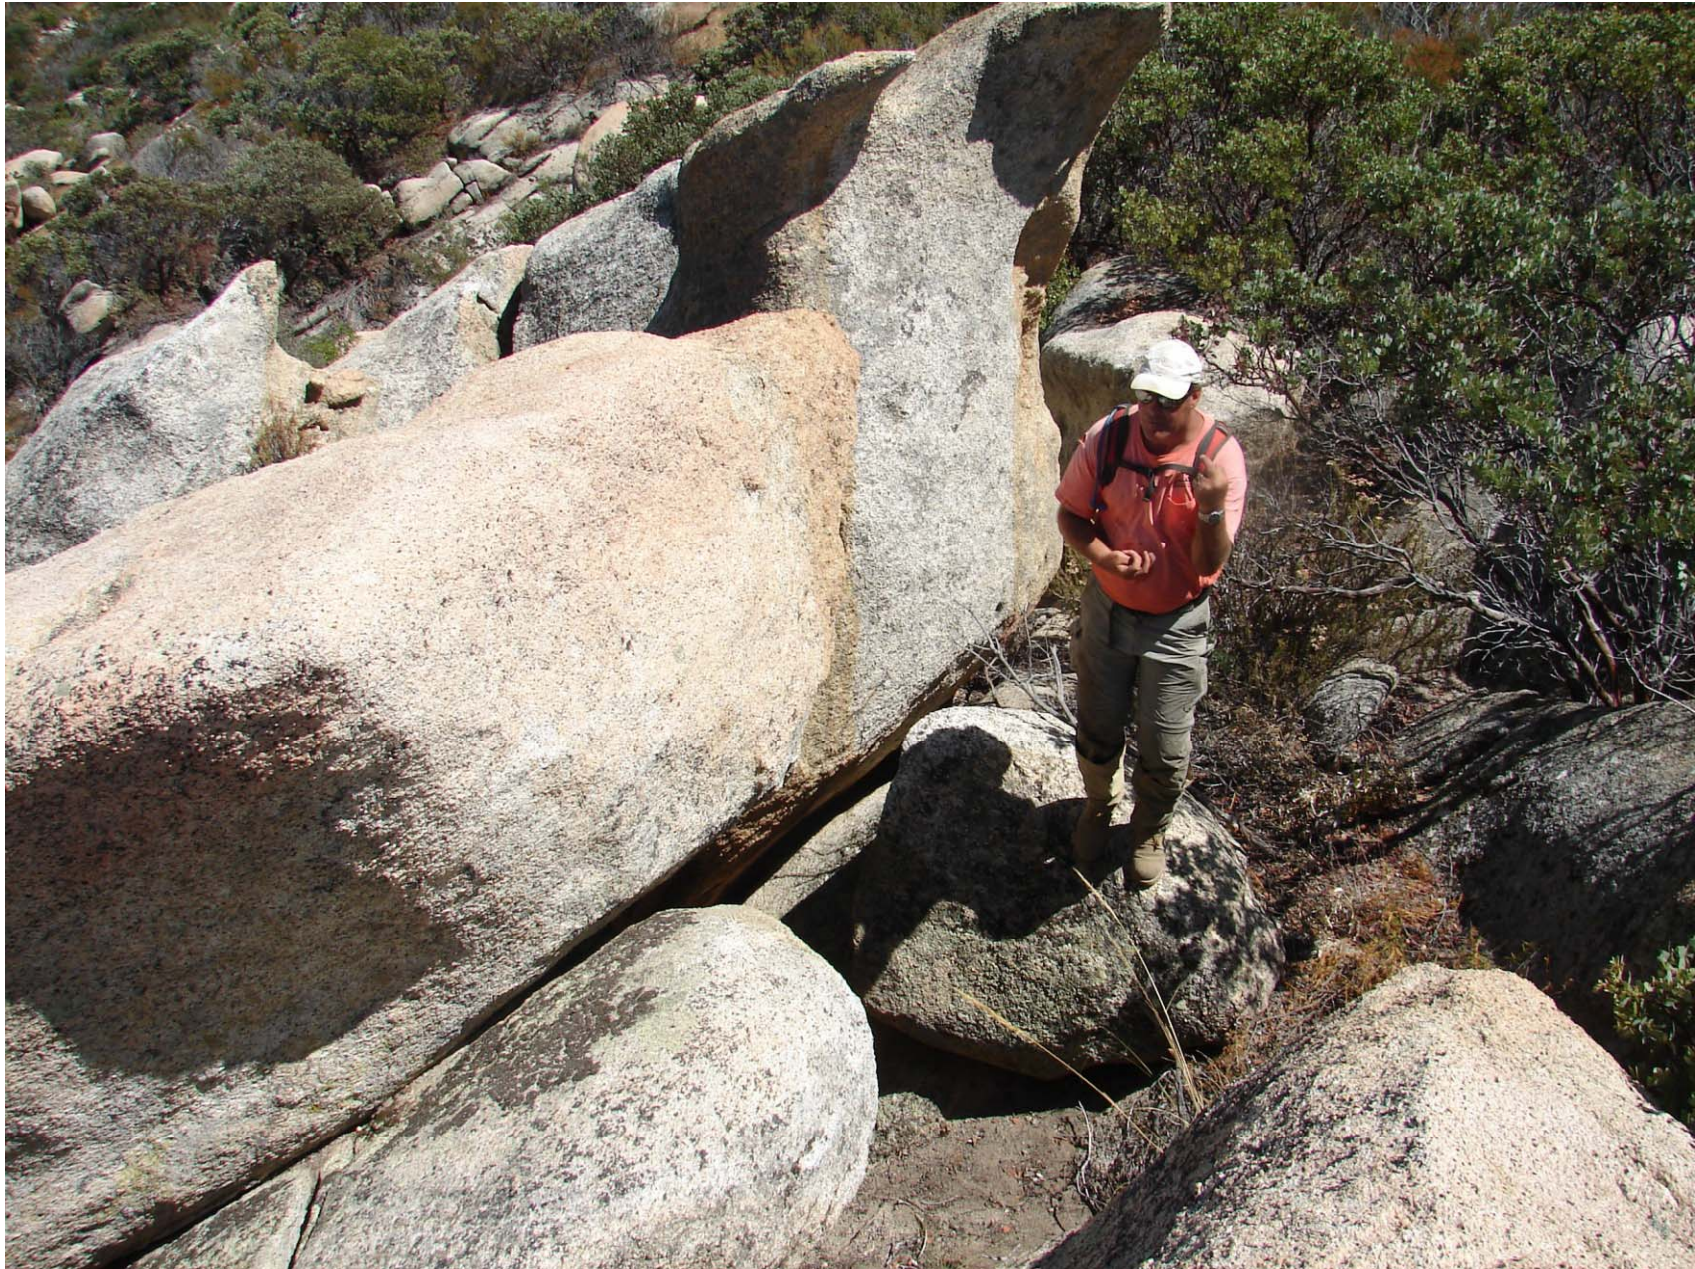
Figure 25

Tower EP73: Large outcrop located at tower location

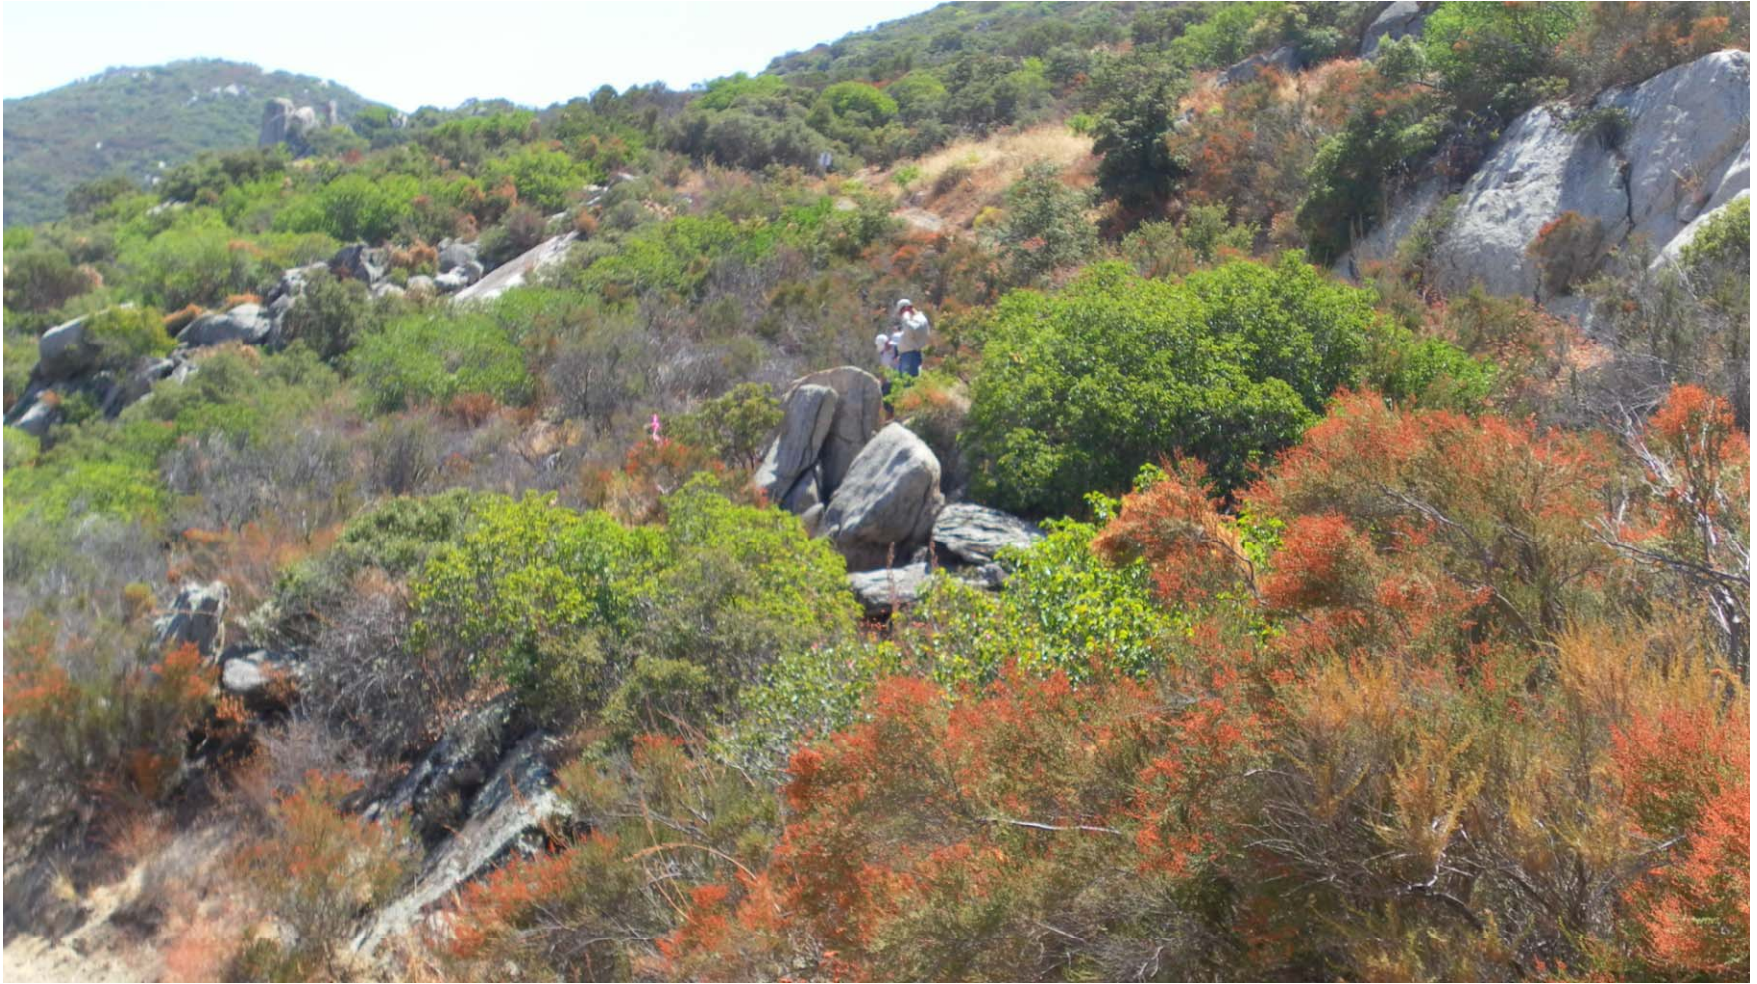
Figure 26

Tower EP75-2: 8.5' tall block located near center of tower

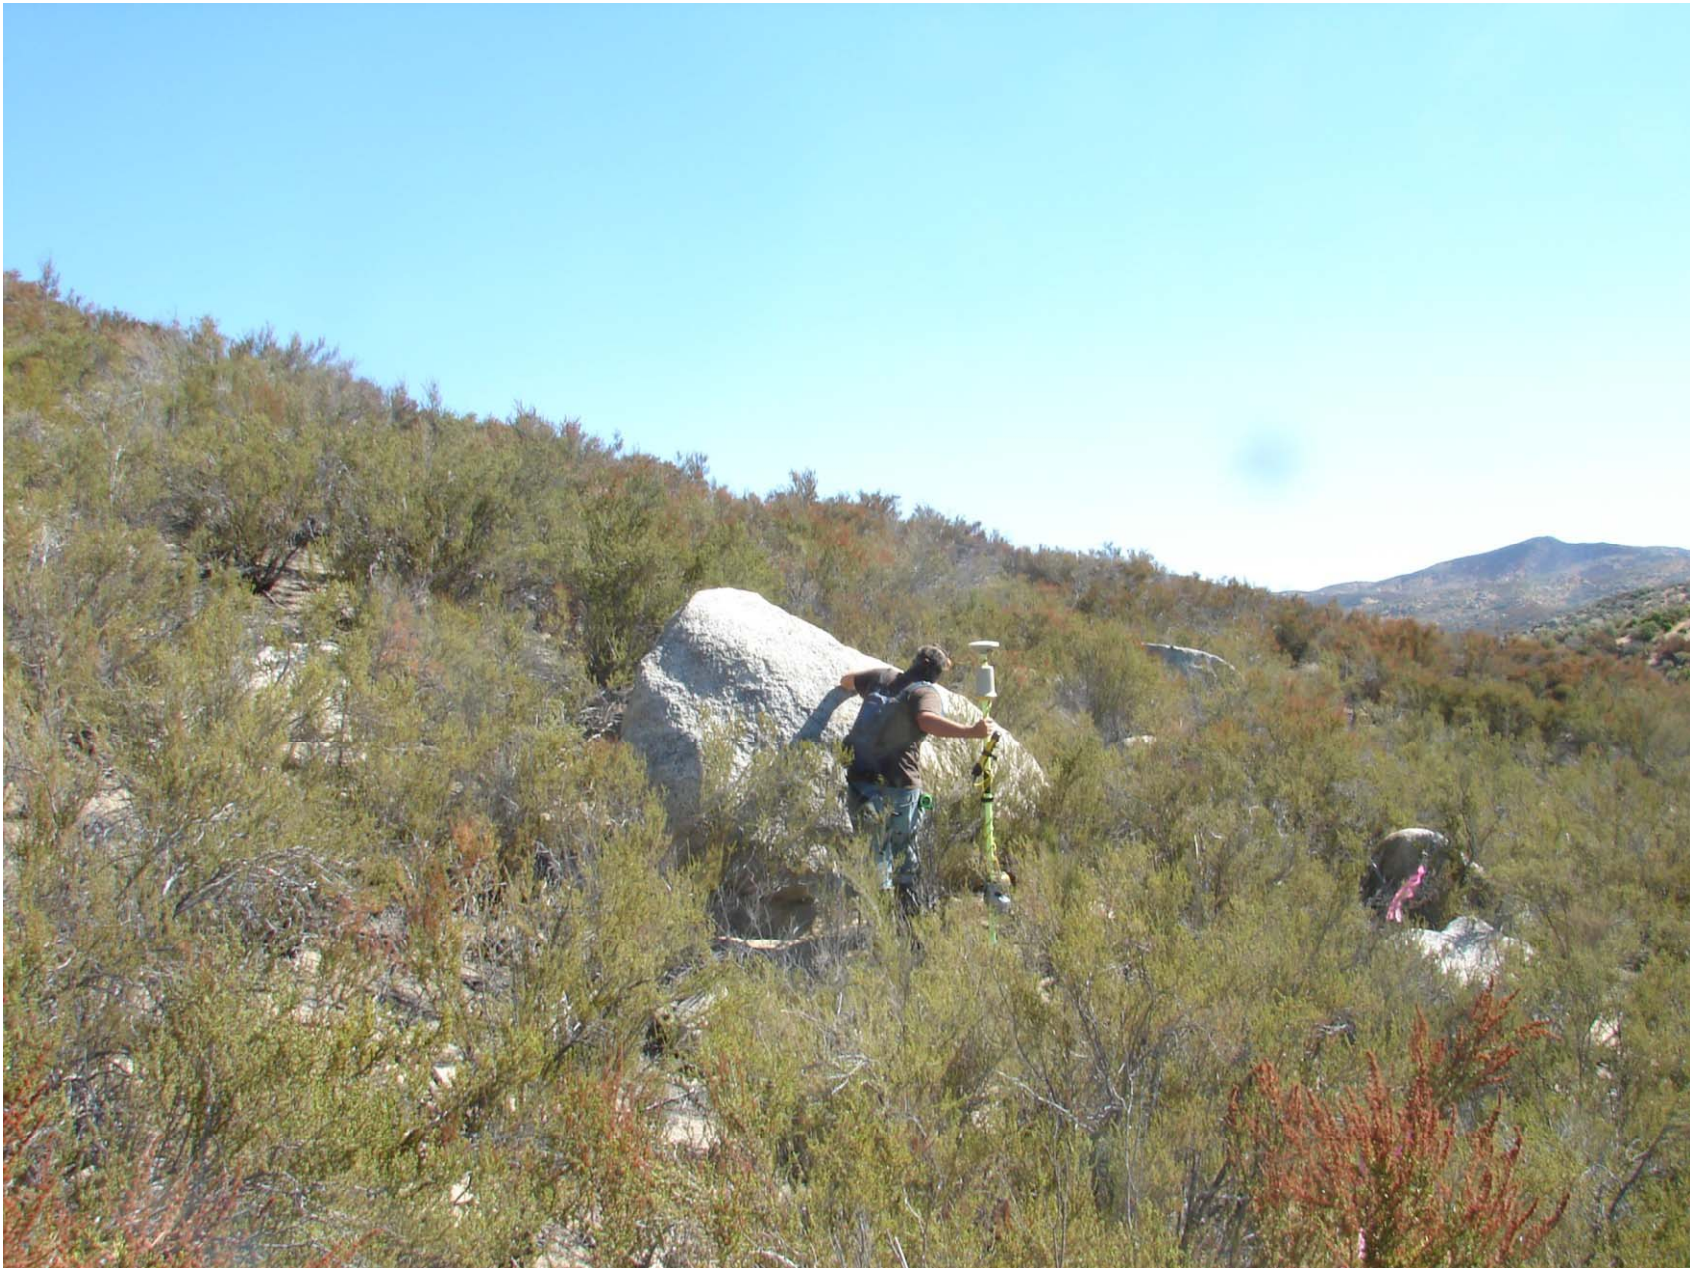
Figure 27

Tower EP120A: Boulder located upslope of tower

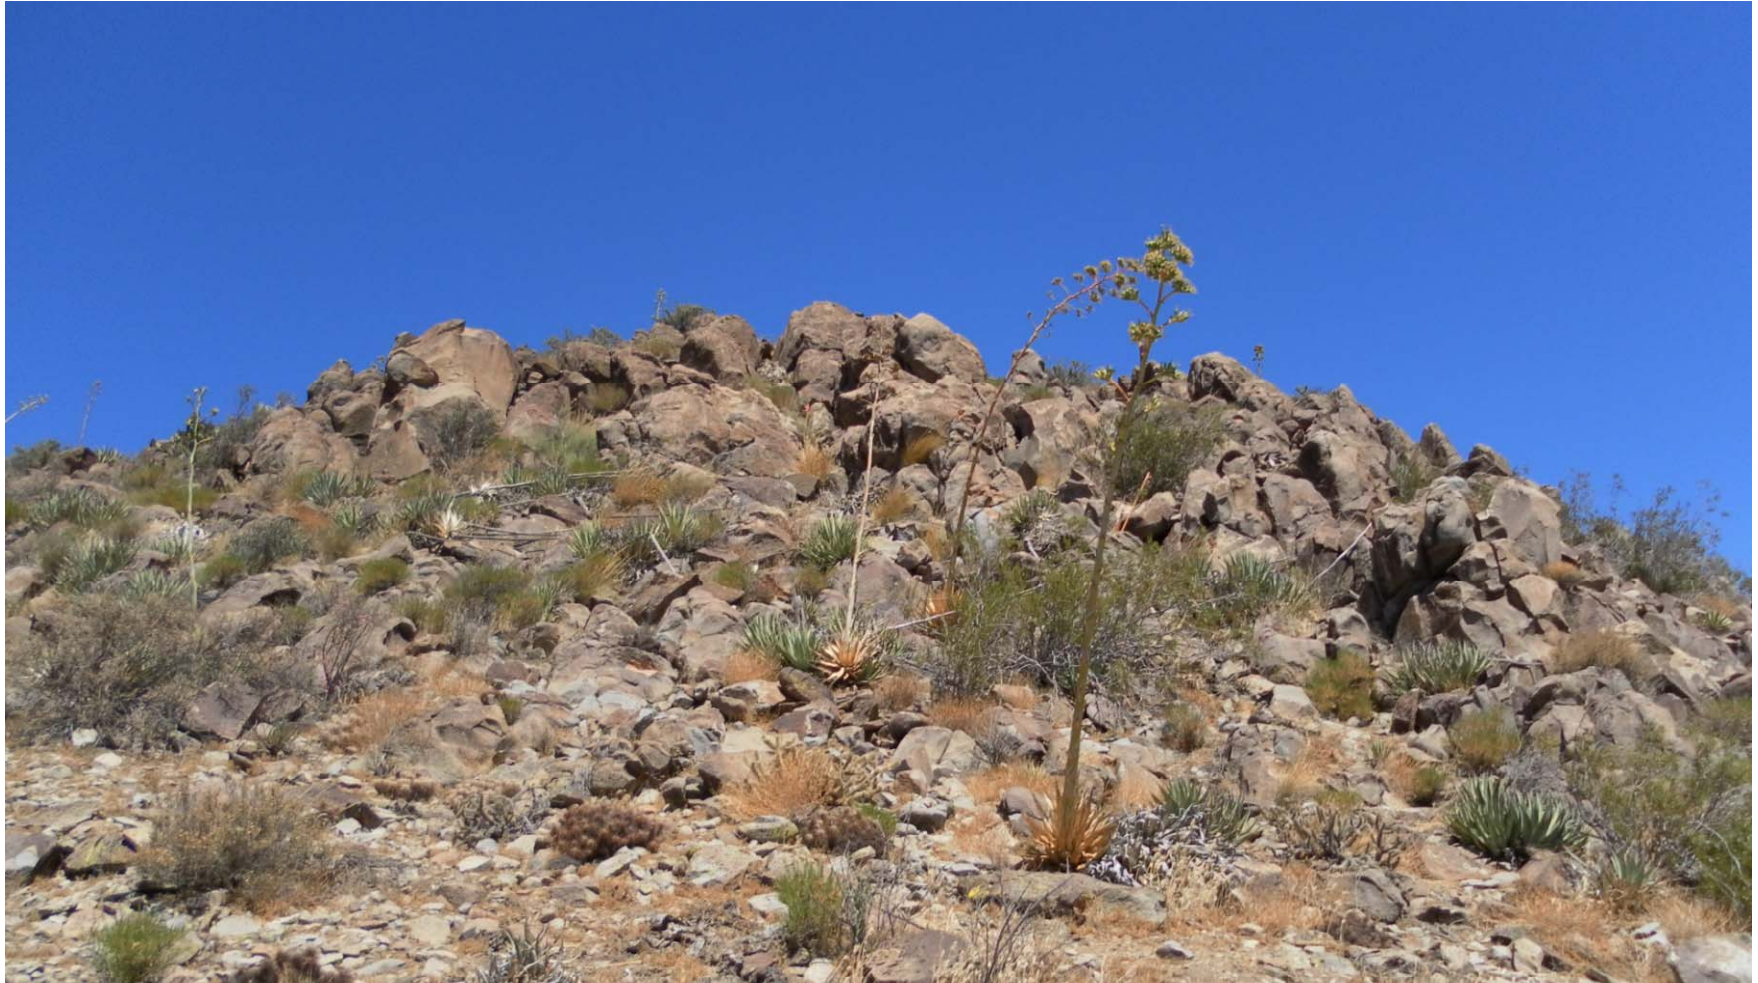
Figure 28

Tower EP254-2: Outcrop located upslope of tower
