PROJECT MEMORANDUM SCE – VIEJO SYSTEM PROJECT

To: Michael Rosauer, CPUC
From: Vida Strong, Aspen Project Manager
Date: October 6, 2004
Subject: Weekly Report #9: September 26, 2004 – October 2, 2004
CPUC Environmental Monitor (EM): Christopher Meyer

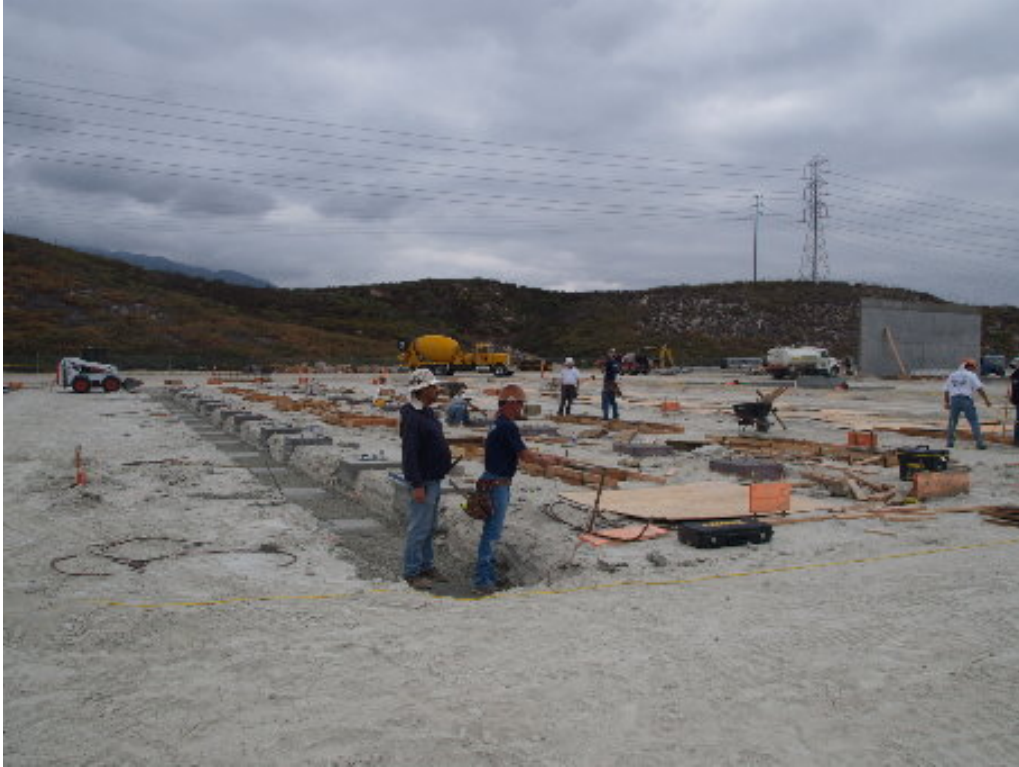
Figure 1 – Crews working on the grounding and foundation for the preformed concrete vaults.

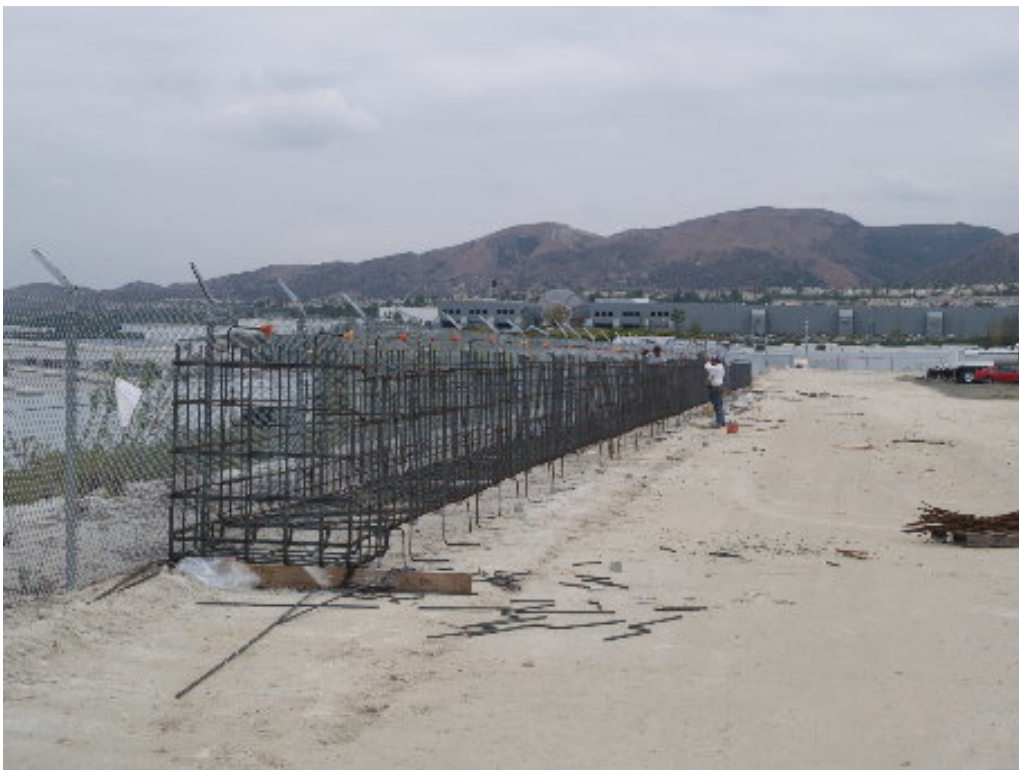
A drilling machine continued working during the subject week. Numerous bore holes throughout the substation site have been completed and crews were building the form work for the various foundation pads. Several of the foundation pedestals have been completed and crews are preparing the area for the conduit trench (see Figure 1). Ironworkers worked to build the rebar cage for the approximately 300-foot long trench adjacent to the A-frames (see Figure 2).

Figure 2 – Ironworkers built the cage for the 300-foot utility trench.

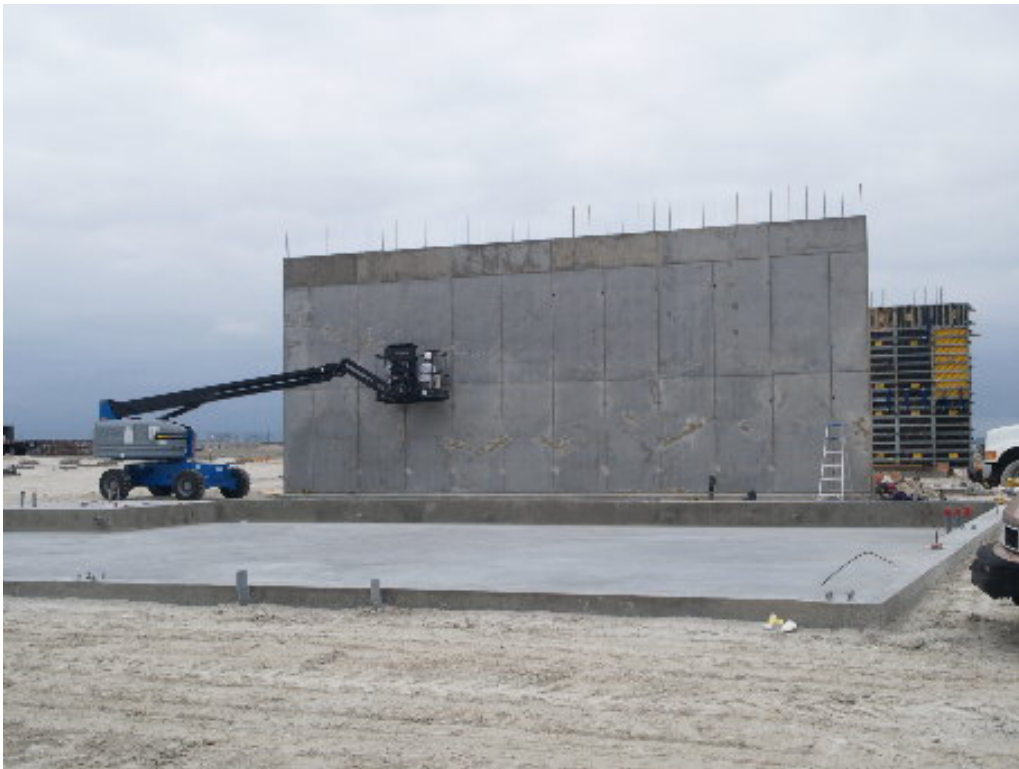
The eastern firewall has been completed and the reusable formwork was moved to the western firewall and the concrete was poured on September 29. A crew worked to finish irregularities on the wall from the forms (see Figure 3). The wall height of the wall will be extended with cinderblocks once the concrete has cured. The purpose of the wall is to protect the adjacent electrical building from a transformer fire and isolate the two A transformers in case of a problem.

Figure 3 – Workers filled imperfections in the eastern firewall left from the reusable formwork. Cinderblocks will be added to the top where rebar protrudes.

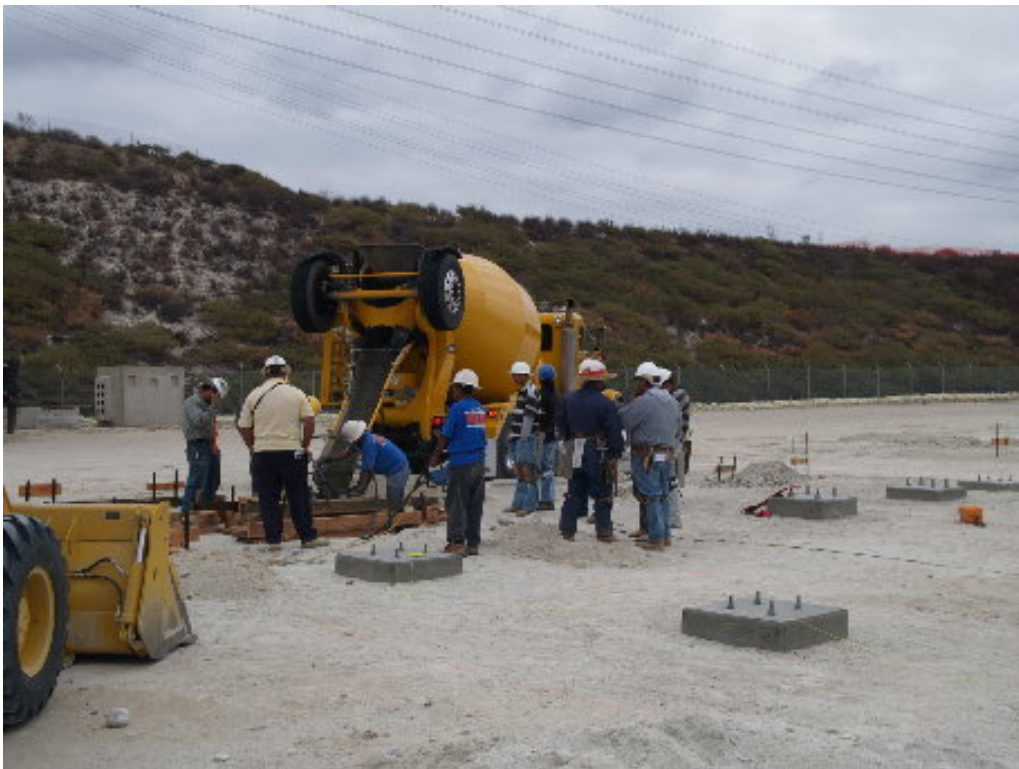
Several concrete trucks were on-site to pour the fifty foundation pedestals that were ready. The crews filled the forms to within a foot of the top, vibrating the concrete to remove air pockets, and then backfilled the edges before pouring to the top of the form (see Figure 4). The crews worked quickly to set the anchor bolts and finish the top of the pedestals before the concrete set (see Figure 5).

Figure 4 – The crew poured concrete into one of the 50 foundation forms that were ready.

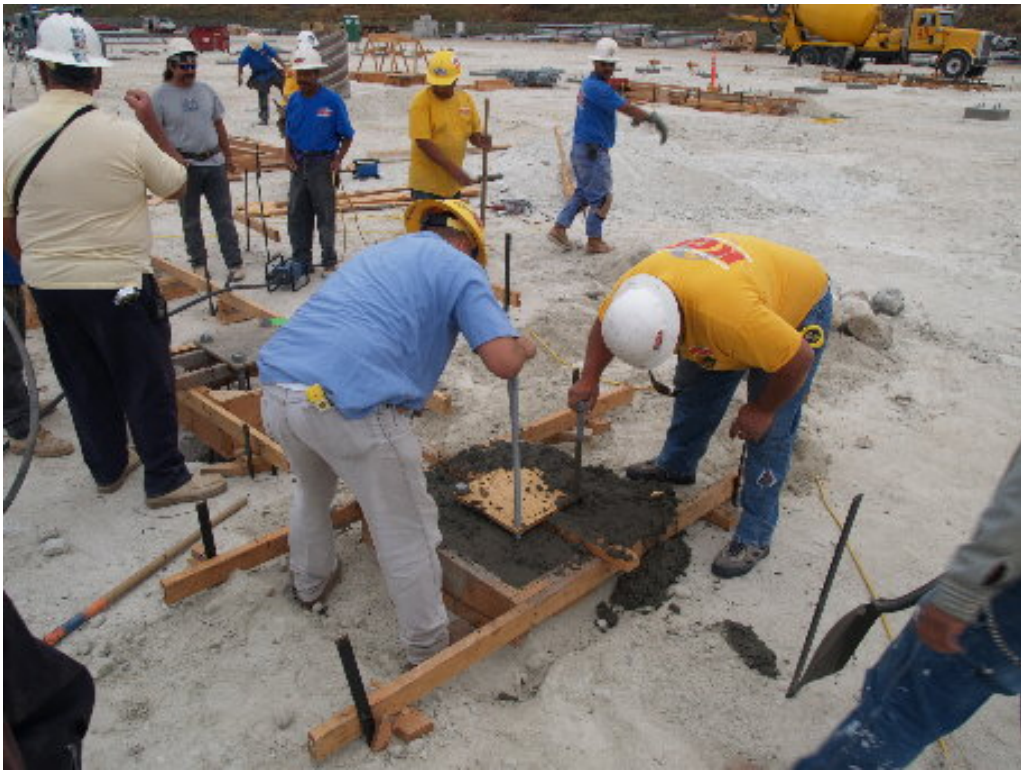
Figure 5 – Concrete workers placed small anchor bolts in the wet concrete prior to setting.
