## **PROJECT MEMORANDUM SCE – VIEJO SYSTEM PROJECT**

**To:** Michael Rosauer, CPUC  
**From:** Vida Strong, Aspen Project Manager  
**Date:** October 13, 2004  
**Subject:** Weekly Report #10: October 3, 2004 – October 9, 2004  
**CPUC Environmental Monitor (EM):** Christopher Meyer

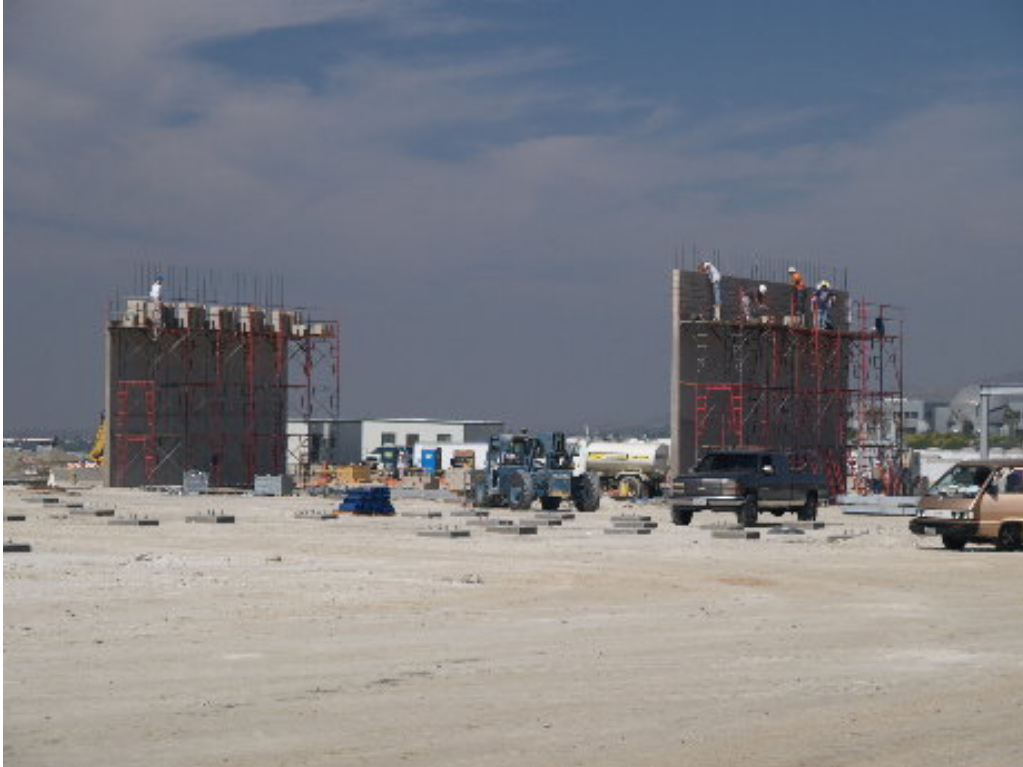
Both firewalls for the A transformers have been completed and the forms removed. The height of the firewalls is being extended with cinderblocks (see Figure 1). The purpose of the firewall is to protect the adjacent electrical building from a transformer fire and isolate the two A transformers in case of a problem. By the later part of the week, the framework for the main mechanical/electrical equipment room (MEER #1) was up (see Figure 2).

**Figure 1** – The firewalls for the A transformers were poured and crews worked to top the walls with cinderblocks.

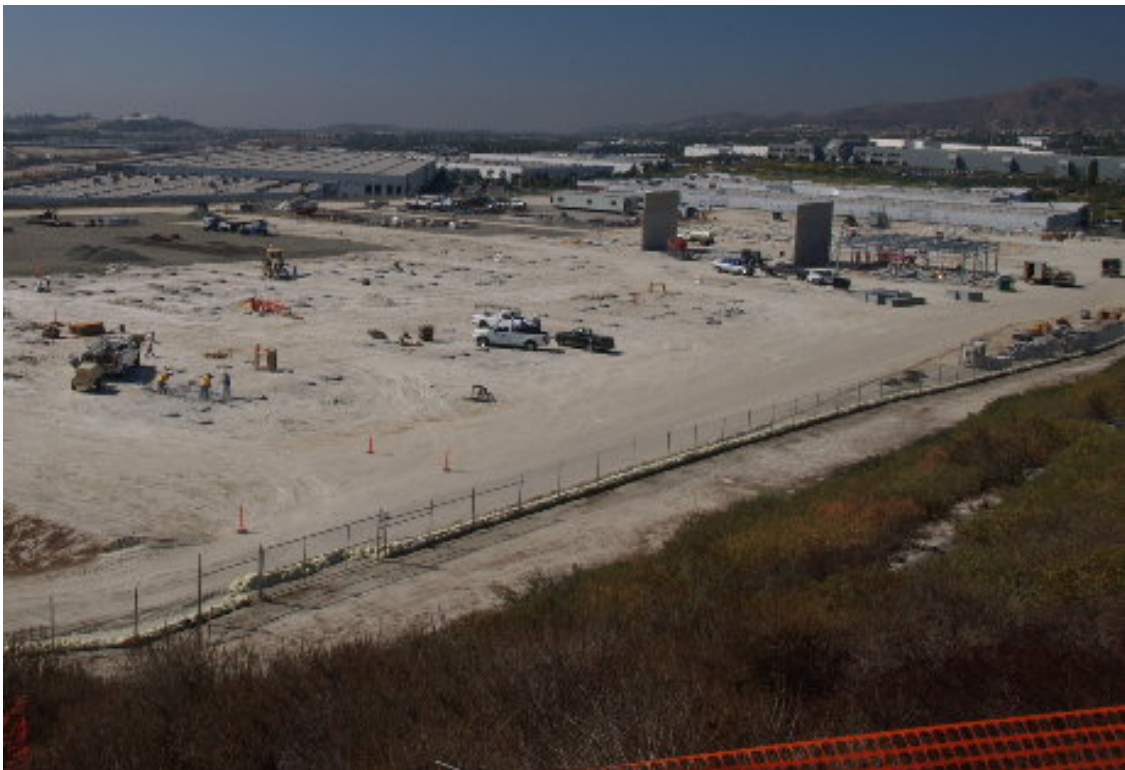
**Figure 2** – Workers erected the metal framework for MEER #1 during the later part of the week (top, right corner).

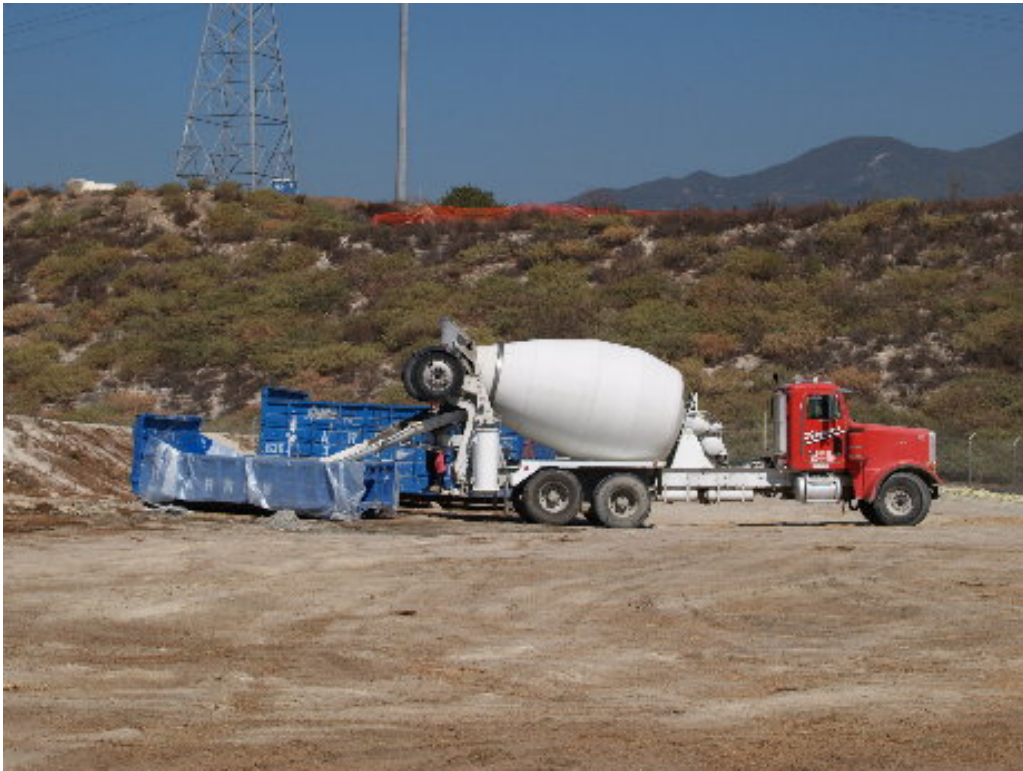
Concrete trucks were on-site to pour the foundations that were ready. The crews filled the forms to within a foot of the top, vibrating the concrete to remove air pockets, and then backfilling the edges before pouring to the top of the form. The crews worked quickly to set the anchor bolts and finish the top of the pedestals before the concrete set. The concrete truck drivers washed out in the lowboy haul-off in the southern laydown area at the substation site (see Figure 3).

**Figure 3** – Concrete trucks were properly washed at a lowboy dumpster set up in the southern laydown area.

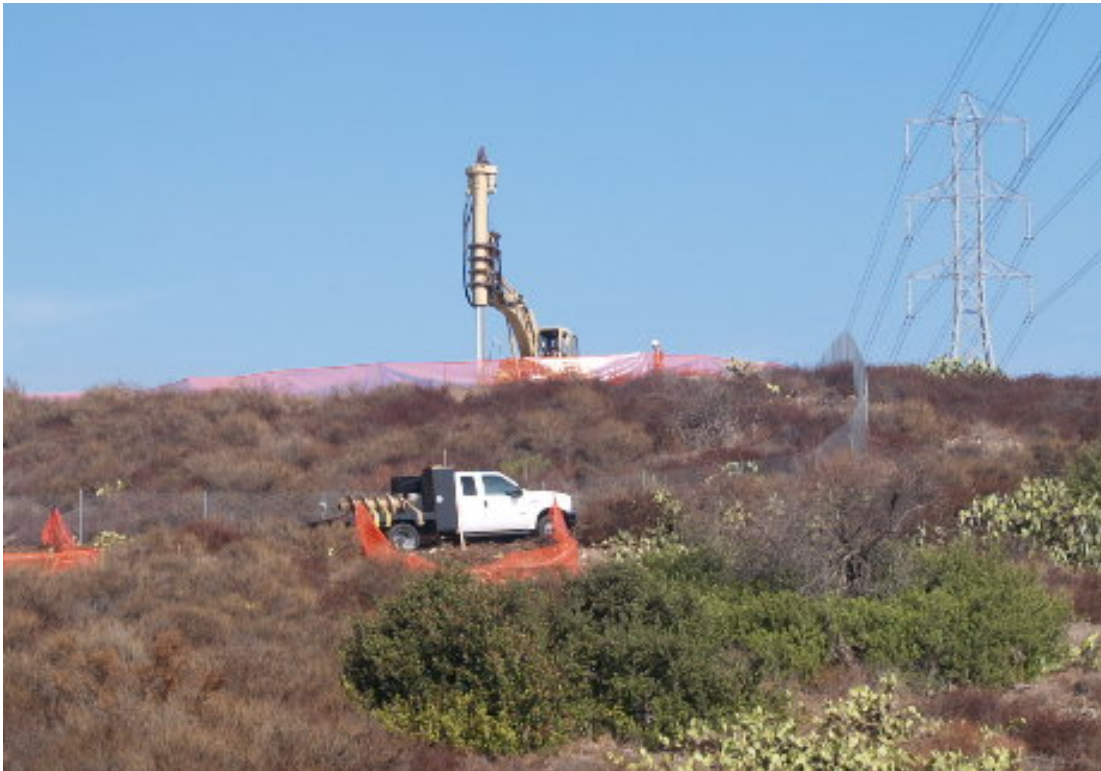
A drilling machine started working on the pole foundations during the subject week (see Figure 4). The drilling machine spent the week working on one foundation bore due to the hard rock. The spoils from the drilling operation were trucked back to the substation site for removal. Iron workers prepared the rebar cages for the 220 kV transmission line foundations.

**Figure 4** – Drilling of the tower foundations on the 220 kV section started during the subject week.

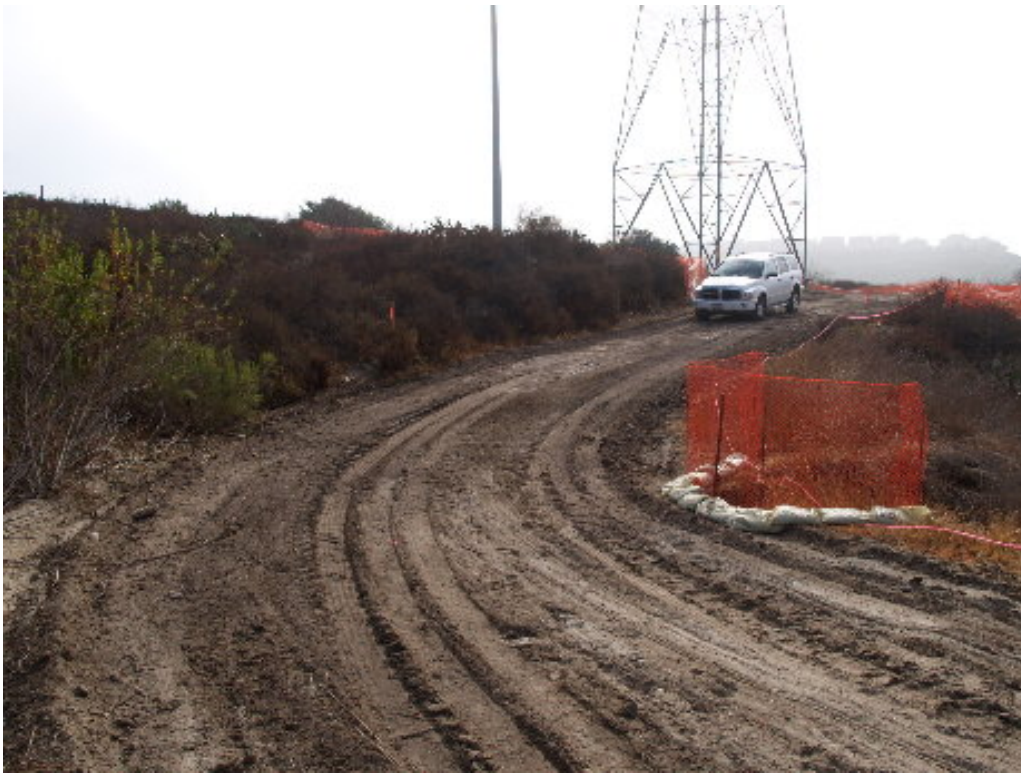
A grader worked to improve the access road to the drilling pads and correct drainage issues before the first rains of the season. The CPUC EM reviewed the access road at the southern portion of the 220 kV section. The access road has been degraded by erosion from several years of rain runoff along the road. The road has continued to move upstream into the habitat as the downstream side eroded. The contractor needs additional space to move a large crane over the degraded section of the access road (see Figure 5). Due to Dept. of Fish and Game restrictions, the erosion to the access road cannot be repaired without a permit. SCE will place a steel plate over the eroded section of the road to allow safe passage of large equipment. SCE will look into getting Fish and Game and US Army Corps of Engineers permits to permanently repair the access road in the future.

**Figure 5** – A section of the access road for the 220 kV line has eroded and needs to be prepared for the safe passage of larger equipment.

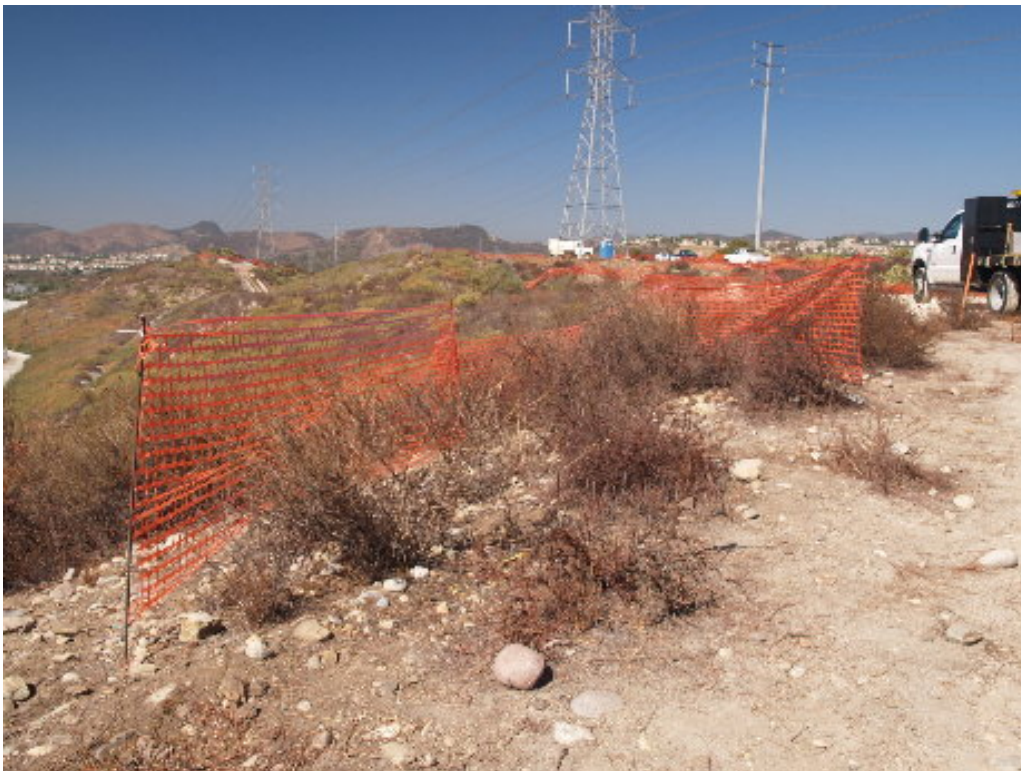
SCE discovered that one of the crane pads was not properly situated for the crane and requested a modification of the exclusion area. The CPUC EM returned to the site and reviewed the SCE request with the LSA biologist. SCE proposed to expand the exclusion area in several sections in exchange to removing a small section to allow access for the equipment (see Figure 6). The change would result in a net increase in protected habitat and result in the salvage of healthier plants. The CPUC EM approved the shift in the exclusion area and photographed the proposed changes.

**Figure 6** – A section of degraded coastal sage scrub habitat to be impacted in exchange for a larger amount of healthier, contiguous habitat.
