PROJECT MEMORANDUM SCE – VIEJO SYSTEM PROJECT

To: Michael Rosauer, CPUC
From: Vida Strong, Aspen Project Manager
Date: October 20, 2004
Subject: Weekly Report #11: October 10, 2004 – October 16, 2004
CPUC Environmental Monitor (EM): Christopher Meyer

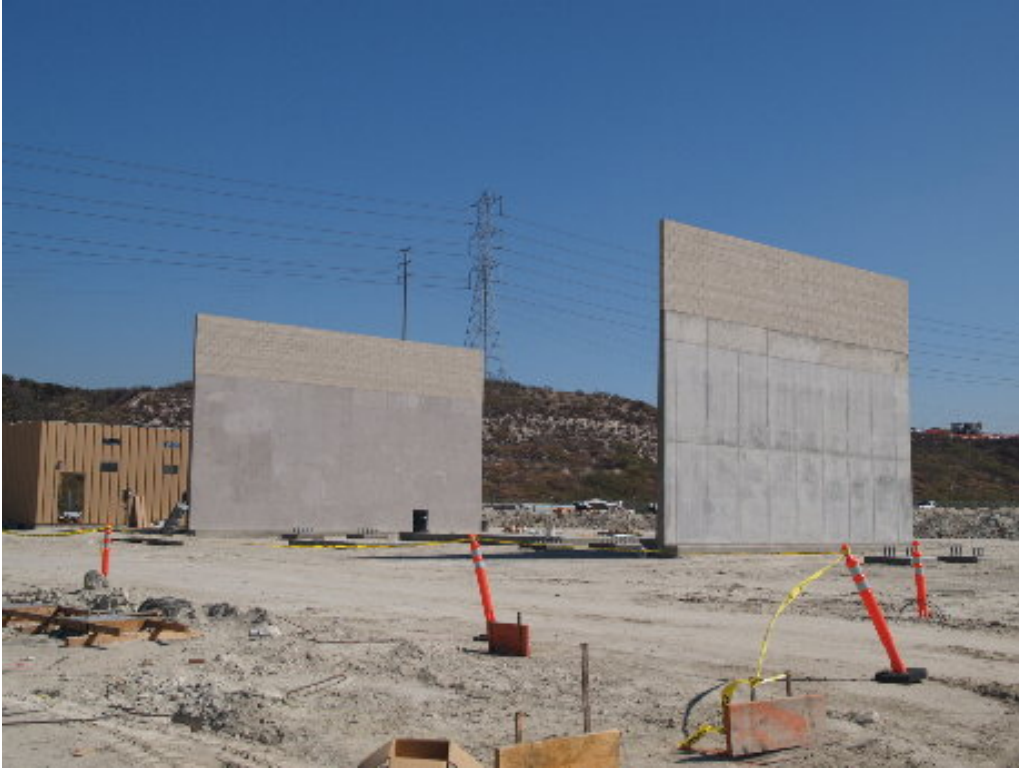
The concrete pour for both firewalls for the A transformers have been completed and the forms removed. The height of the firewalls was extended with cinderblocks and work on the walls is finished (see Figure 1). The purpose of the firewall is to protect the adjacent electrical building from a transformer fire and isolate the two A transformers in case of a problem. A specialized crew worked on the sheet metal walls of the 220 kV main mechanical/electrical equipment room (MEER #1) (see Figure 2). The foundation for the smaller 60 kV MEER #2 building has been poured and will be constructed after the completion of the MEER #1. An operator worked with a backhoe to excavate the main trench leading into the MEER #1 (see Figure 3). A series of smaller trenches were excavated perpendicular to the main trench. Pre-cast concrete forms will be set onto pads in both the feeder and main trenches to carry the electrical cables (see Figure 4).

Figure 1 – The tops of the firewalls for the A transformers were completed with cinderblocks.

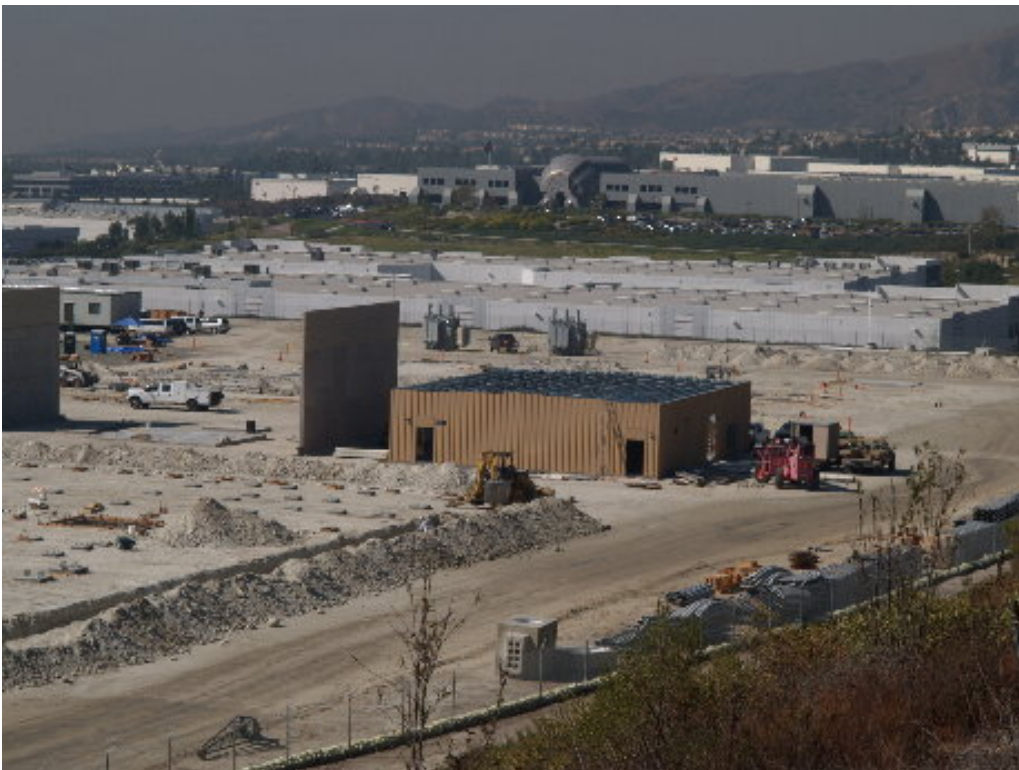
Figure 2 – A specialized crew installed the metal walls for MEER #1 during the later part of the week.

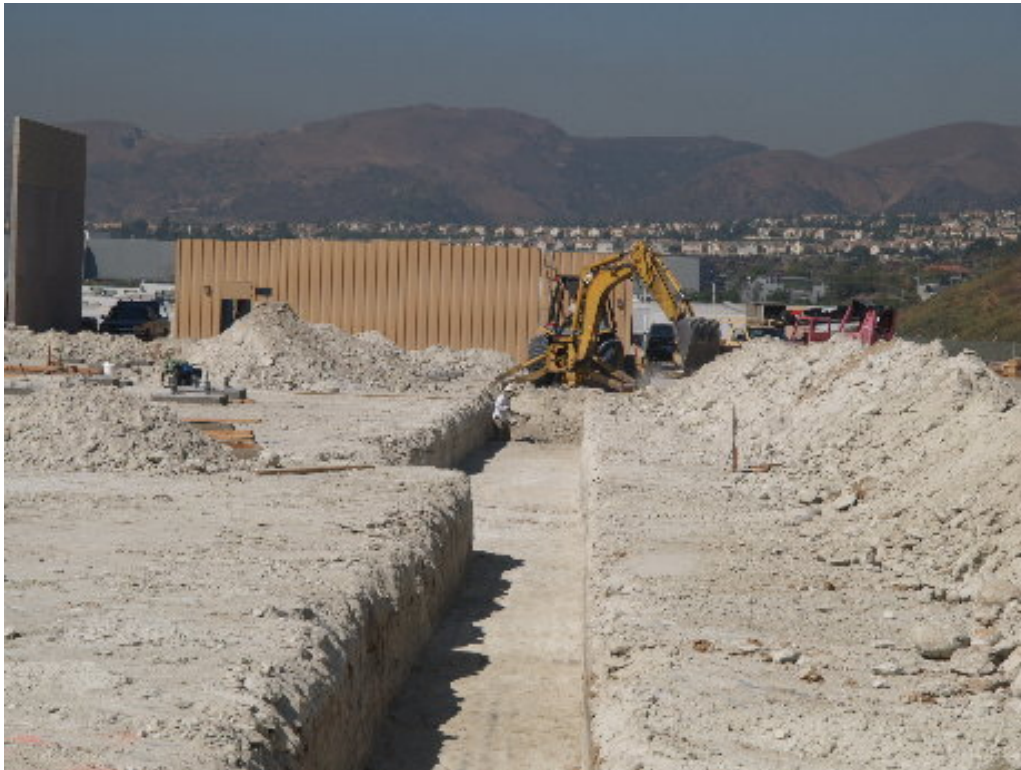
Figure 3 – An operator excavated the main trench leading into the 220 kV MEER #1.

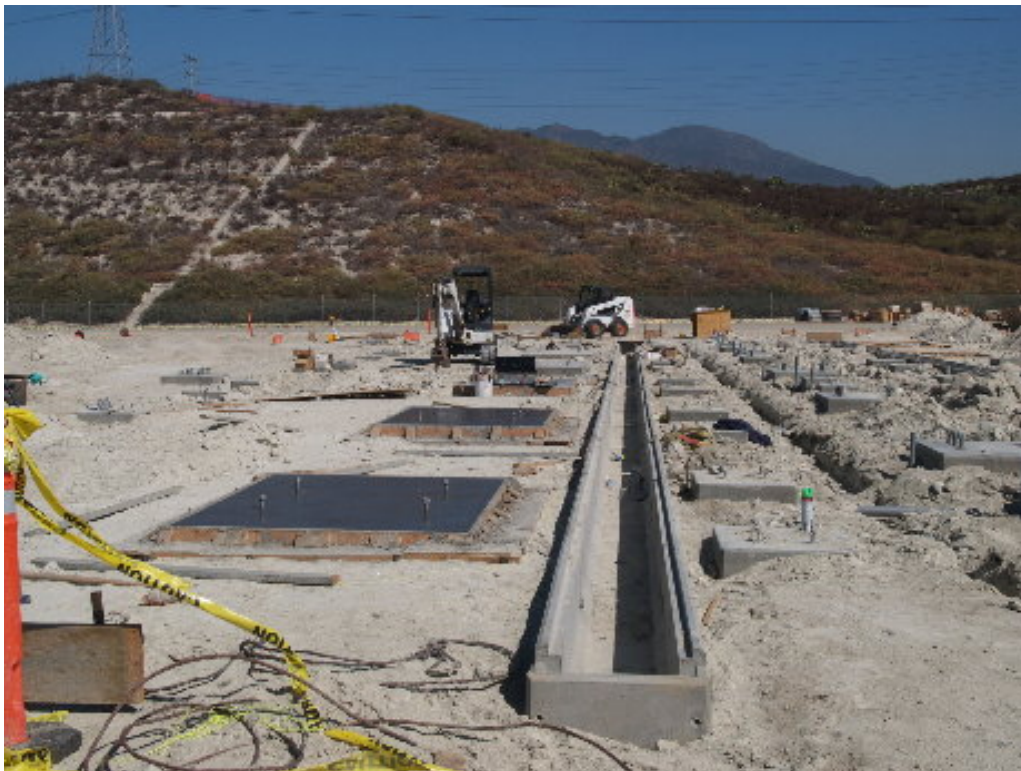
Figure 4 – A series of small pre-cast concrete trenches lead into the main trenches and then into MEER #1 or MEER #2. Pictured is the smaller trench for the 66 kV system.

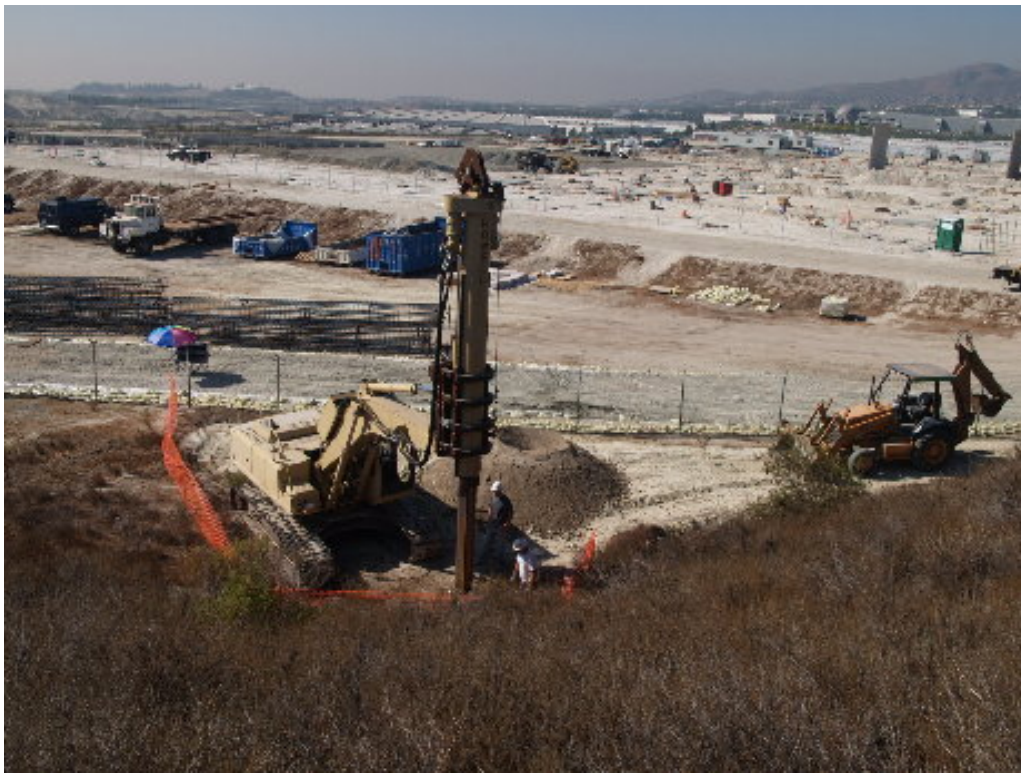
A drilling machine continued working on the pole foundations, moving to the lower site during the subject week (see Figure 5). An operator in a backhoe moved the spoils from the drill site to the north due to the restricted space at the tower pad. .

Figure 5 – The drilling machine worked on the pole foundation at the base of the hill adjacent to the south end of the substation site.

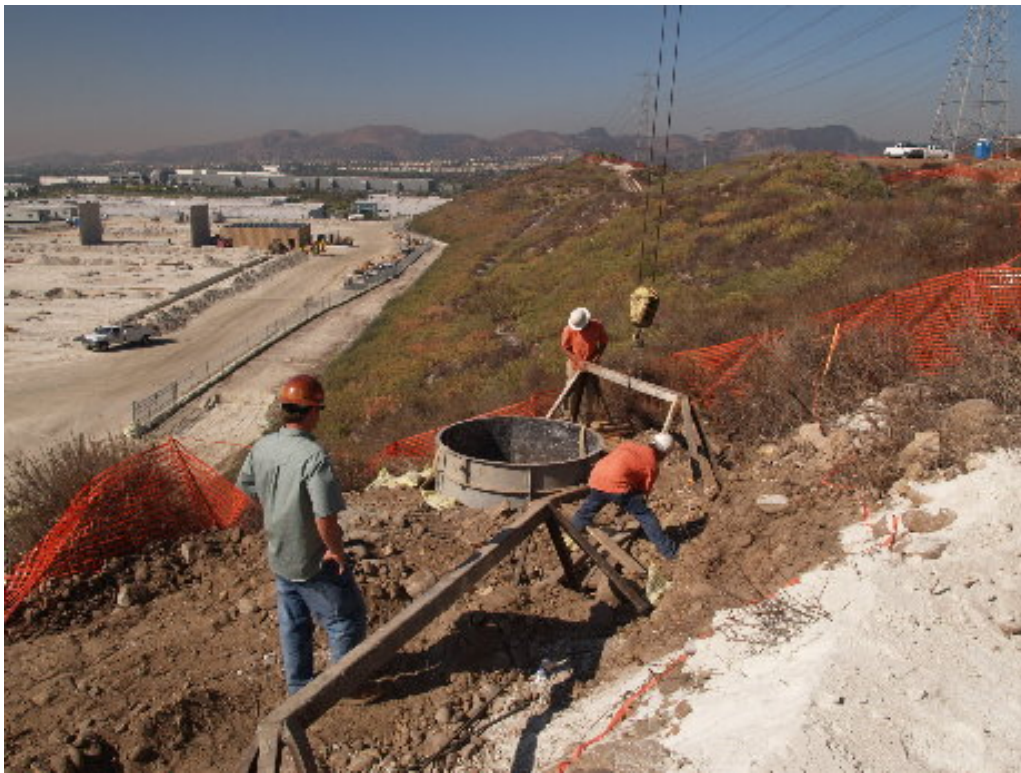
A crew worked on preparing a location for the concrete pour on the side slope above the southern end of the substation site (see Figure 6). The crew had difficulty setting the tripod supports for the anchor bolts and encroached into the sensitive habitat that was slated for avoidance in an exclusion zone shift the previous week. The crew also assembled the anchor bolts for the foundations (see Figure 7). The access roads to the various tower pad locations have been graded and improved for all-weather access.

During the previous week, SCE proposed to expand the exclusion area in several sections in exchange for removing a small section to allow access for the equipment. The change was to result in a net increase in protected habitat and result in the salvage of healthier plants and the CPUC EM approved the shift in the exclusion area. The agreement included the relocation of the orange exclusion fencing to keep construction impacts out of the traded areas. This relocation of the exclusion fencing was not completed and work progressed inside to areas slated for salvage despite the impacts to the island of vegetation that was previously protected. The CPUC EM notified SCE by voicemail and email so that the situation can be addressed.

Figure 6 – A crew worked in the healthier, contiguous section coastal sage scrub habitat that was to be avoided in exchange for the island of vegetation in the foreground that has been buried.

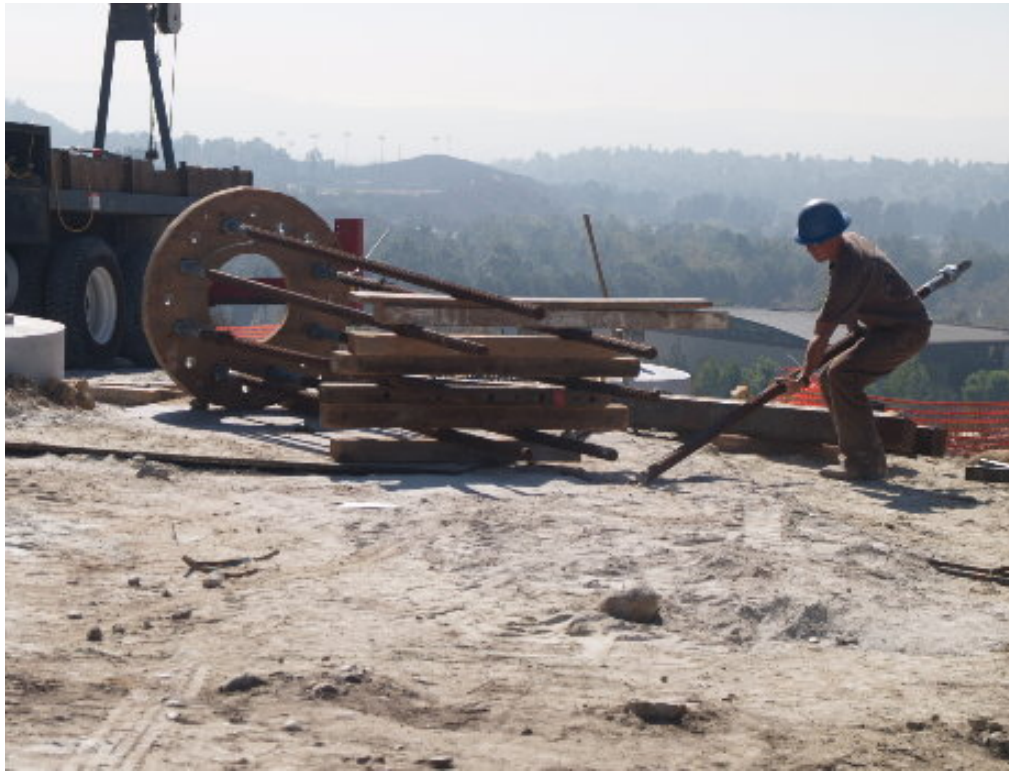
Figure 7 – A worker assembled the anchor bolts for the 220 kV foundations on the hill above the substation site.
