PROJECT MEMORANDUM SCE – VIEJO SYSTEM PROJECT

To: Jensen Uchida, CPUC
From: Vida Strong, Aspen Project Manager
Date: October 26, 2004
Subject: Weekly Report #12: October 17, 2004 – October 23, 2004
CPUC Environmental Monitor (EM): Christopher Meyer

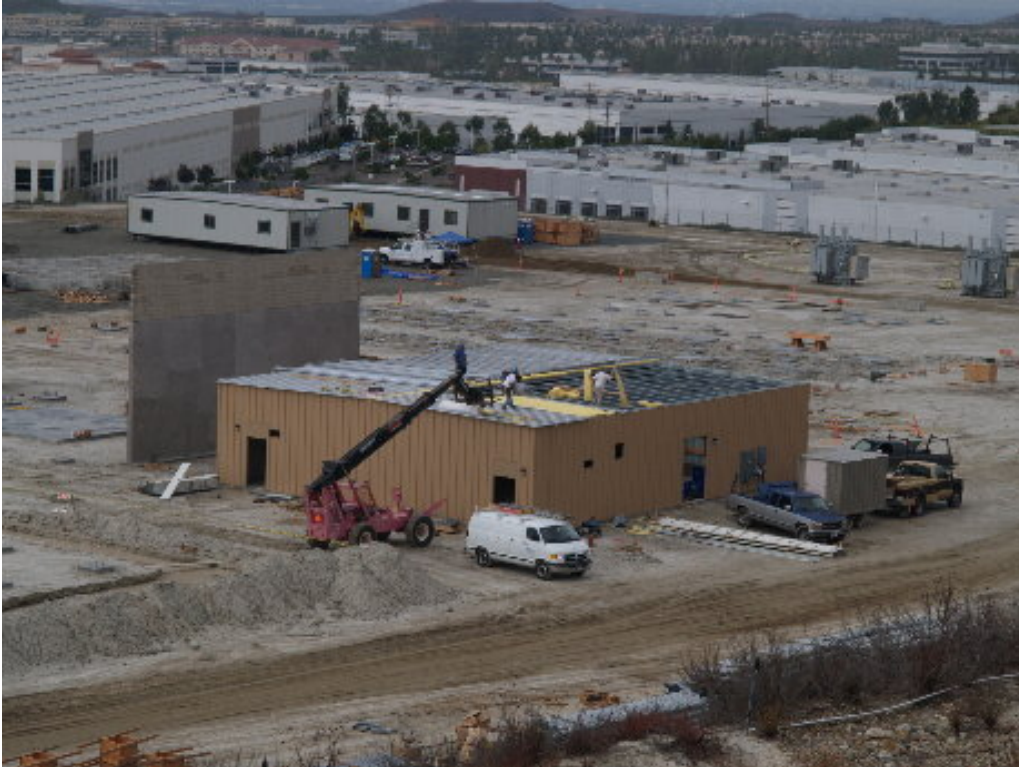
The specialized crew working on the insulation and roofing of the 220 kV main mechanical/electrical equipment room (MEER #1) was the only construction crew working on the substation site during the site visit (see Figure 1). An operator worked with a backhoe to place base rock on the access road and parking area outside the construction trailer (see Figure 2). The remainder of the construction site was fairly saturated from the recent rains and work was suspended.

Figure 1 – A specialized crew installed insulation and worked on the roofing for MEER #1 during the week despite the rain.

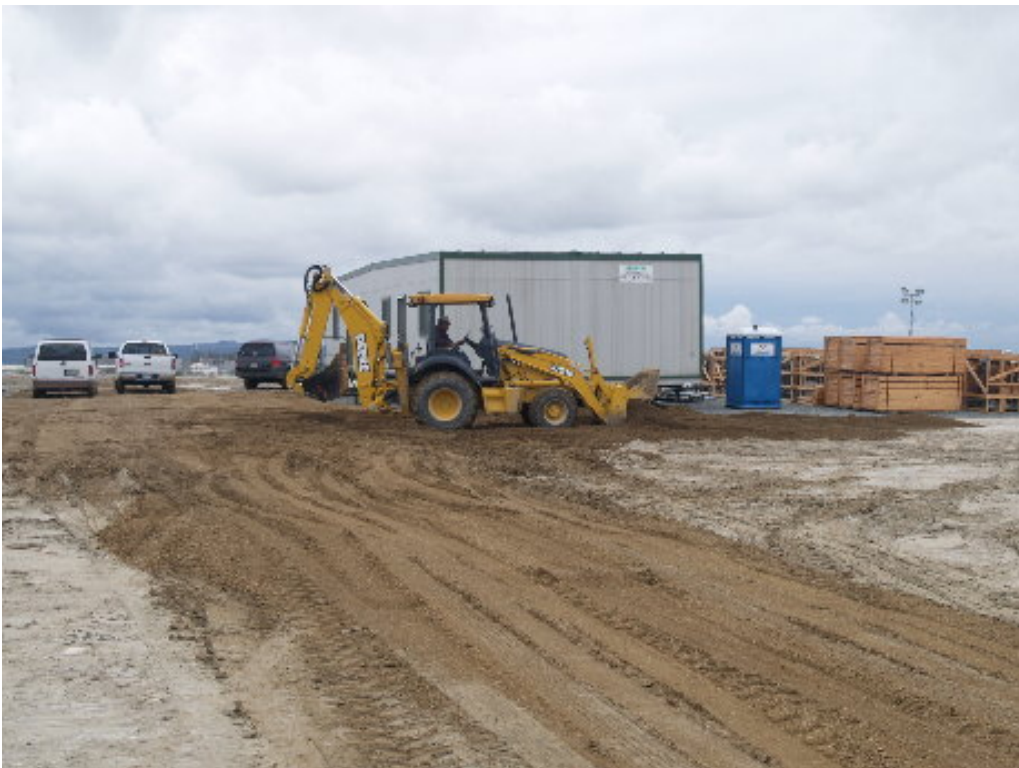
Figure 2 – An operator worked with a backhoe to place base rock on the access road and parking area for the construction trailers on the substation site.

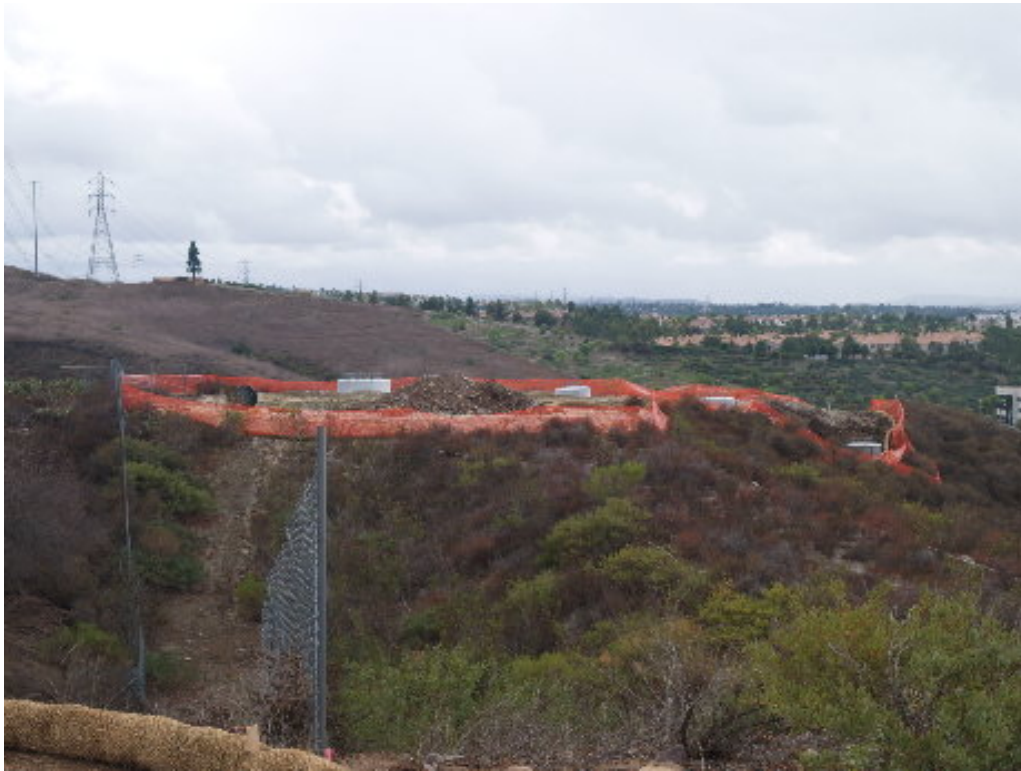
Several foundations were completed prior to the work stoppage (see Figure 3).

Figure 3 – Several complete foundations on the transmission line right-of-way.

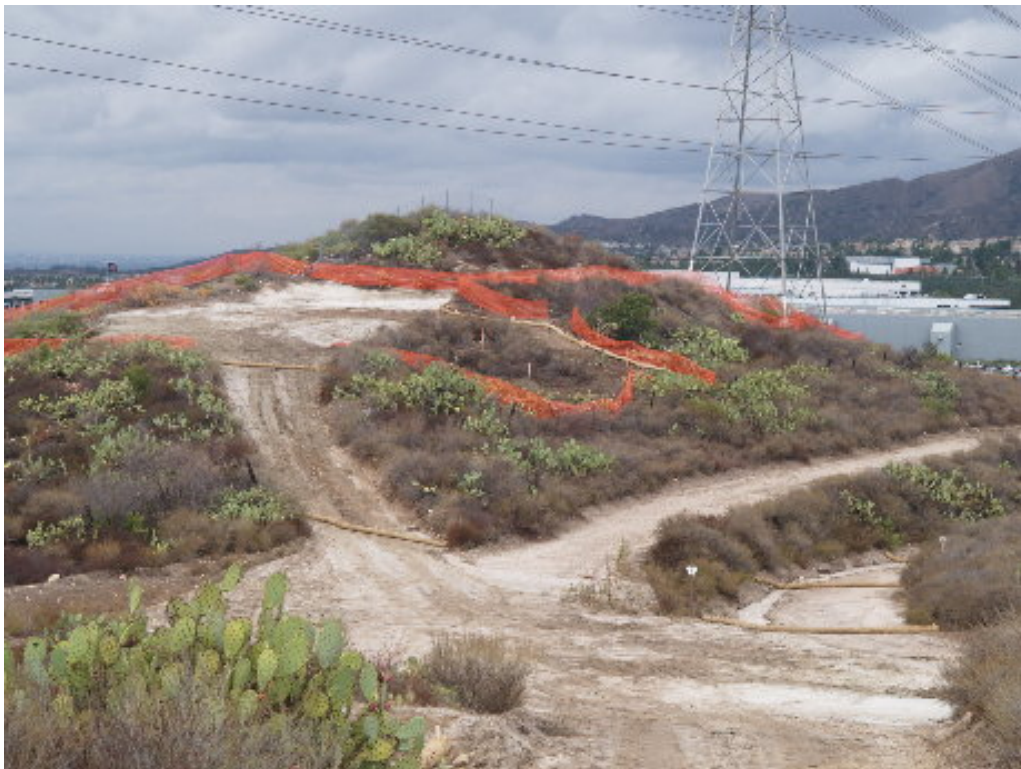
The BMPs installed on the 220 kV right-of-way appeared to be effective (see Figure 4). No significant erosion or sedimentation was noted during the site visit. Straw waddles have been installed on the tower pad sites and the access roads. The spoil pile for the drilling operation was partially covered with jute netting and surrounded with straw waddles to minimize sediment transport (see Figure 5). Steel plates have been installed over the drainage ditch on the access road from the substation site to allow vehicle passage without impacts to the water (see Figure 6).

Figure 4 – SCE has installed straw waddles at the pad locations and along access roads on the 220 kV corridor to control erosion and sedimentation.

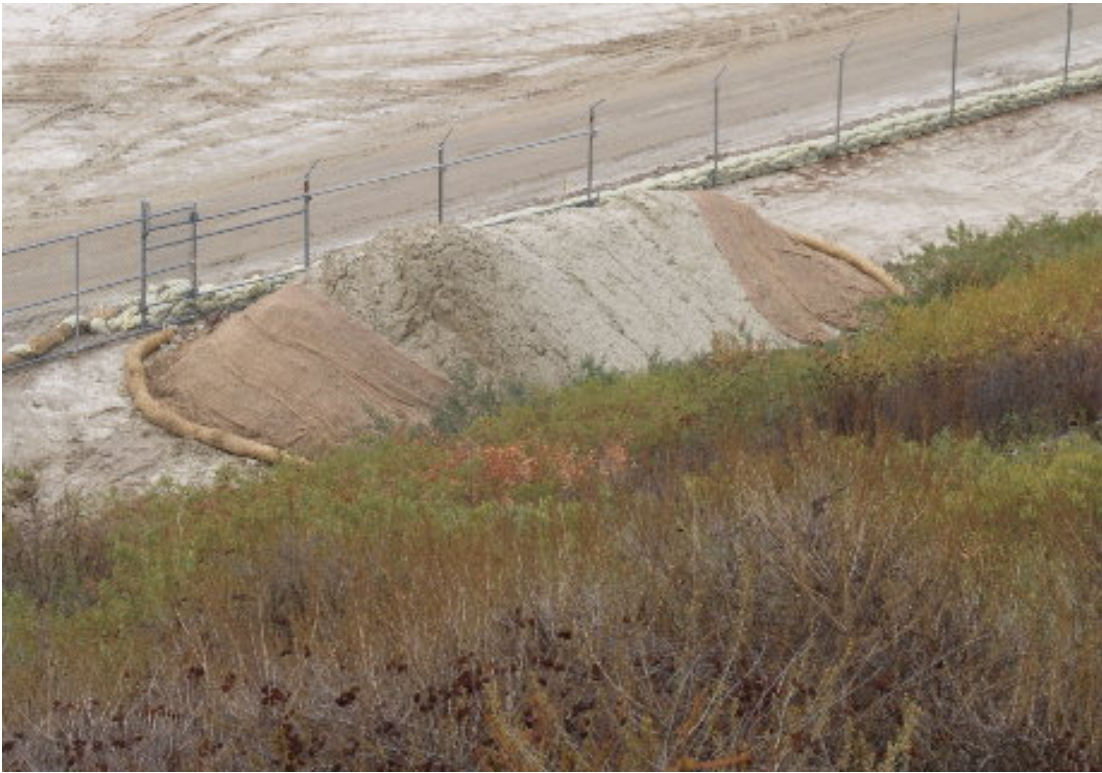
Figure 5 – The spoil pile for the pole foundation at the base of the hill adjacent to the south end of the substation site has been partially covered to minimize sedimentation.

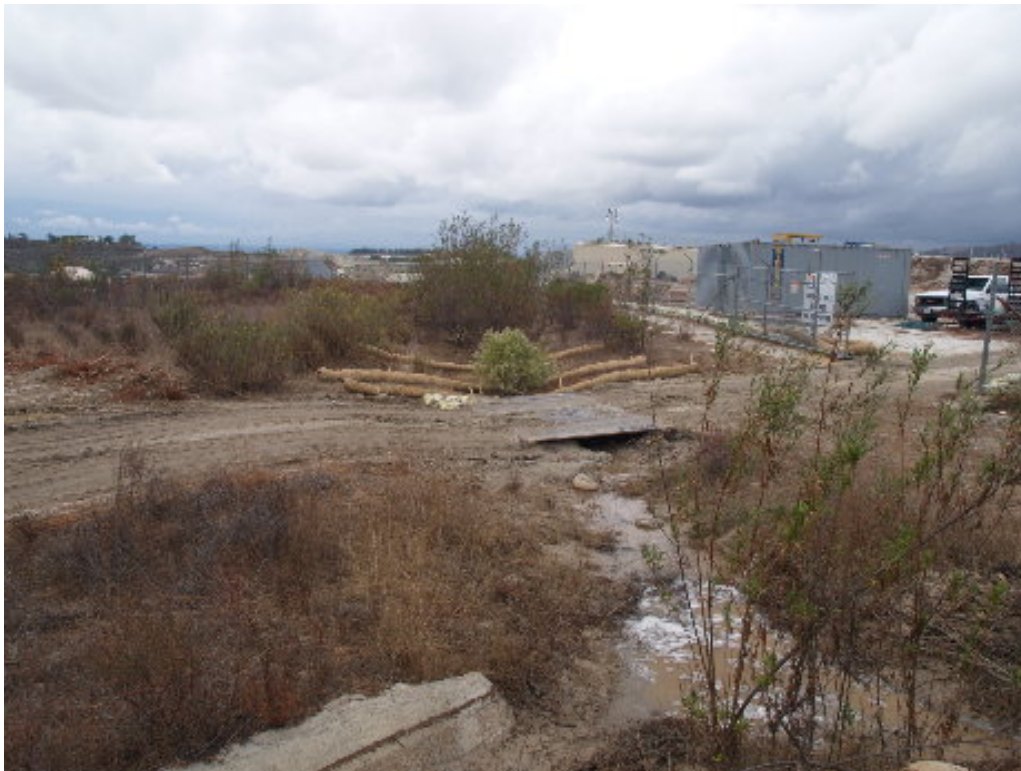
Figure 6 – Steel plates were installed on the access road for the 220 kV line to prevent vehicle traffic in the flowing water.
