PROJECT MEMORANDUM SCE – VIEJO SYSTEM PROJECT

To: Jensen Uchida, CPUC
From: Vida Strong, Aspen Project Manager
Date: November 10, 2004
Subject: Weekly Report #14: October 31, 2004 – November 6, 2004
CPUC Environmental Monitor (EM): Christopher Meyer

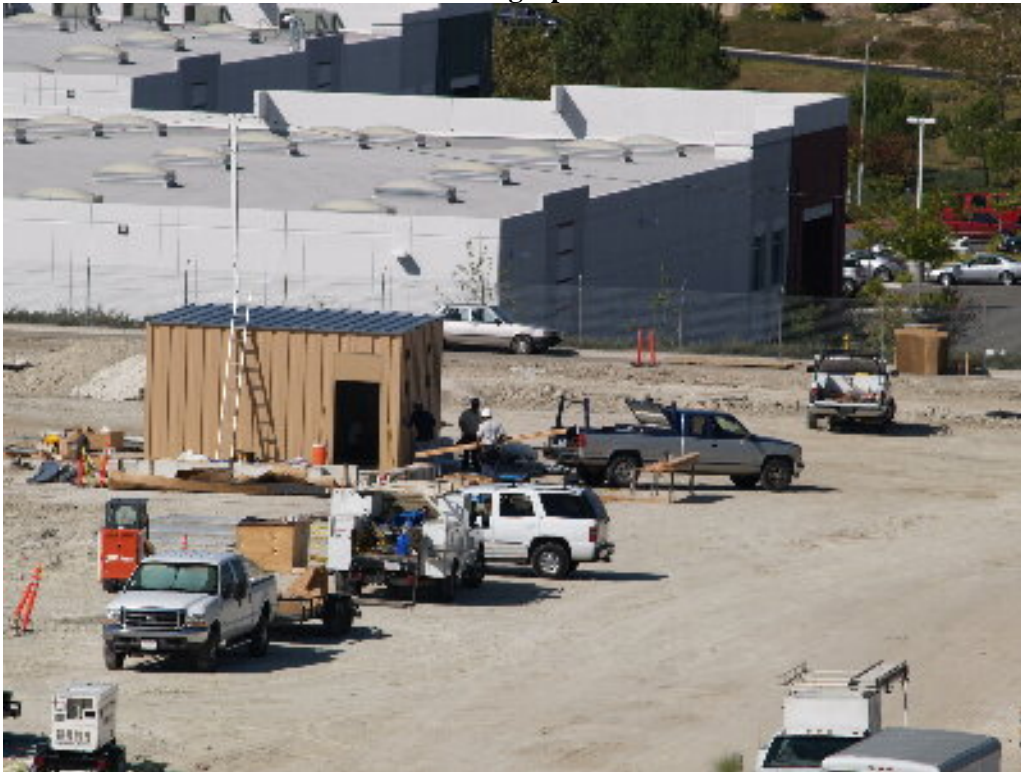
Specialized crews worked on the interior of the 220 kV main mechanical/electrical equipment room (MEER #1) and the 66 kV MEER #2 on the substation site during the site visit (see Figure 1). The substation site has dried after the recent rains and work has resumed outside the MEER structures.

Figure 1 – The smaller 66 kV MEER #2 has been erected on the foundation and the specialized crew worked on the exterior sheet metal.

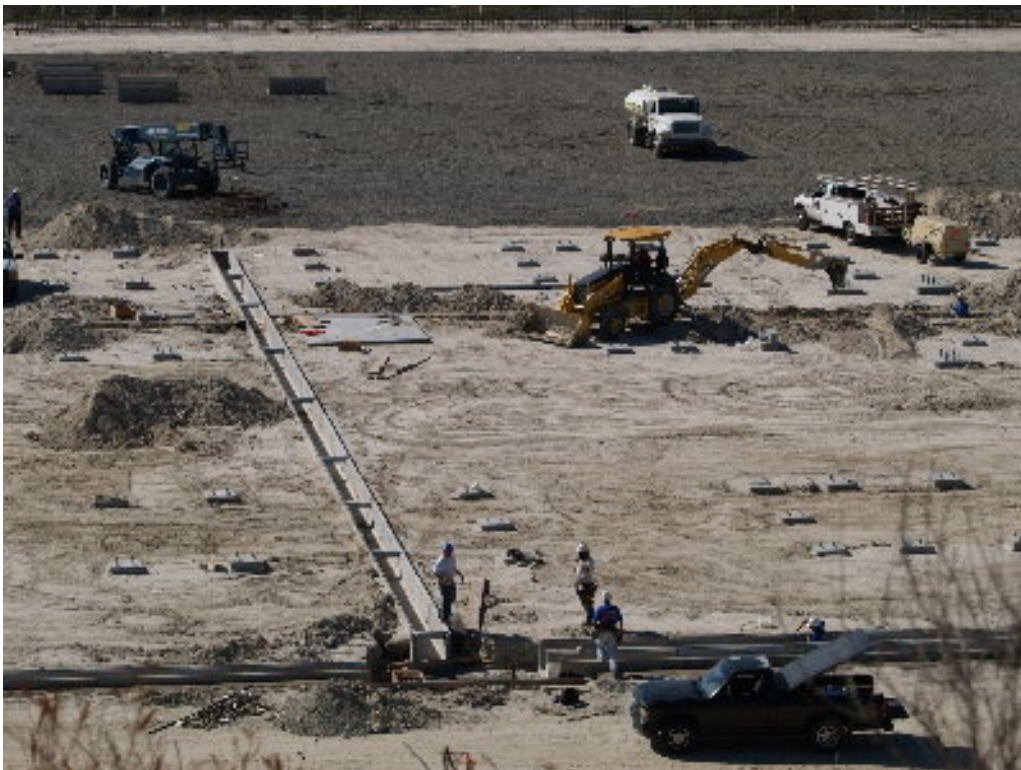
Several crews worked on excavation and preparation of the electrical trenches (see Figure 2). An operator worked with a backhoe to excavate a section of the trench while another crew worked on preparing the trenches for future installation of electrical cables.

Figure 2 – Crews worked on excavation and preparation of the pre-cast concrete electrical trenches on the substation site.

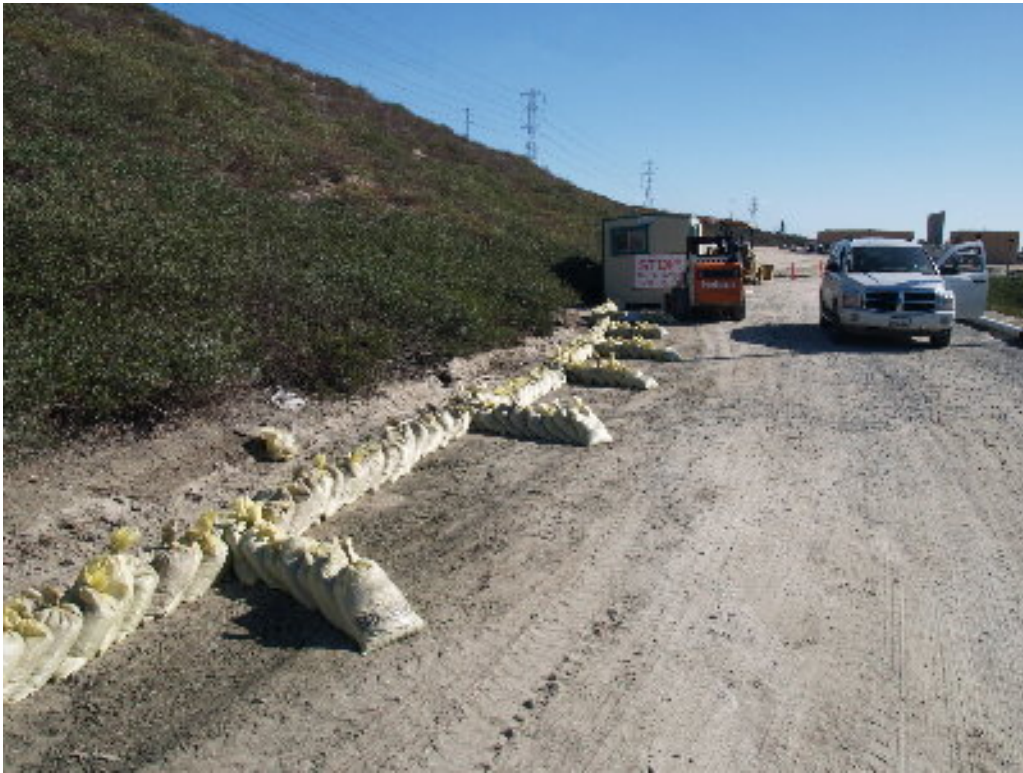
The Best Management Practices (BMPs) installed on the substation site appeared to be functioning properly in most cases. The reliance on straw wattles instead of silt fencing for sediment control will require additional maintenance and was overwhelmed by some flows during the heavy rainfall. The sandbags placed on the north end of the project near the guard shack to control the excessive run-off and sediment were replaced and the sediment from the recent rains cleaned up (see Figure 3). Two workers repaired the storm drain grating on the access road to the substation site (see Figure 4). Once the grating is repaired, filter-fabric can be used to limit sediment entering the storm drain. No off-site impacts were noted during the site visit and the maintenance of the BMPs appeared to be effective.

Figure 3 – The rows of sandbags placed near the guard shack were replaced and sediment removed.

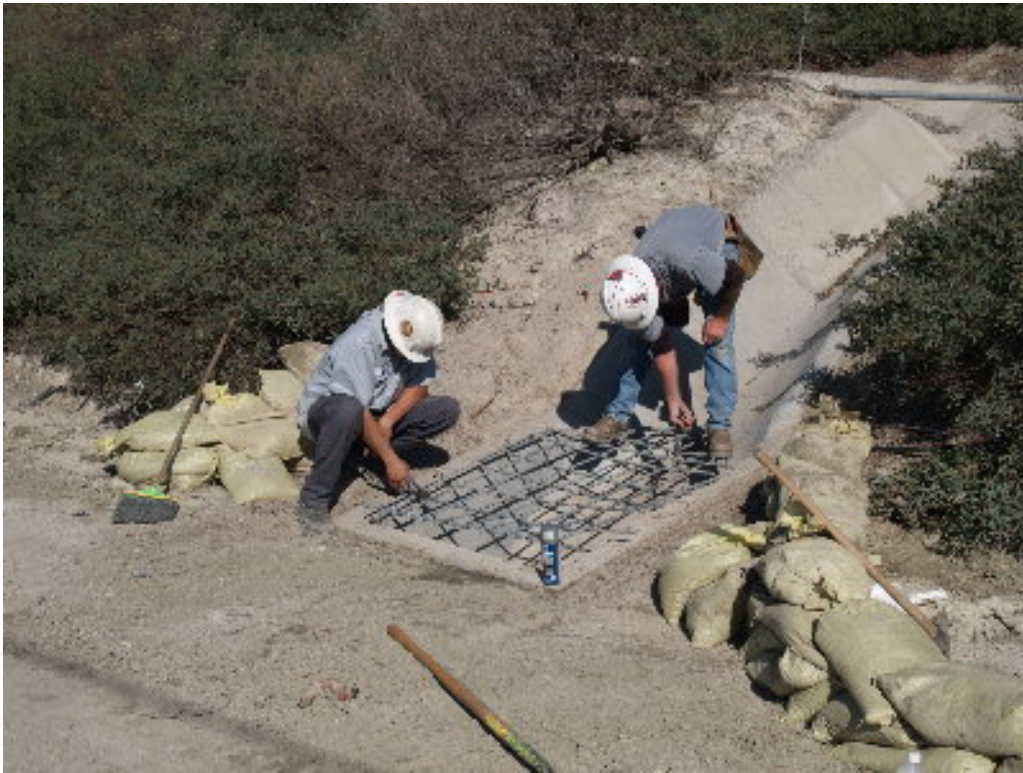
Figure 4 – The grate north of the guard shack on the access road was repaired so that filter fabric could be installed properly.

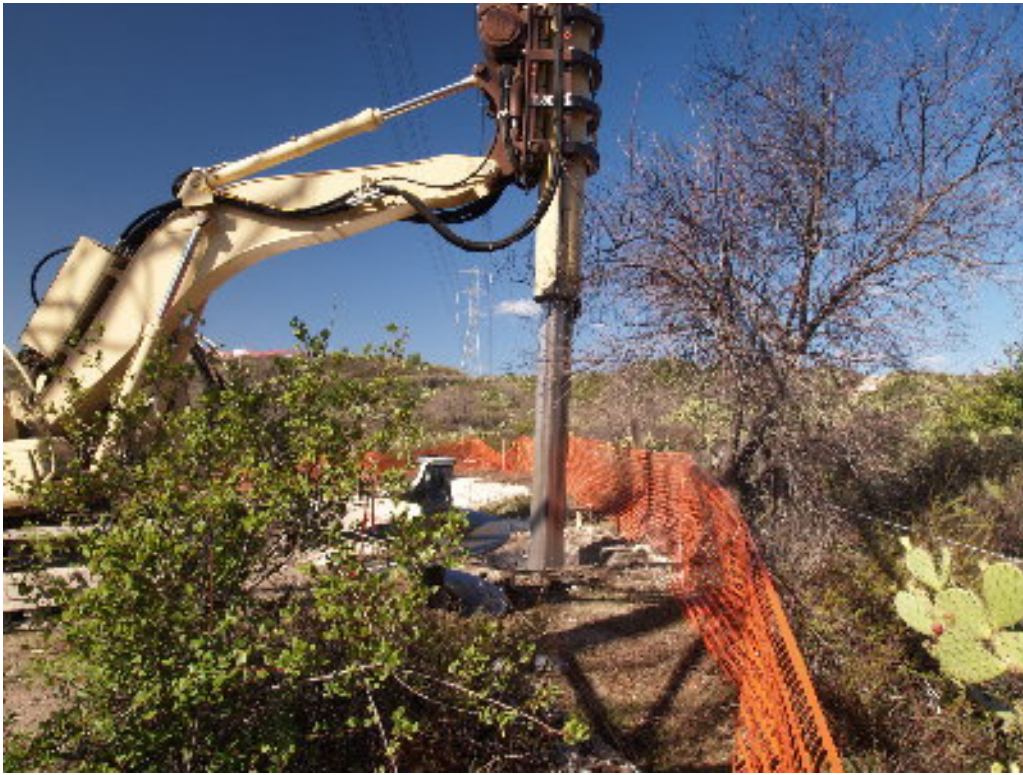
The only work that occurred on the 220 kV transmission line corridor during the site visit was drilling of foundations southwest of the substation site. The drilling crew will work on several foundations in the same location and anticipates faster progress due to softer material. The current drilling location is imme-

diately adjacent to a tree inside the exclusion zone and the crews were being careful not to damage the tree (see Figure 5). The crew will request permission from the SCE environmental coordinator to lift the fencing to place the base of the anchor bolt support structure within the exclusion zone. No environmental impact is anticipated if the crew coordinates with the SCE biologist.

Figure 5 – The drilling crew worked on several foundations at the base of the hill southeast of the substation site.

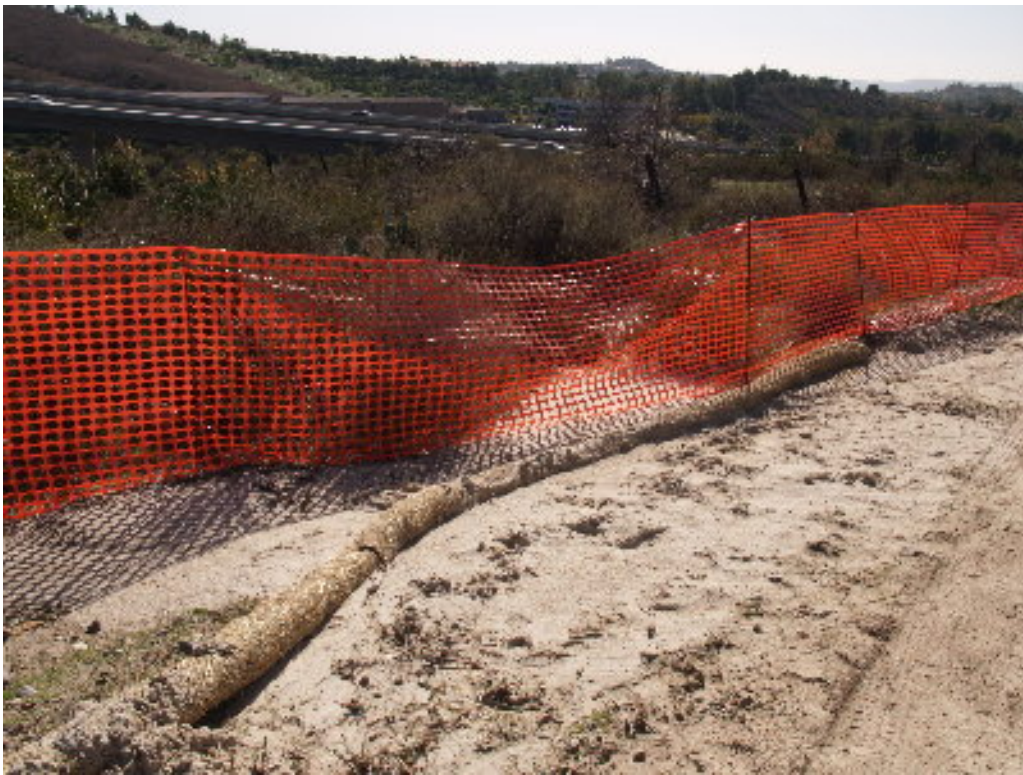
Some of the BMPs installed on the 220 kV right-of-way appeared to have been effective during the recent storms; however, the heavy rains and resultant sediment overwhelmed the straw waddles in several places and need maintenance (see Figure 6). Straw waddles have been installed on the tower pad sites and the access roads. The construction coordinator on the 220 kV transmission line will oversee the maintenance and upgrading of the sediment controls where they were overwhelmed or not effective.

Figure 6 – Some of the straw wattle sediment barriers on the 220 kV transmission line have been overwhelmed by recent sediment and need maintenance and possible upgrading.
