PROJECT MEMORANDUM SCE – VIEJO SYSTEM PROJECT

To: Jensen Uchida, CPUC
From: Vida Strong, Aspen Project Manager
Date: November 24, 2004
Subject: Weekly Report #16: November 14, 2004 – November 20, 2004
CPUC Environmental Monitor (EM): Christopher Meyer

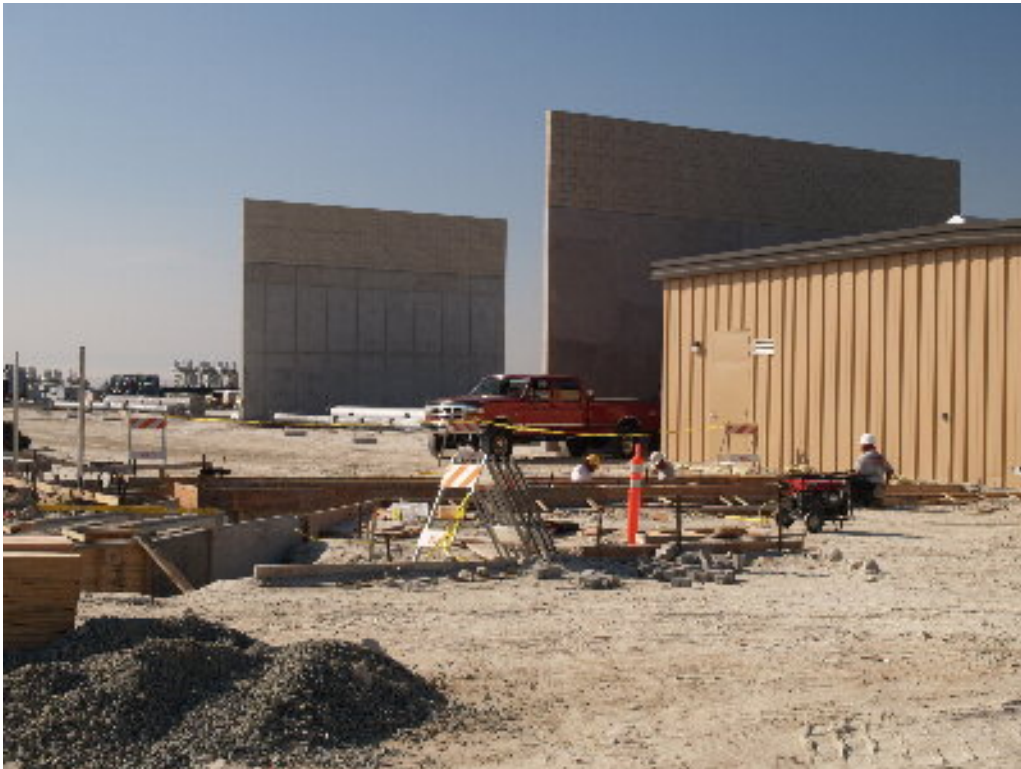
A crew worked on the formwork for the concrete trench that will connect to the 220 kV MEER #1 on the substation site during the site visit (see Figure 1). This section of poured concrete trench will connect the series of pre-fabricated trenches to MEER #1.

Figure 1 – Crews worked on the forms for the concrete section linking the pre-cast concrete trenches to the MEER #1.

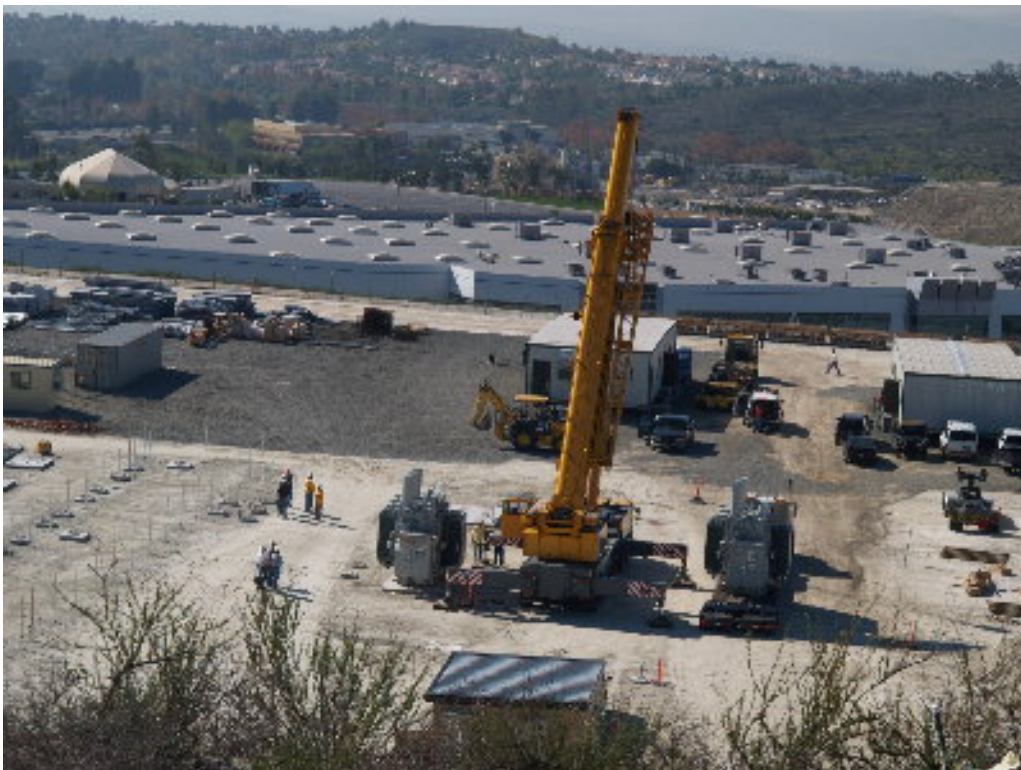
One crew worked with a 300-ton crane to set the B transformers on their foundations (see Figure 2). The crane arrived on-site without counterweights and was not able to extend the boom more than a few degrees away from center. This problem required the crew to move the transformers in two steps, with the crane located as close as possible to the foundations. SCE elected to unload the other equipment from the flat-bed trailers with the wheeled fork-lift. Several supports on the southern portion of the substation site were raised with a smaller crane (see Figure 3).

Figure 2 – A 300-ton crane was used to place the B transformers onto foundations.

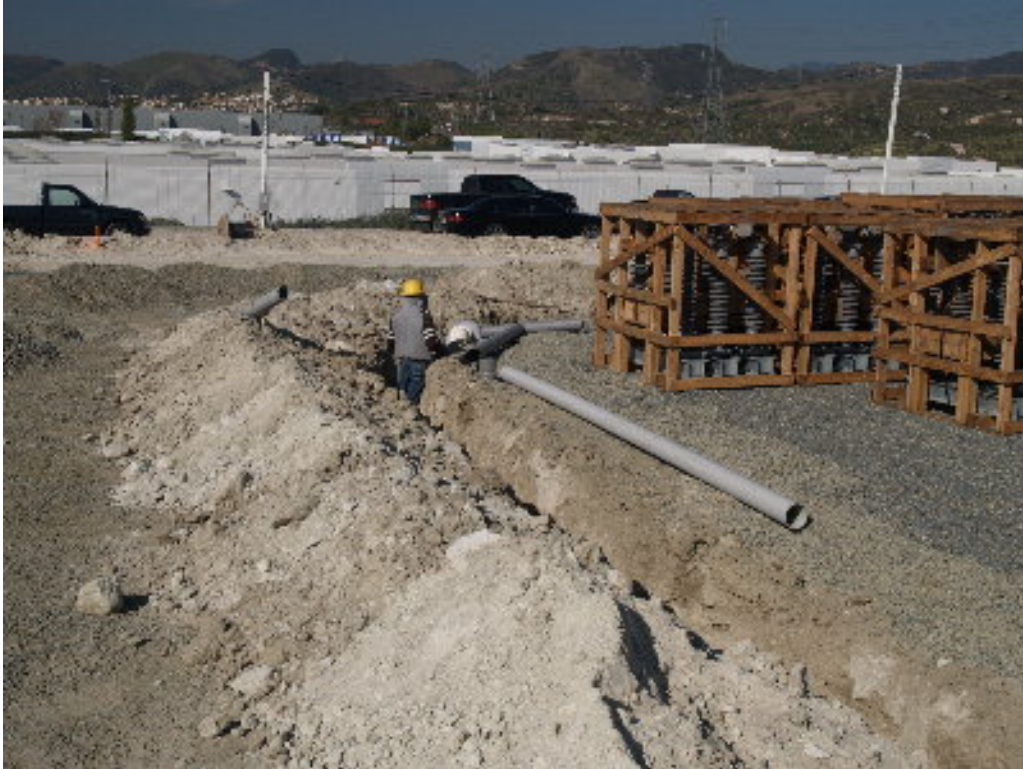
A small crew worked on the conduits for the fiber-optic communication lines inside the substation site (see Figure 4). A separate contractor, Three Kings Construction, worked on the fiber-optic trenches outside the actual substation site.

Figure 3 – A crew worked on the fiber-optic conduit within the substation site.

The CPUC EM reminded SCE that the fiber-optic line is part of the project and the work being completed by Three Kings Construction needs to be in compliance with all project mitigation measures. The paleontologist will coordinate with the crew on any trenching of native soils.

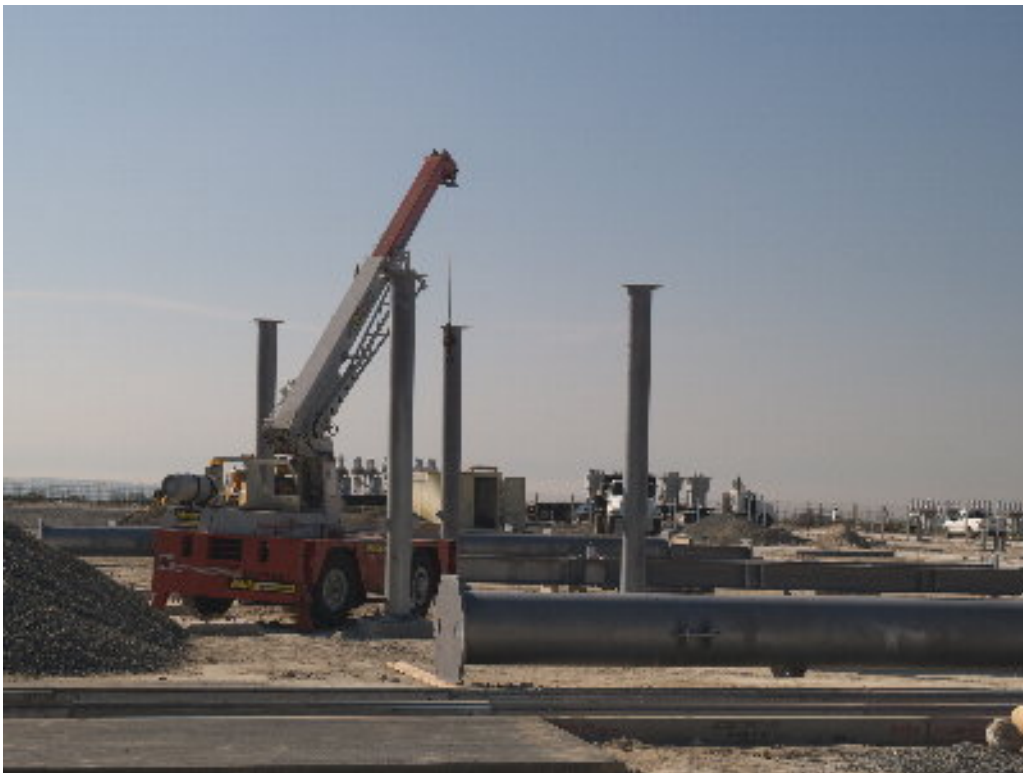
Figure 4 – A small crane was used to raise the supports on the southern end of the substation site.

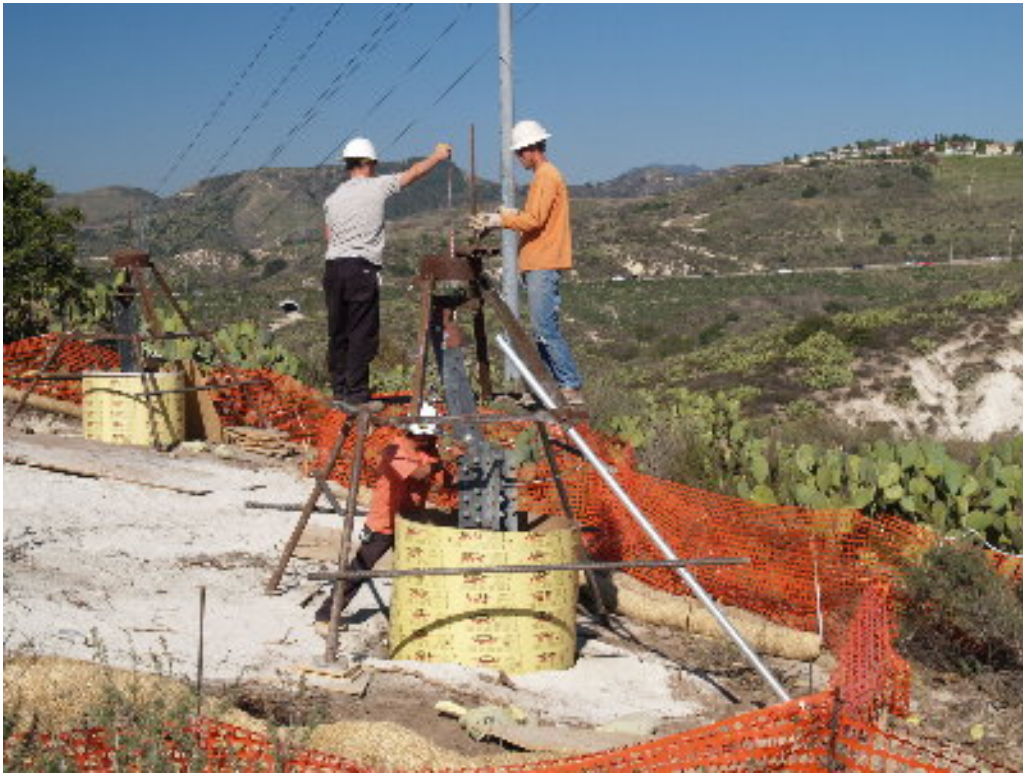
A small crew worked on setting the stub angles at the final foundations along the 220 kV transmission line corridor, above the substation site during the subject week (see Figure 5). Once the stub angles are properly situated, the concrete will be poured for the lattice structure foundations.

Figure 5 – A crew set the stub angles for the northern 220 kV lattice tower foundations.

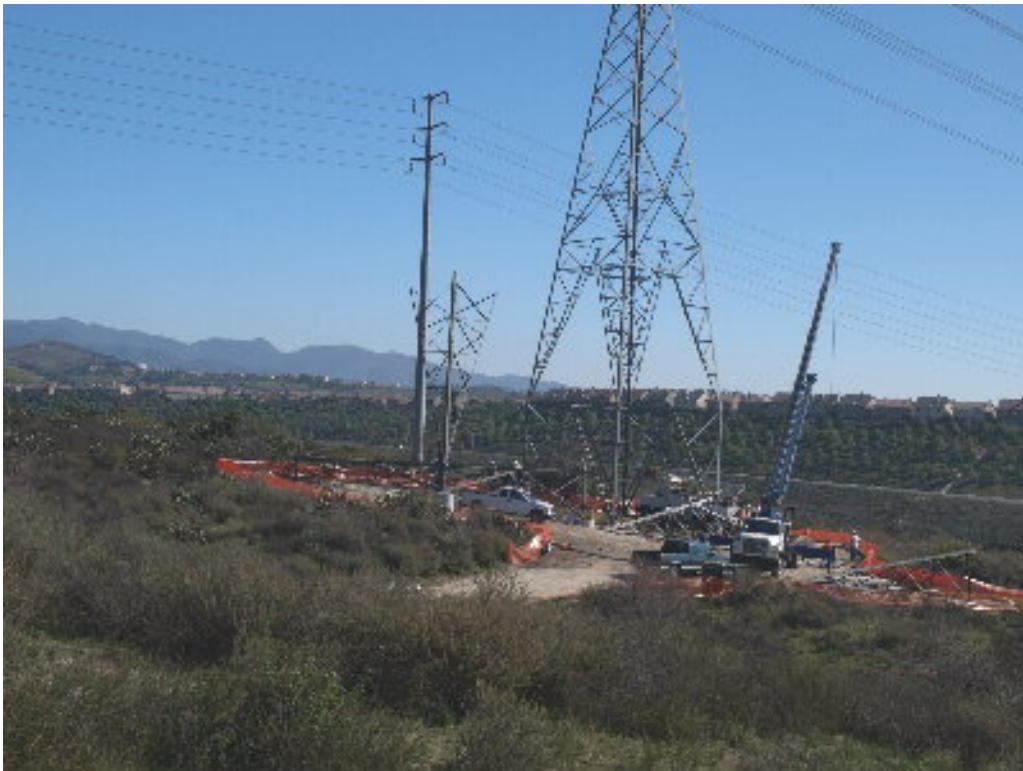
Specialized crews started the erection of the steel sections for the southern lattice tower (see Figure 6). The bottom section of the middle lattice structure has been completed and the crews have a small section to erect before work stops (see Figure 7). The height of the lattice sections is limited by the clearances required between the structures and the live transmission lines. The crews will prepare the upper sections and wait for an outage to complete raising the lattice towers.

Figure 6 – Crews started erecting the lattice tower at the base of the hill southeast of the substation site.

SCE needs to move the exclusion fencing near the southern tower location. The transmission line superintendent needs to move a crane to the north side of the tower to set the eastern lattice sections. The SCE biologist will examine the habitat and monitor any vegetation clearing. SCE will place plating over the habitat and avoid the mature sage and cactus, using a sparsely vegetated corridor for access.

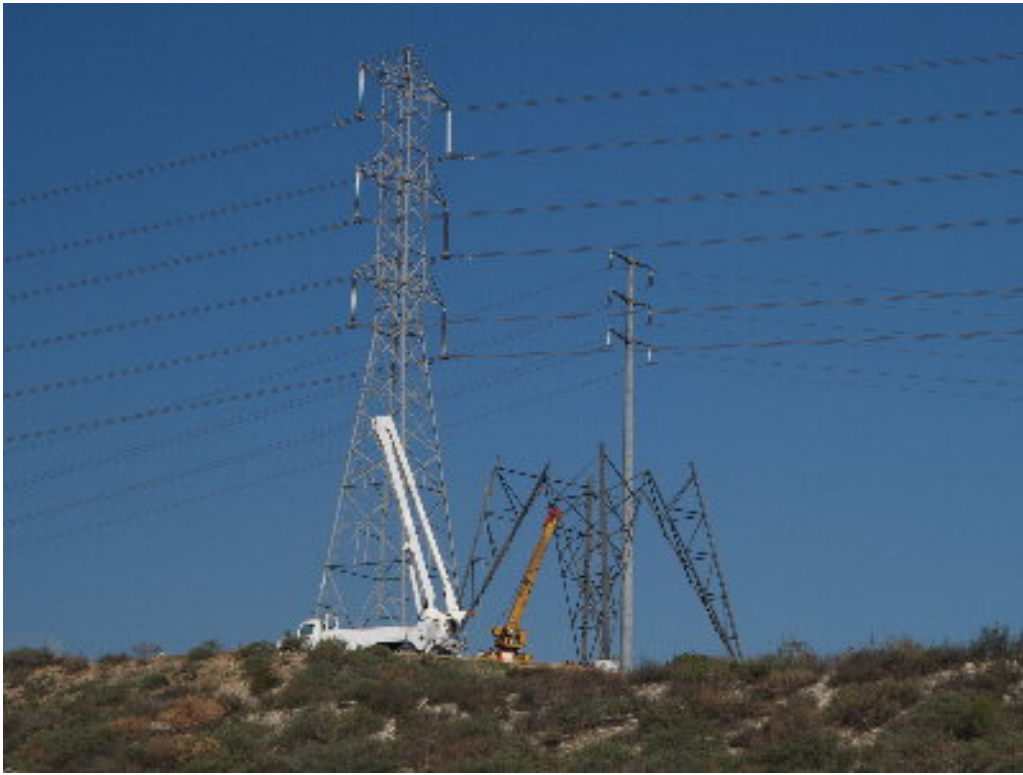
Figure 7 – The lower section of the middle lattice structure on the 220 kV transmission corridor has been completed.
