PROJECT MEMORANDUM SCE – VIEJO SYSTEM PROJECT

To: Jensen Uchida, CPUC
From: Vida Strong, Aspen Project Manager
Date: December 1, 2004
Subject: Weekly Report #17: November 21, 2004 – November 27, 2004
CPUC Environmental Monitor (EM): Christopher Meyer

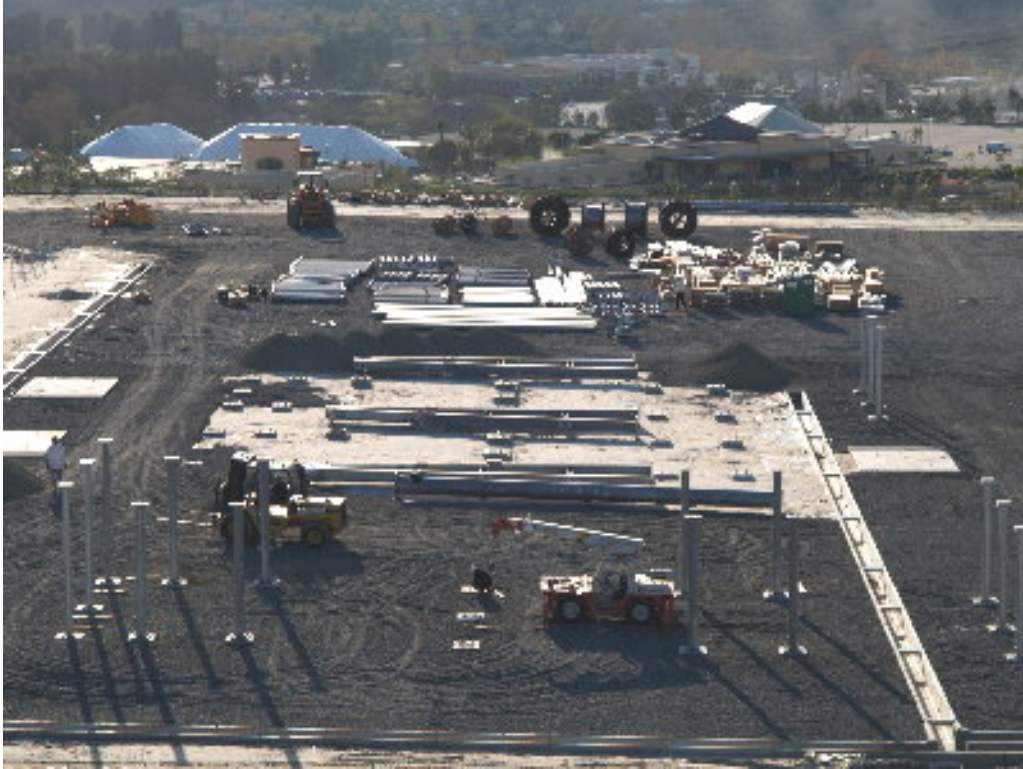
Crews on the southern portion of the substation site continued to prepare supports for raising (see Figure 1). Gravel has been spread over the southern half of the substation site. Gravel has been stockpiled on the north end of the substation site and will be spread once trenching has been completed (see Figure 2).

Figure 1 – A small crew worked on the supports on the southern end of the substation site.

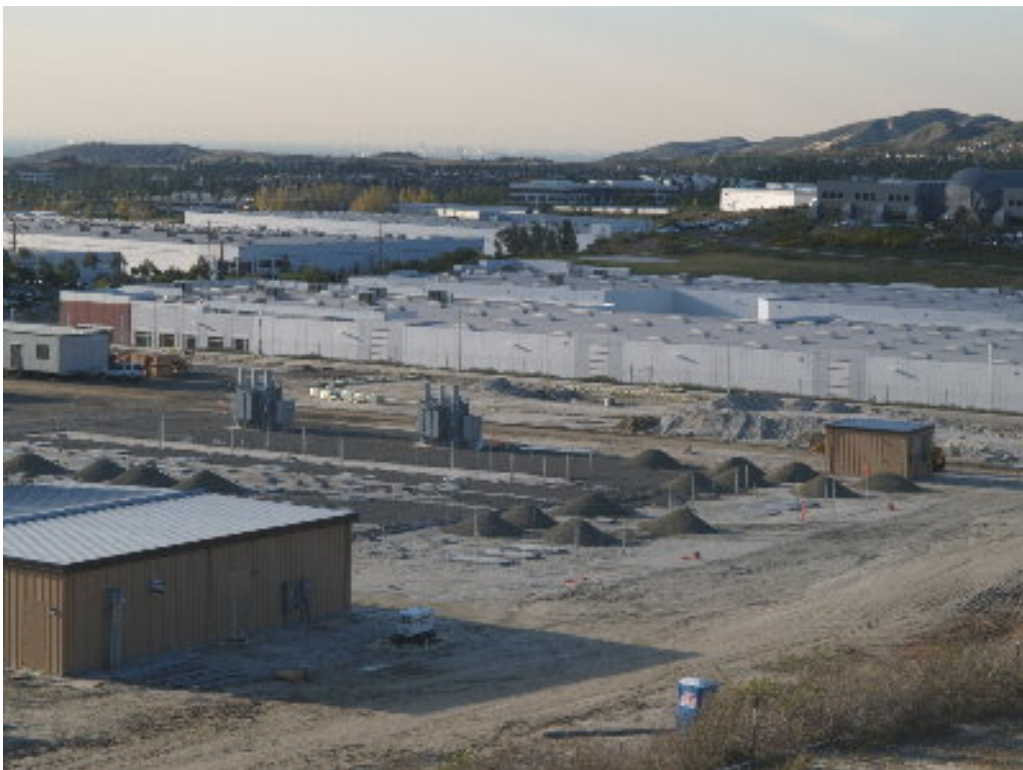
Figure 2 – Gravel piles were stockpiled on the northern end of the substation site while trenching is completed.

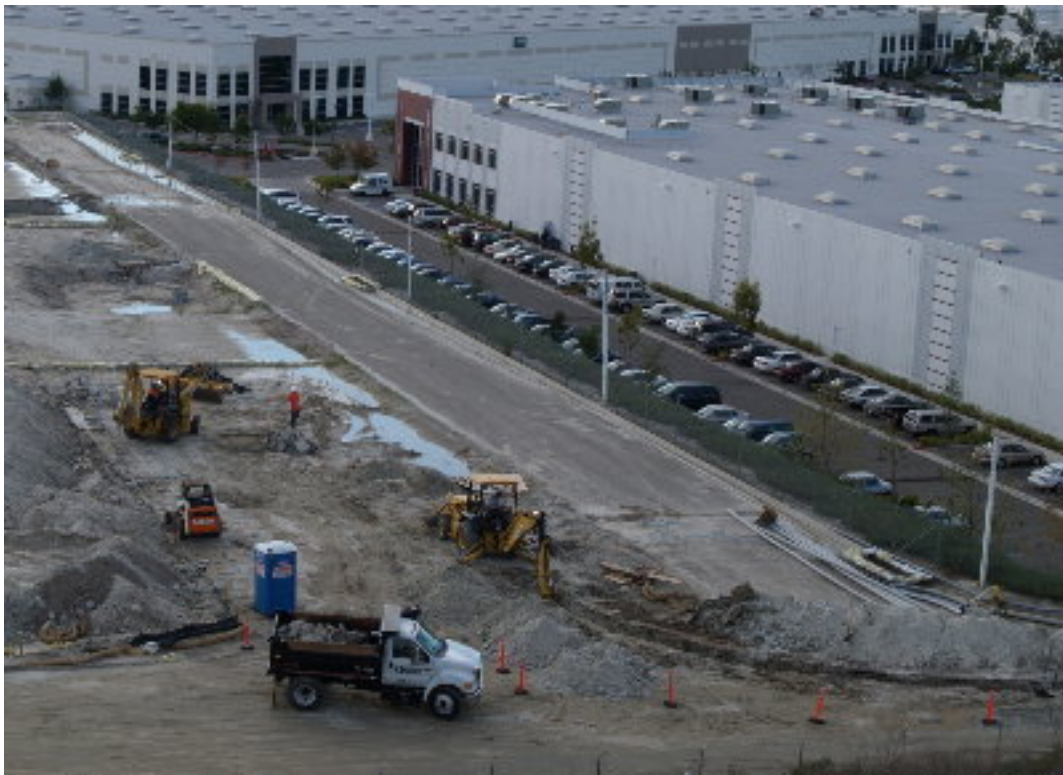
A small crew worked on the conduits for the fiber-optic communication lines inside the substation site (see Figure 3). A separate contractor, Three Kings Construction, continued working on the fiber-optic trenches outside the actual substation site.

Figure 3 – A crew worked on the fiber-optic conduit within the substation site.

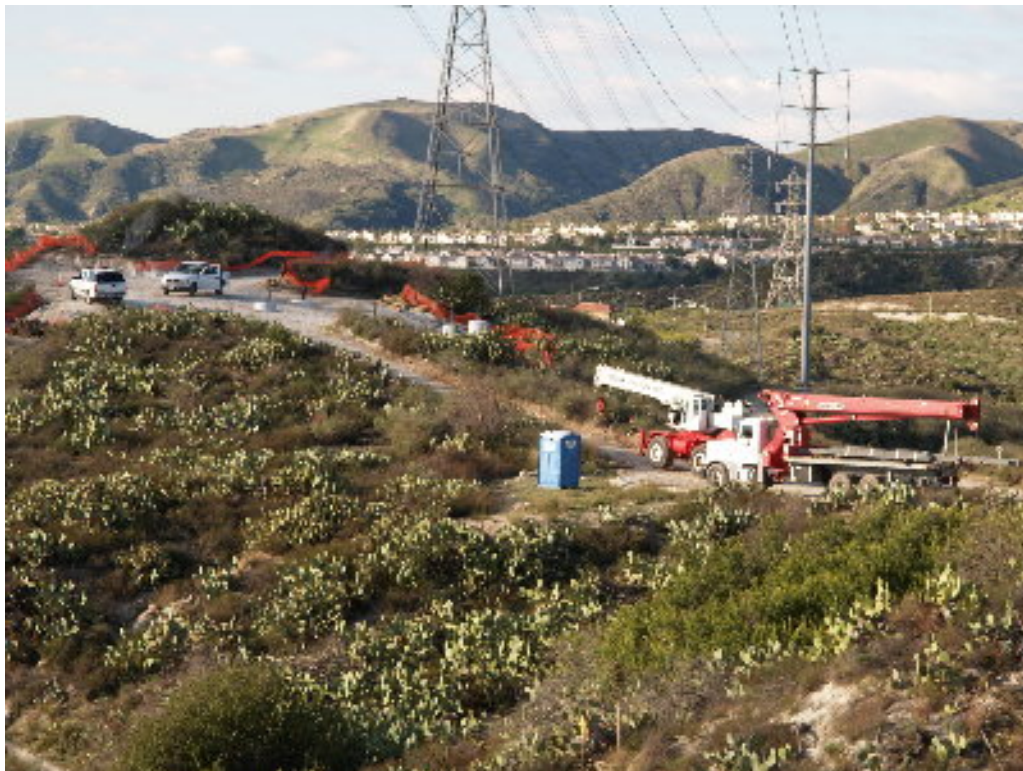
The contractor completed setting the stub angles and pouring concrete at the final foundations along the 220 kV transmission line corridor, above the substation site during the subject week. Once the stub angles are properly situated, the concrete will be poured for the lattice structure foundations. A mobile crane was setting up to set section of steel in place for erection of the lower sections of the tower (see Figure 4).

Figure 4 – The foundations were completed on the northern 220 kV tower and a small crane brought on-site to unload the steel for the lower tower section.

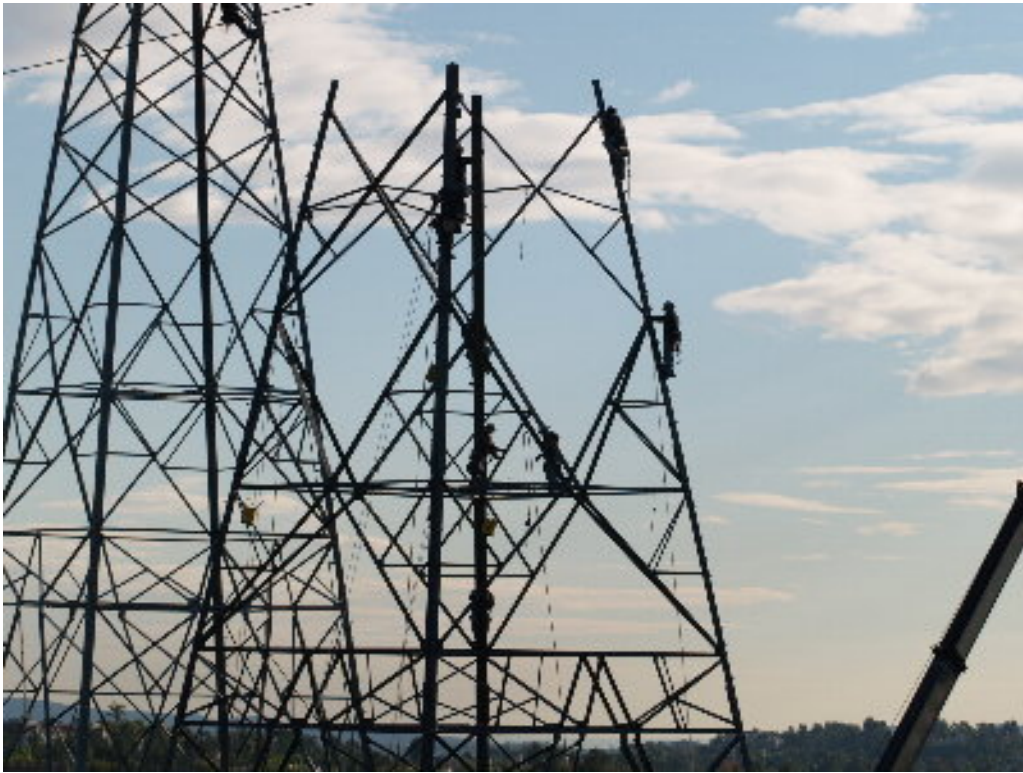
Specialized crews worked on the erection of the steel sections for the southern lattice tower (see Figure 5). The bottom section of the middle lattice structure has been completed and the crews were working to assemble the next section on the ground (see Figure 6). The height of the lattice sections is limited by the clearances required between the structures and the live transmission lines. The crews will prepare the upper sections and wait for an outage to complete raising the lattice towers.

Figure 5 – Specialized crews continued erecting the lattice tower at the base of the hill southeast of the substation site.

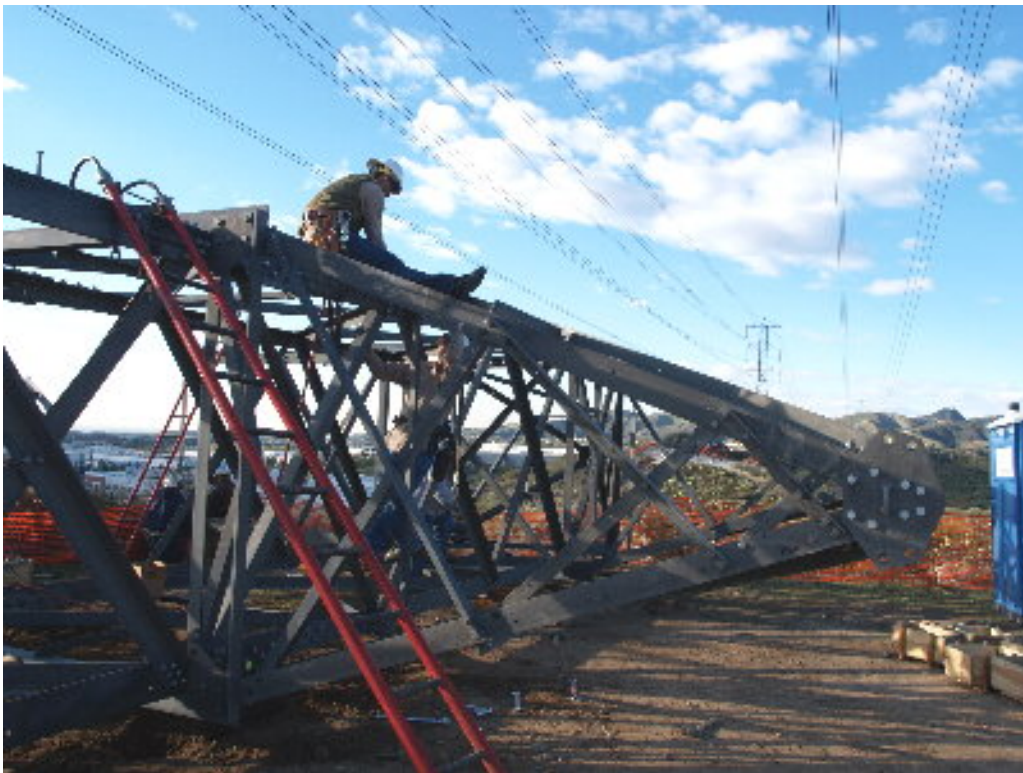
Figure 6 – Crews worked on the ground to assemble the upper section of the middle lattice structure on the 220 kV transmission corridor.
