PROJECT MEMORANDUM SCE – VIEJO SYSTEM PROJECT

To: Jensen Uchida, CPUC
From: Vida Strong, Aspen Project Manager
Date: December 6, 2004
Subject: Weekly Report #18: November 28, 2004 – December 4, 2004
CPUC Environmental Monitor (EM): Christopher Meyer

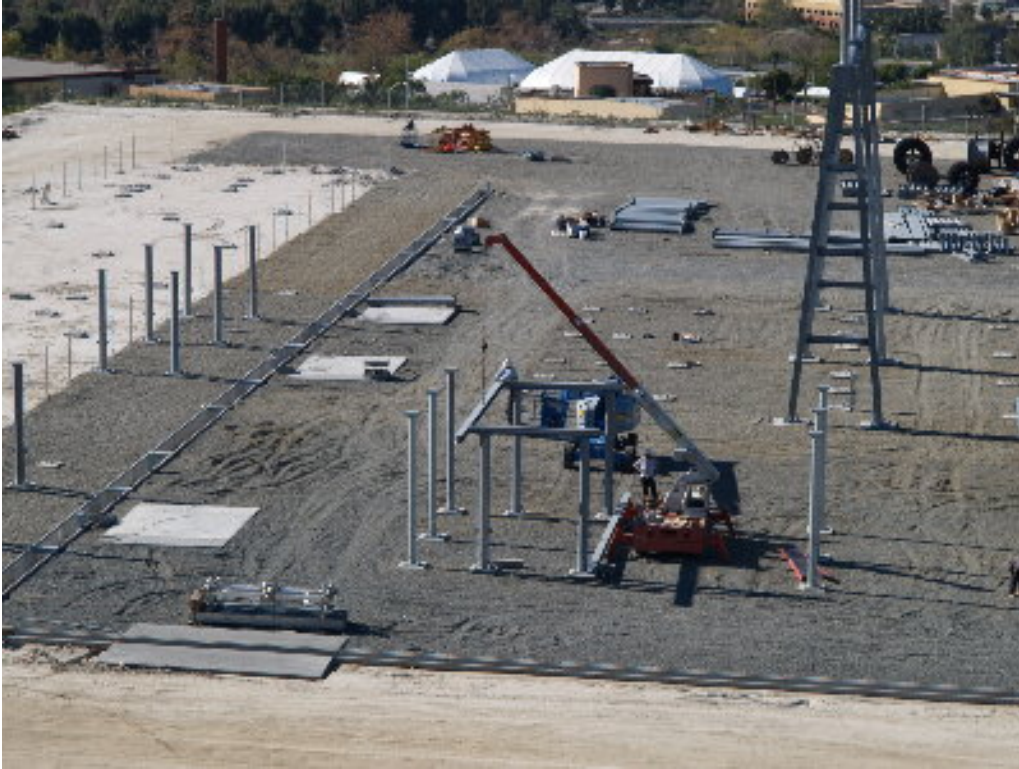
Crews on the southern portion of the substation site used a small crane to set horizontal sections on the supports (see Figure 1). The large A-frame racks have been raised and a crew worked to prepare the racks for cable (see Figure 2). The majority of the work on the large racks occurred earlier in the week, before the site visit.

Figure 1 – A small crew worked with a crane to set the horizontal sections on the supports on the southern end of the substation site.

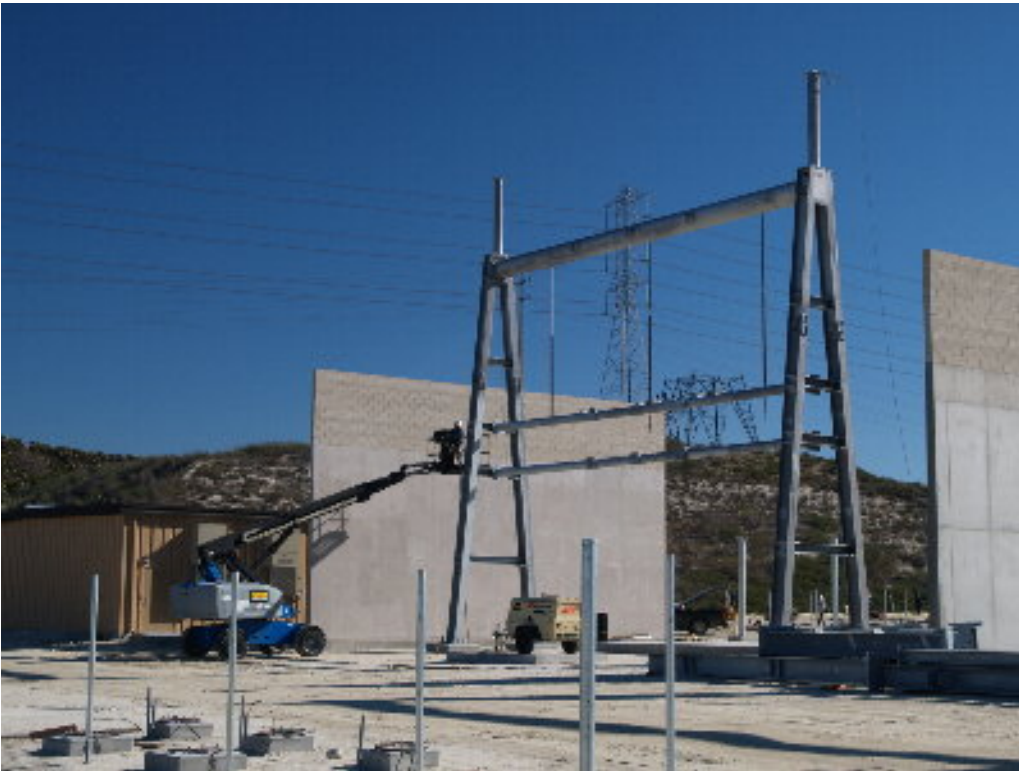
Figure 2 – The large racks have been raised and a crew worked to prepare the racks for cable.

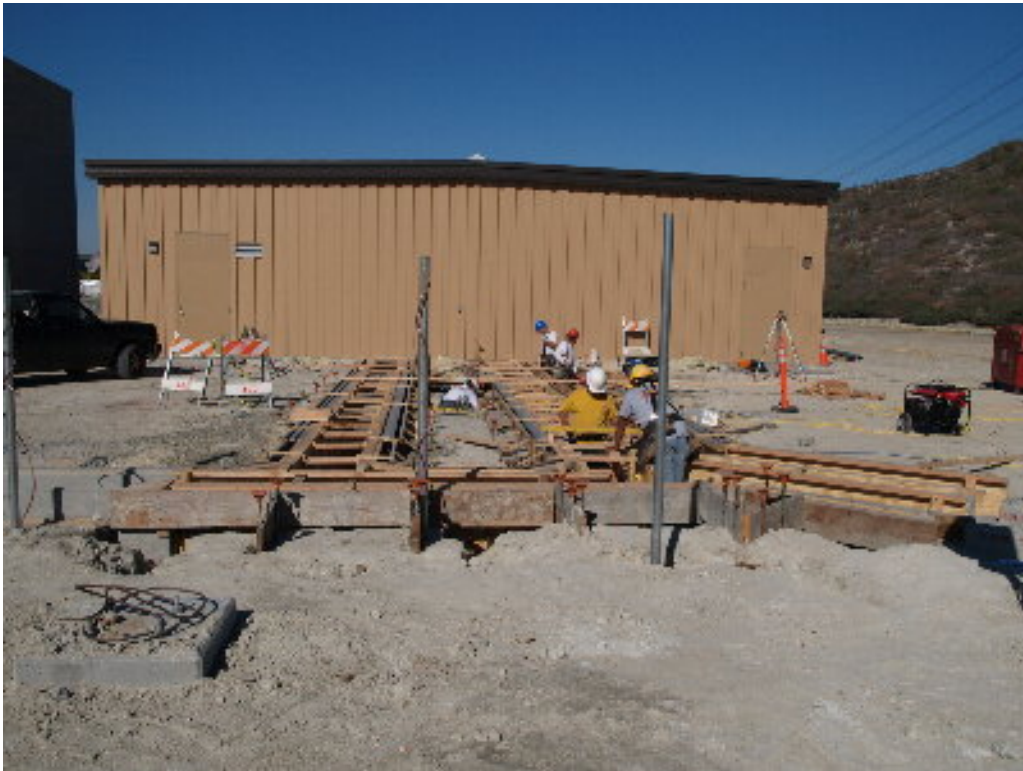
The bulk of the work on the substation site during the site visit was at the formed trench entering Mechanical Electrical Engineering Room (MEER) #1. The crew were resetting the form work for the poured section of trenching that will connect the pre-cast concrete trenches with MEER #1 (see Figure 3). The crews performed this task before, however water and sediment from the heavy storms damaged the form work and the forms were removed and rebuilt. The sections of pre-cast concrete trenches have to be connected with formed sections (see Figure 4).

Figure 3 – A larger crew worked to rebuild the trench forms leading into MEER #1.

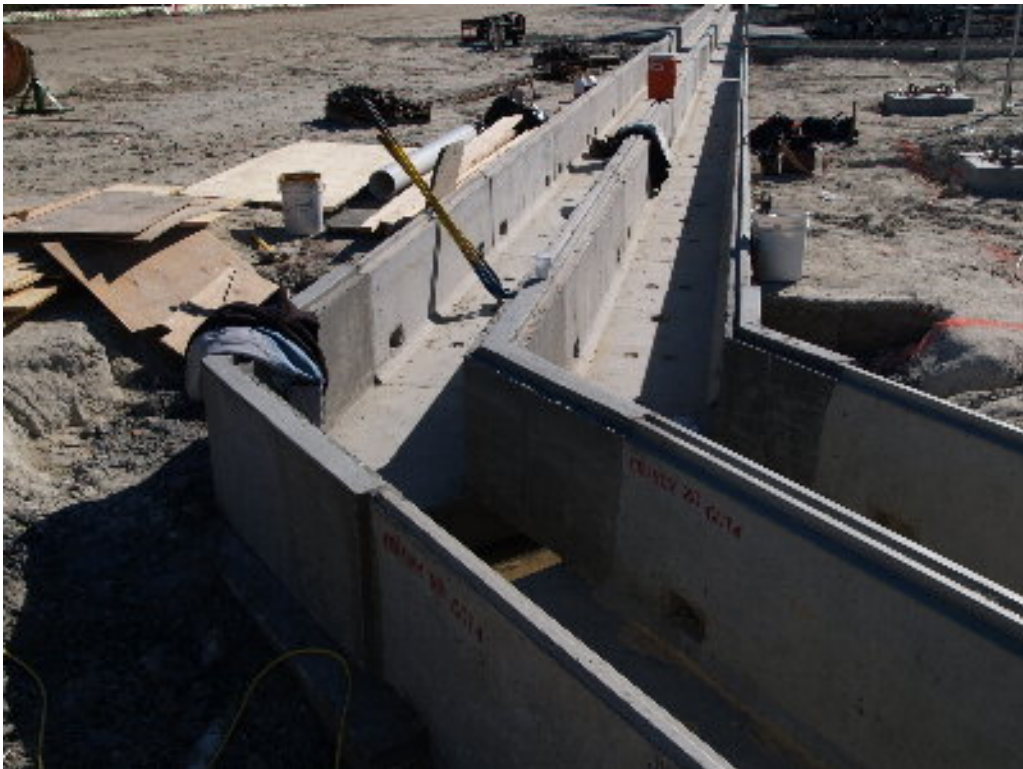
Figure 4 – The pre-cast concrete sections of trench need to be connected by formed sections at angles and intersections (see darker formed angle).

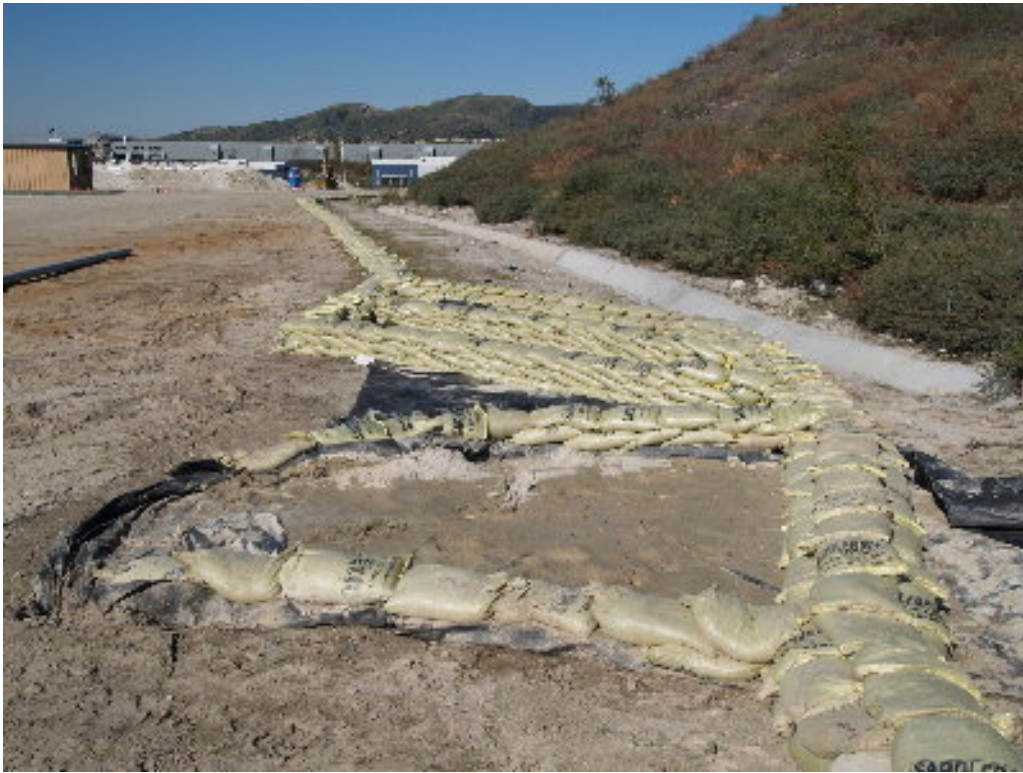
The Best Management Practices (BMPs) installed on the substation site appeared to be ready for the predicted rains. The fence between the substation site and the hill to the east has been removed to allow completion of the grading plan and the BMPs were shifted east. The crews constructed a series of sediment traps to allow any sediment in the rain run-off to settle before entering the concrete drainage ditch (see Figure 5). The reliance on straw waddles instead of silt fencing for sediment control will require additional maintenance and can be overwhelmed by flows during heavy rainfall. No off-site impacts were noted during the site visit and the maintenance of the BMPs appeared to be effective.

Figure 5 – A series of sediment traps were constructed further to the east after the fence was removed.

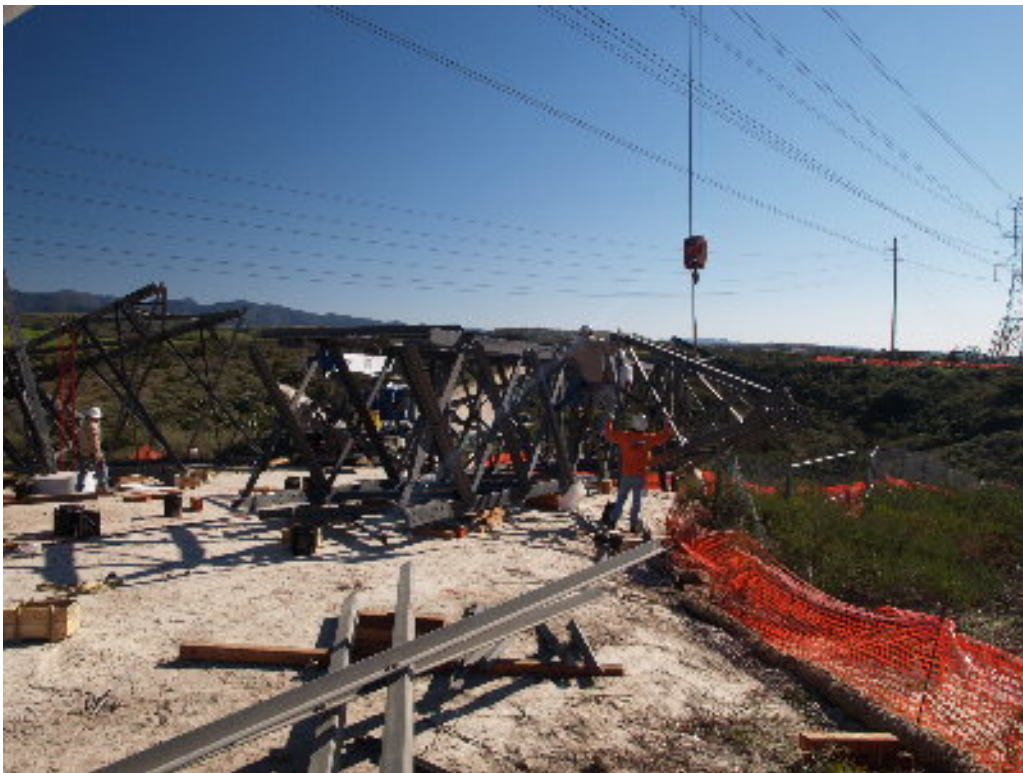
The bottom sections of all the lattice structure has been completed and raised and the crews were working to assemble the next sections on the ground (see Figure 6). No other work occurred on the transmission line segment during the site visit. The height of the lattice sections is limited by the clearances required between the structures and the live transmission lines. The crews will prepare the upper sections and wait for an outage to complete raising the lattice towers. The upper section of the middle tower has been assembled and is secured to the lower section awaiting an outage (see Figure 7). The scheduled outage has been delayed until the first week of January due to the longer than expected outage at San Onofre Power Plant.

Figure 6 – Crews worked on the ground to assemble the upper section of the northern lattice structure on the 220 kV transmission corridor.

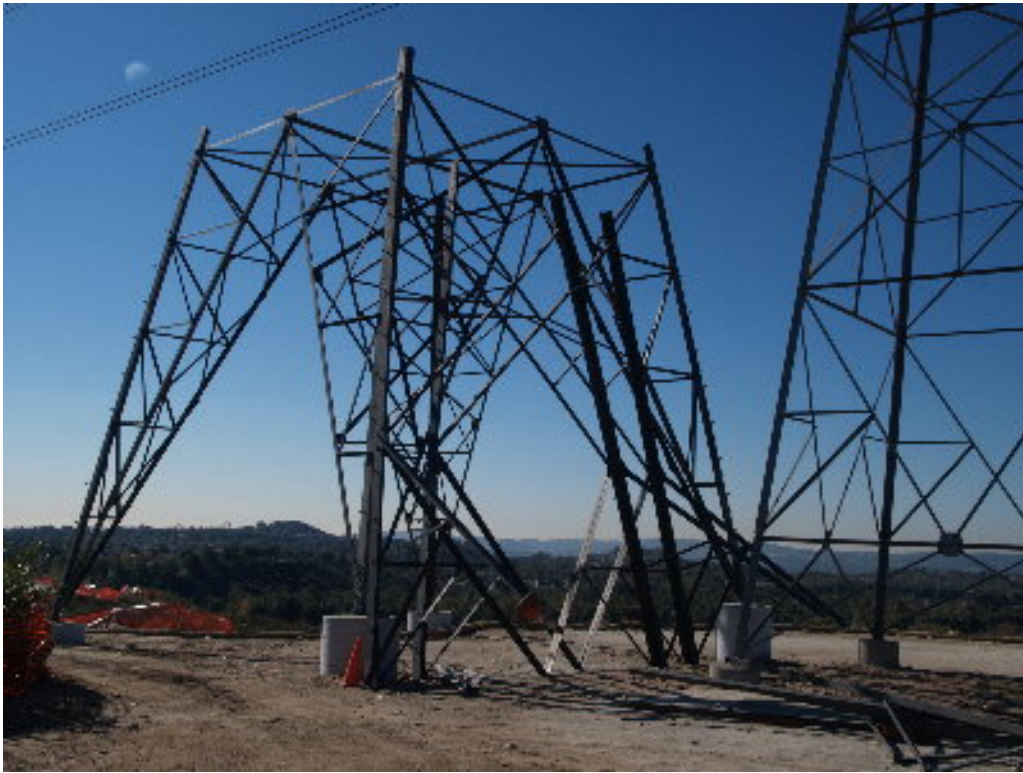
Figure 7 – The upper section of the middle lattice structure on the 220 kV transmission corridor has been assembled and is ready to raise.

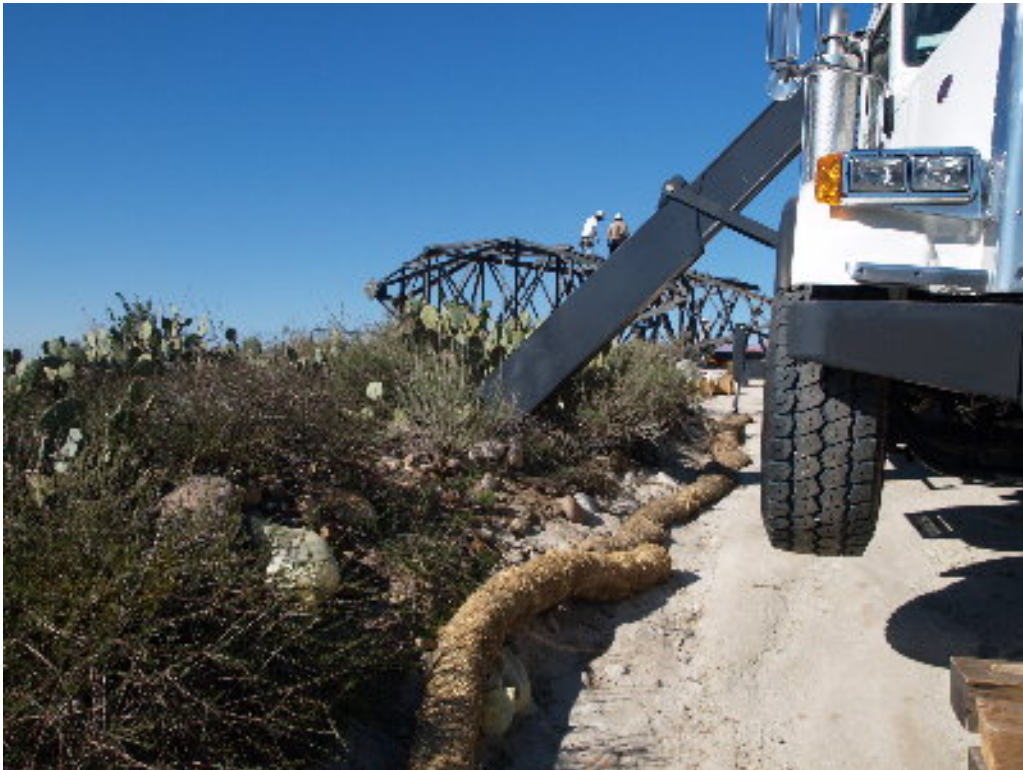
It was noted that one of the crane outriggers was set off the access road and on the vegetation (see Figure 8). The CPUC EM will check with the SCE biologist on this issue.

Figure 8 – A mobile crane outrigger was set off the access road into the vegetation on the 220 kV transmission corridor.
