PROJECT MEMORANDUM SCE – VIEJO SYSTEM PROJECT

To: Jensen Uchida, CPUC
From: Vida Strong, Aspen Project Manager
Date: December 14, 2004
Subject: Weekly Report #19: December 5–11, 2004

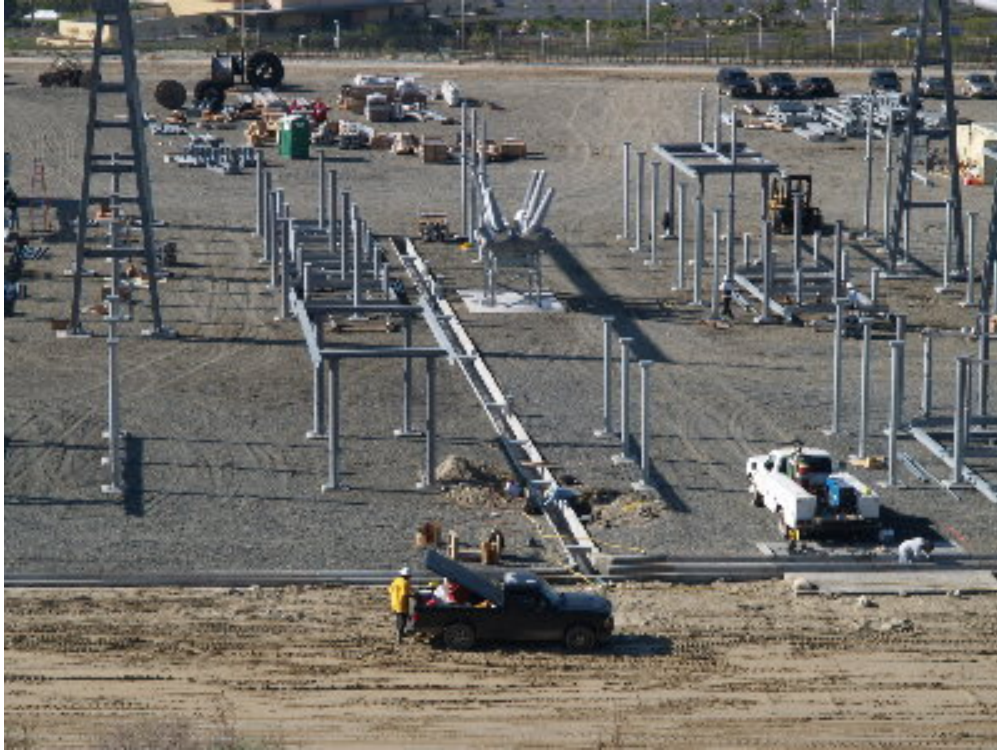
Crews on the southern portion of the substation site worked to tie-in conduits to the pre-cast concrete trench (see Figure 1). The bulk of the work on the substation site during the site visit continued to be at the Mechanical Electrical Engineering Room (MEER) #1. The crew finished pouring section of trenching that will connect the pre-cast concrete trenches with MEER #1 and were finishing the recent pour of the slab (see Figure 2).

Figure 1 – A small crew worked to connect conduits to the pre-cast trench on the southern end of the substation site.

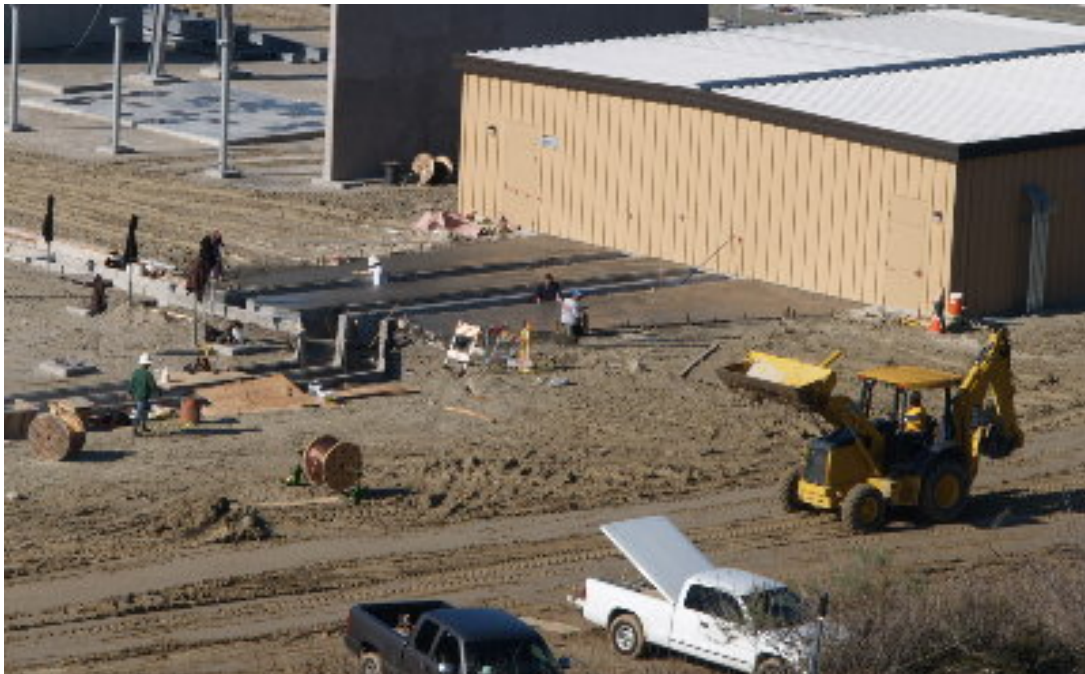
Figure 2 – A larger crew worked on finishing the concrete slab outside the south wall of MEER #1. The backhoe operator worked on maintaining the access road.

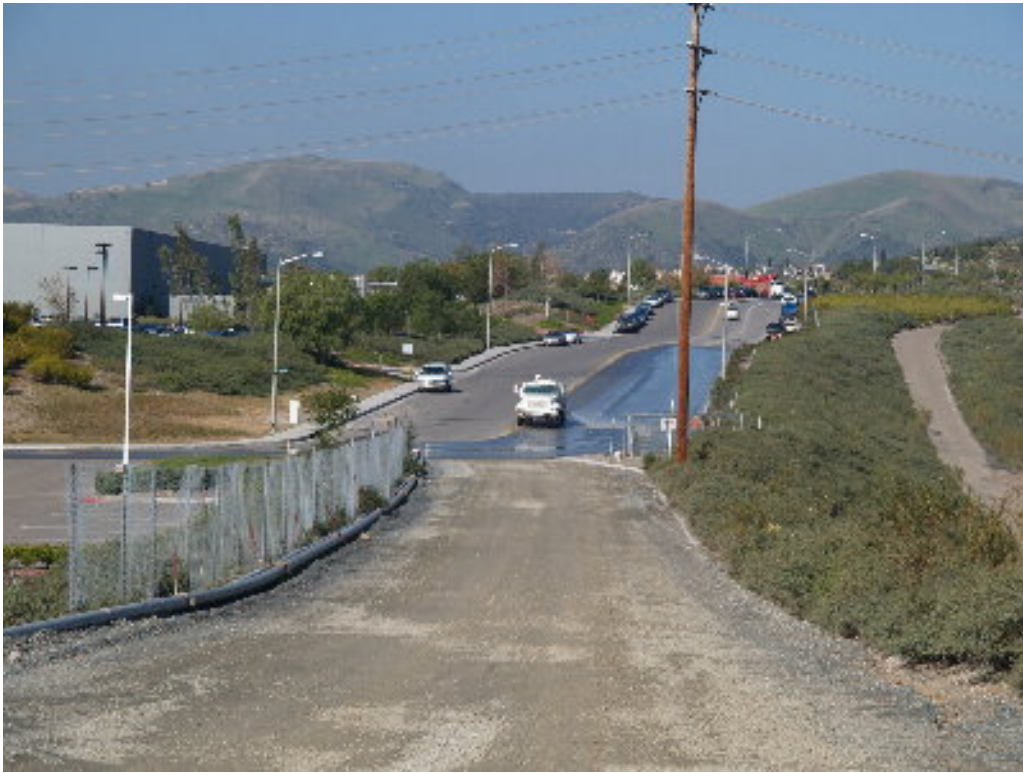
An operator in a backhoe worked to remove ruts in the access road within the substation site and preserve safe access throughout the facility. A small multi-purpose machine was fitted with a sweeper attachment and used to clean the public roads outside the substation site. Once the roads were swept, the water truck was used to wash down any remaining soil tracked from the site (see Figure 3).

Figure 3 – An operator washed down the road after cleaning off the majority of dust and mud with the sweeper.

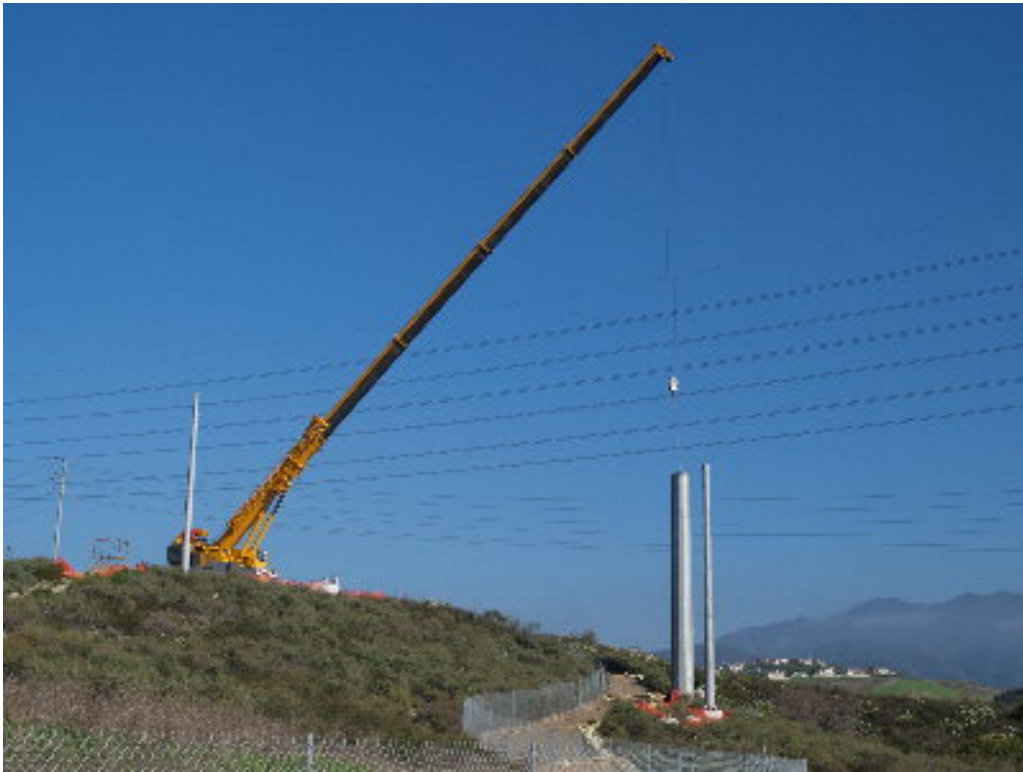
Hill Crane brought a large mobile crane on-site to raise the steel poles on the 220 kV transmission line corridor during the site visit (see Figure 4).

Figure 4 – Hill Crane set the steel pole sections on the foundations southeast of the substation site.

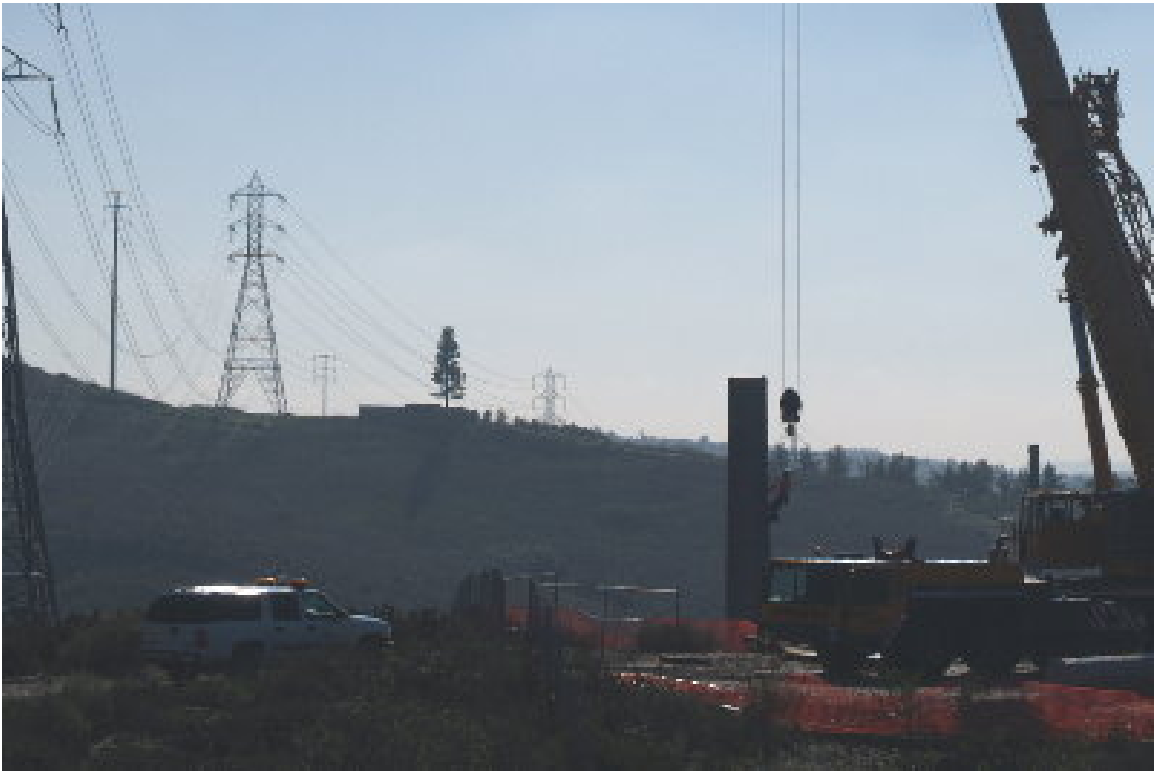
The crane was set up on the pad prepared between the middle and southern lattice towers and was able to reach the pole sections staged in the workspace south of the substation site. Once the lower sections had been set and secured to the foundations, the crew prepared the steel poles for the upper sections (see Figure 5). No other work occurred on the transmission line segment during the site visit. The height of the lattice sections is limited by the clearances required between the structures and the live transmission lines. The scheduled outage has been delayed until the first week of January due to the longer than expected outage at San Onofre Power Plant.

Figure 5 – Workers prepared the steel towers for the upper sections once the lower sections were secured.

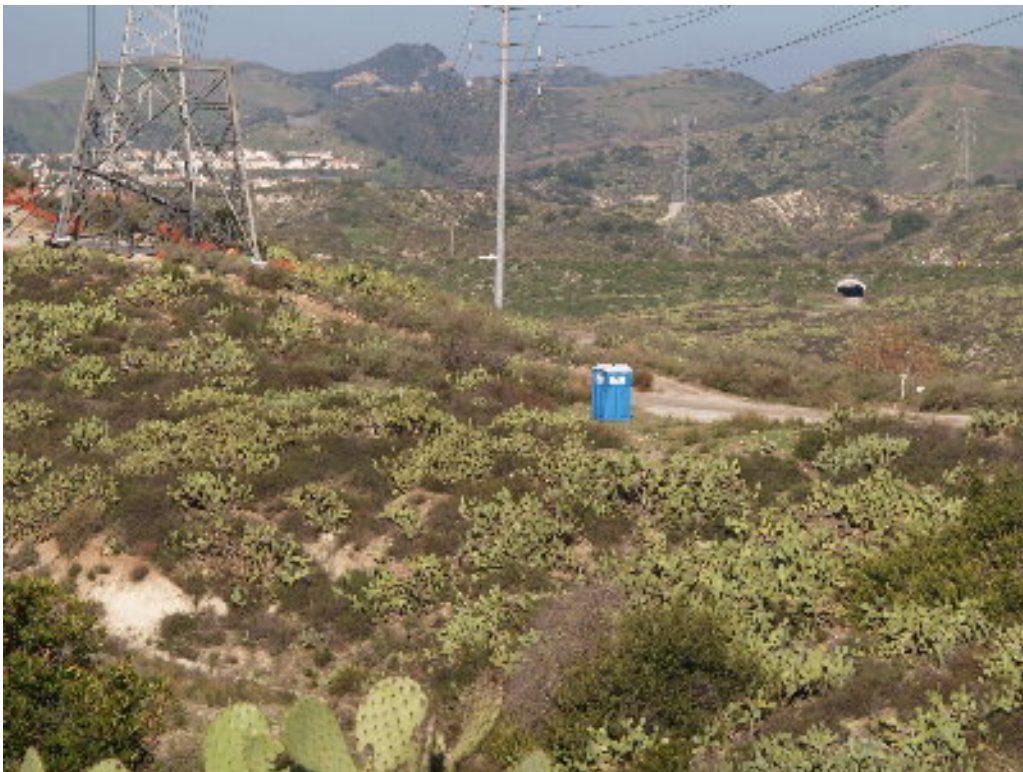
Many of the straw wattles had been moved to the side on the access roads to allow access during construction. The materials were on-site and the contractor was putting them back in place when no work was occurring in case of unexpected rains. No significant erosion or sediment issues were noted on the right-of-way. The BMPs along the edge of the right-of-way have been maintained and left in place. The contractor has not moved the portable toilet away from the hillside to protect against chemicals spilling into the habitat (see Figure 6).

Figure 6 – The chemical toilet is still on the hill over the drainage near the northern lattice structure on the 220 kV transmission corridor.

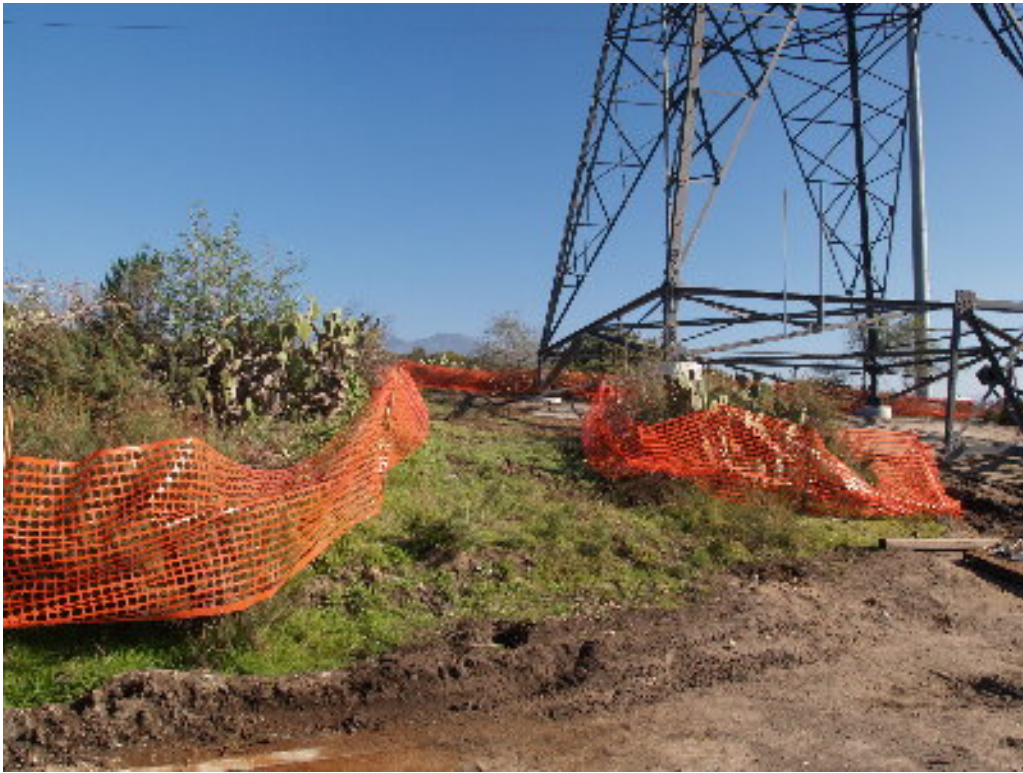
SCE has moved the exclusion fencing near the southern tower location (see Figure 7). The transmission line superintendent needs to move a crane to the north side of the tower to set the eastern lattice sections. The SCE biologist has examined the habitat and will monitor any vegetation clearing. SCE will place plating over the habitat and avoid the mature sage and cactus, using a sparsely vegetated corridor for access.

Figure 7 – The proposed crane access at the lower lattice structure on the 220 kV transmission corridor has been delineated.
