PROJECT MEMORANDUM SCE – VIEJO SYSTEM PROJECT

To: Jensen Uchida, CPUC
From: Vida Strong, Aspen Project Manager
Date: January 4, 2004
Subject: Weekly Report #22: December 26, 2004 – January 1, 2004
CPUC Environmental Monitor (EM): Christopher Meyer

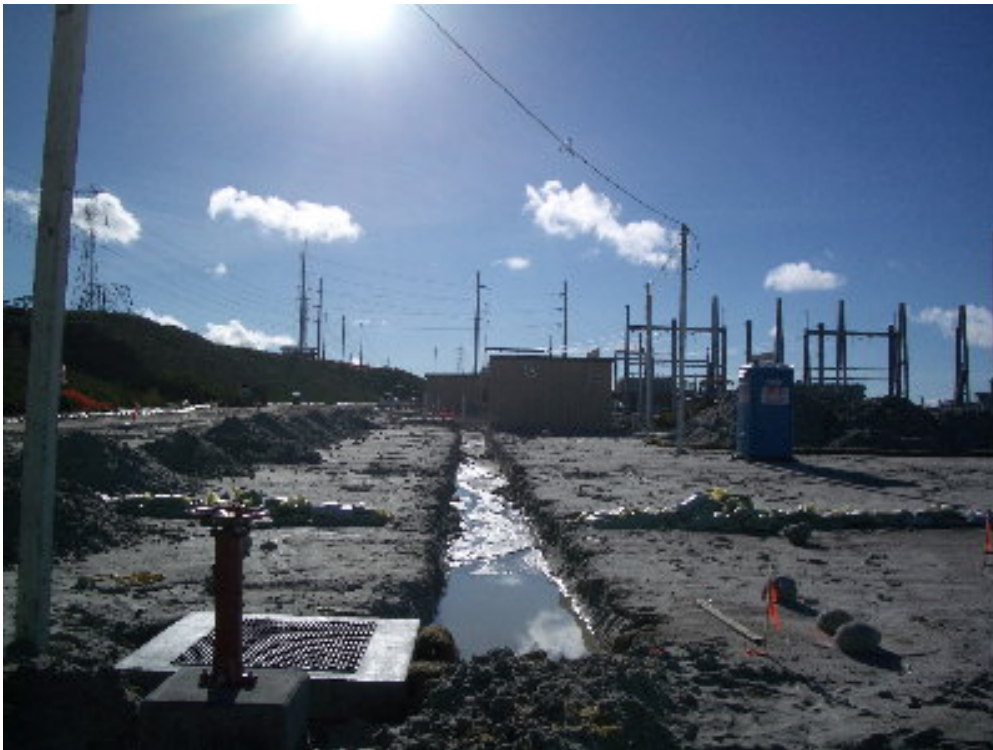
Figure 2 – Recently excavated trenches have filled with storm water.

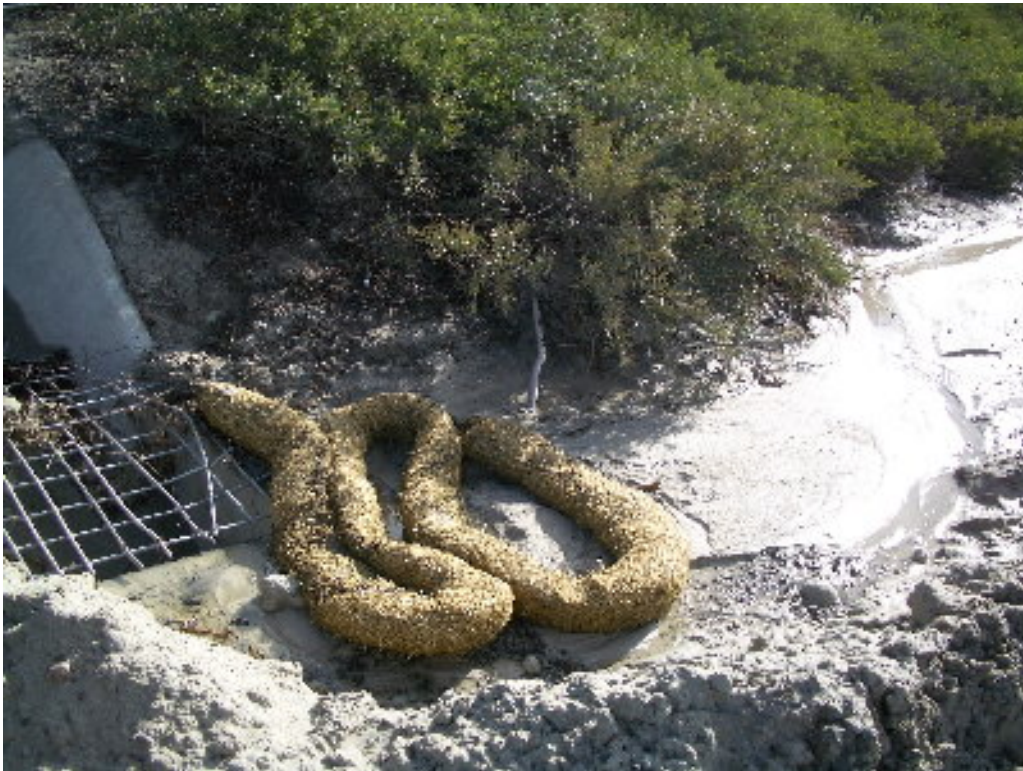
In general, the Best Management Practices (BMPs) installed on the substation site have been installed properly and maintained. However, the sandbags and straw waddles installed on the access road to the substation site were not placed properly, resulting in turbid water entering the storm drain system (see Figure 3). The contractor addressed the issue with the sandbags and straw waddles prior to any comments by the CPUC EM and was actively reviewing storm water issues throughout the site. No other off-site impacts were noted during the site visit and the maintenance of the BMPs appeared to be effective.

Figure 3 – Loose spoils had been placed to direct water into the storm drain without proper sediment control devices in place.

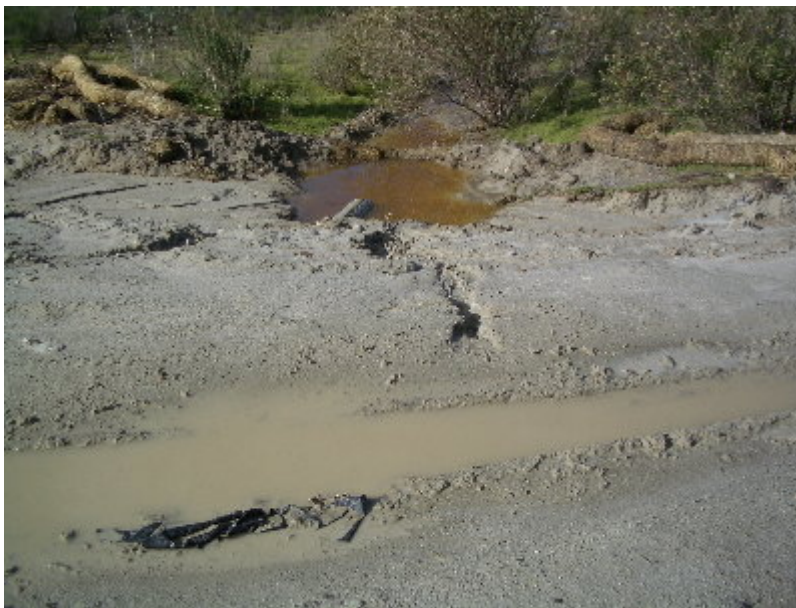
The straw wattles that had been moved to the side on the access roads to allow access during construction were back in place for the recent rains. Three erosion and sedimentation issues were noted on the right-of-way during the site visit. The culvert crossing near the substation back gate needs protection on the downstream side of the road (see Figure 4). Erosion down the west access road has placed sediment into the plated drainage, under the steel plates (see Figure 5). Minor erosion was noted under the southern lattice structure (see Figure 6). One vehicle did use the right-of-way after the roads were saturated from recent rains, leaving ruts for the sediment from the lattice tower erosion to follow back to the drainage. Many of the BMPs along the edge of the right-of-way have been maintained and improved in places. The contractor has moved the portable toilet away from the hillside to protect against chemicals spilling into the habitat.

Figure 4 – BMPs are required at the culvert crossing near the substation back gate.

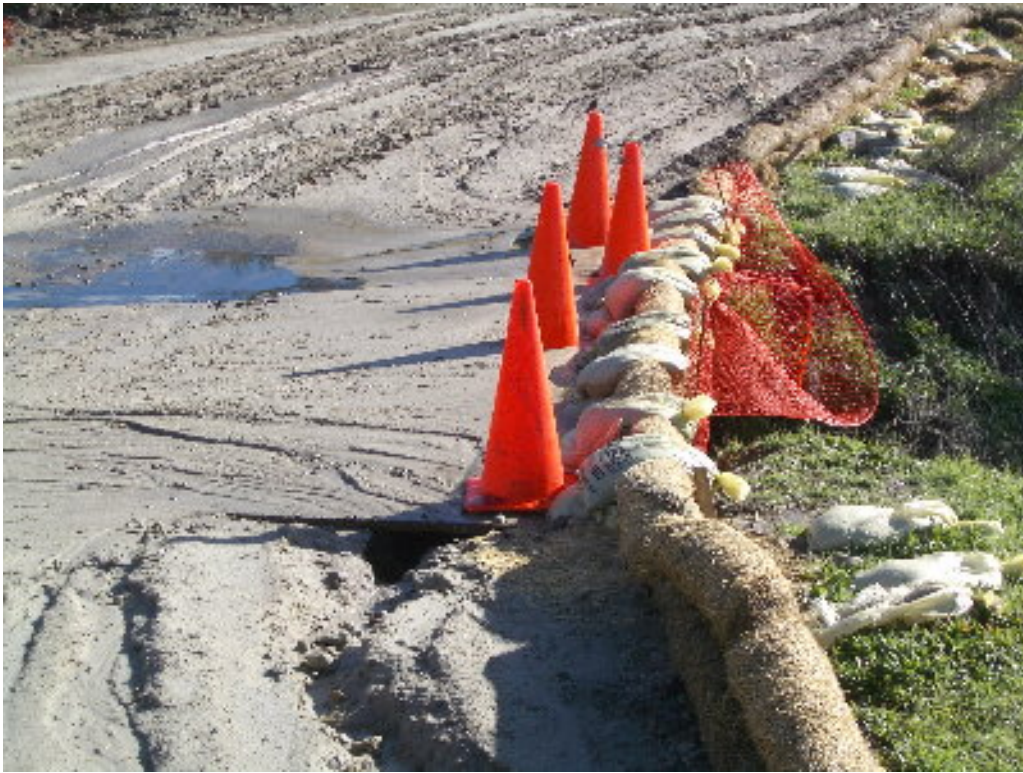
Figure 5 – Erosion from 220 kV access road has bypassed BMPs and sediment has entered the drainage.

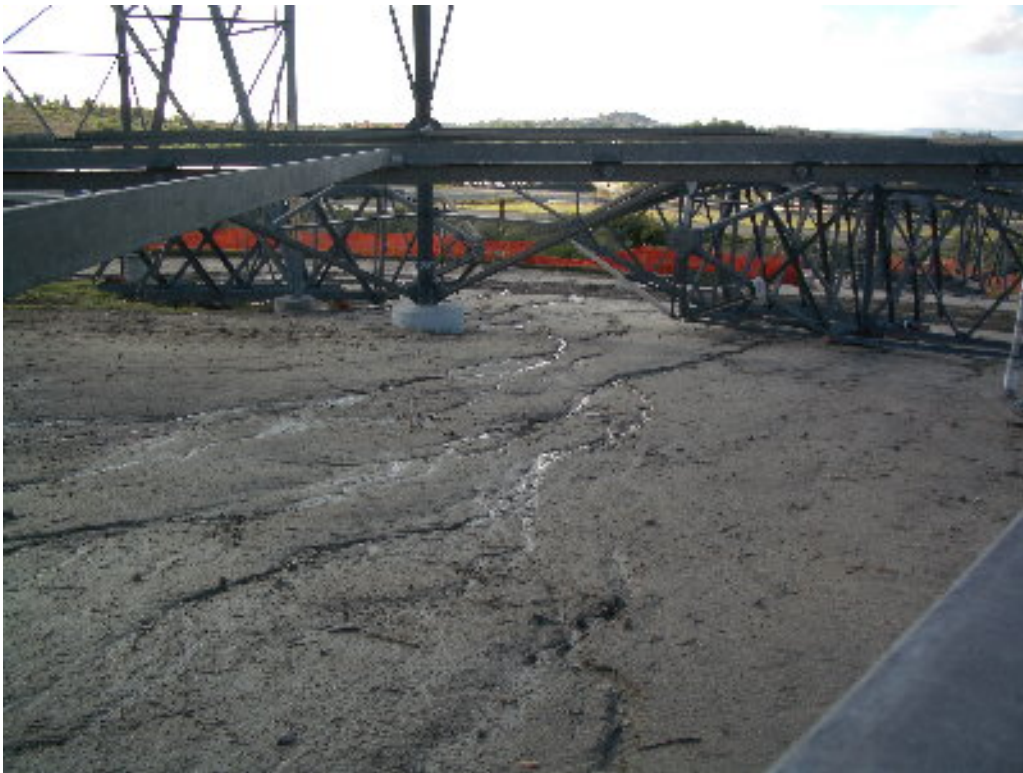
Figure 6 – Minor erosion from the lattice tower pad flowing into the recent vehicle ruts.
