PROJECT MEMORANDUM SCE – VIEJO SYSTEM PROJECT

Subject: Weekly Report #23: January 2, 2005 – January 8, 2005

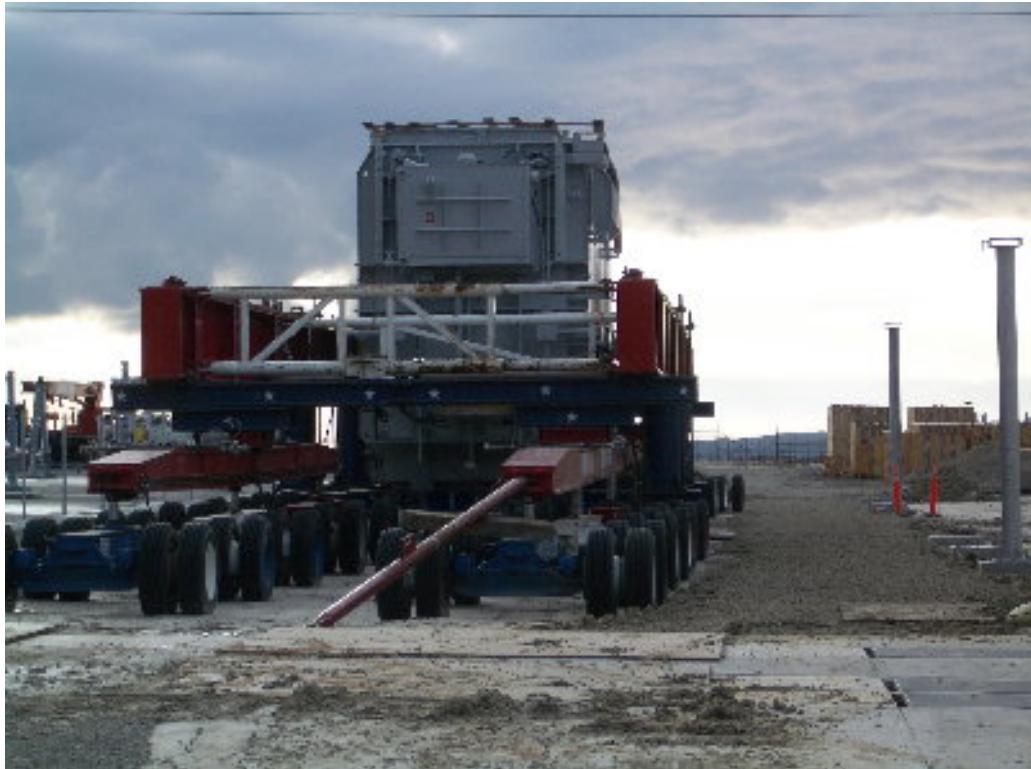
Rock has been spread around the truck holding the second of the A transformers to facilitate setting the transformer once the ground dries (see Figure 1). Additional rock was spread along the access routes around the substation site to address the consistent rain and mud issues. Sandbags and other BMPs on sections of the substation site were removed to provide room for spreading the rock and will be back in place for the predicted rains.

Figure 1 – Crews have spread rock around the truck holding the second A transformer and will set it onto the pad after the predicted rain.

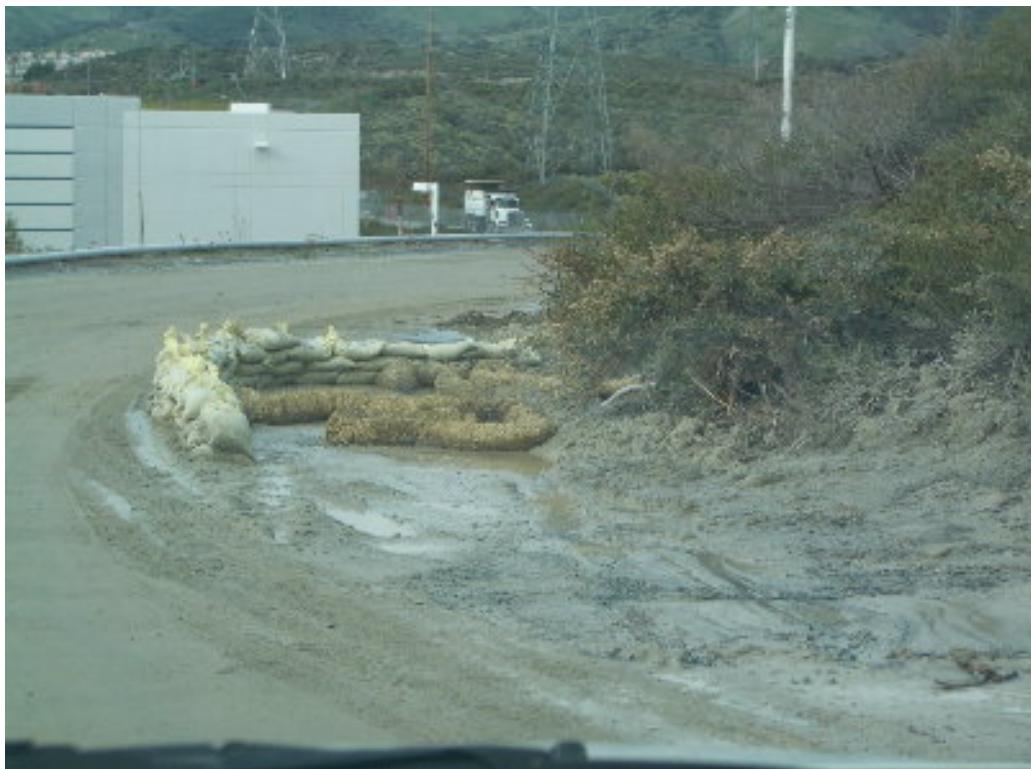
In general, the Best Management Practices (BMPs) installed on the substation site have been installed properly and maintained. The sandbags and straw waddles installed on the access road to the substation site were repaired following the recent heavy rains (see Figure 2). The CPUC EM informed SCE that the public right-of-way outside the substation site needs to be cleaned as soon as the rock delivery has been completed, or prior to any rain (see Figure 3). No other off-site impacts were noted during the site visit and the maintenance of the BMPs appeared to be effective.

Figure 2 – The BMPs at the storm drain on the access road were repaired.

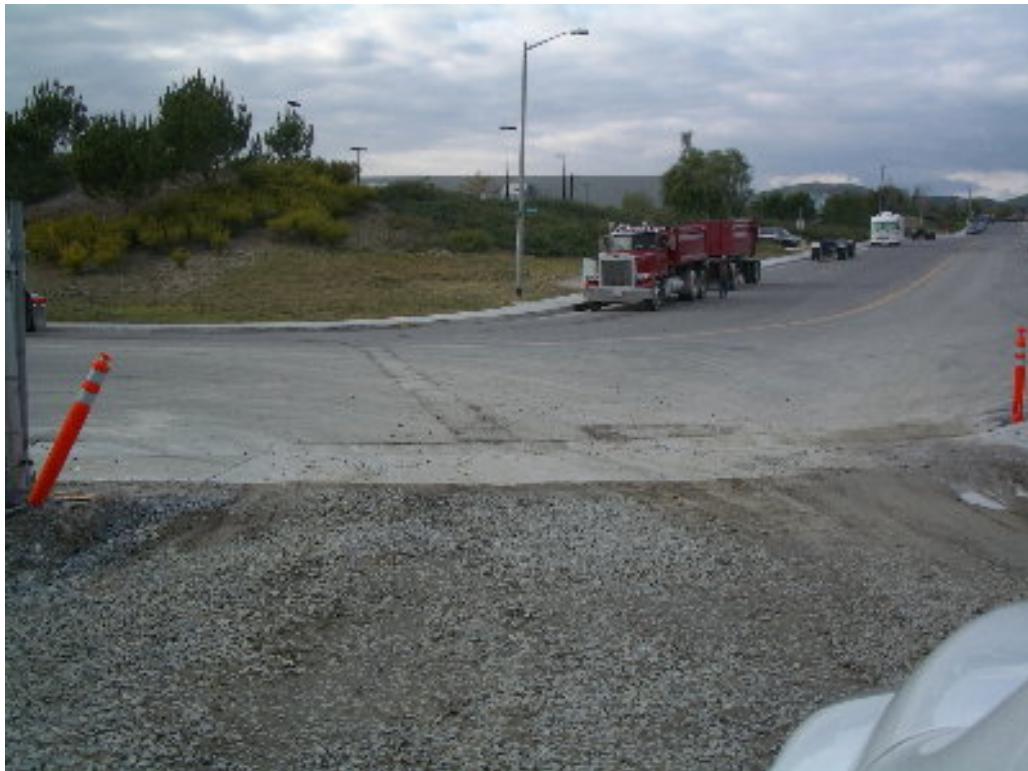
Figure 3 – Material tracked onto the public right-of-way will be cleaned prior to the predicted rains.

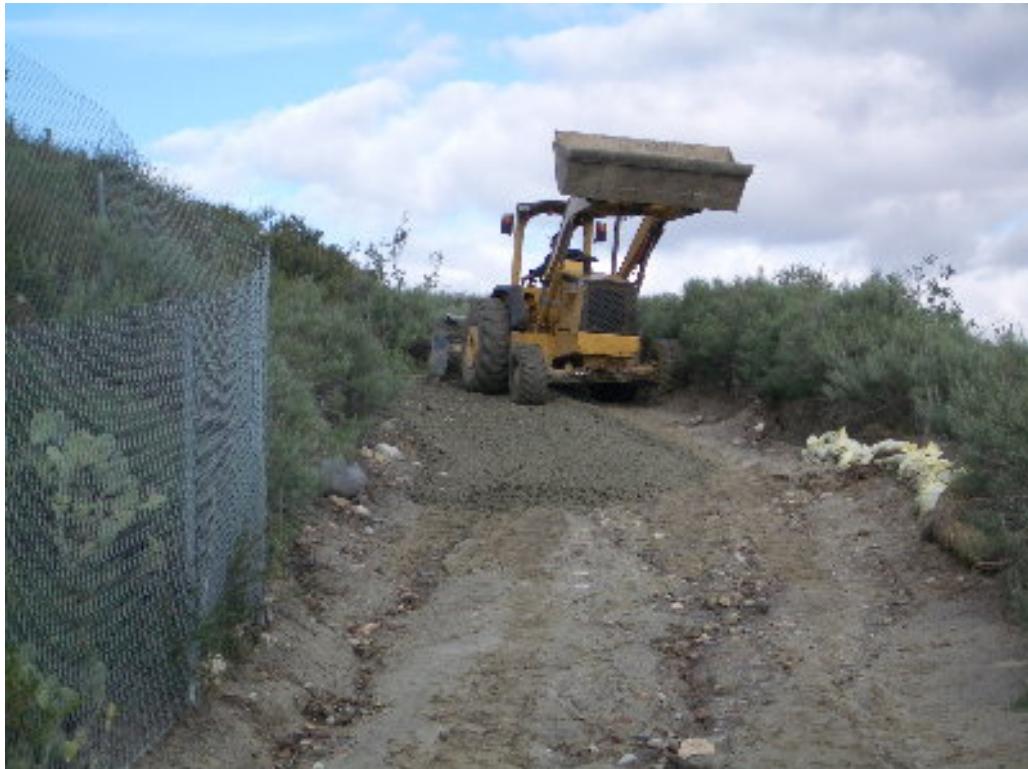
Crews worked to place rock on the access roads for the 220 kV transmission line in preparation for the planned outage (see Figure 4). Once the rock was down, trucks brought in materials for stringing line during the outage. An operator worked with a backhoe to cut the pad for the Bronto man-lift on the western access road (see Figure 5).

Figure 4 – Rock was spread on the 220 kV access road to address erosion and provide all-weather access.

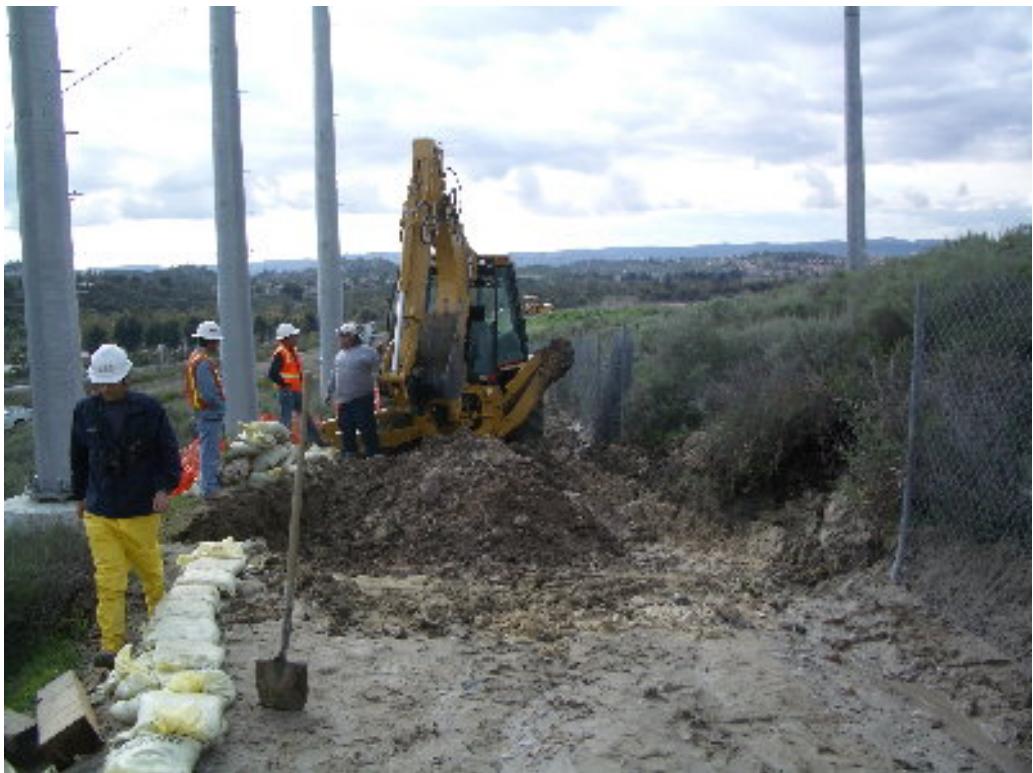
Figure 5 – A crew prepared the pad for the Bronto man-lift under the supervision of the LSA EI.

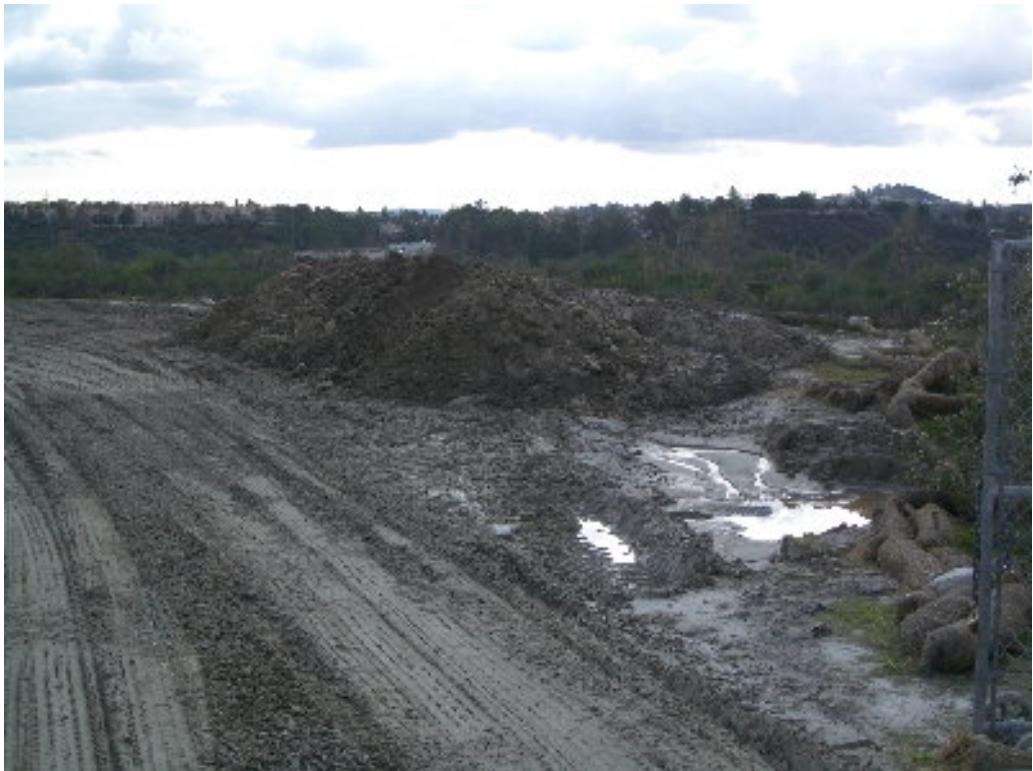
The straw waddles that had been moved to the side on the access roads to allow access during construction were back in place for the recent rains. The placement of rock addressed the erosion and sedimentation issues that were noted on the previous site visit. The culvert crossing near the substation back gate still needs protection on the downstream side of the road and wet spoils from the road work were set near the drainage (see Figure 6). The LSA EI was on-site watching the road and excavation activities and spoke with an operator about encroaching on the habitat. The CPUC EM informed the LSA EI that the spoil pile at the culvert needs to be moved or stabilized and the downstream side of the culvert protected.

Figure 6 – The spoil pile needs to be addressed and BMPs are required at the culvert crossing near the substation back gate.
