## **PROJECT MEMORANDUM SCE – VIEJO SYSTEM PROJECT**

**To:** Jensen Uchida, CPUC  
**From:** Vida Strong, Aspen Project Manager  
**Date:** February 16, 2005  
**Subject:** Weekly Report #28: February 6, 2004 – February 12, 2005  
**CPUC Environmental Monitor (EM):** Christopher Meyer

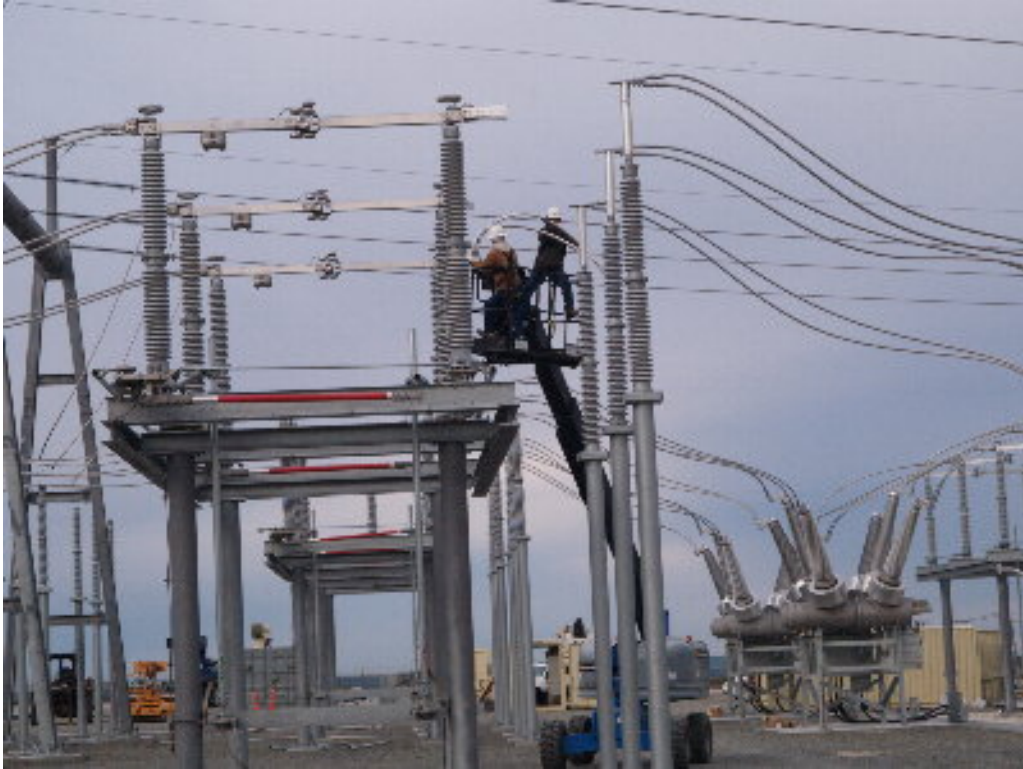
1. NRG crews worked on the 66 kV cable and disconnect switches, as well as circuit breakers during the subject week. Crews with NRG also worked on the disconnect switch, bypasses, and circuit breaker on the 220 kV section of the substation (see Figure 1). A NRG crew worked with a small mobile crane to set steel in the 220 kV section of the substation.

**Figure 1** – A small NRG crew worked on the 220 kV bypasses.

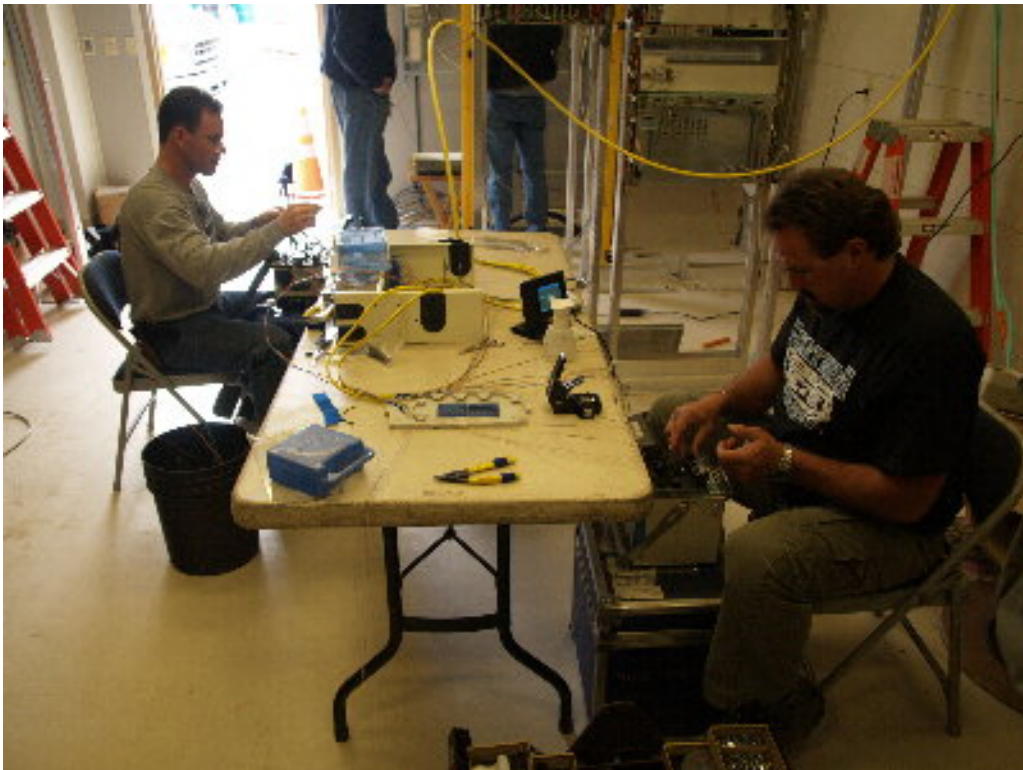
3. The Mechanical Electrical Engineering Room (MEER) contractor, EMSS, continued on wiring the 19-inch racks within MEER #1. The crew from the SCE Testing and Maintenance section continued testing the 66 kV and 220 kV equipment within MEER #1. The fiber optic contractor worked to splice the fiber optic in MEER #1 (see Figure 2).

**Figure 2** – The fiber optic contractor worked on splicing within MEER #1.

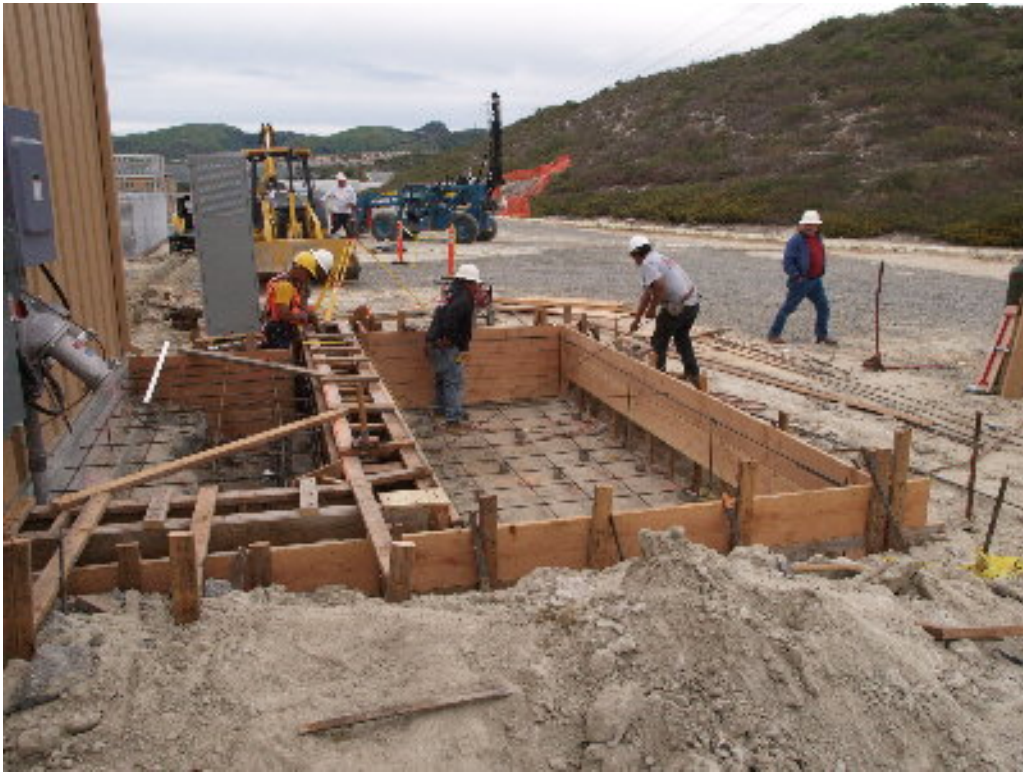
4. A crew with Kindness worked to frame a new trench for cables entering MEER #1 after the previous conduit bank was insufficient to handle the amount of cables entering the building (see Figure 3).

**Figure 3** – Kindness worked on the cable trench entering MEER #1. The trench will replace the conduit that was too small for the number of cables entering MEER #1.

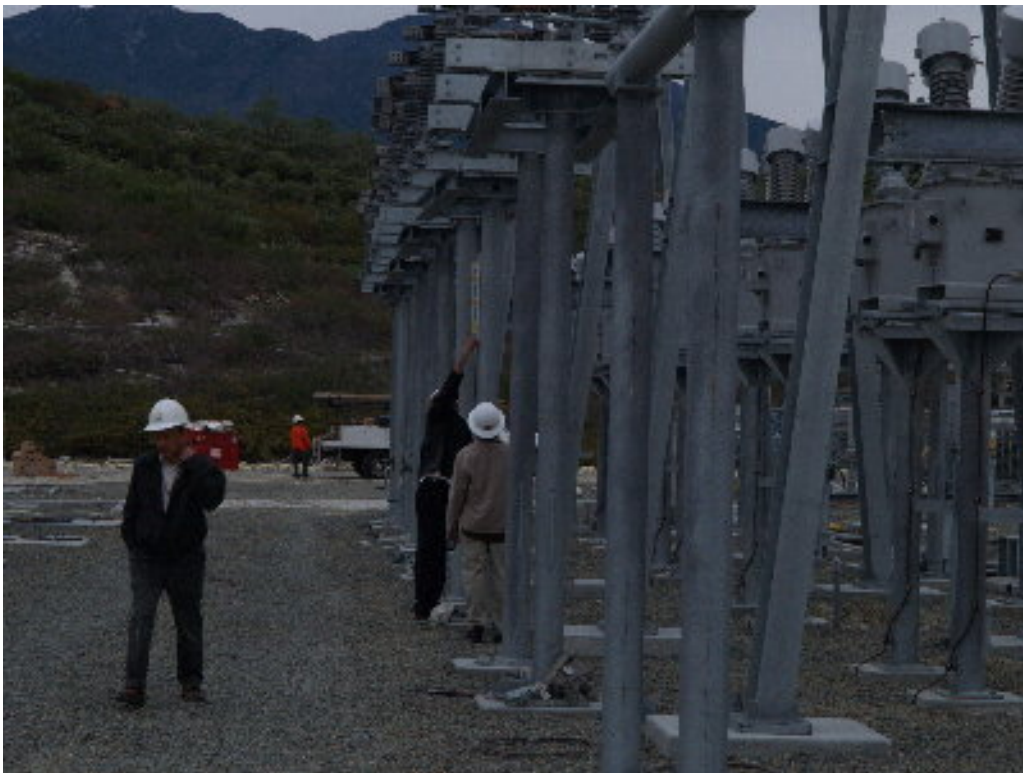
5. Engineers with SCE reviewed the steel poles erected on the 66 kV section of the substation site (see Figure 4). The welds at the base of the poles are off, causing the poles to be out of plumb. The problem is not anticipated to affect the structural integrity of the poles.

**Figure 4** – Engineers reviewed the poles that were out of plumb due to fabrication errors.

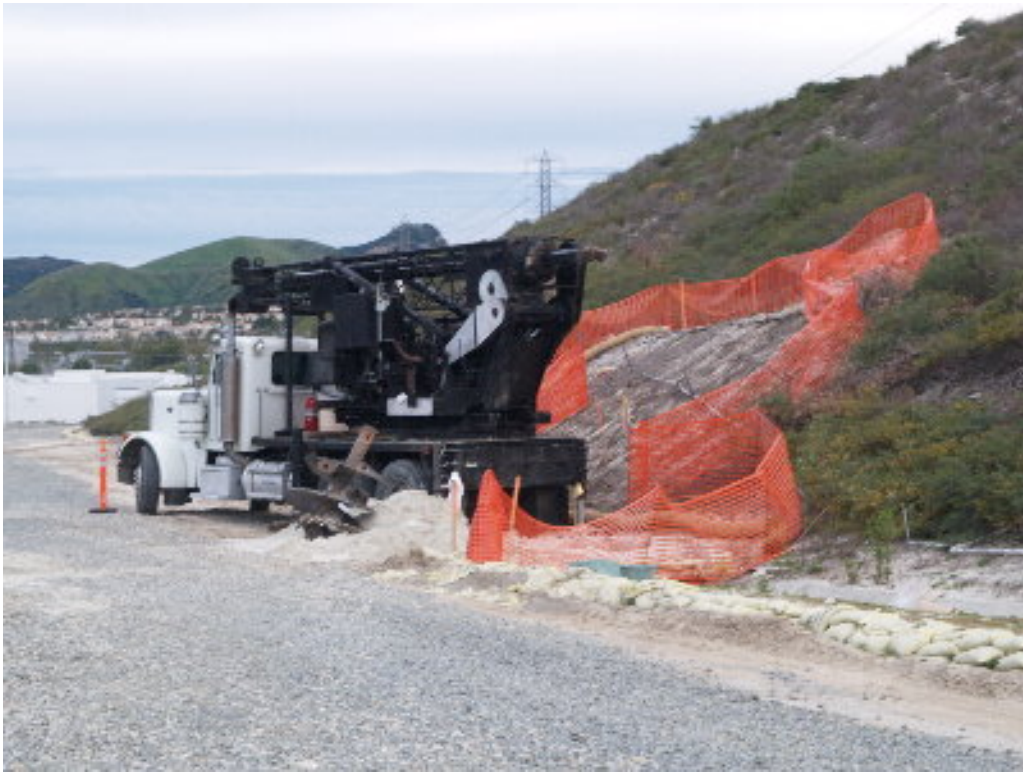
1. The SCE transmission line contractor excavated the foundations for the 66 kV steel poles within the substation site (see Figure 5). The crew followed the same procedure as the drilling contractor for the steel support foundations within the substation site, but with a larger diameter excavation.
2. Once the foundations had been excavated, the rebar cages and anchors bolts were placed in preparation for the concrete pour.
3. The civil contractor for the 66 kV transmission right-of-way worked to construct the pads and access roads for the permanent and temporary poles leaving the substation site. The crew used a small bulldozer and a backhoe to create the pad for the pad and a front-end loader to import spoils to build up the pad (see Figure 6). A geologist was on-site to test the compaction of the pad during construction and after completion.

**Figure 5** – The drilling contractor worked to excavate the foundation for the 66 kV poles.

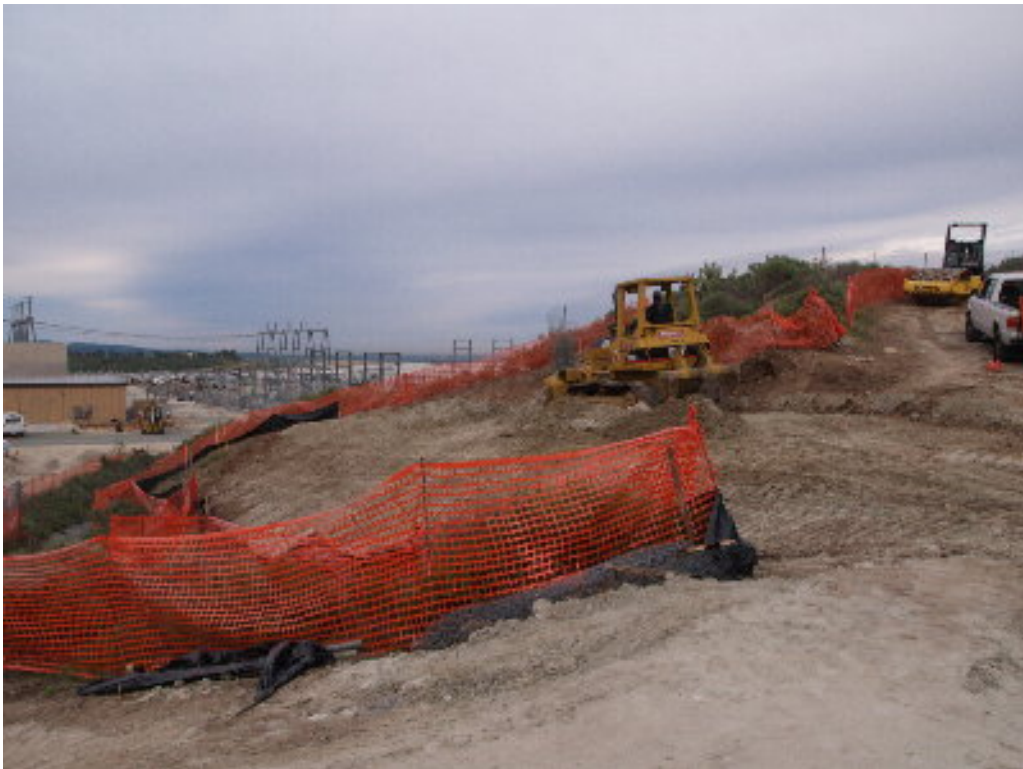
**Figure 6** – A small bulldozer was used to cut the pad for the 66 kV pole.

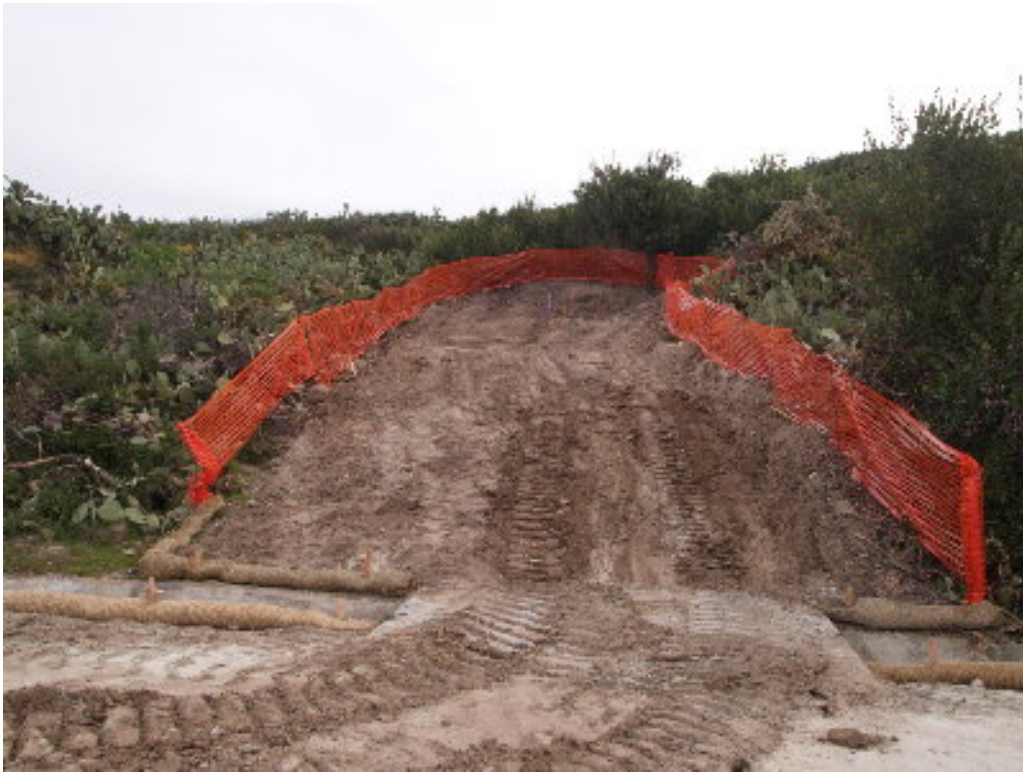
The CPUC EM reviewed concerns over the placement and installation of BMPs on the 66 kV right-of-way with the SCE Biologist. Many of the BMPs would not stop sediment from leaving the construction area or were installed parallel to the slope (see Figure 7).

**Figure 7** – The BMPs originally installed on the 66 kV right-of-way will need improvement to handle the predicted rain events.
