PROJECT MEMORANDUM SCE – VIEJO SYSTEM PROJECT

To: Jensen Uchida, CPUC
From: Vida Strong, Aspen Project Manager
Date: February 24, 2005
Subject: Weekly Report #29: February 13 – February 19, 2005.
CPUC Environmental Monitor (EM): Christopher Meyer

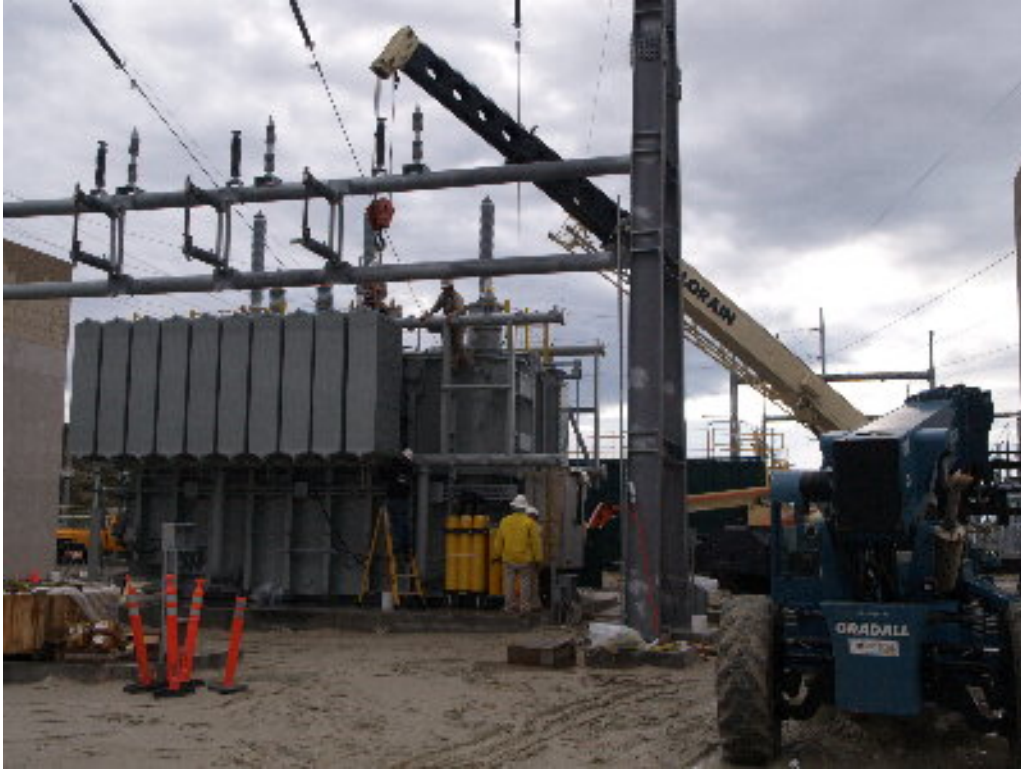
Figure 1 – A SCE crew worked to install the external cooling fins on the A-bank transformers.

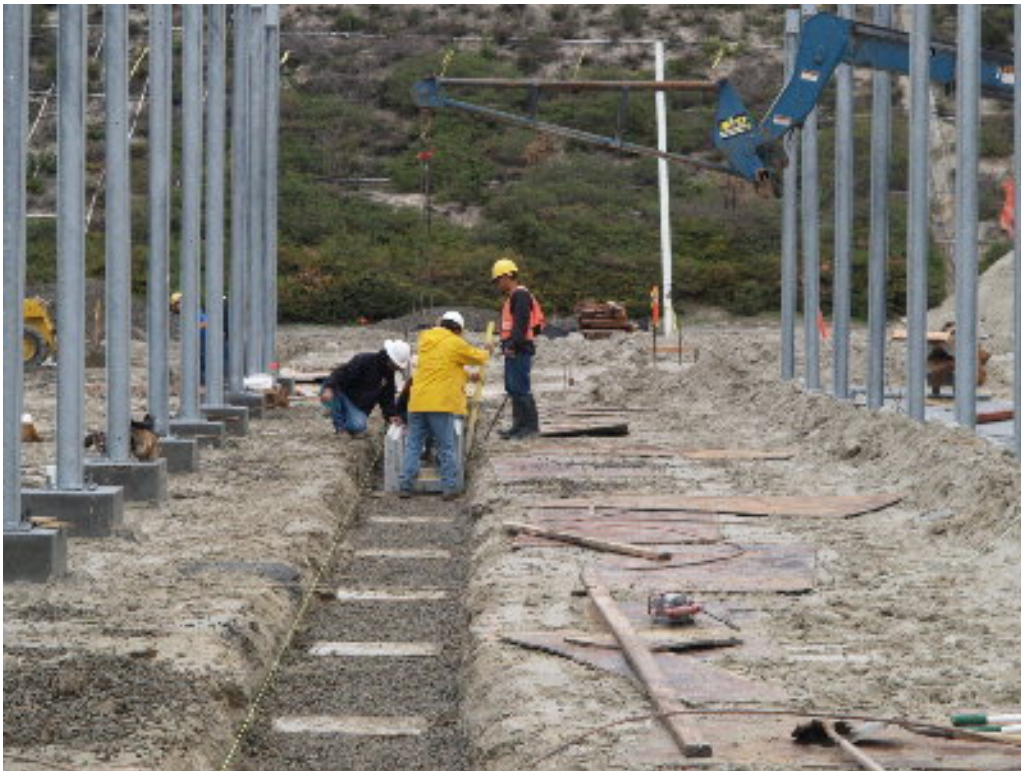
Figure 2 – The Kindness crew worked to place and adjust the pre-formed concrete trenches for the 12 kV section of the substation.

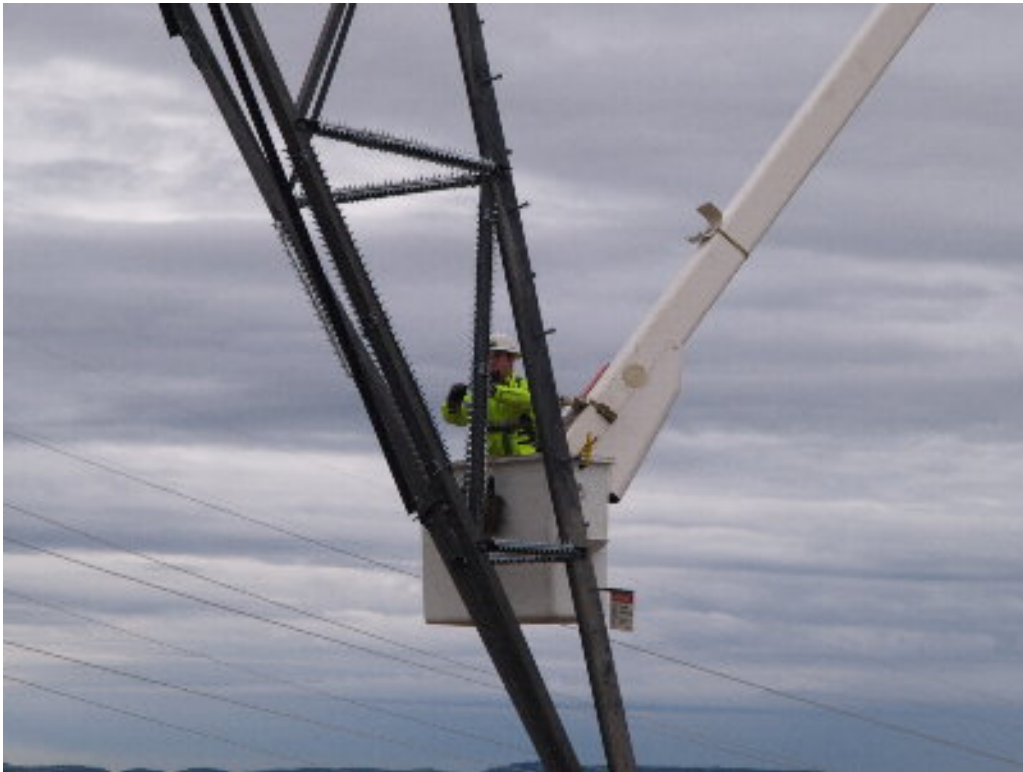
Figure 3 – The 220 kV construction contractor worked to install climbing deterrents on the lattice towers.

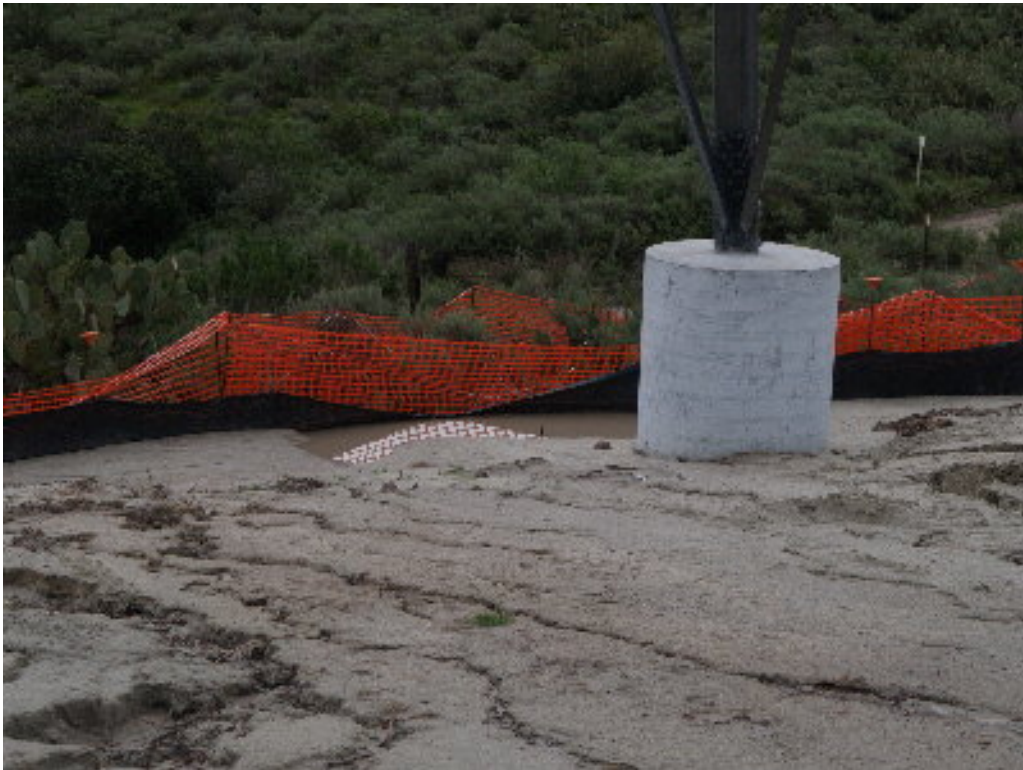
Although additional BMPs have been installed on the 220 kV transmission line right-of-way, maintenance has not occurred since the last storm event. The silt fencing that has been installed around the northern structure is full of sediment (see Figure 4). The straw waddles are also overwhelmed with silt is several locations on the 220 kV segment. The CPUC EM reviewed the issues in the field with SCE and issued a verbal warning on BMP installation and maintenance.

Figure 4 – The silt fencing on the 220 kV transmission line corridor was overwhelmed in several places and requires maintenance.

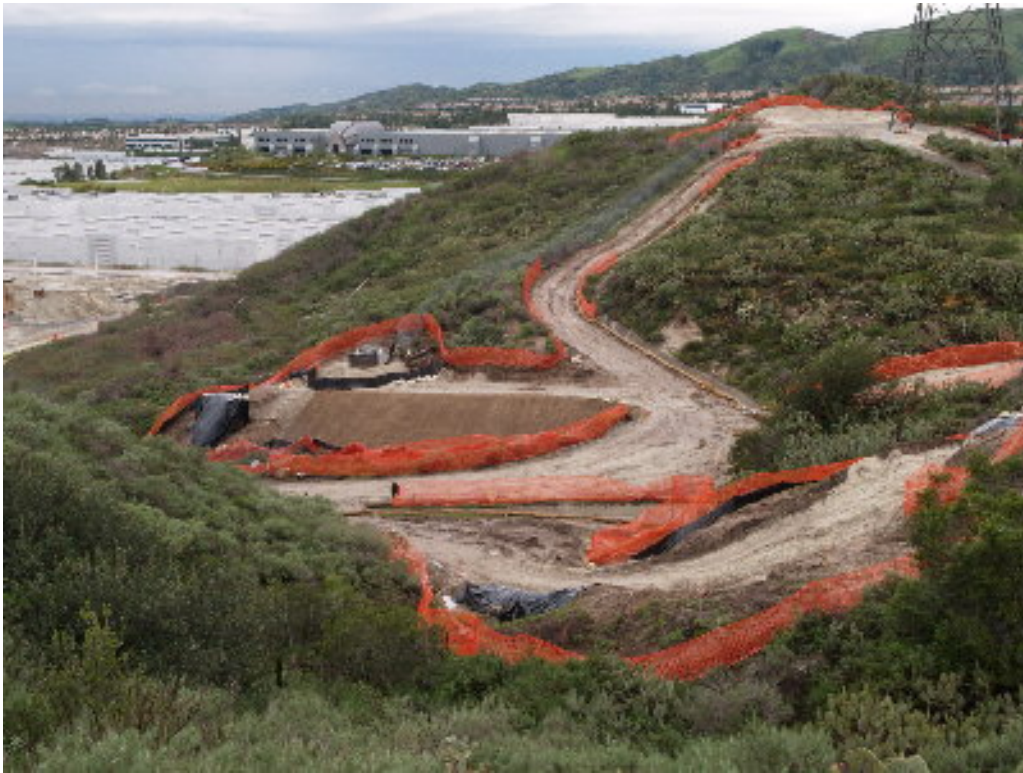
Figure 5 – Pads have been graded and one foundation poured on the 66 kV transmission line corridor.

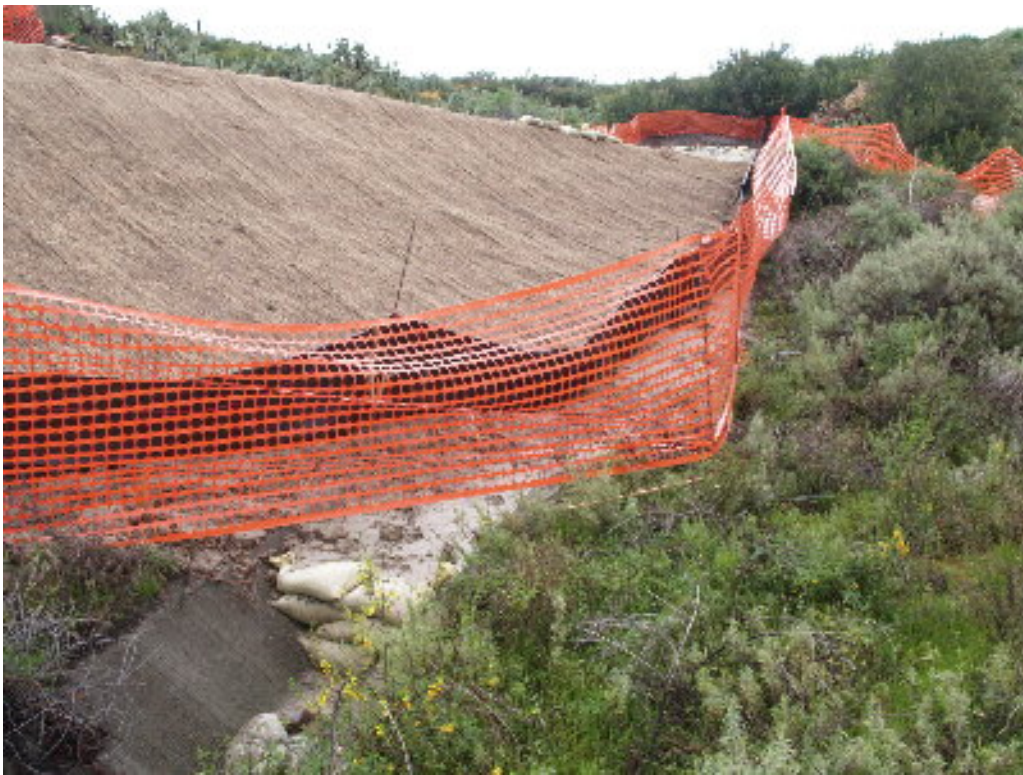
The CPUC EM reviewed concerns over the placement and installation of BMPs on the 66 kV right-of-way with the SCE contractor. Many of the BMPs stopped sediment from leaving the construction area; however, some were installed parallel to the slope and others need maintenance (see Figure 6). The contractor dispatched the workers on-site to maintain the BMPs and improve the BMPs that were installed parallel to the slope.

Figure 6 – The BMPs originally installed on the 66 kV right-of-way will need improvement to handle the predicted rain events.
