PROJECT MEMORANDUM SCE – VIEJO SYSTEM PROJECT

To: Jensen Uchida, CPUC
From: Vida Strong, Aspen Project Manager
Date: April 6, 2005
Subject: Weekly Report #35: March 27 – April 2, 2005.
CPUC Environmental Monitor (EM): Christopher Meyer

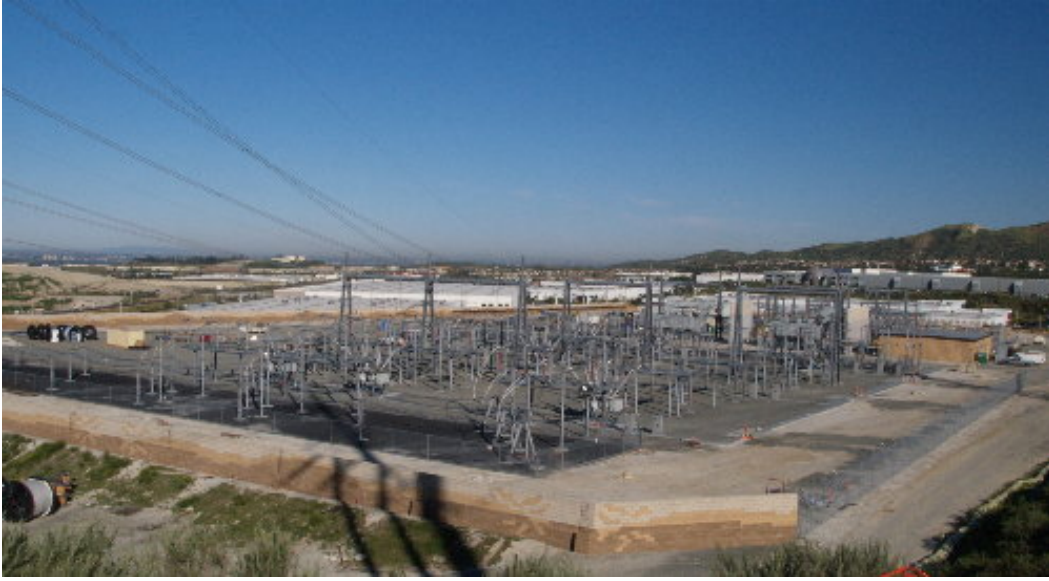
Summary of Activity: Limited activity was occurring at the substation site during the site visit due to late work performed by NRG the previous shift (see Figure 1). NRG worked late to prepare for the energization of the 220 kV section of the substation and the crews were on a rest period during the site visit. The crews returned later in the day after having the required time off between shifts. The following activities were observed during the site visit:

Figure 1 – Overview of the substation site as of April 1, 2005. Only limited work was occurring on the substation site during the site visit.

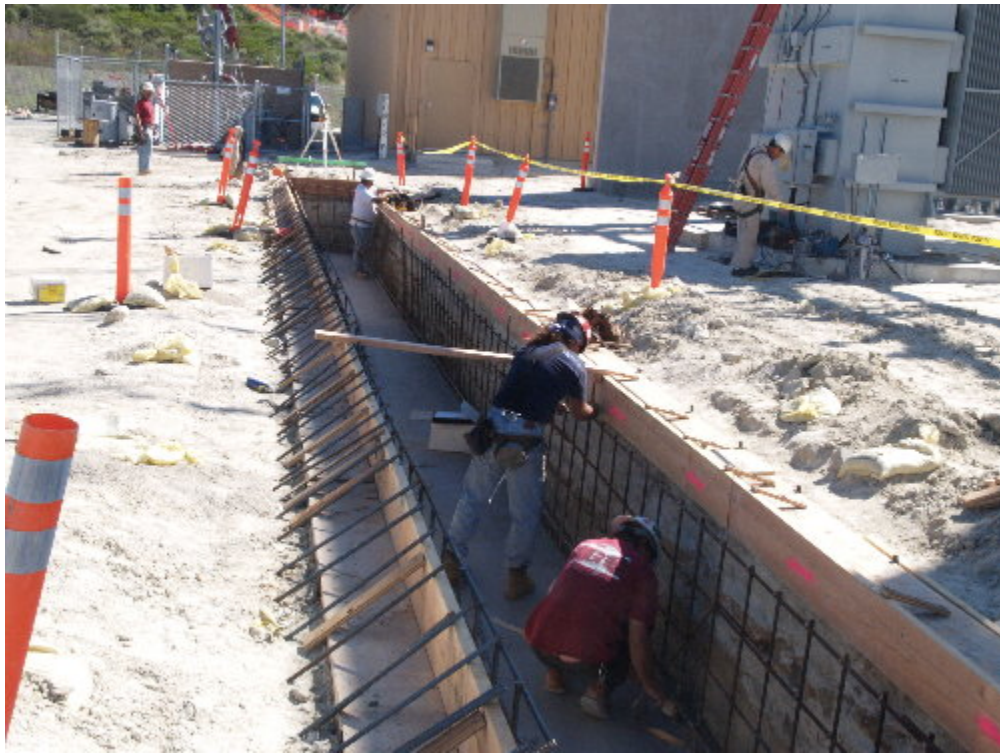
1. Work continued on the main trench running east-west, dividing the 220 kV and 66 kV sections of the substation site. The crew worked to attach an extension to the rebar cage in order to have the proper distance from the top of the rebar cage to the surface of the concrete (see Figure 2).

Figure 2 – Crews worked on the rebar cage for the concrete trench west of MEER #1.

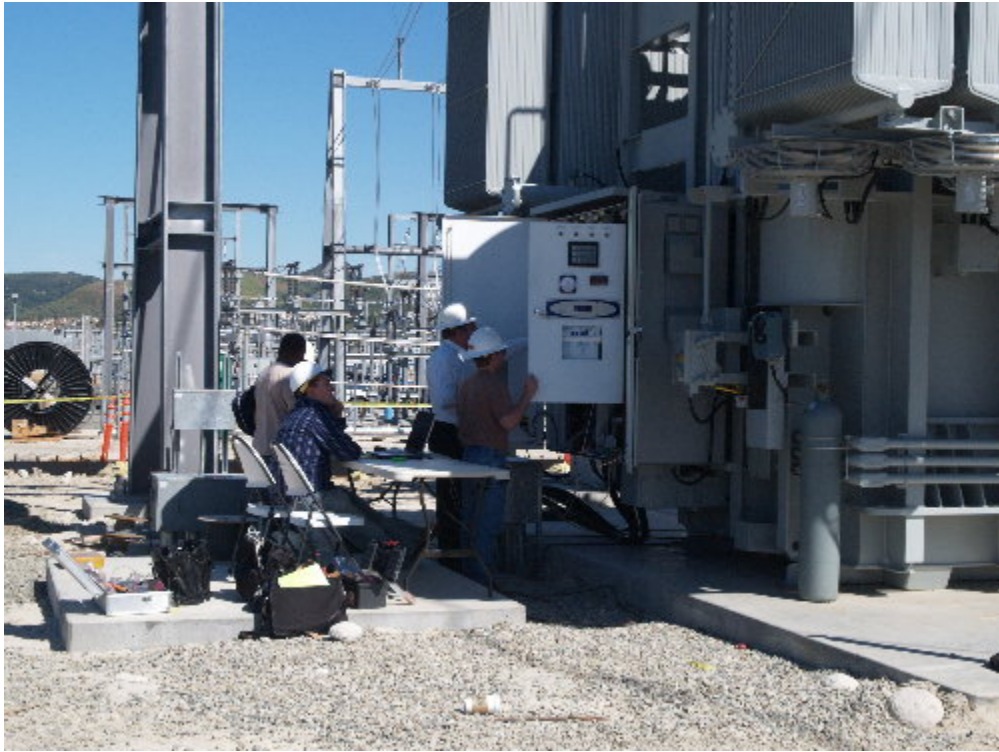
2. Testing crews worked on the A-bank transformers to test the function of the cooling and other systems (see Figure 3).
3. Reycon continued working on the block wall on the northern side of the station during the site visit. The cap has been placed on the top of the along the southern and western sides. Reycon also worked to set the blocks for the spill wall on the north side of the substation site. The spill wall will be coated and will block any spilled petroleum from reaching the drainage system.

Figure 3 – Testing crews worked to check the various functions of the A-bank transformers prior to operation.

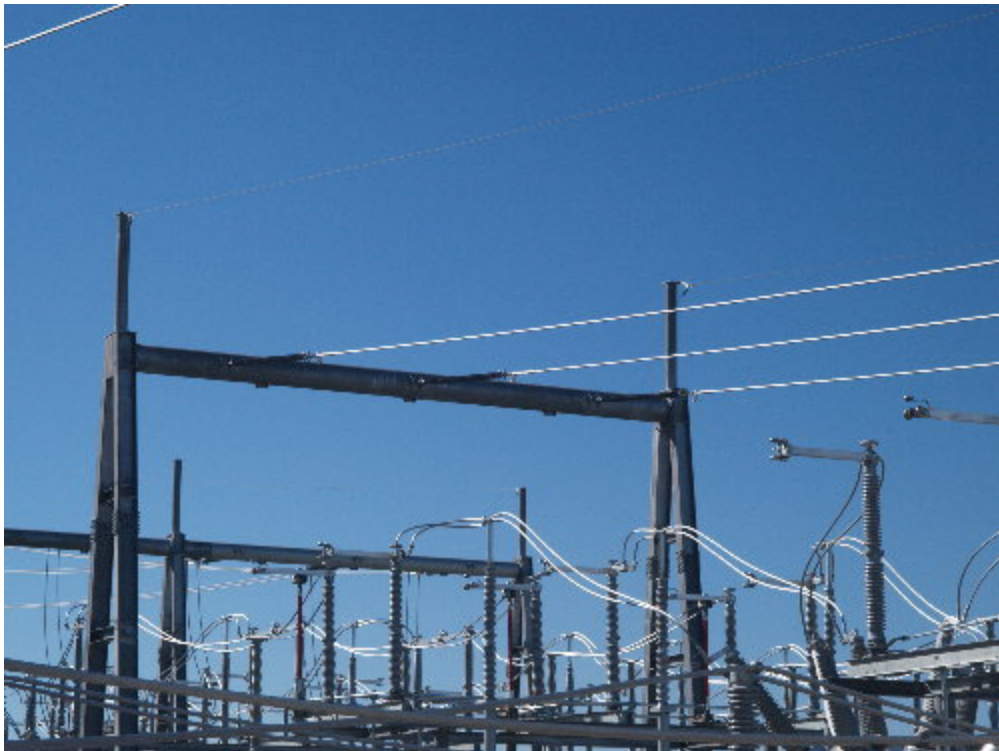
4. The Union crew has prepared the foundation forms for the second gate, but it has not been poured.
5. The 220 kV circuits from the risers to the 220 kV section of the substation site have been removed as a safety measure when the 220 kV portion of the substation site is energized (see Figure 4). The 220 kV section of the substation site will be marked off with caution tape when energized and the disconnection of the circuit will allow crews to work safely in the 66 kV and 12 kV sections of the substation site. With the completion of the majority of the civil work, the remaining crews at the substation site have experience working in energized stations. SCE provided the CPUC EM with an orientation on visiting an energized station.

Figure 4 – The circuits on the risers connecting the 220 kV portion to the rest of the substation site have been removed for safety.

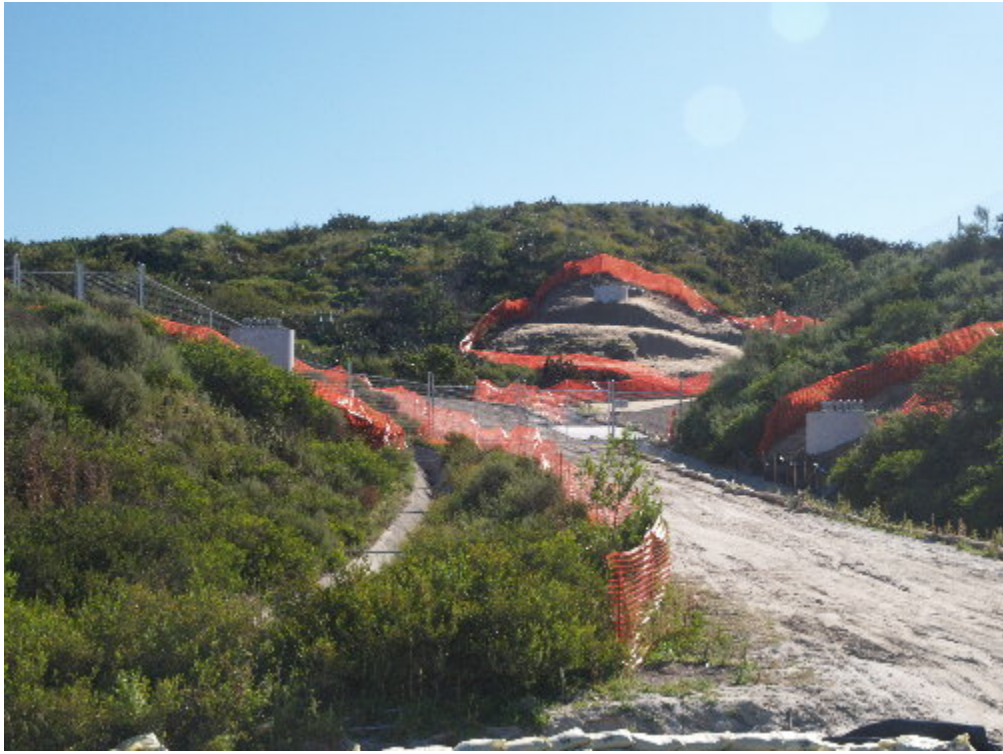
The NTP for the 66 kV work within the City of Lake Forest was issued on February 1, 2005. The fence on the hillside between the substation site and the habitat conservation area has been replaced (see Figure 5). This was completed by the time of the site visit and no other work occurred on the 66 kV transmission line segment during the site visit.

Figure 5 – The cyclone fence on the hillside above the substation site was replaced.
