PROJECT MEMORANDUM SCE – VIEJO SYSTEM PROJECT

To: Jensen Uchida, CPUC
From: Vida Strong, Aspen Project Manager
Date: April 13, 2005
Subject: Weekly Report #36: April 3 – April 9, 2005.
CPUC Environmental Monitor (EM): Christopher Meyer

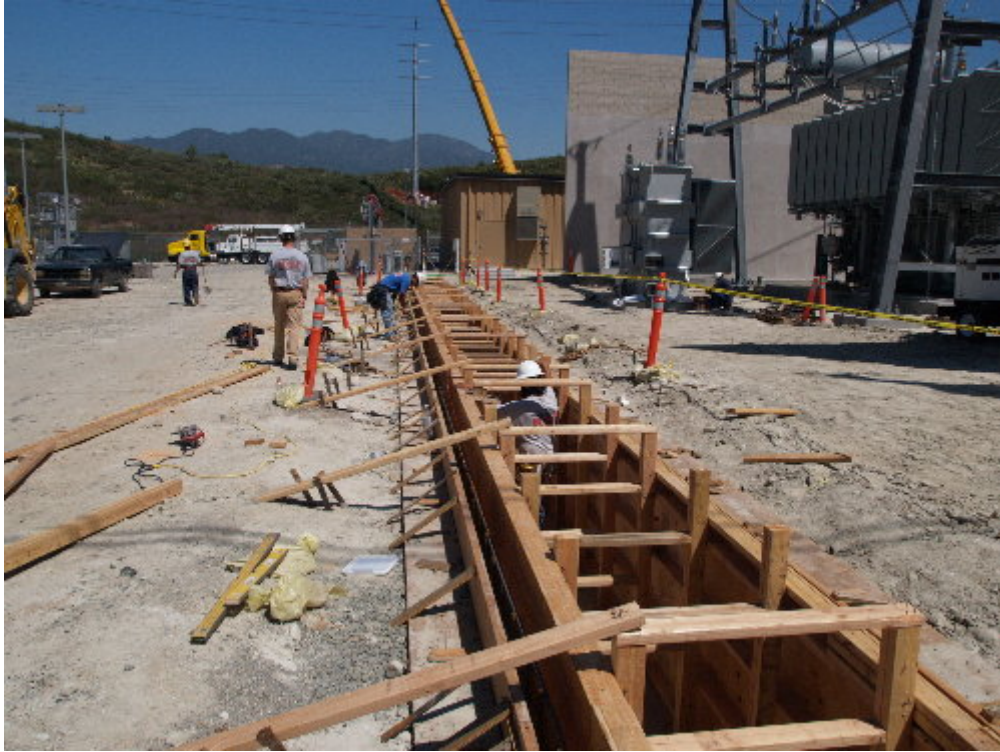
1. Work continued on the main trench running east-west, dividing the 220 kV and 66 kV sections of the substation site. The crew constructed the wooden forms that provide for both the bottom and sides of the trench (see Figure 1). The form was almost ready for concrete at the time of the site visit.

Figure 1 – Crews worked on the wooden form that surrounds the rebar cage for the concrete trench west of MEER #1..

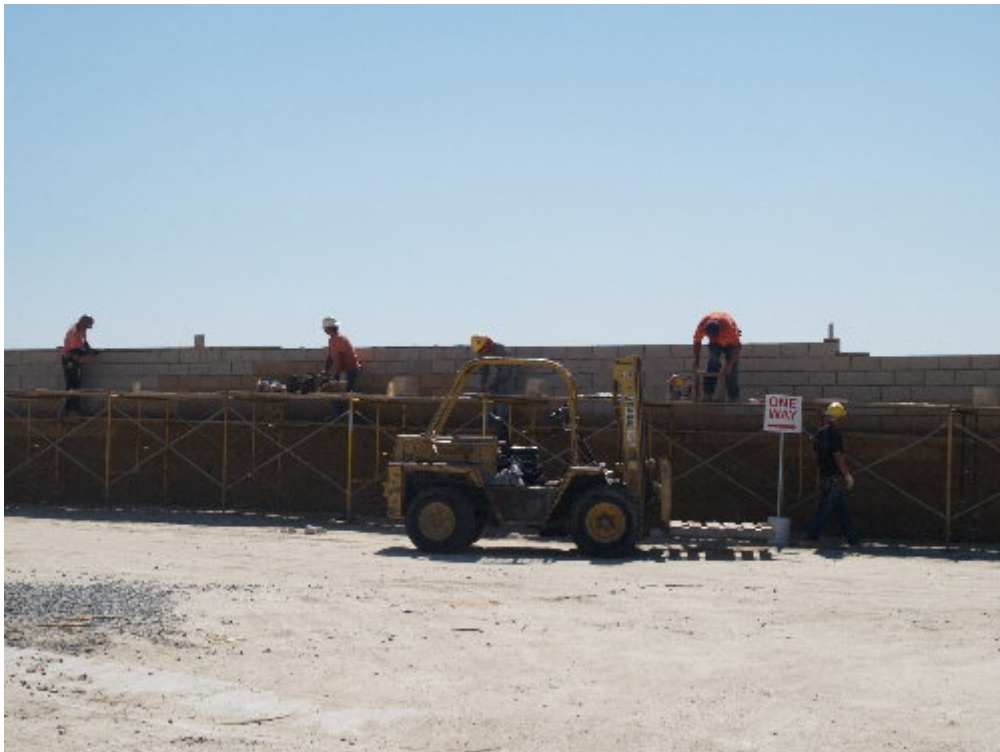
3. Reycon continued working on cutting and installing the cap-stones for the block wall on the western side of the station during the site visit (see Figure 2). The crew continued to make very good progress on the walls throughout the substation site.

Figure 2 – The Reycon crew worked to set the cap-stones for the block wall.

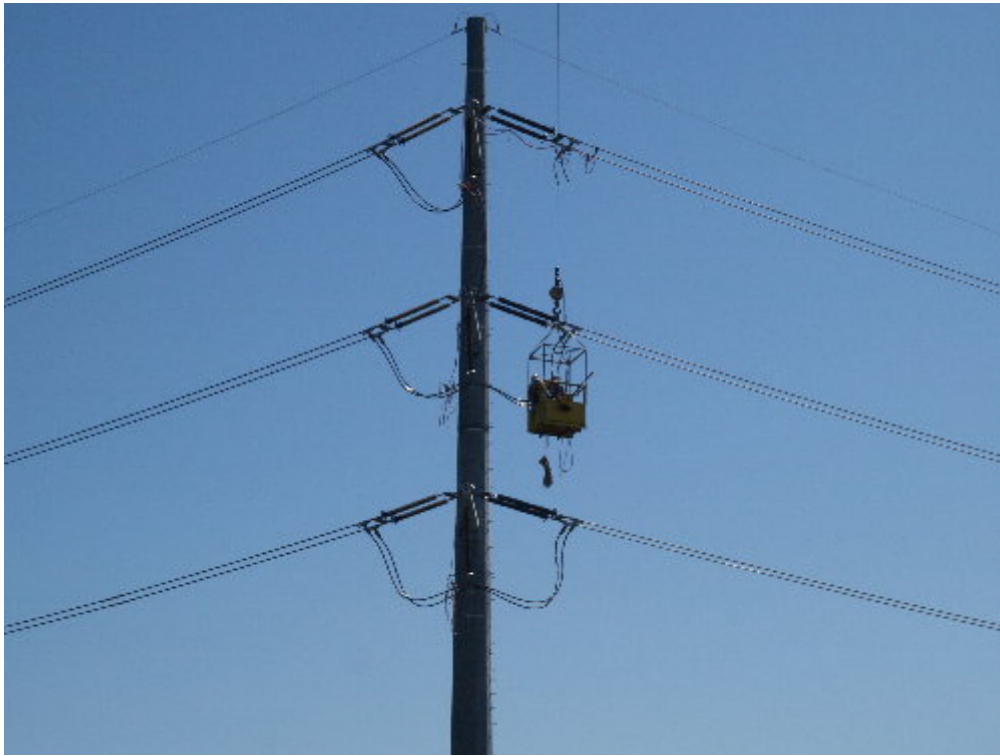
One SCE transmission line crew worked on the 220 kV transmission line segment during the site visit. The crew removed the short sections of conductor that bypassed the substation site and installed jumpers so that both transmission lines will now feed into the 220 kV section of the substation site (see Figure 3).

Figure 3 – The SCE transmission line crew worked to connect the jumpers between the two sections of conductor at the turning pole. Note the missing jumper on the top right-hand side of the steel pole.

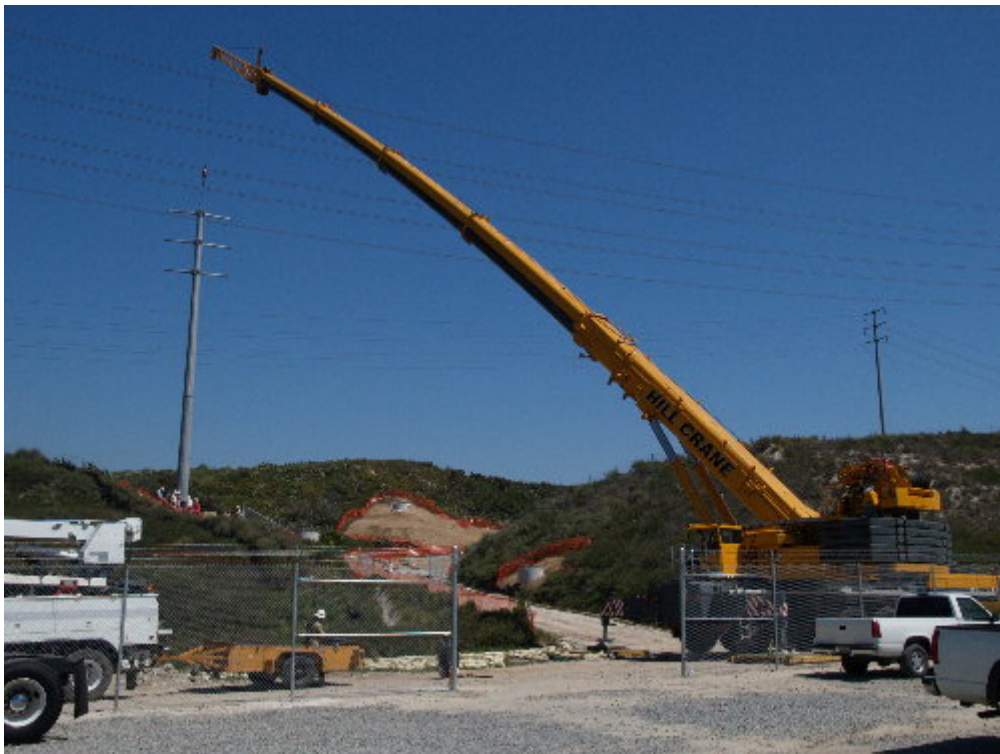
1. The NTP for the 66 kV work within the City of Lake Forest was issued on February 1, 2005. A larger crew worked with Hill Crane to set the steel poles on the 66 kV foundations poured recently (see Figure 4). The crane was parked on the disturbed area at the base of the hill and no grading was required. The crew used the lower bolts to attain the proper angle for the pole (see Figure 5). The poles are set at a very slight angle away from the load to minimize stresses on the foundation and the pole.
2. The permanent plated crossings for the v-ditch on the 66 kV section east of the substation site have been completed (see Figure 6). The rock placed up-slope of the crossing should minimize sediment transport into the v-ditch.

Figure 4 – A larger crew worked with Hill Crane to set a steel pole on a 66 kV foundation.

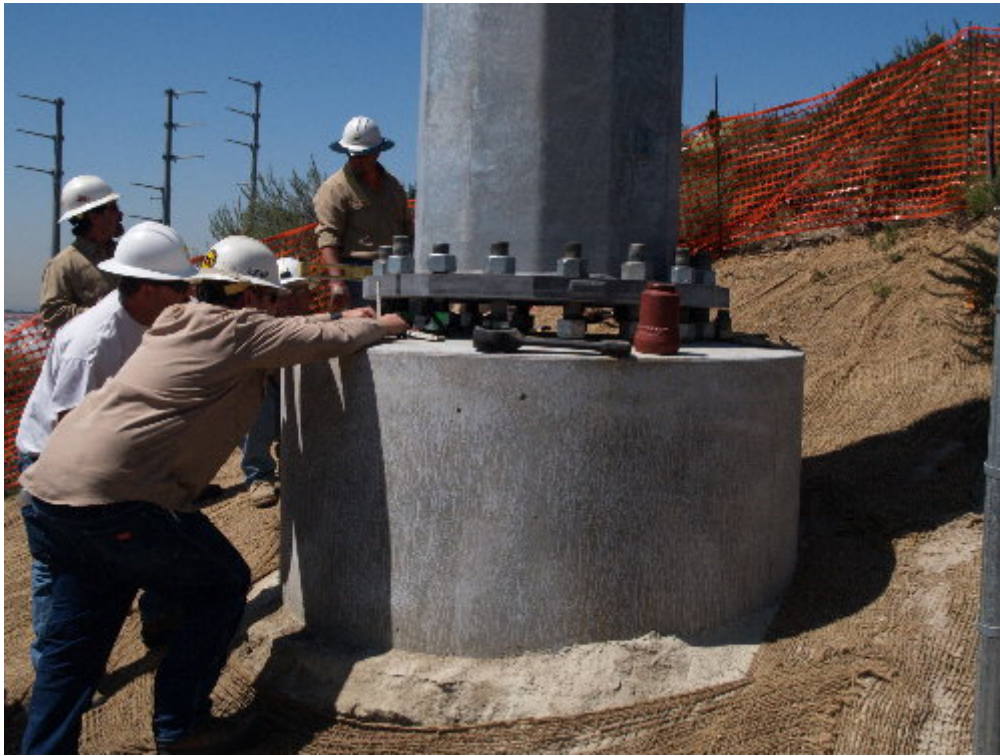
Figure 5 – The crew used the lower bolts to attain the proper angle for the pole.

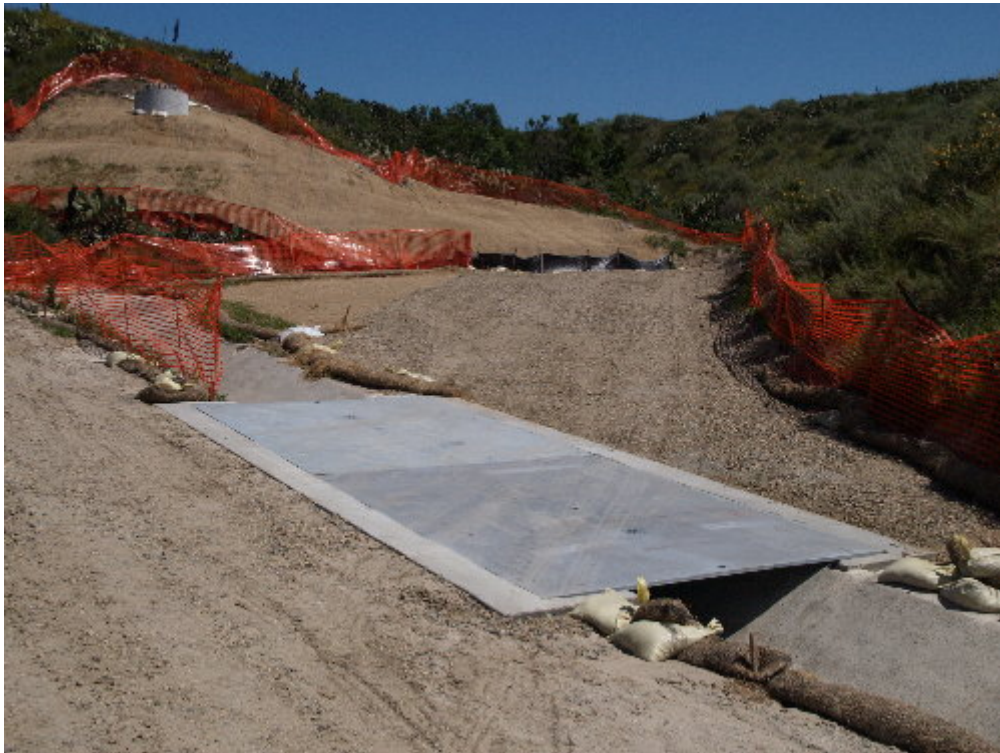
Many of the BMPs stopped sediment from leaving the construction area; however, some continue to need maintenance. The v-ditches will need to be cleaned of sediment prior to any predicted rain events.

Figure 6 – The permanent plated crossings for the v-ditch on the 66 kV section east of the substation site have been completed.
