PROJECT MEMORANDUM SCE – VIEJO SYSTEM PROJECT

To: Jensen Uchida, CPUC
From: Vida Strong, Aspen Project Manager
Date: April 19, 2005
Subject: Weekly Report #37: April 10 – April 16, 2005.
CPUC Environmental Monitor (EM): Christopher Meyer

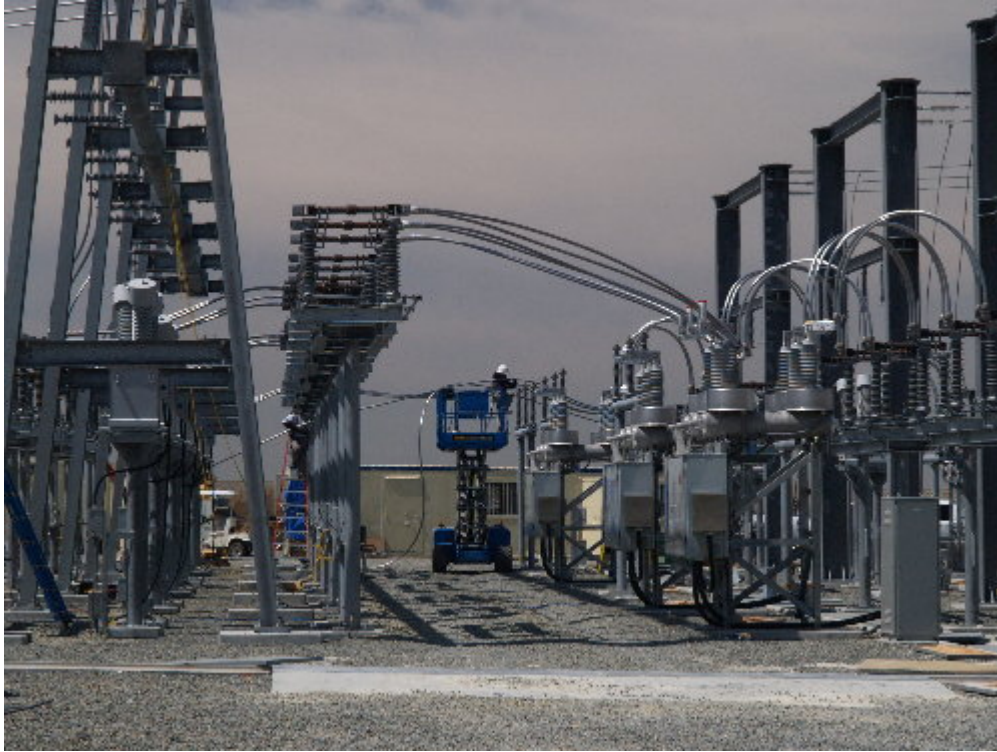
2. NRG continued making connections within the 66 kV section of the substation site. The crew worked on many of the short connections between various pieces of equipment and the conductors running from the risers (see Figure 1).

Figure 1 – NRG continued working on the small connections between the various equipment within the 66 kV section of the substation.

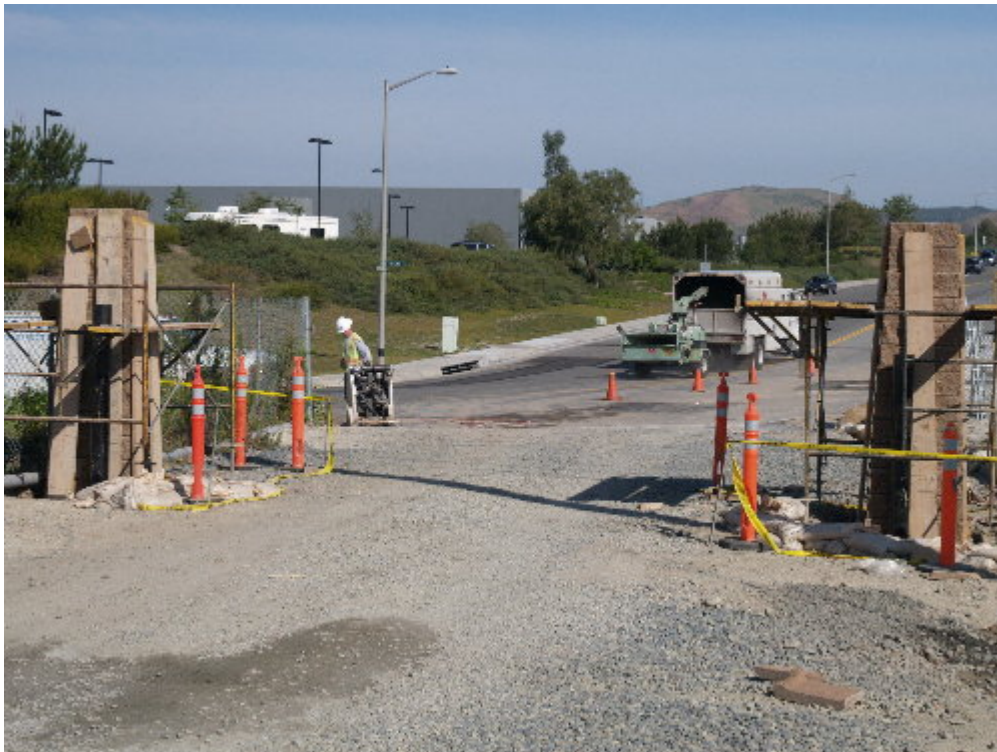
3. Reycon continued working on architectural details for the block wall around the substation during the site visit. The gateposts and block columns for the gate at the public right-of-way have been placed (see Figure 2).

Figure 2 – The Reycon crew has built the block columns at the gate on Definition Road.
Note: The truck and chipper are not project-related.

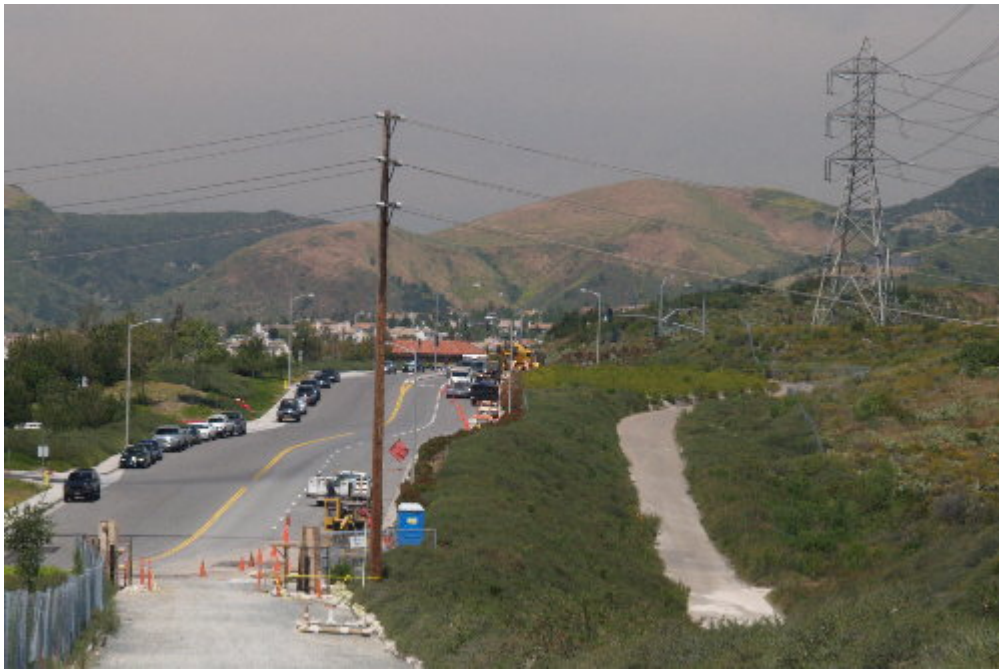
4. Work occurred on the public right-of-way during the site visit as crews trenched, placed conduit, and backfilled on Definition Road between the substation entrance and Glenn Ranch Road (see Figure 3). Traffic control was in place and the slurry trucks were being washed out in the trench; however, the traffic control for the saw-cutting near the Definition Road gate left little room for two-way traffic around the sharp bend in the road.

Figure 3 – Crews trenched, placed conduit, and backfilled on Definition Road between the substation entrance and Glenn Ranch Road.

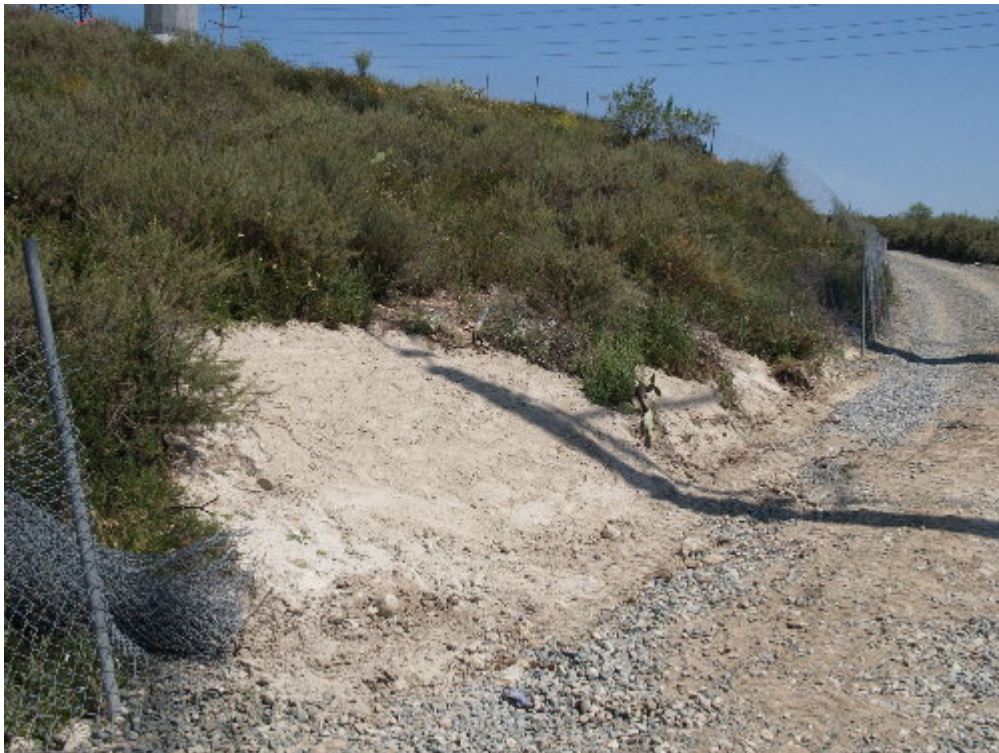
One restoration crew from American worked on the 220 kV transmission line segment during the site visit. The crew backfilled and re-contoured the slope cut for the man-lift outriggers during construction of the 220 kV line (see Figure 4). The crew has been informed of the California gnatcatcher nests in the area and work was confined to the disturbed area.

Figure 4 – The crew with American worked to restore sections of the hillside impacted during 220 kV construction.

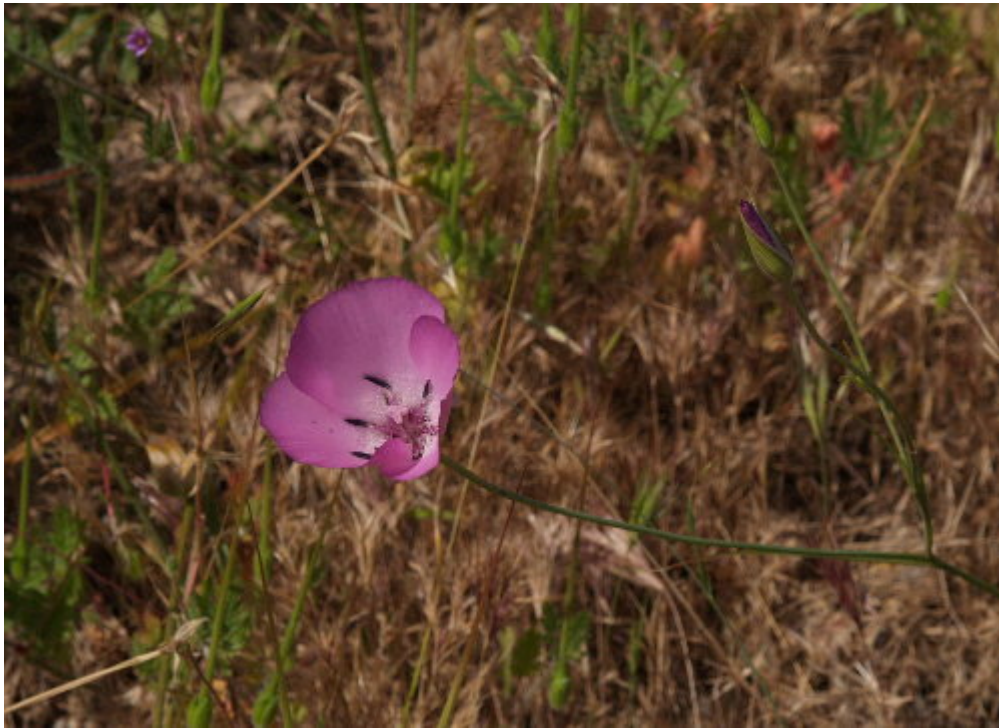
Although common mariposa lilies were observed blooming on the 220 kV right-of-way, no foothill mariposa lilies were noted by the CPUC EM during a brief walk along the right-of-way (see Figure 5).

Figure 5 – Common mariposa lilies were observed in bloom on the 220 kV right-of-way.

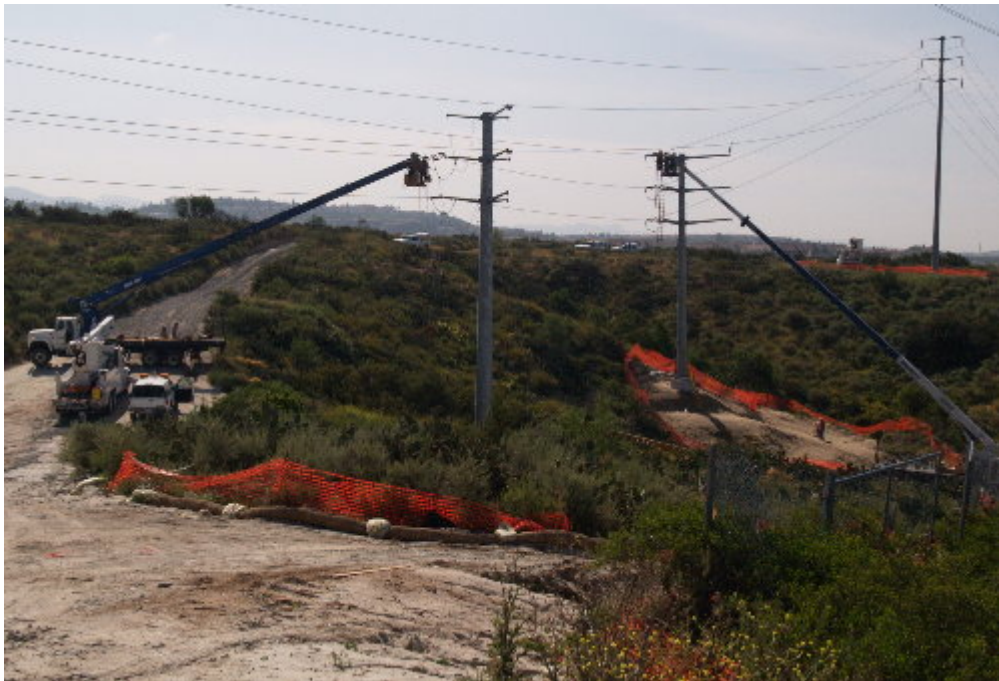
The NTP for the 66 kV work within the City of Lake Forest was issued on February 1, 2005. A crew worked with two larger man-lifts to run conductor between two steel poles on the 66 kV section above the substation site (see Figure 6). The conductor will bypass the substation temporarily and will be removed after conduit is strung from each pole into the 66 kV section of the substation and the 66 kV section is ready for energization.

Figure 6 – Crews worked on conductor for the 66 kV line east of the substation during the site visit.
