## **PROJECT MEMORANDUM SCE – VIEJO SYSTEM PROJECT**

**To:** Jensen Uchida, CPUC  
**From:** Vida Strong, Aspen Project Manager  
**Date:** April 26, 2005  
**Subject:** Weekly Report #38, April 17 – April 23, 2005.  
**CPUC Environmental Monitor (EM):** Christopher Meyer

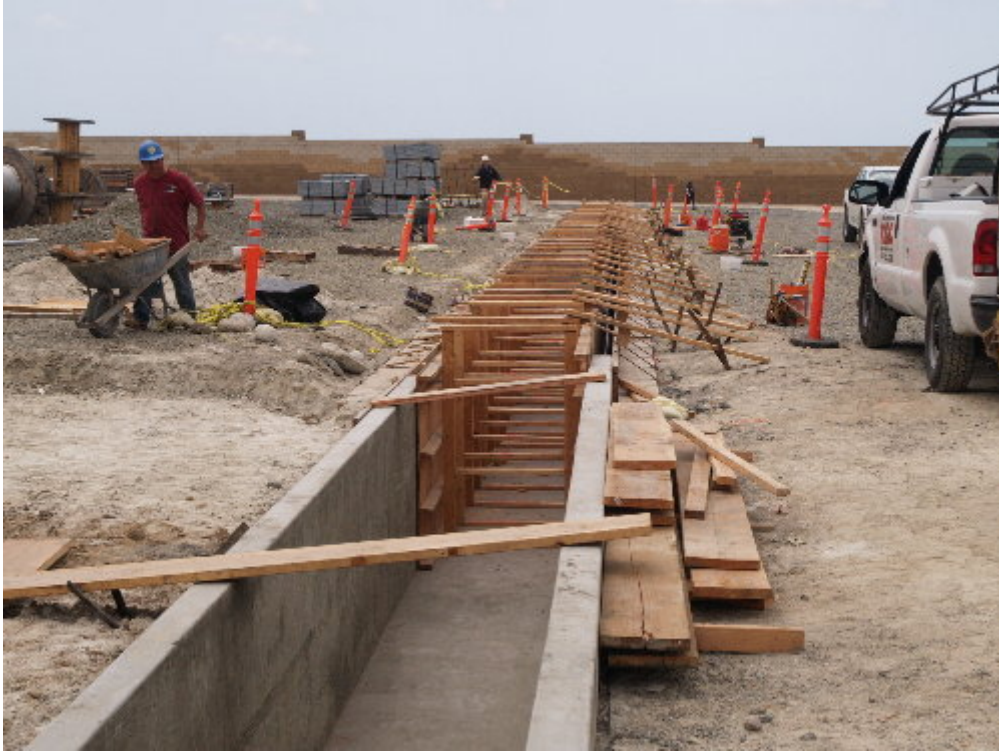
1. Work continued on the main trench running east-west, dividing the 220 kV and 66 kV sections of the substation site. The first section has been poured and the forms removed. The forms are in place for the western section and a small crew worked to prepare for pouring concrete (see Figure 1).

**Figure 1** – The second section of the large trench was formed for concrete.

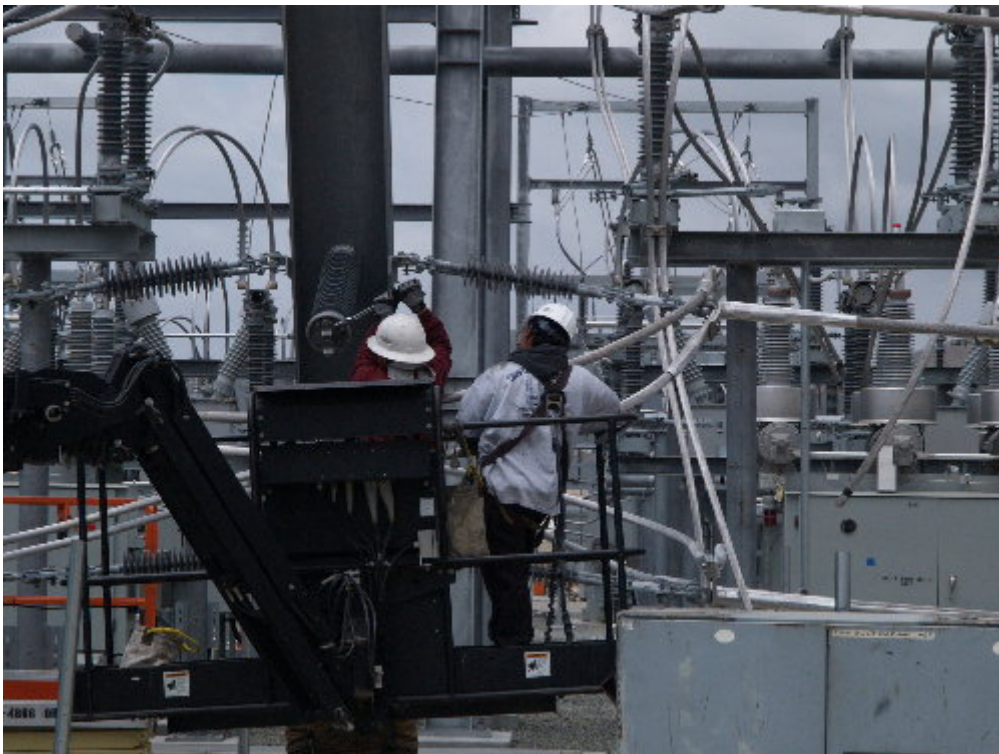
2. NRG continued making connections within the 66 kV section of the substation site. The crew worked on many of the short connections between various pieces of equipment and insulators (see Figure 2).

**Figure 2** – NRG continued working on the small connections between the various equipment within the 66 kV section of the substation.

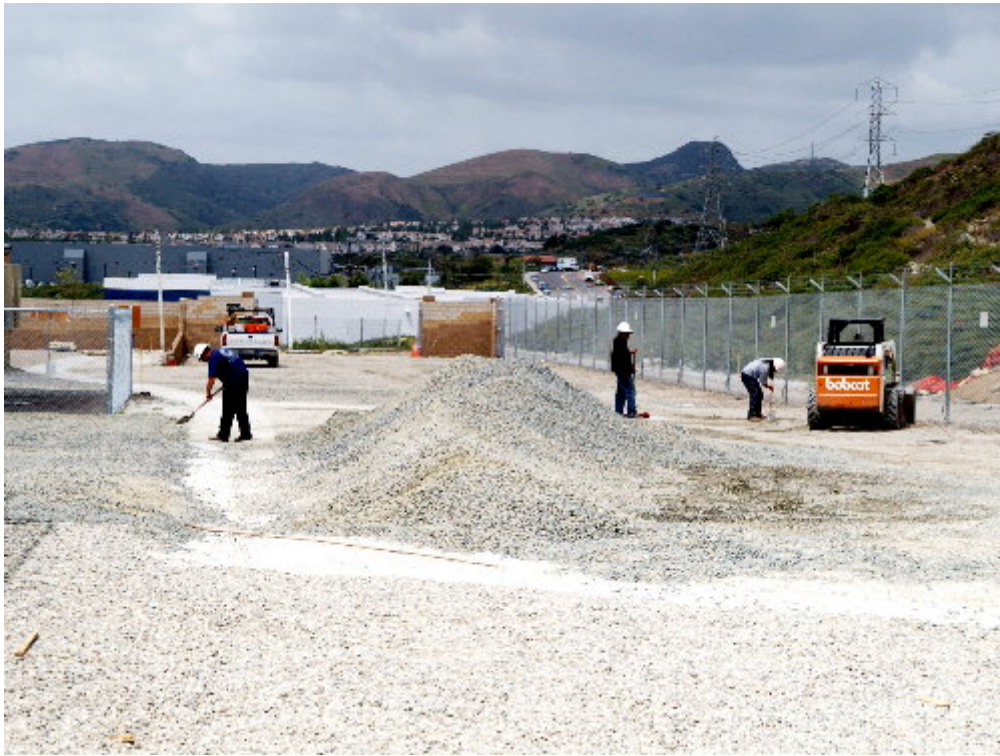
4. A crew with American worked to clean construction debris from the substation site. The crew also worked to clean out the v-ditches around the substation site (see Figure 3).

**Figure 3** The American crew worked on cleaning out the v-ditches surrounding the substation site.

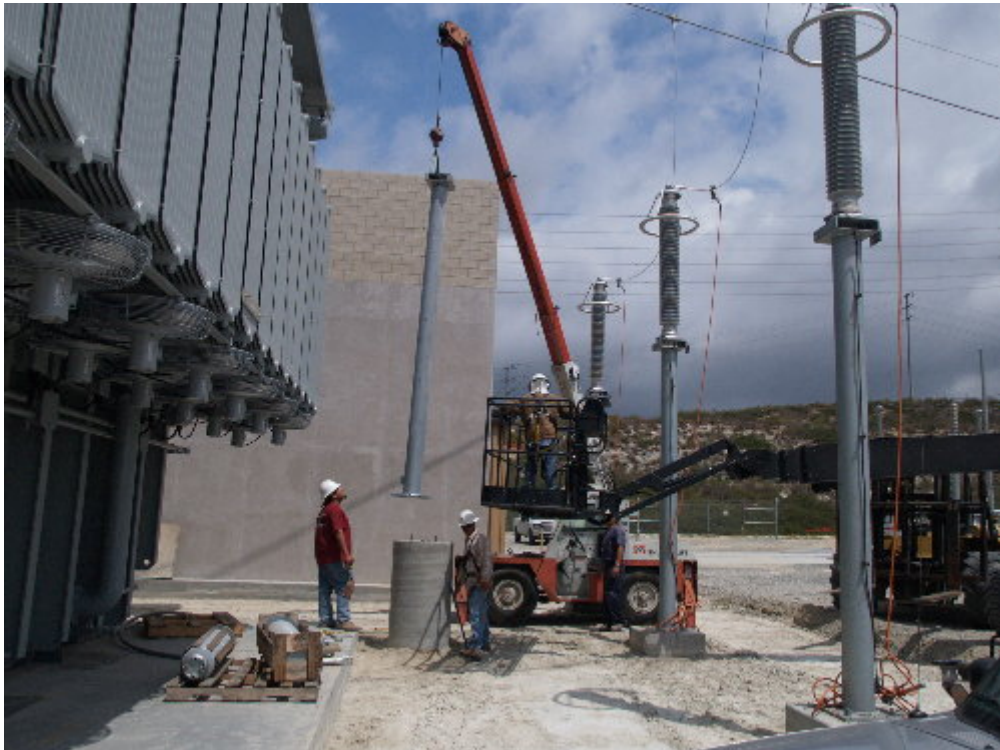
5. A small crew worked to trench in and connect grounding wires at the A-bank transformers while another crew worked on the south side of the transformer setting the new off-set pole that will provide for the proper separation between the conductor and the oil tank on the transformer (see Figure 4).

**Figure 4** – The new off-set pole was set on the south side of the A-bank transformer.

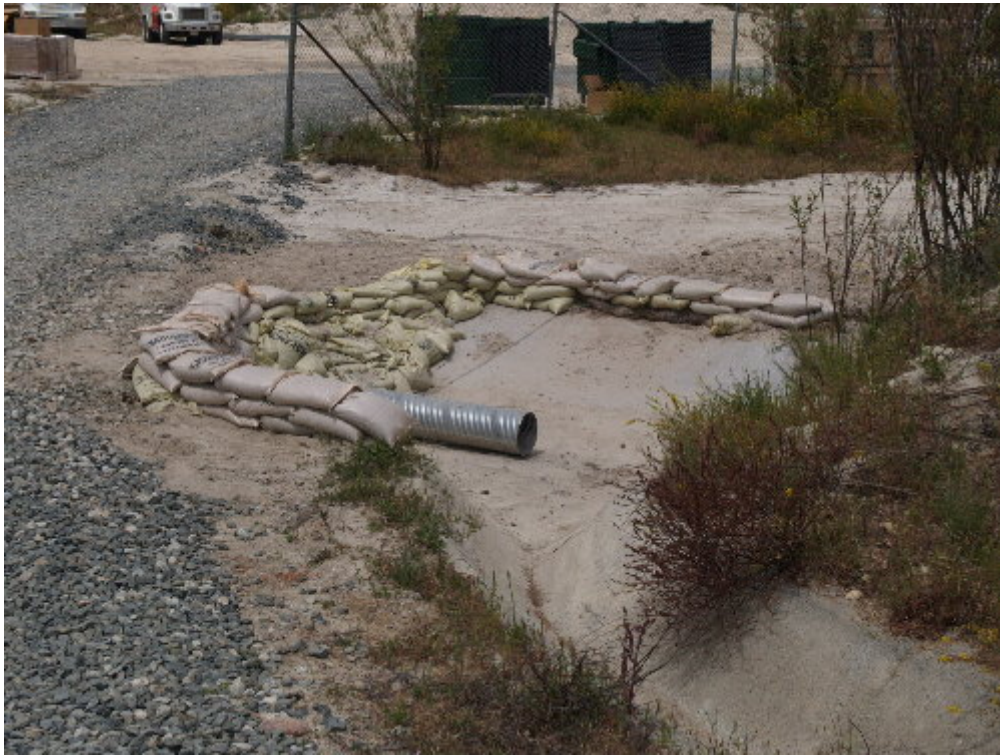
One restoration crew from American worked on the 220 kV transmission line segment, but was not working in the area during the site visit. The crew re-contoured the work pad for the man-lift during construction of the 220 kV line and cleaned silt out of the drainage ditches along the access road (see Figure 5). The crew has been informed of the California gnatcatcher nests in the area and work was confined to the disturbed area.

**Figure 5** – The American crew cleaned silt out of the concrete lined ditch on the 220 kV right-of-way.

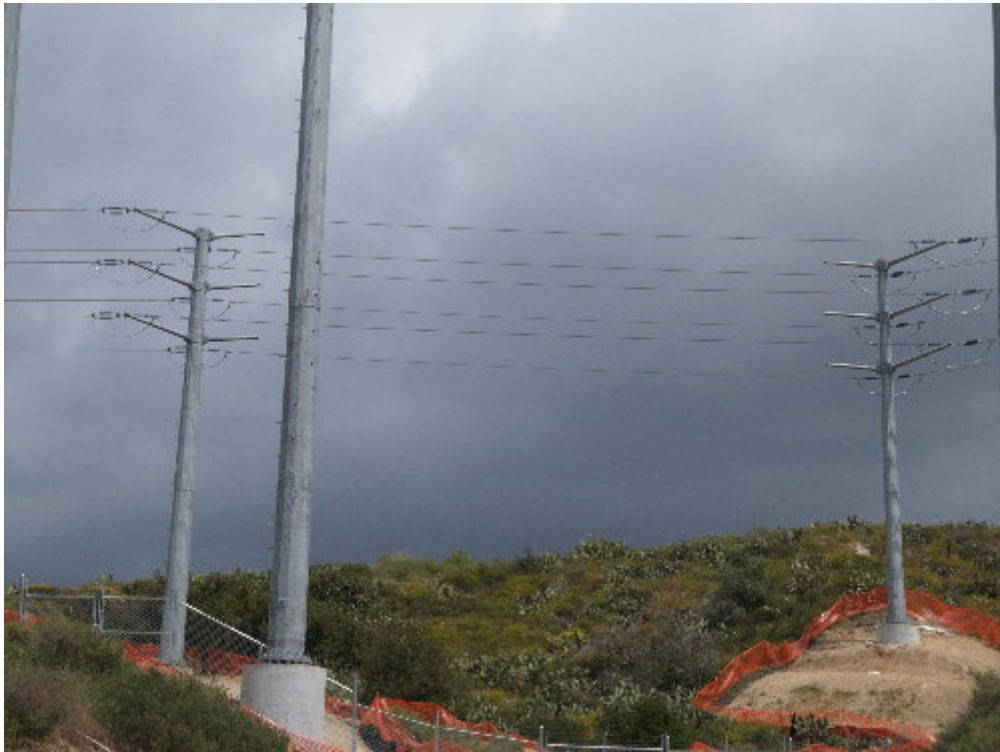
The NTP for the 66 kV work within the City of Lake Forest was issued on February 1, 2005. Although no construction was occurring during the site visit, the conductor temporarily bypassing the substation has been completed and will be removed after conduit is strung from each pole into the 66 kV section of the substation and the 66 kV section is ready for energization (see Figure 6).

**Figure 6** – Crews worked on conductor for the 66 kV line east of the substation prior to the site visit.
