PROJECT MEMORANDUM SCE – VIEJO SYSTEM PROJECT

To: Jensen Uchida, CPUC
From: Vida Strong, Aspen Project Manager
Date: May 19, 2005
Subject: Weekly Report #41, May 8 – May 14, 2005.
CPUC Environmental Monitor (EM): Christopher Meyer

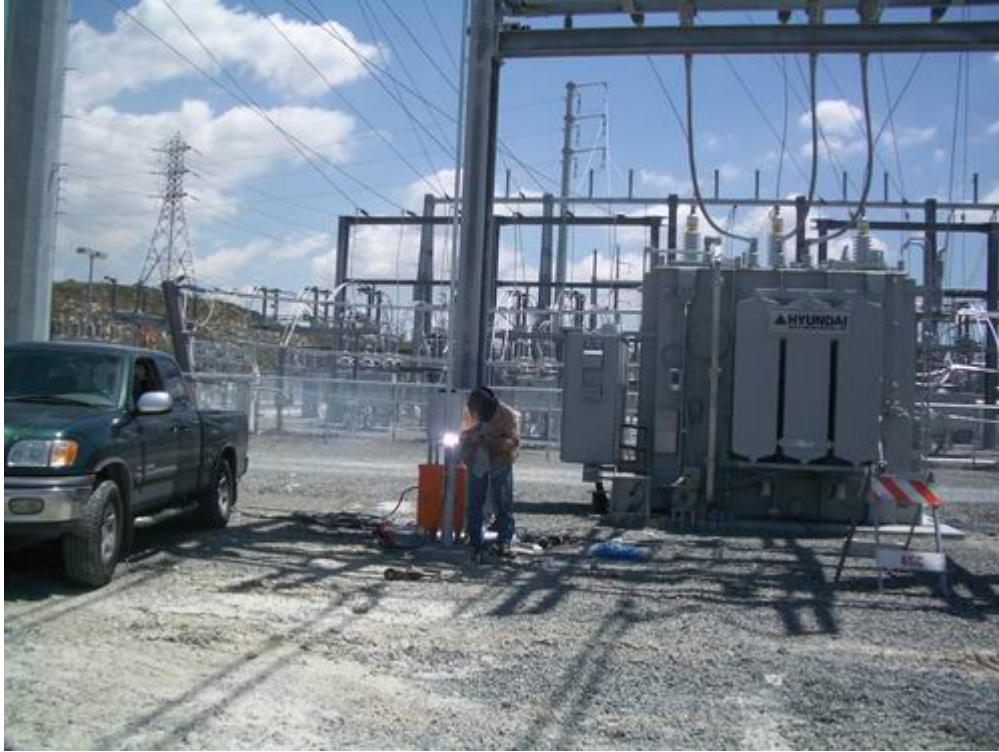
2. Manual disconnect switches have been connected on the north end of the 66 kV portion of the site (connecting to the 12 kV portion) and the foundations have been poured. A welder worked on the disconnect switches during the site visit (see Figure 1).

Figure 1 – The foundations for the manual disconnect switches have been poured and a welder worked to complete the installation.

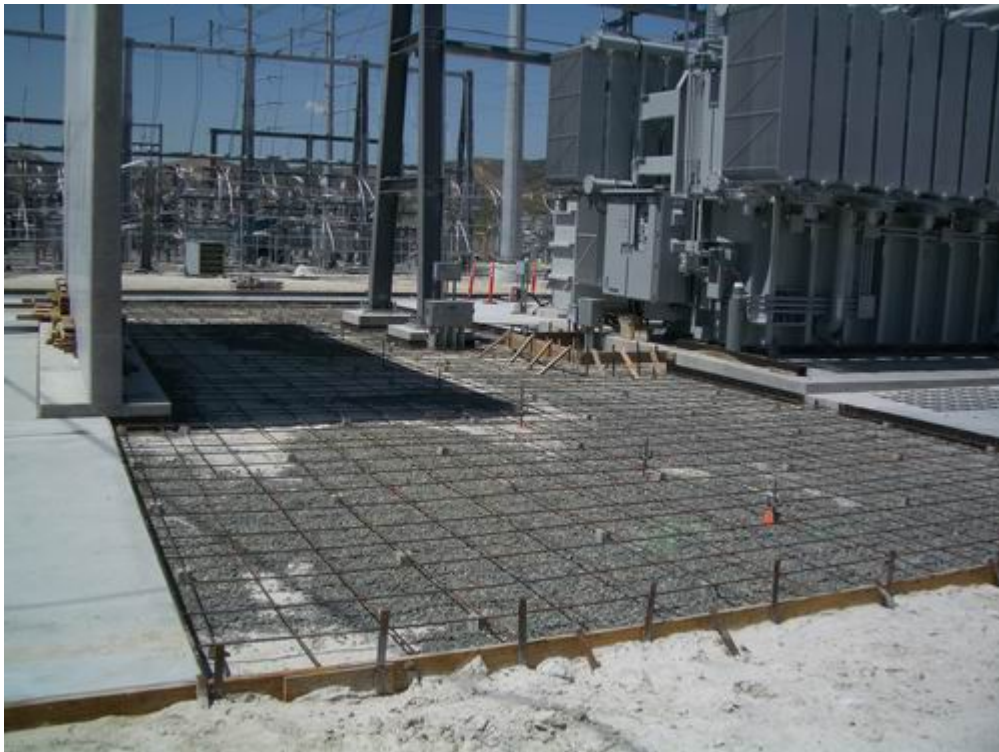
3. Several forms around the A-bank transformers were prepared for concrete and poured during the later part of the previous week. The next sections have been formed in preparation for future concrete pouring (see Figure 2). An asphalt berm will be placed around the perimeter of the pad to contain the oil from the transformers in case of an accident.

Figure 2 – The forms between the various foundations are ready for concrete. The concrete pads on either side were poured the previous week.

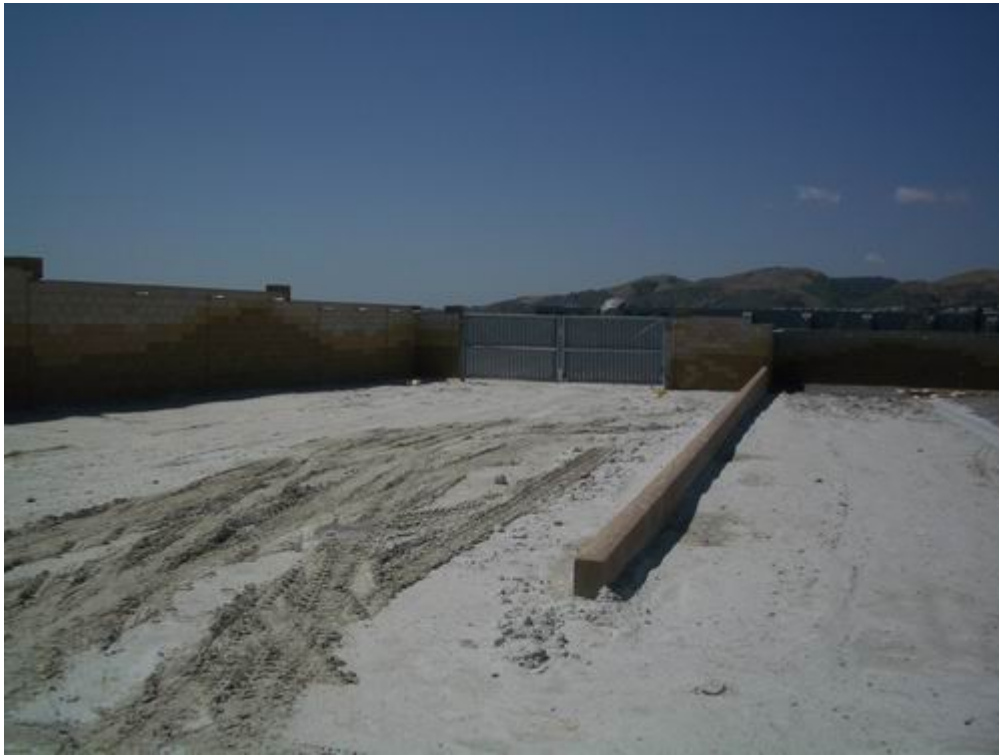
4. The main and side gates have been hung on the previously completed supports (see Figure 3). The substation is now completely surrounded by either block wall or cyclone fencing.

Figure 3 – The main gate and side gate have been set on the previously installed supports.

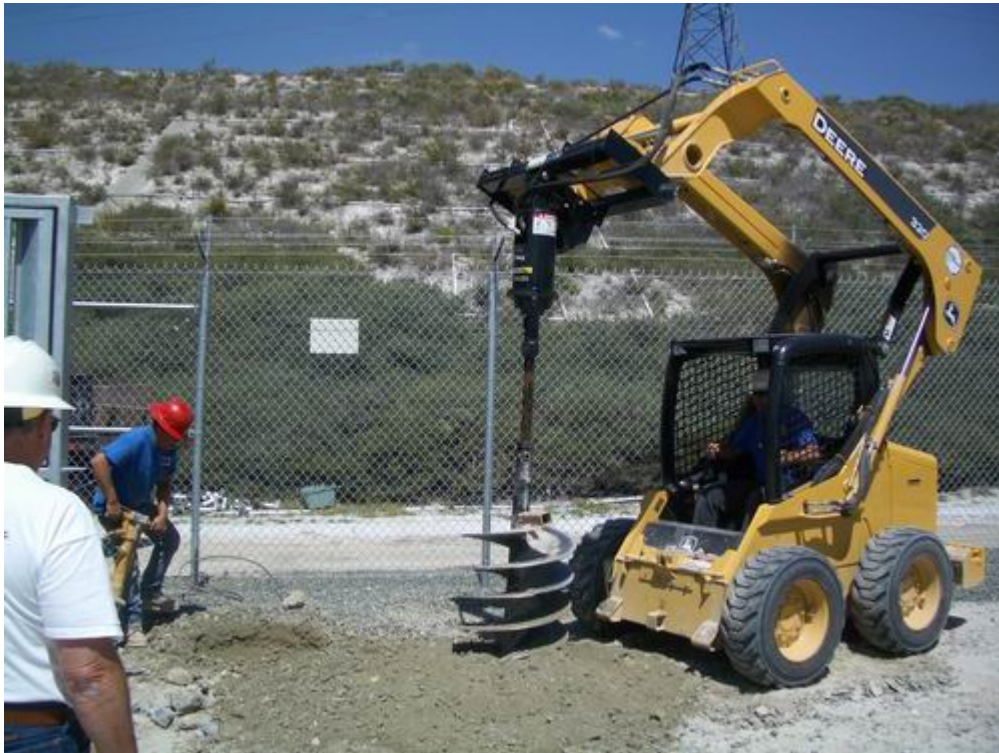
5. A small crew with KGC worked on augering small foundations for light standards throughout the substation site (see Figure 4). These light standards will be tied into the grounding grid when completed.

Figure 4 – KGC worked on excavating for the light standard foundations throughout the substation site.

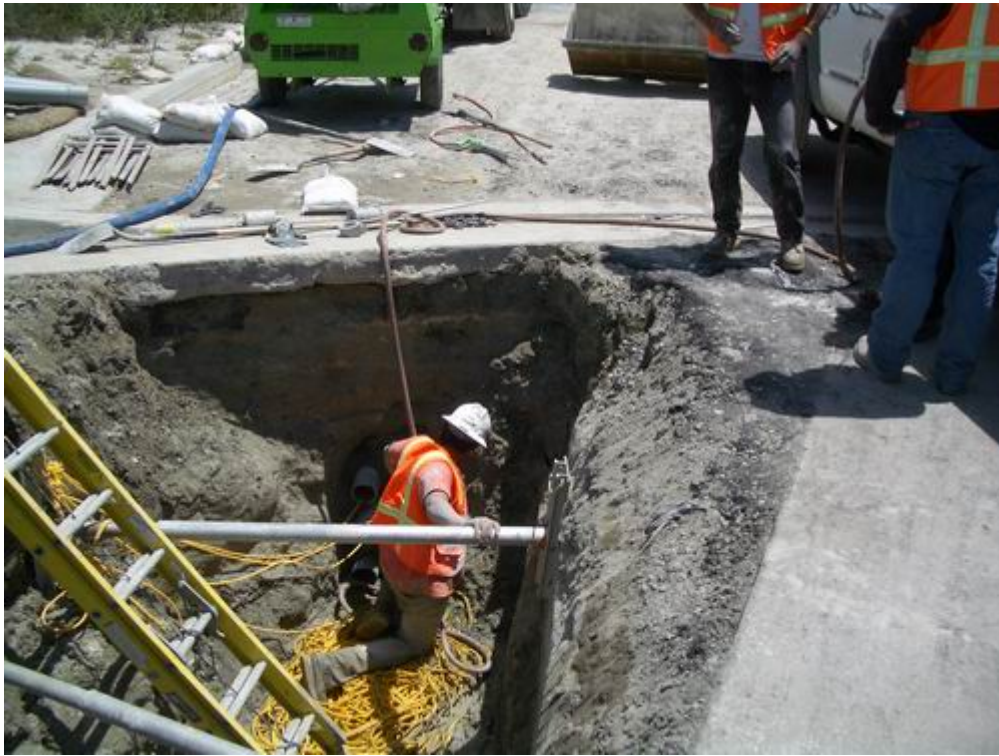
6. A crew with Arizona Pipeline worked on Definition Road outside the substation site on the 12 kV buried cables connecting the substation to the distribution network. The crews have been trenching, placing conduit, and backfilling with a slurry mix. The crew experienced difficulty cleaning out the conduit placed by Three Kings Construction earlier in the project (see Figure 5). The crew worked to clean out cement slurry that entered an uncapped conduit near the access entrance on Definition Road.

Figure 5 – Arizona Pipeline worked to clean out the previously placed conduit between Definition Road and the substation site.

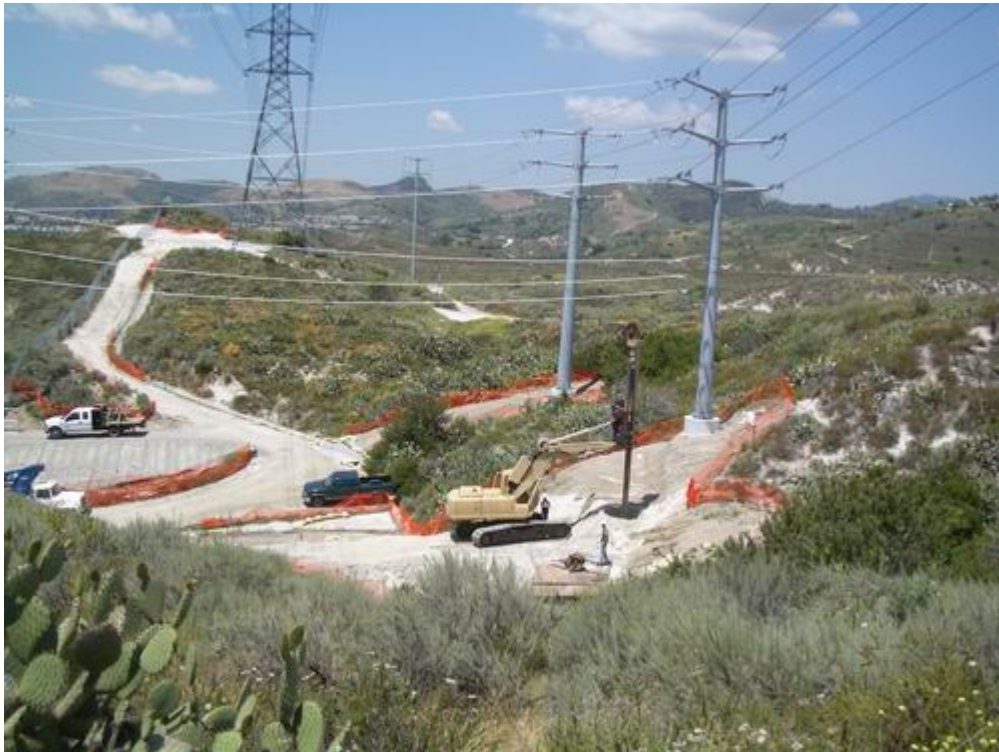
A crew worked with a drilling machine to start excavations for the 66 kV H-structures that will run from the Viejo Substation into the City of Mission Viejo (see Figure 6). No construction was observed on the 66 kV line within Mission Viejo (NTP #4).

Figure 6 – Crews worked on drilling for the 66 kV H-structure foundations during the site visit.
