## **PROJECT MEMORANDUM SCE – VIEJO SYSTEM PROJECT**

**To:** Jensen Uchida, CPUC  
**From:** Vida Strong, Aspen Project Manager  
**Date:** June 16, 2005  
**Subject:** Weekly Report #45, June 5 – June 11, 2005.  
**CPUC Environmental Monitor (EM):** Christopher Meyer

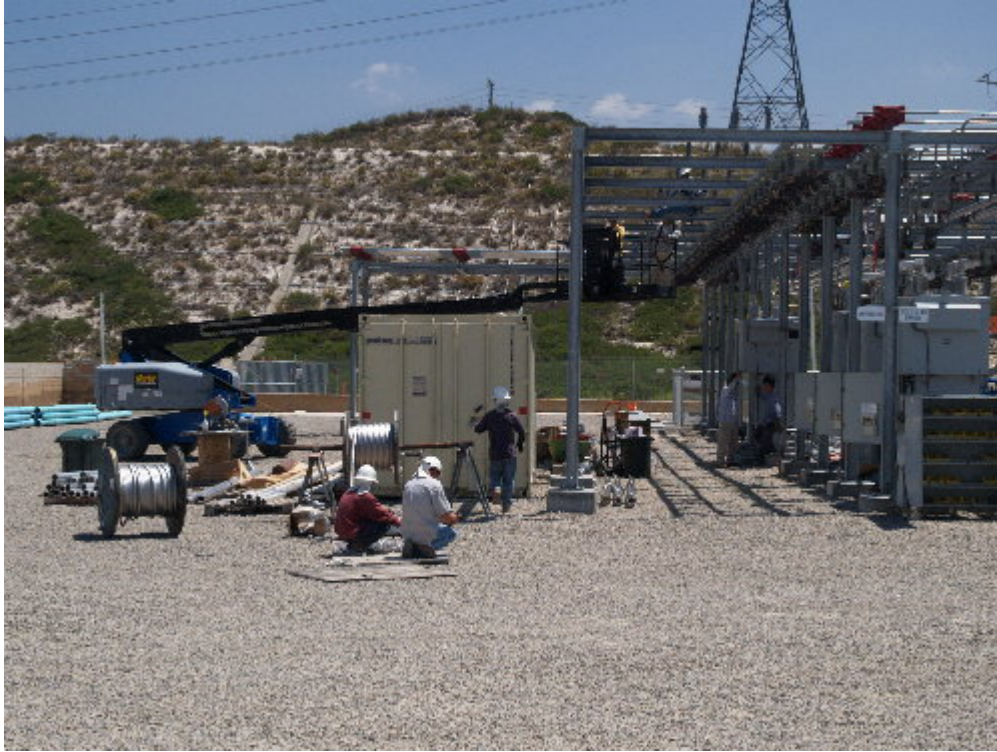
1. Several small NRG crews continued working within the 12 kV section of the substation site (see Figure 1). The B-bank transformers are not energized. These smaller transformers run between the 66 kV and 12 kV sections of the substation. The 66 kV section of the substation has been energized and is marked by safety tape.

**Figure 1** – NRG continued working on the 12 kV portion of the substation.

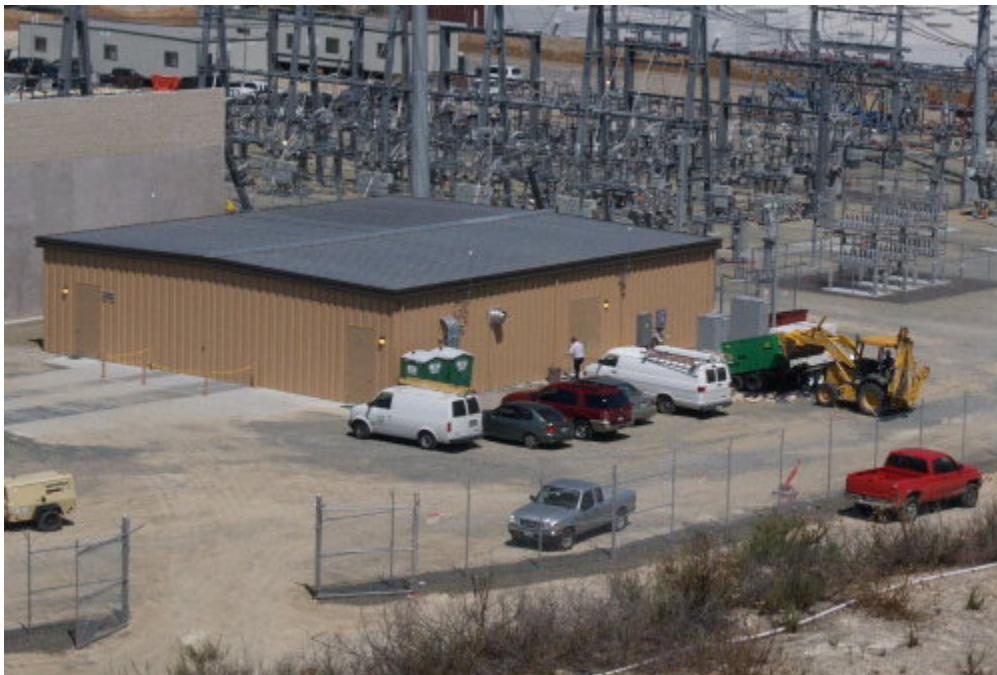
2. A permanent generator was delivered to the MEER #1 and will be wired into the system to run as a backup (see Figure 2).
3. The 220 kV section of the substation site has been marked off with caution tape now that it is energized. The several sections of the 66 kV portion of the site, which are energized, have been surrounded with cyclone fencing and caution tape as well. With the completion of the majority of the civil work, the remaining crews at the substation site have experience working in energized stations. SCE previously provided the CPUC EM was provided with an orientation on visiting an energized station.

**Figure 2** – An emergency generator was set outside MEER #1.

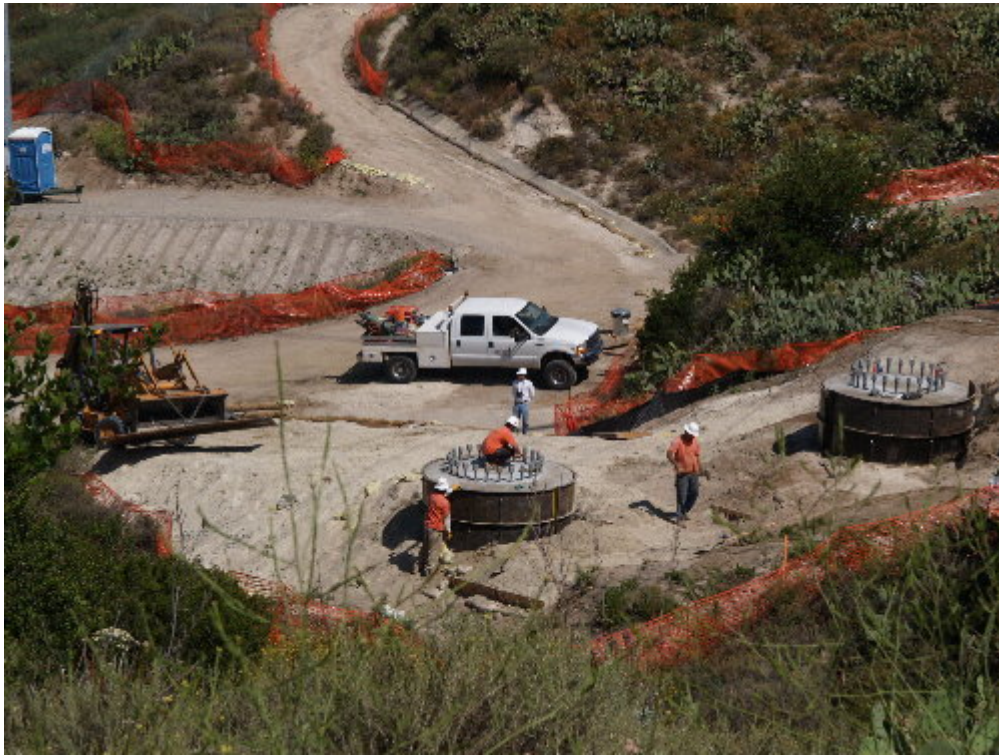
1. The foundation for the H-structure nearest the substation site, Structure 13, has been poured and a crew worked to remove the steel forms from the two foundations for the structure (see Figure 3).

**Figure 3** – The forms for the new foundations for Structure 13 were removed during the site visit.

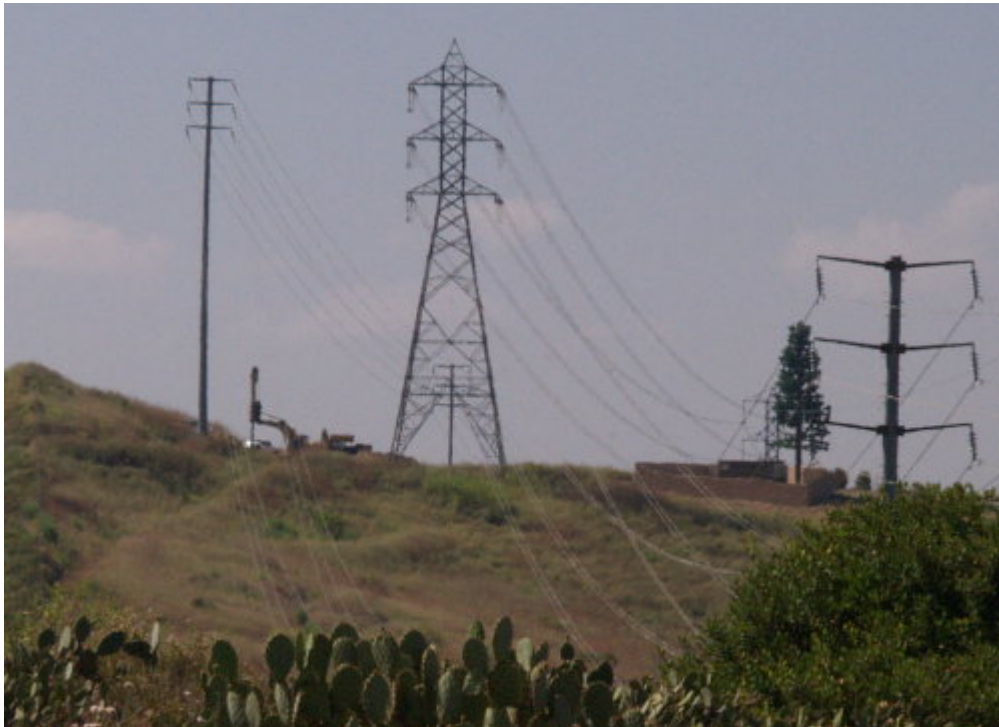
2. The crew drilling at Structure 10 returned to the site after a short break and continued excavating the foundations (see Figure 4). Structure 10 is on the outskirts of Mission Viejo and no involvement with the public was noted by the CPUC EM.

**Figure 4** – Work continued on the foundations for Structure 10, in the City of Mission Viejo.

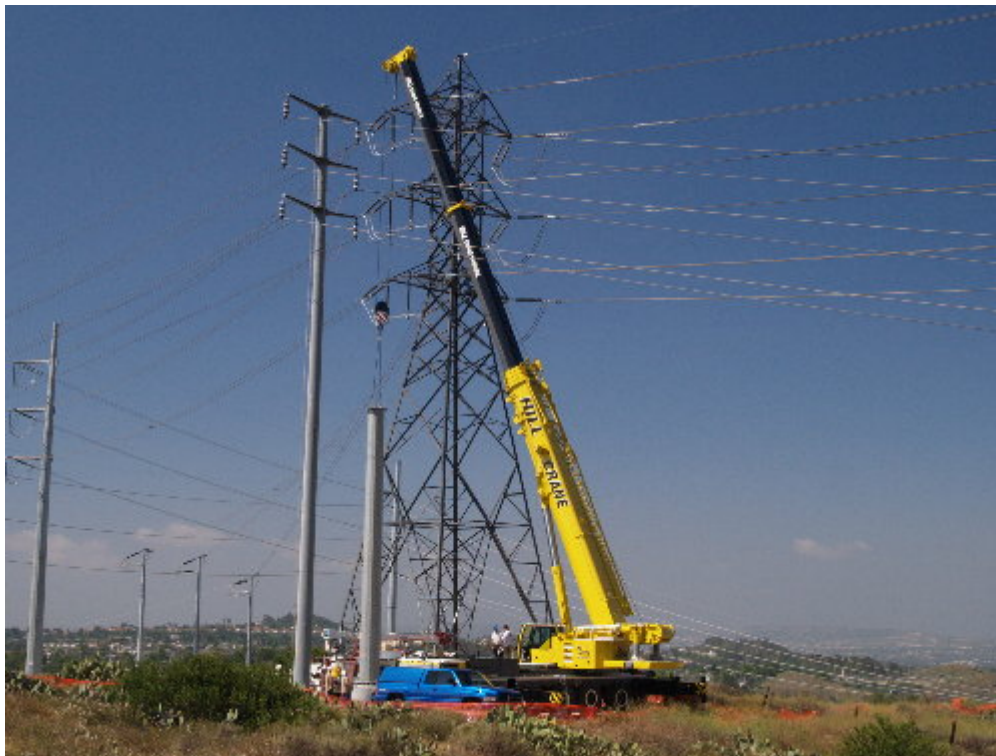
3. A large mobile crane was moved to Structure 12 and crews worked to raise the steel pole sections that will make up the H-structure (see Figure 5). The upper section of the pole is bolted onto the lower section to allow for a more precise alignment between the two pole sections. Workers helped align the pole as it was lowered by the crane operator and then bolted the upper section (see Figure 6). The operation proceeded very smoothly during the site visit. The adjacent circuit was de-energized during the operation for safety.

**Figure 5** – A large mobile crane was set up on-site to assist in raising the steel sections of H-Structure 12.

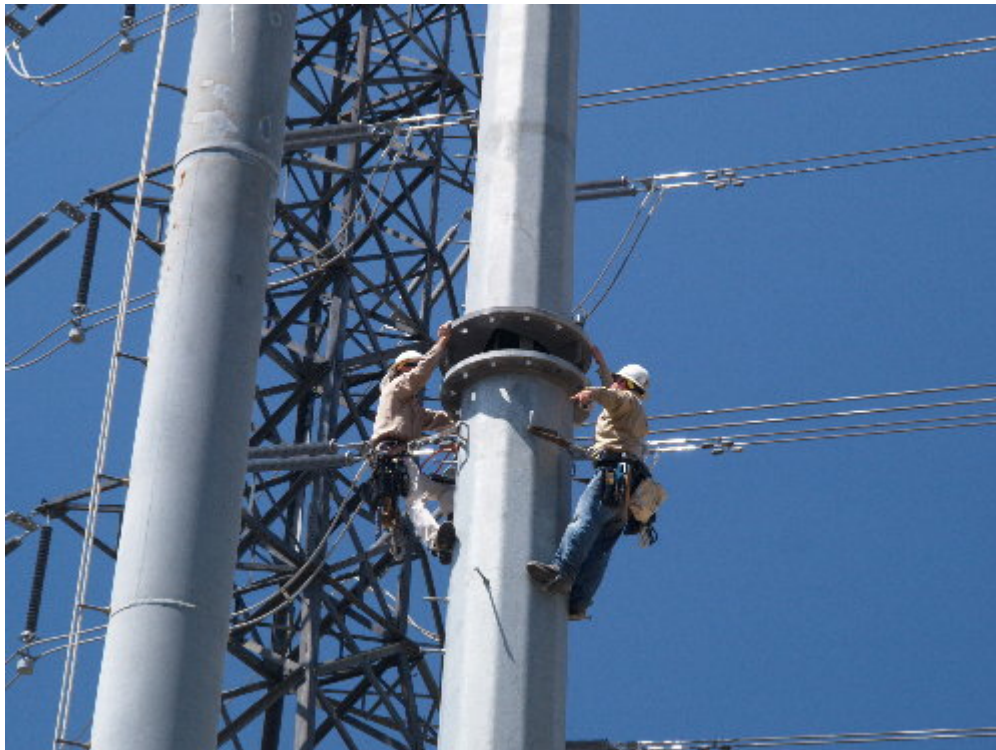
**Figure 6** – Workers helped guide the upper section of the east pole for H-Structure 12 and then bolted the sections together.
