# PROJECT MEMORANDUM SCE – VIEJO SYSTEM PROJECT

**Date:** July 5, 2005

**Subject:** Weekly Report #48, June 26 – July 2, 2005.

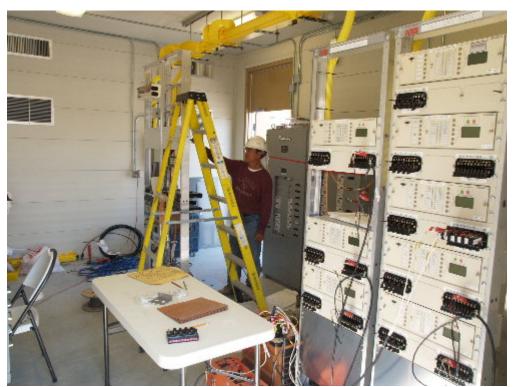
- 1. A small NRG crew continued working within the 12 kV section of the substation site. Work occurred within MEER #2 during the site visit (see Figure 1). The B-bank transformers are not energized and the 66 kV and 12 kV portions of the substation site have not been connected. These smaller transformers run between the 66 kV and 12 kV sections of the substation. The 66 kV section of the substation has been energized and is marked by safety tape.

Figure 1 – NRG worked within MEER #2 during the site visit.

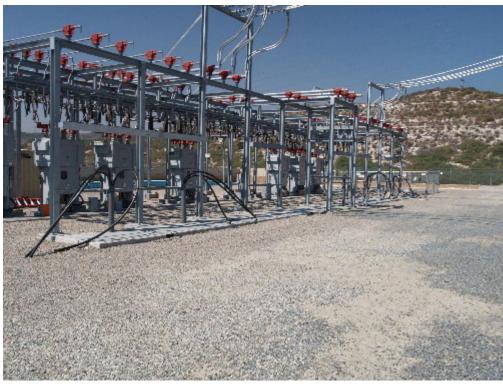
- 2. The underground cables that will connect the substation site to the SCE distribution system have been stubbed out at the 12 kV racks and will be connected to send electricity out from the substation (see Figure 2).

**Figure 2** – The underground cables have been stubbed out at the 12 kV racks for later connection.

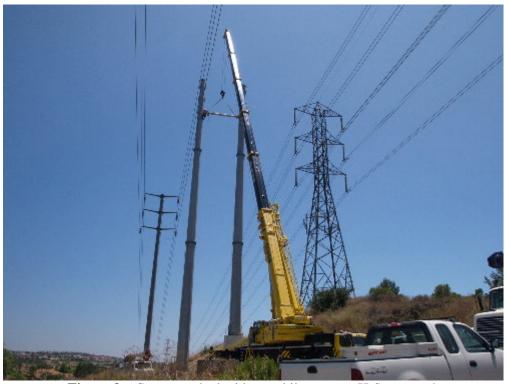
1. Crews at H-Structure 9 worked on setting the three cross members with a large mobile crane during the site visit (see Figure 3). The construction activities were within the disturbed area and no issues were noted. The superintendent noted that the areas disturbed in the slope for setting the crane will be restored and stabilized. Once lifted into place, workers on the two steel poles aligned and attached the cross members (see Figure 4).

**Figure 3** – Crews worked with a mobile crane at H-Structure 9 to attach the cross members.

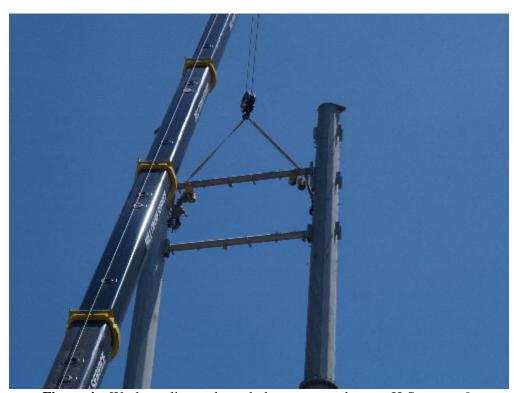
**Figure 4** – Workers align and attach the cross members on H-Structure 9.
