PROJECT MEMORANDUM SCE – VIEJO SYSTEM PROJECT

To: Jensen Uchida, CPUC
From: Vida Strong, Aspen Project Manager
Date: July 20, 2005
Subject: Weekly Report #50, July 10 – July 16, 2005.
CPUC Environmental Monitor (EM): Christopher Meyer

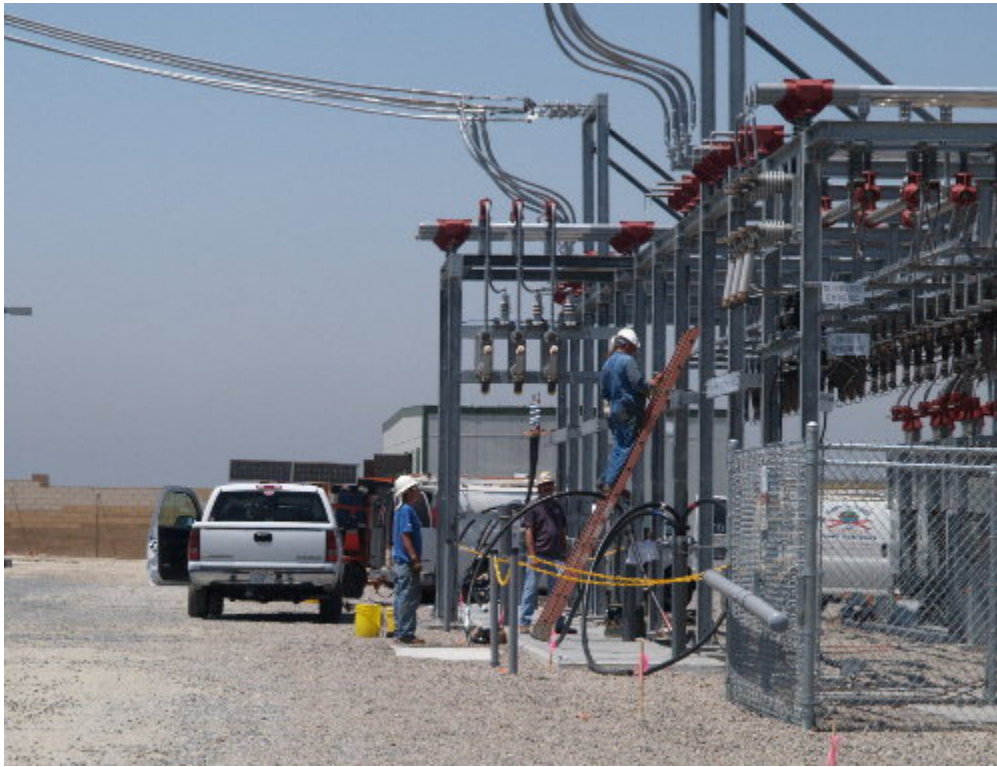
1. The electrical subcontractor, Hampton Tedder, had a crew working on the 12 kV racks during the site visit (see Figure 1). The crew worked to connect the underground cables that will connect the substation site to the SCE distribution system. Two of the four bundles stubbed out at the 12 kV portion of the substation site have been connected to the racks.

Figure 1 – A Hampton Tedder crew worked to connect the underground cables to the racks; thereby connecting the substation site to the SCE distribution system.

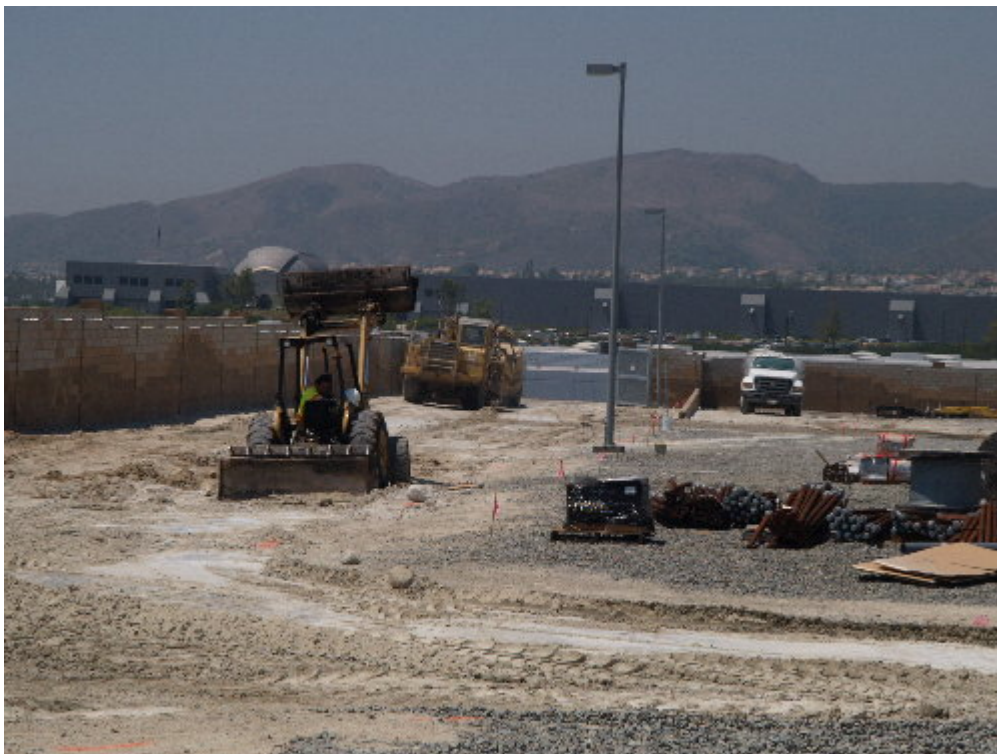
2. The road contractor has started working on the asphalt within the substation site and the access road between the substation site and Definition Road (see Figure 2). The contractor worked with motor-graders and blades to prepare the roads prior to paving. Water trucks were used to keep the fugitive dust under control and keep the moisture content of the soil at the best level for compaction. The temporary generators were moved to allow paving around MEER #1.

Figure 2 – The paving contractor worked to grade the road sites prior to paving.

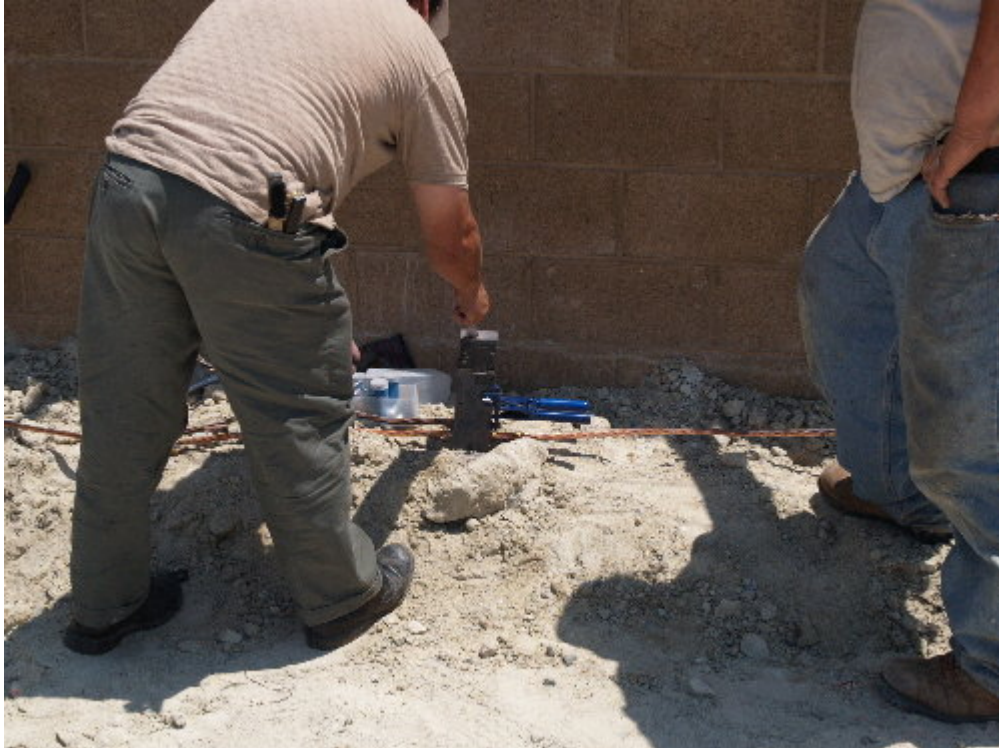
3. A small crew worked to repair sections of the grounding grid that were damaged during the grading process. The workers laid new lengths of copper grounding wire and connected them by CAD welding (see Figure 3).

Figure 3 – A small crew worked to repair the grounding grid within the substation site.

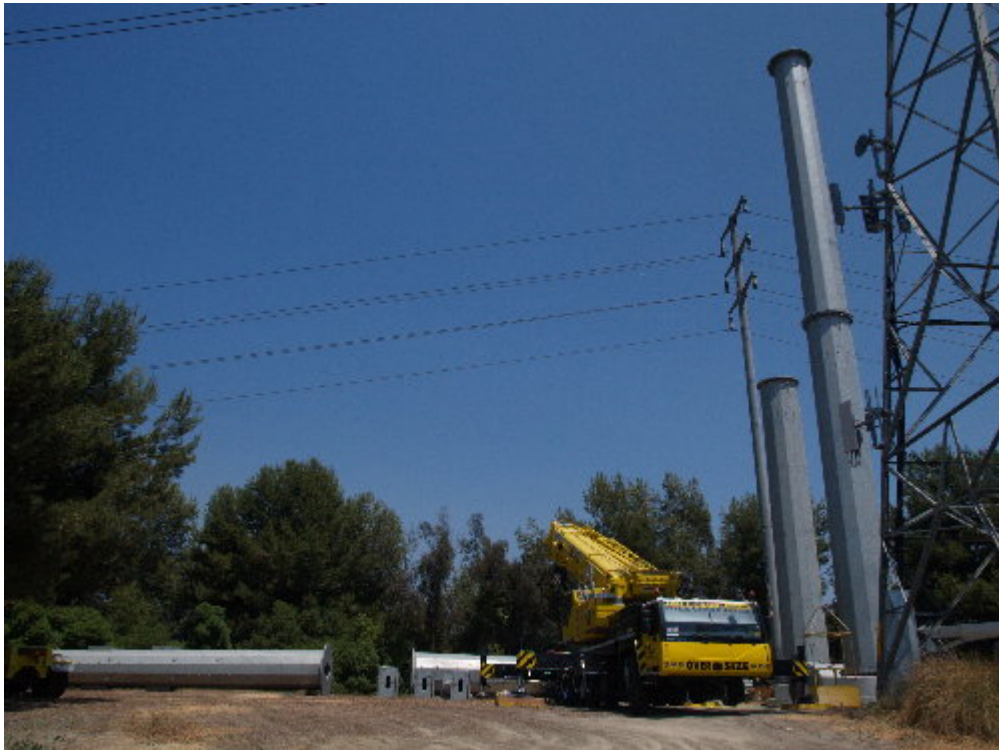
1. The Hill Crane was set up at Structure 7 and the crew worked in the morning, before work was shut down in order to re-energize the adjacent power line (see Figure 4). Work cannot safely proceed without taking the adjacent lines out of service. Those lines were needed to address the power demands during the extended heat spell.
2. H-Structures 10, 9, and 8 have been raised and the cross members attached (see Figure 5).

Figure 4 – The Hill Crane was at Structure 7, waiting for work to resume.

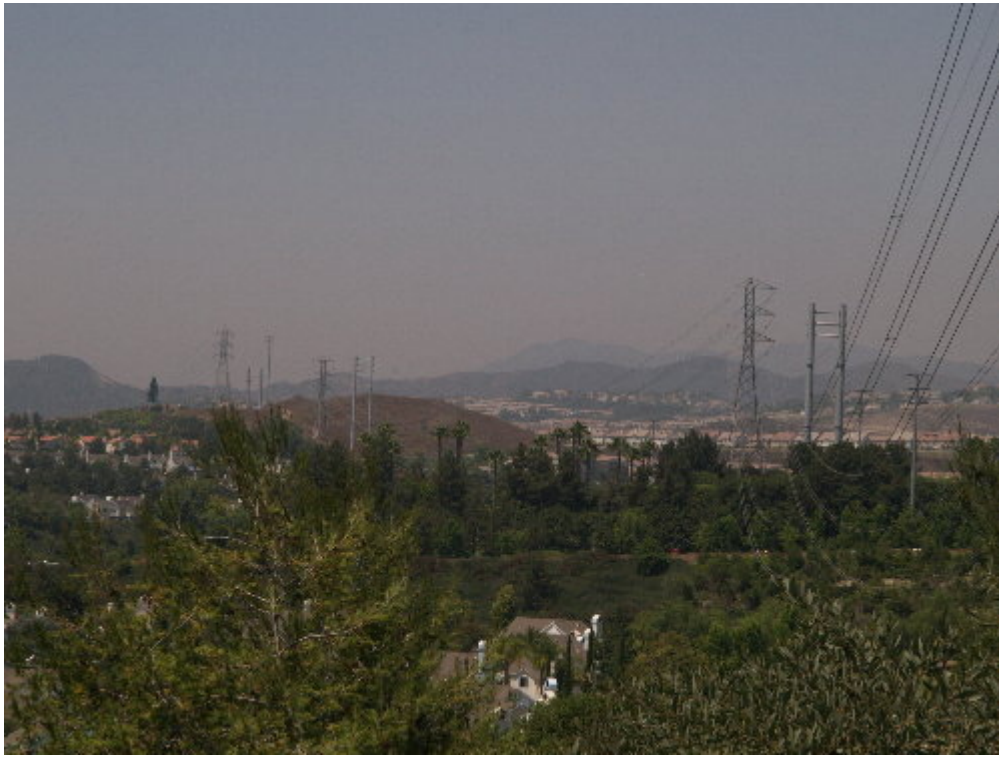
Figure 5 – Raised H-Structures 8, 9, and 10, looking to the north. H-Structure 8 is in the foreground and H-Structures 9 and 10 are in the distance.
