PROJECT MEMORANDUM SCE – VIEJO SYSTEM PROJECT

To: Jensen Uchida, CPUC
From: Vida Strong, Aspen Project Manager
Date: July 26, 2005
Subject: Weekly Report #51, July 17 – July 23, 2005.

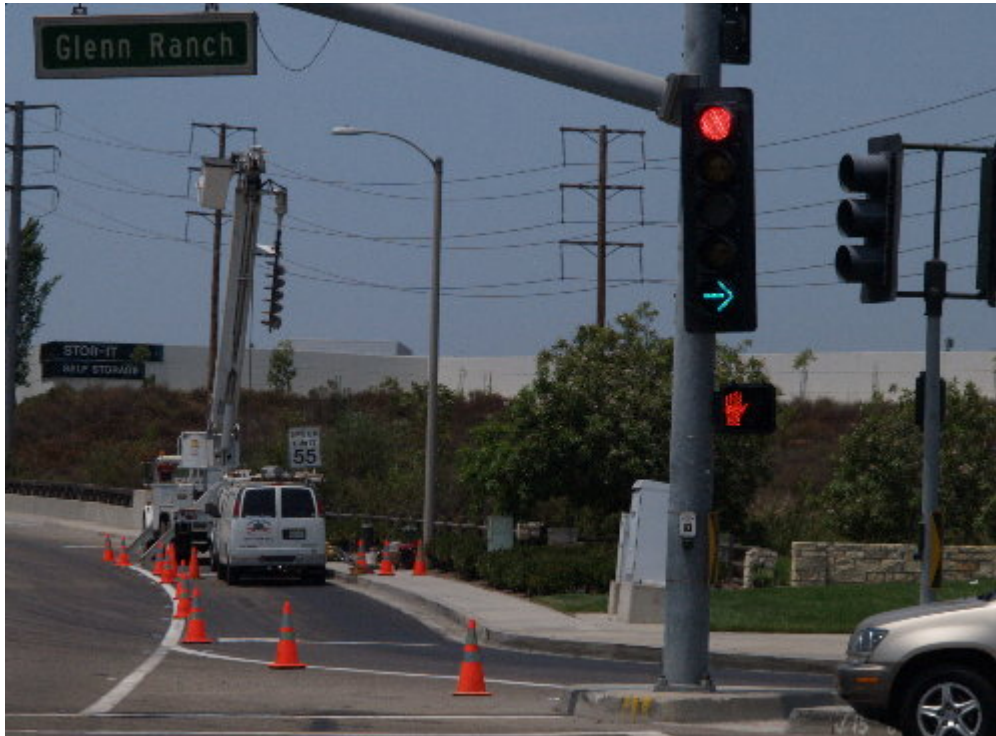
1. The electrical subcontractor, Hampton Tedder, had a crew working in the 12 kV vault on Portola Parkway during the site visit (see Figure 1). The vault connects the 12 kV from the substation to the local distribution system. Hampton Tedder has connected four sets of three 12 kV underground conductors to the racks in the substation.

Figure 1 – A Hampton Tedder crew worked in the underground vault on Portola Parkway, connecting the substation site to the SCE distribution system.

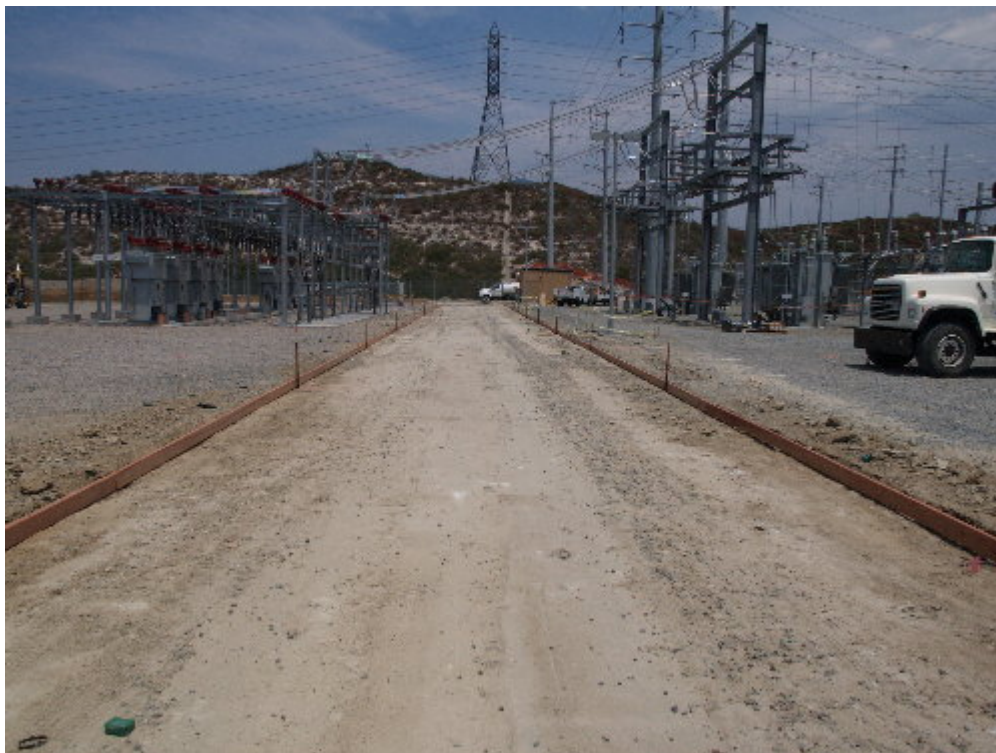
2. The road contractor has finished the rough grading for the asphalt road within the substation site (see Figure 2). No work was occurring on paving during the site visit.

Figure 2 – The paving contractor finished rough grading of the substation roadway prior to paving.

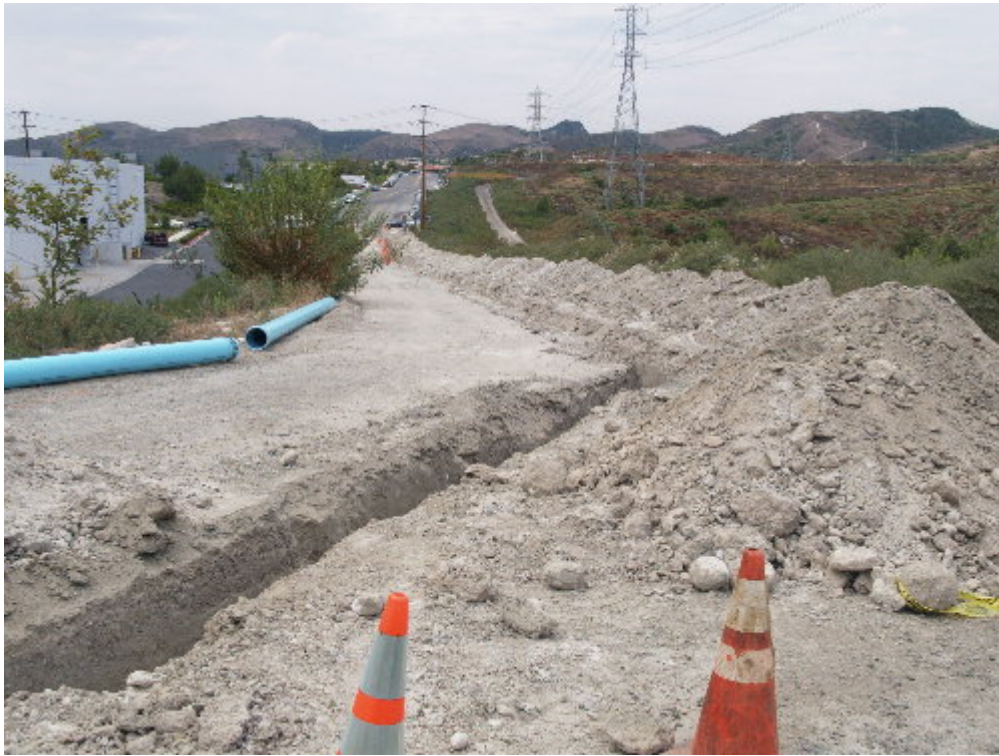
3. A subcontractor worked with a backhoe to excavate the trench for the fire control system (see Figure 3). The ground was very hard and progress on the trenching was slow.

Figure 3 – A subcontractor worked to trench through the hard ground and lay the water supply line for the fire control system.

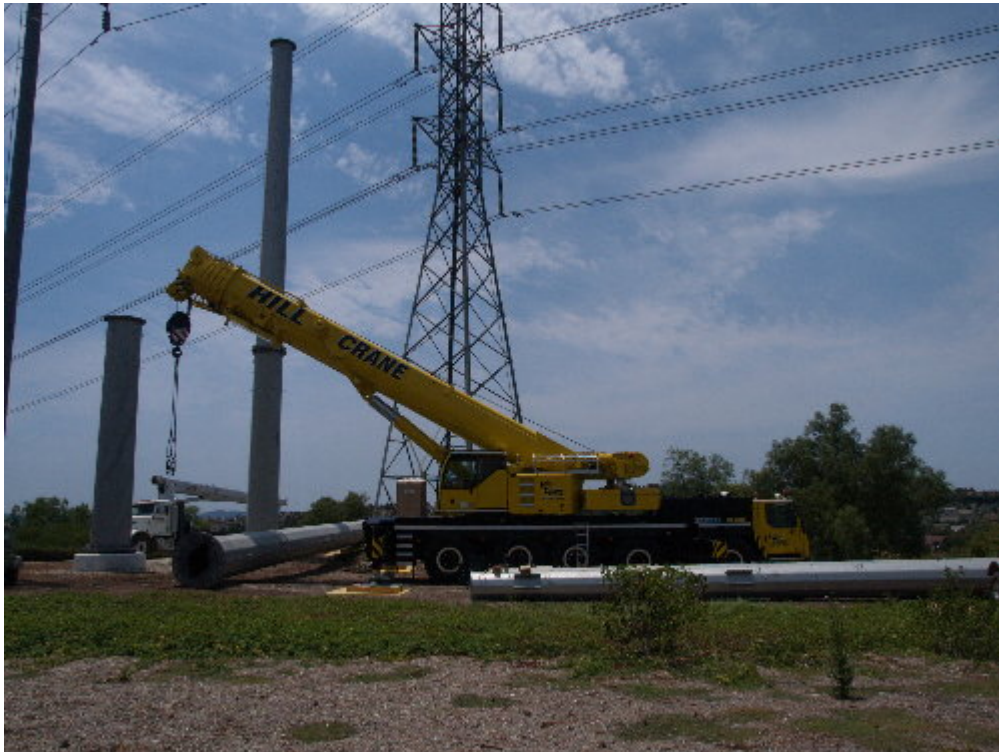
1. The Hill Crane was set up at Structure 6 and the crew worked in the morning, before work was shut down in order to re-energize the adjacent power line (see Figure 4). Work cannot safely proceed without taking the adjacent lines out of service. Those lines were needed to address the power demands during the extended heat spell. Arizona Pipeline may take some time off until work can proceed without interruption.
2. H-Structures 10, 9, and 8 have been raised and the cross members attached. Most of the work has been completed on Structure 7.

Figure 4 – The Hill Crane was at Structure 6, waiting for work to resume.
