PROJECT MEMORANDUM SCE – VIEJO SYSTEM PROJECT

To: Jensen Uchida, CPUC
From: Vida Strong, Aspen Project Manager
Date: August 10, 2005
Subject: Weekly Report #53, July 31 – August 6, 2005.
CPUC Environmental Monitor (EM): Christopher Meyer

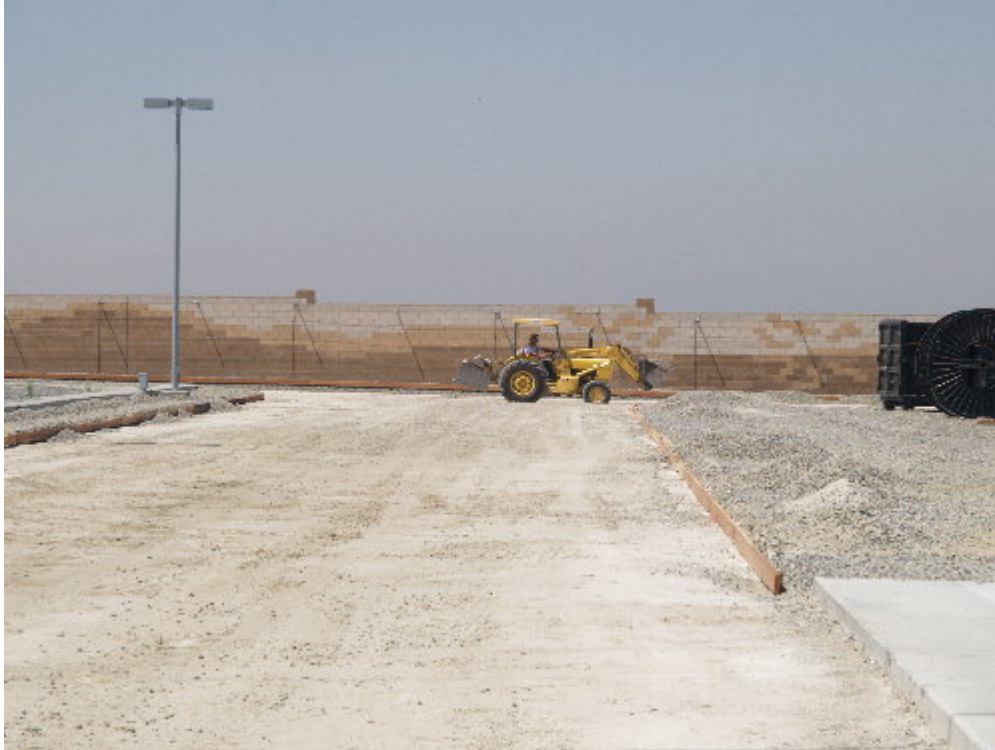
1. The road contractor had crews working with a grader to complete final grading of the roads within the substation site in preparation for paving. The roads around the edges of the site will receive base prior to the asphalt and the roads crossing through the site will receive an extra 2 inches of asphalt instead of base rock. A backhoe was used to place rock on the apron on the roads prior to placing asphalt (see Figure 1). No water truck was on-site for the work during the site visit. The contractor was pulling a small water trailer behind a pickup truck (see Figure 2). The water trailer had very little pressure and dust was still visible leaving the work area during the rock moving activities. SCE has requested that the contractor bring a water truck to the site to control dust during paving activities. No work was occurring on paving during the site visit.

Figure 1 – The paving contractor crew worked placing rock on the borders for the substation roadway prior to paving.

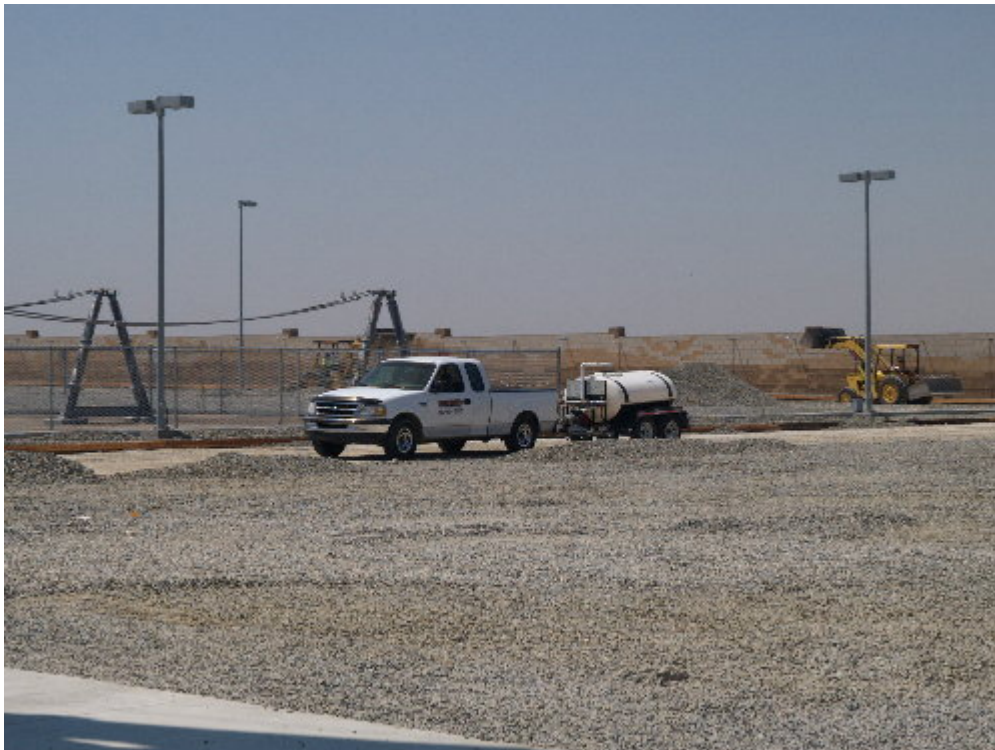
1. Watering of the gravel pile and grading will need to improve to avoid off right-of-way fugitive dust. For all other operations, the CPUC EM observed that construction was in compliance with mitigation measures adopted in the MND and other permitting requirements.

Figure 2 – A small water trailer was used to control dust rather than a water truck during the site visit.

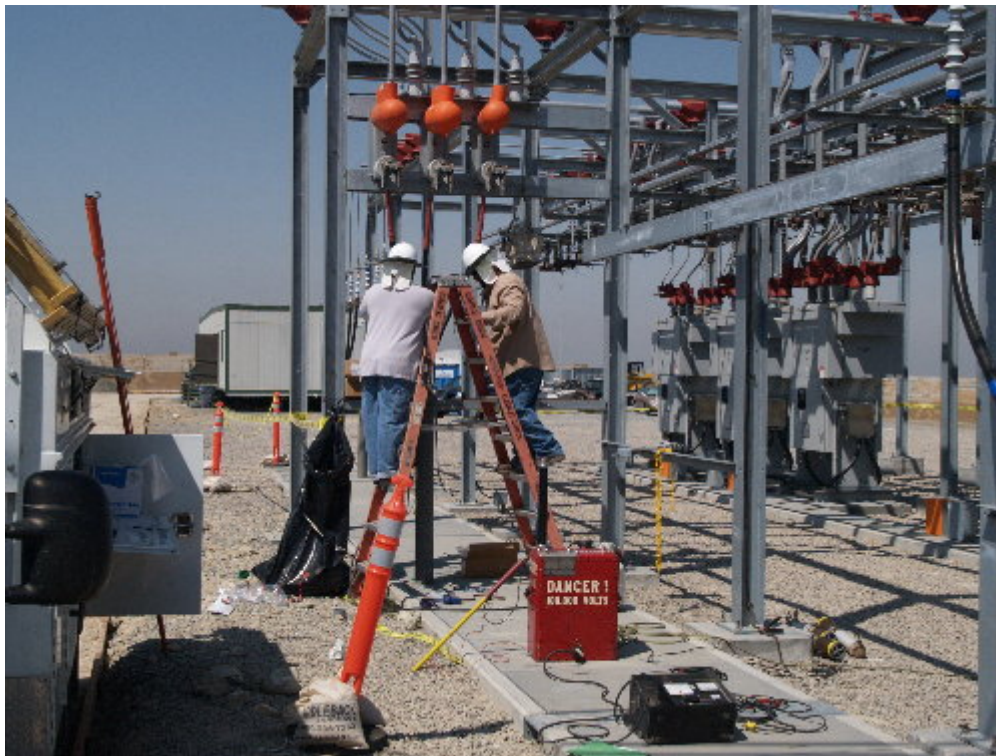
3. An SCE crew worked within the substation site on the 12 kV system during the site visit. The crew worked to connect the 12kV station light and power to both the 12 kV rack and the transformer adjacent to MEER #1 (see Figure 3). The power cable between the 12 kV rack and MEER #1 has been placed underground.

Figure 3 – An SCE crew worked to connect station light and power during the site visit.

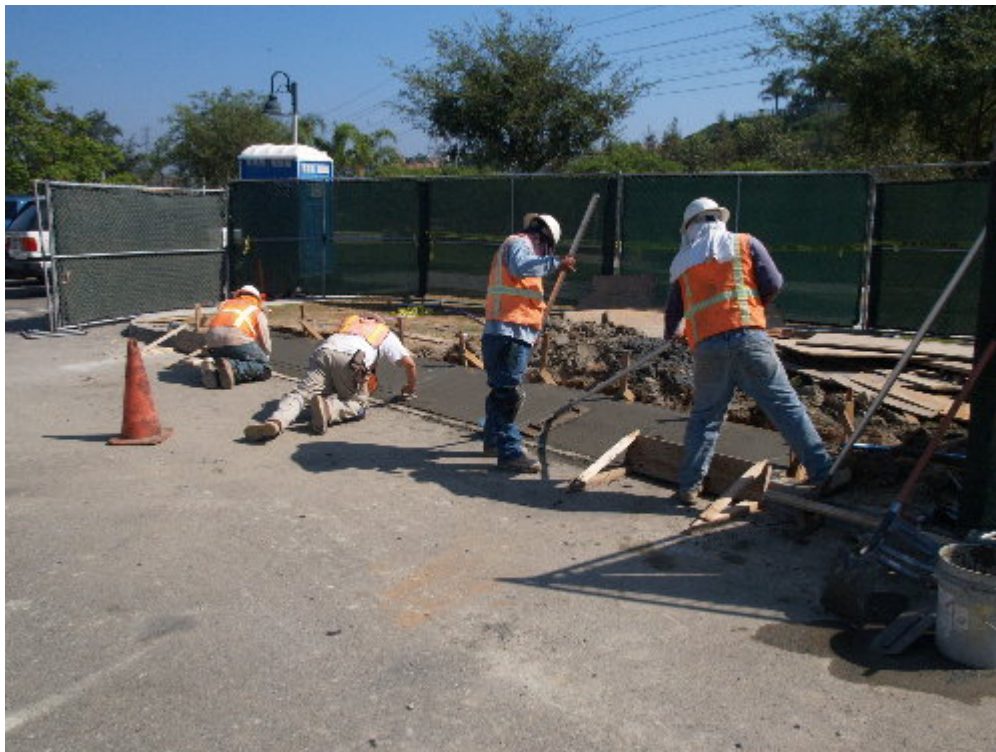
2. An Arizona Pipeline crew worked at Olympiad Park to form and pour a concrete access way at the curb (see Figure 4). Access to the right-of-way passed through a portion of the park and SCE will restore the access according to the previous agreement with the park. The concrete v-ditch adjacent to the access road was cleaned of debris and sediment. The concrete path crossed by the access route was damaged by the heavy equipment and may require repair and/or improvement. Work on the excavation of foundations for the H-Structures has been completed and the drilling machine will be removed from the Chiquita Substation area soon.

Figure 4 – An Arizona Pipeline crew worked on the curb access at Olympiad Park.

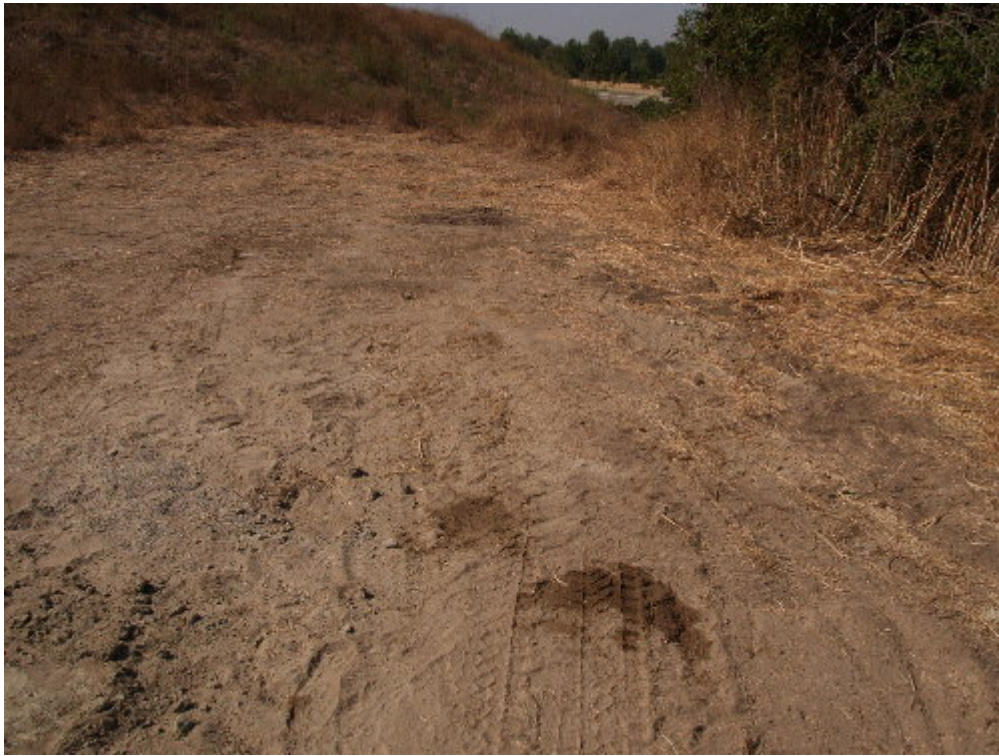
SCE was notified by the CPUC EM about a small oil spill in the work area near Structure 1 (see Figure 5). The spill was small and appeared to be relatively new automobile oil. Arizona Pipeline dispatched a small crew to address the spill.

Figure 5 – The small oil spill at the Chiquita Substation will be addressed by Arizona Pipeline.
