## PROJECT MEMORANDUM SCE – VIEJO SYSTEM PROJECT

To: Jensen Uchida, CPUC
From: Vida Strong, Aspen Project Manager
Date: August 24, 2005
Subject: Weekly Report #55, August 14 – August 20, 2005.
CPUC Environmental Monitor (EM): Christopher Meyer

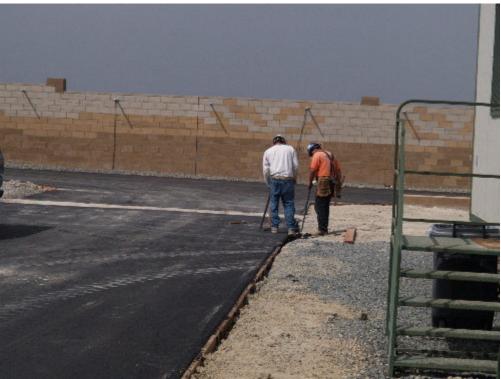
- 1. The road contractor's skip loader was down for repair at the time of the site visit and crews worked to replace forms broken by vehicle traffic through the substation site (see Figure 1). The road contractor worked on Saturday to pave all the roads within the substation site (see Figure 2). Some of the corners were considered too sharp by SCE and the radius at these locations will be corrected. In addition to the asphalt repairs, the road contractor will be placing additional rock on the margins of the roads within the substation site.

**Figure 1** – The paving contractor repaired forms damaged by vehicle traffic.

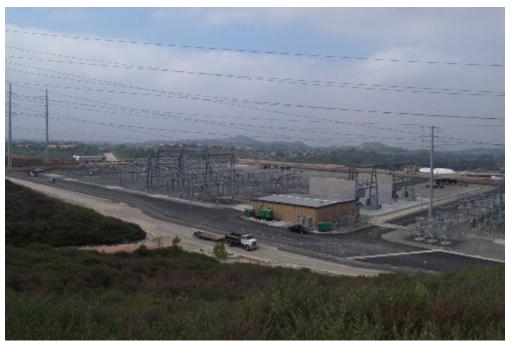
**Figure 2** – Substation site after the paving on Saturday.

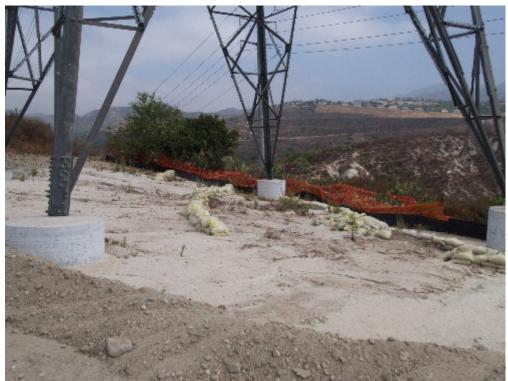
- 1. The invasive plant species in the recontoured area of the 220 kV right-of-way, adjacent to the native plant communities, have been removed by SCE without disturbing the native species (see Figure 3). The area adjacent to the project is dominated by native species and is part of a habitat conservation area.
- 2. Several sensitive bird species were noted in the habitat adjacent to the 220 kV right-of-way. The SCE biologist will work with the crews to avoid any impact to the habitat or disturbance of the nesting birds if any work resumes in the area.

**Figure 3** – The non-native plants were removed at the 220 kV structure above the substation site.

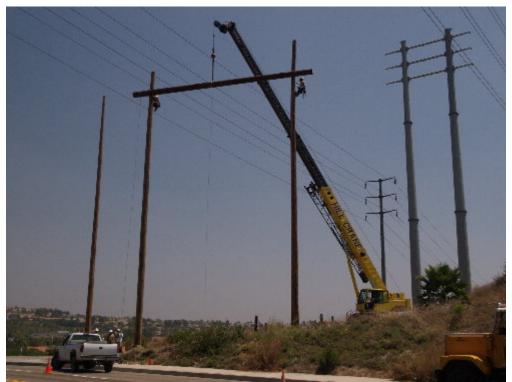
- 1. An SCE transmission line crew worked on Aliso Parkway installing a guard structure in preparation for upcoming stringing activities. Once the cross member was raised to the correct elevation, linemen secured it with cables (see Figure 4).
- 2. In order to work under an ISO outage and Caltrans approved closure of the 241 toll road, SCE prepared the H-structures between the substation and Structure 10 (see Figure 5). Travelers and ropes were installed on these structures in preparation for the pull. SCE and LSA biologists worked to clear the area between Structures 12 and 11 prior to any impacts with dropped conductor or pulling wires.

Figure 4 – An SCE transmission line crew worked to set the guard structure on Aliso Parkway.

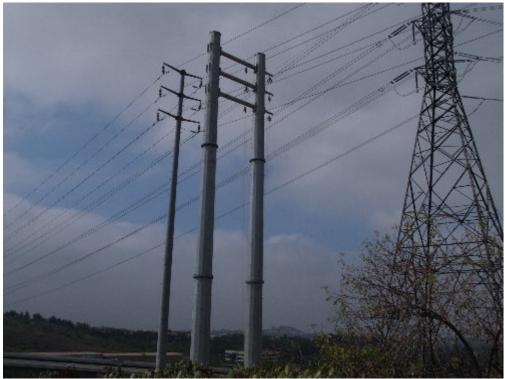
**Figure 5** – H-structure 11 prepared for Saturday pull across the 241 toll road.
