## **PROJECT MEMORANDUM SCE – VIEJO SYSTEM PROJECT**

**To:** Jensen Uchida, CPUC  
**From:** Vida Strong, Aspen Project Manager  
**Date:** October 18, 2005  
**Subject:** Weekly Report #62, October 9 – October 15, 2005.  
**CPUC Environmental Monitor (EM):** Christopher Meyer

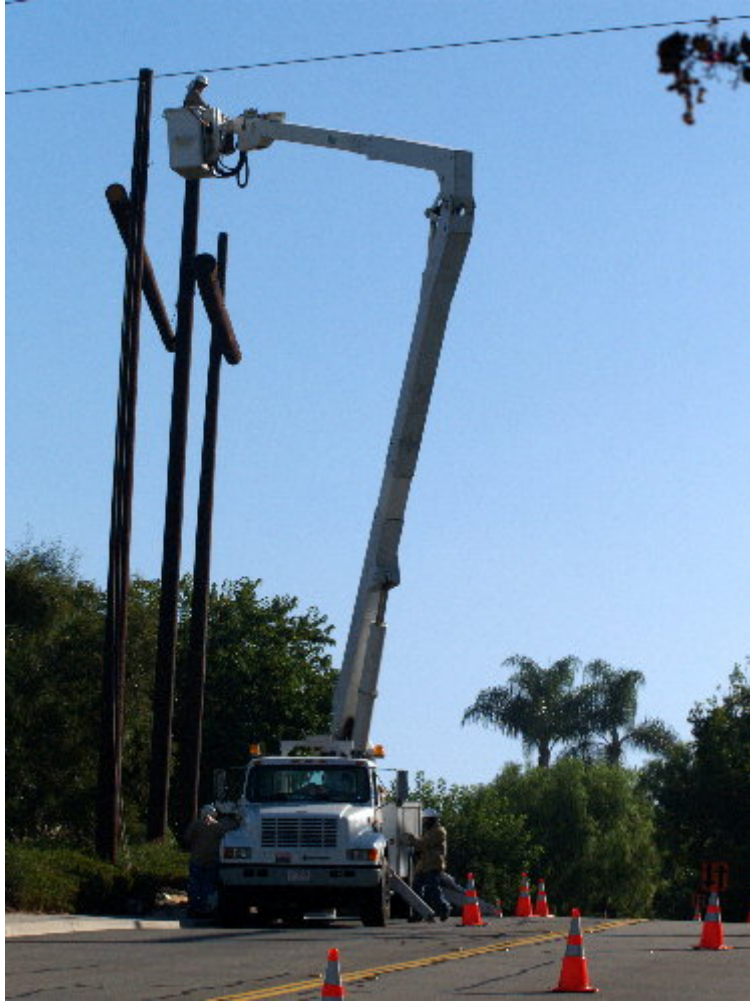
1. SCE transmission line crews worked to extend the guard structures at La Barca in preparation for stringing activities during the site visit. The crews worked with a truck-mounted crane to raise the limber section that were attached to the existing guard structure in order to provide protection of the conductor to the west (see Figure 1). Proper traffic controls were placed for the work on La Barca (see Figure 2).
2. Crews and equipment were staged at H-Structure 10 in preparation for pulling the conductor between Structure 10 and Structure 7 (see Figure 3). All work observed during the site visit was within previously disturbed areas and on access roads.

**Figure 1** – The transmission line crew used a truck mounted man-lift and crane to raise the timber for extending the guard structure at La Barca.

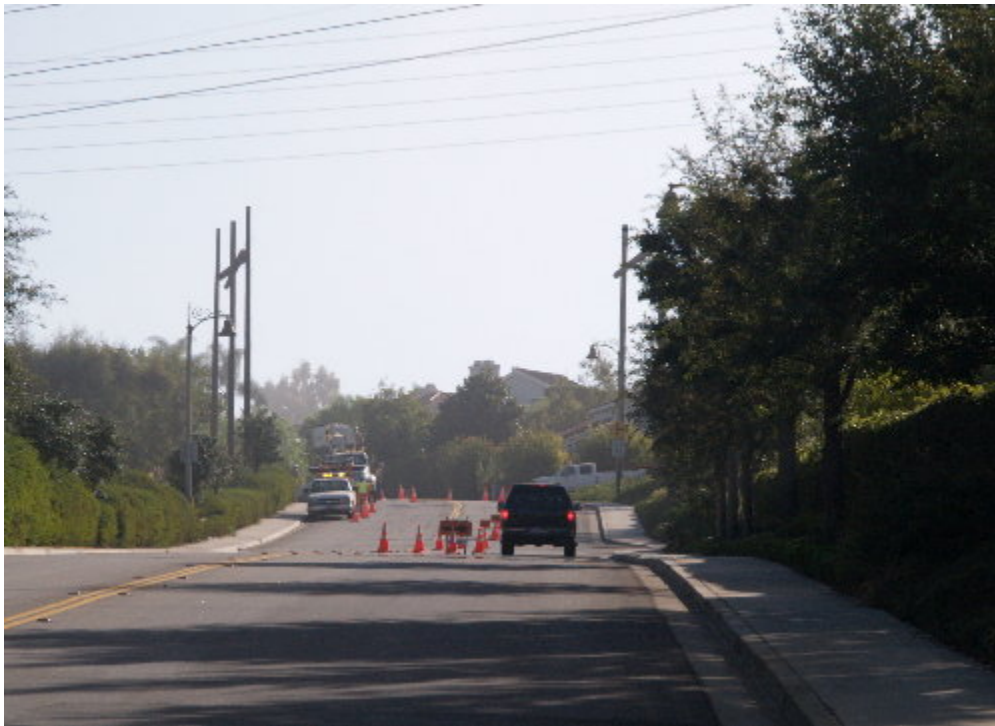
**Figure 2** – Although only the curb was used during extension of the guard structure, traffic controls were placed to protect both the crews and the public.

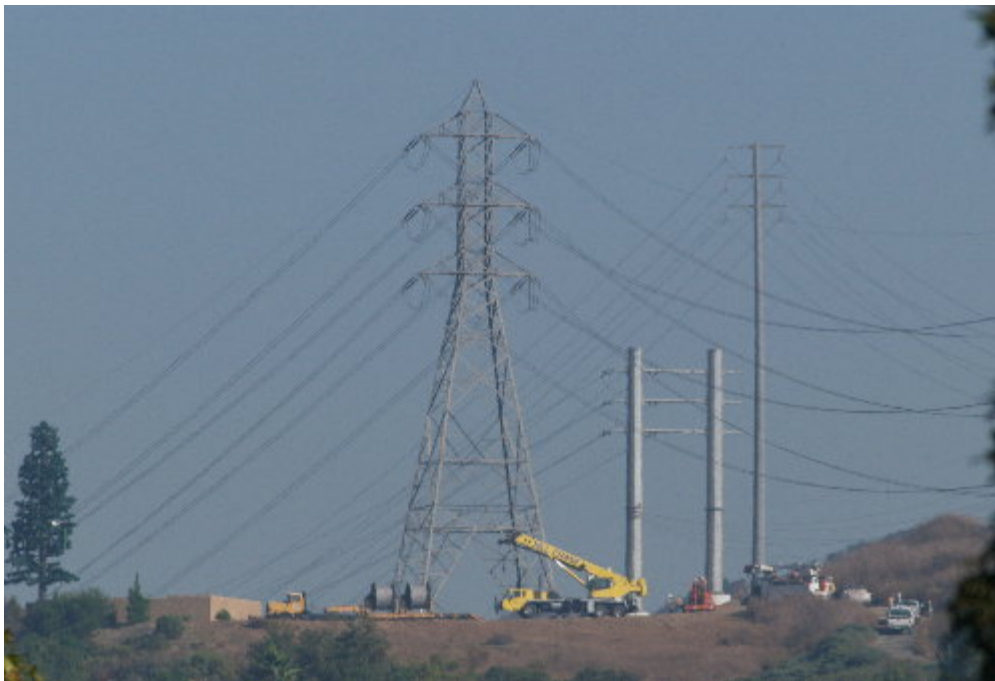
**Figure 3** – Reels of conductor and stringing equipment was set at H-Structure 10 to prepare for pulling conductor between Structure 10 and Structure 7.
