Aspen Environmental Group

PROJECT MEMORANDUM SCE – VIEJO SYSTEM PROJECT

Subject: Weekly Report #66, November 6 – November 12, 2005.

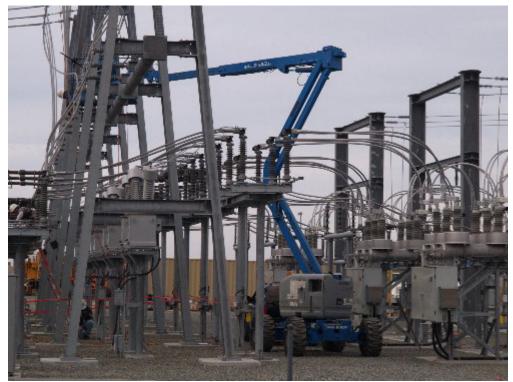
- 2. A crew worked within the Viejo Substation during stringing activities associated with the 66 kV right-of-way (see Figure 1).
- 3. The 220 kV section of the substation site has been marked off with caution tape now that it is energized. The several sections of the 66 kV portion of the site, which are energized, have been surrounded with cyclone fencing and caution tape as well. With the completion of the majority of the civil work, the remaining crews at the substation site have experience working in energized stations. SCE previously provided the CPUC EM with an orientation on visiting an energized station.

Figure 1 – A small crew worked within the Viejo Substation during the stringing activities.

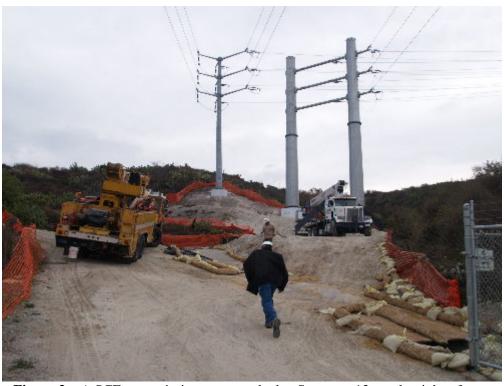
1. Two SCE transmission line crews were set during the site visit to switch lines over from the adjacent poles to the center position of the new H-Structures at transition points at the Viejo and Chiquita Substations (see Figure 2). One crew worked at each substation performing similar activities. The conductor has been strung through the center position on Structure 12, but was ended at Structure 13 until this week's activities (see Figure 3). No other work was noted during the site visit.

Figure 2 – A SCE transmission crew worked at Structure 13, on the right-of-way above the Viejo Substation, preparing to move conductor to the center position between Structure 13 and the substation.

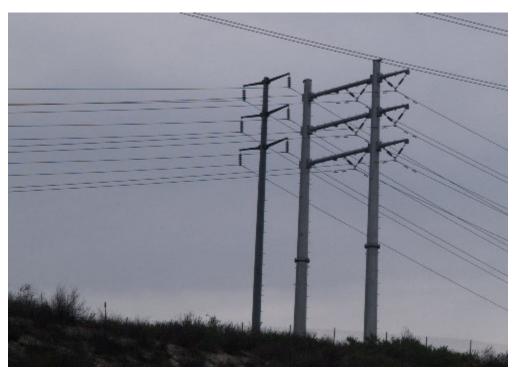
Figure 3 – Conductor can be seen in one of the center positions of Structure 12. The H-Structures are designed to accommodate two circuits in the center position; however, only one will be placed at this time.

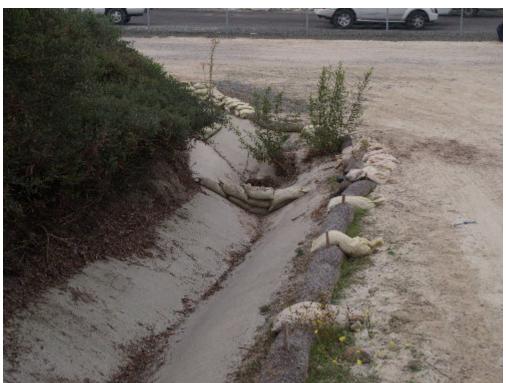
BMPs have been implemented at the base of the guard structures to prevent the loose material from being transported onto the public right-of-way. The BMPs placed in v-ditches below the new pads have been maintained in preparation for predicted rainfall (see Figure 4).

Figure 4 – The BMPs in and around the Viejo Substation were cleaned out in preparation for the predicted rainfall.

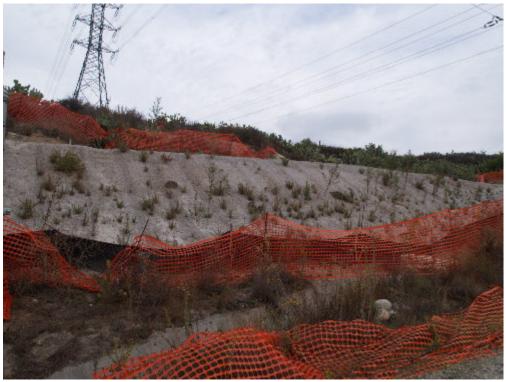
The slope below the pads above the Viejo Substation have been covered with jute netting in preparation for restoration and native vegetation has emerged through the netting (see Figure 5). The non-native species should be removed before they produce seed.

Figure 5 – Some recruitment of native species was observed on the slopes of the structure pads above the Viejo Substation.
