PROJECT MEMORANDUM SCE – VIEJO SYSTEM PROJECT

To: Jensen Uchida, CPUC
From: Vida Strong, Aspen Project Manager
Date: January 25, 2006
Subject: Weekly Report #73, January 15 - January 21, 2006.
CPUC Environmental Monitor (EM): Jenny Slaughter

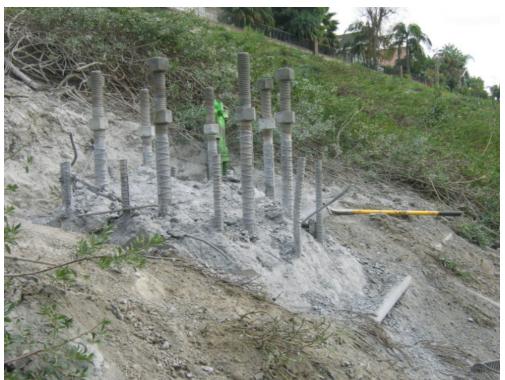
- 1. SCE crews continued to install fiber optic tabs on several of the structures during the site visit.
- 2. SCE subcontractor, Arizona Pipeline, has been onsite to remove the old tower footings. Most of these footings are being removed using a backhoe, but some will require dismantling by hand because of the location of the footing (see Figure 1).
- 3. SCE crews plan to restore the right-of-way by doing some minor grading and installing v-ditches. Work that remains to be done includes removing the dismantled poles and restoring access roads.
- 4. Other work included installation of fiber optic vaults under the base of transmission towers (see Figure 2). Although this work is taking place within the SCE right-of-way, it is unrelated to the Viejo transmission project.

Figure 1 – Arizona Pipeline crew dismantling a tower footing by hand.

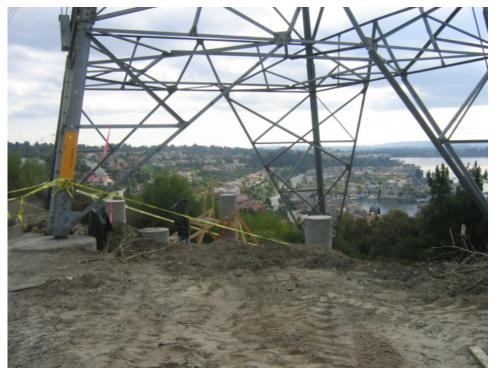
Figure 2 – Fiber optic vault structure construction at a lattice tower within the SCE right-of-way.
