PROJECT MEMORANDUM
SDG&E VINE 69/12-KV SUBSTATION PROJECT

To: Eric Chiang, Project Manager, CPUC
From: Vida Strong, Aspen Project Manager
Date: September 19, 2016
Subject: Monitoring Report #4: August 28 to September 10, 2016

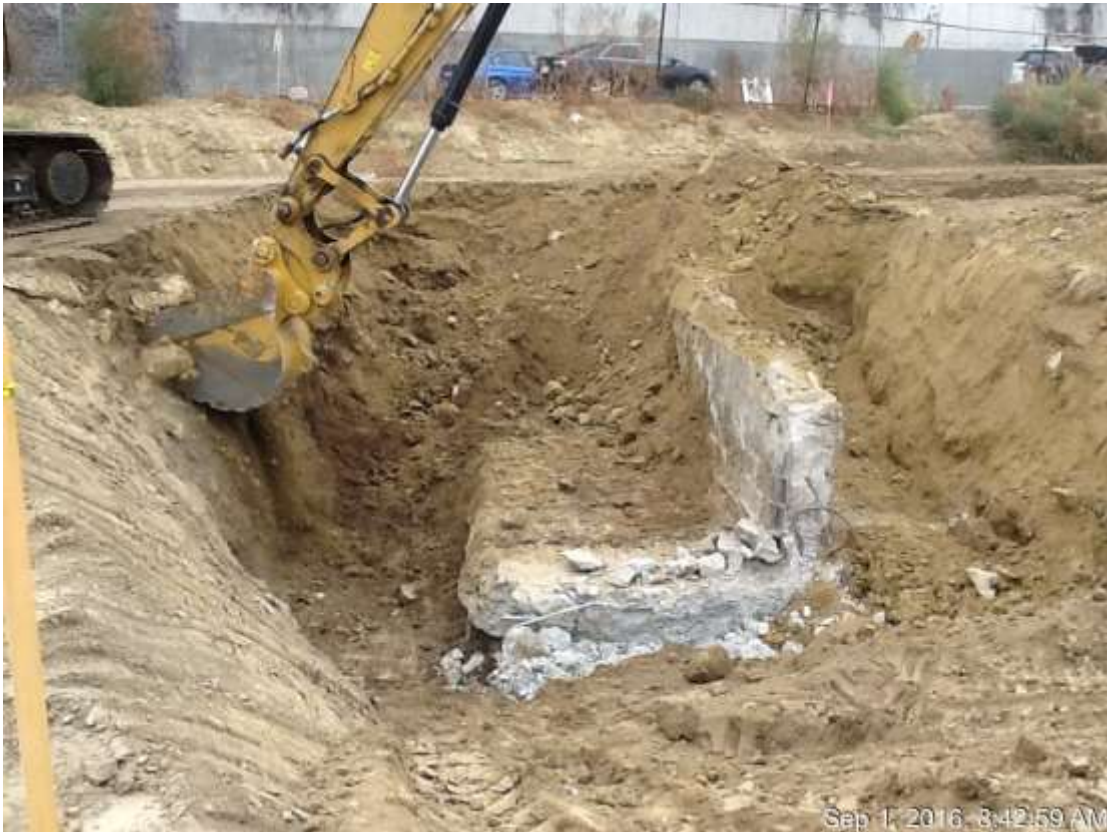
3. Demolition and removal of the buried foundation was completed during the subject period (see Figures 1 and 2). The debris from the demolition was hauled off site on a daily basis.

Figure 1 – Demolition of the concrete foundation identified at the Vine Substation site.

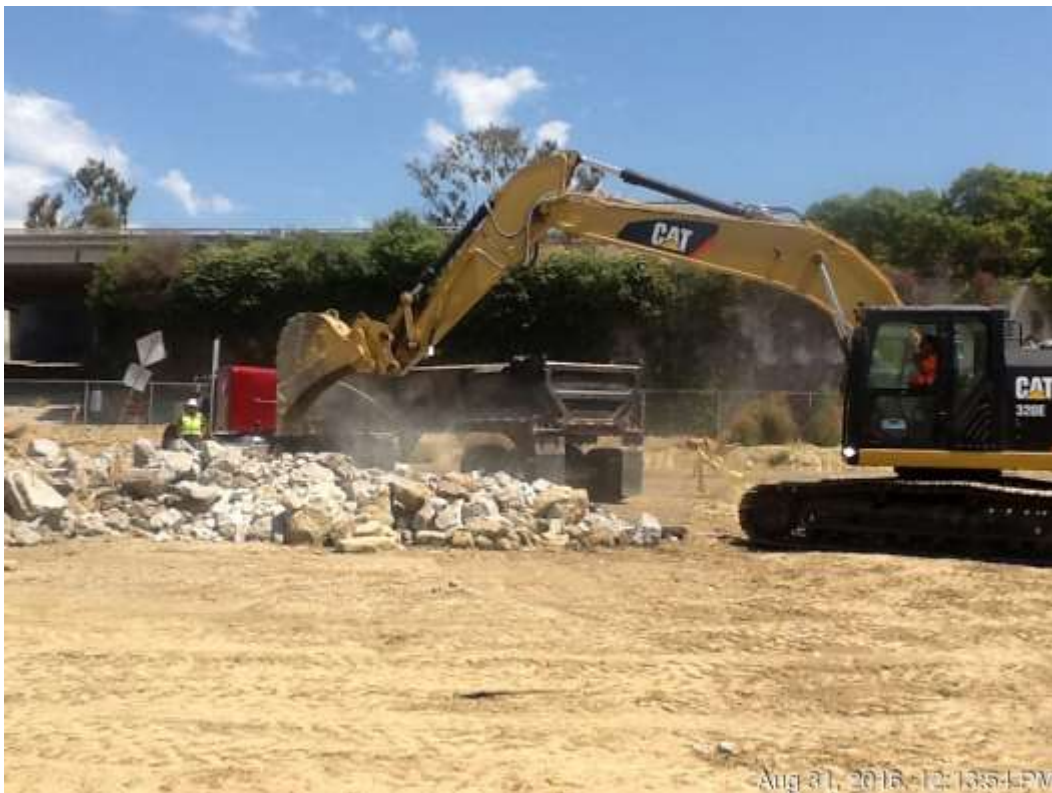
Figure 2 – The foundation was crushed into pieces and hauled offsite for disposal.

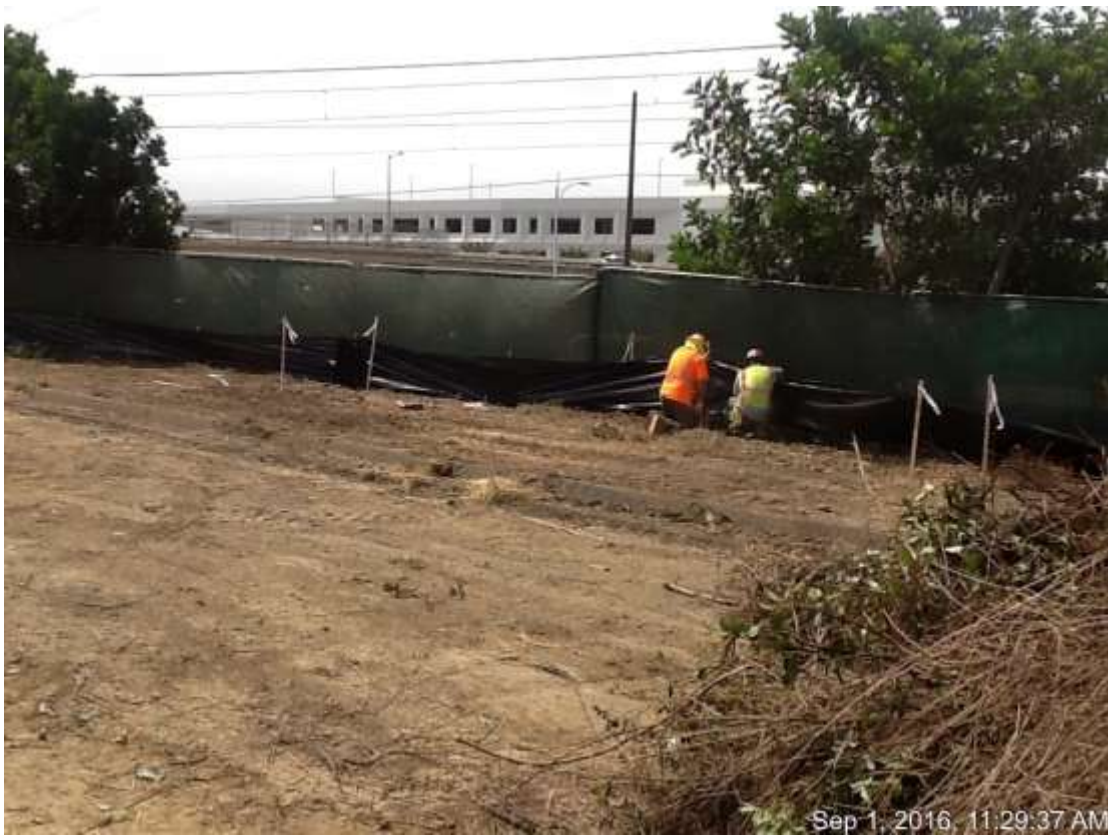
4. Crews removed the existing fencing along the railroad right-of-way and constructed a temporary perimeter fence. Railway safety flaggers were present during the fence installation (see Figure 3).

Figure 3 – Temporary fence installation along the railroad right-of-way.

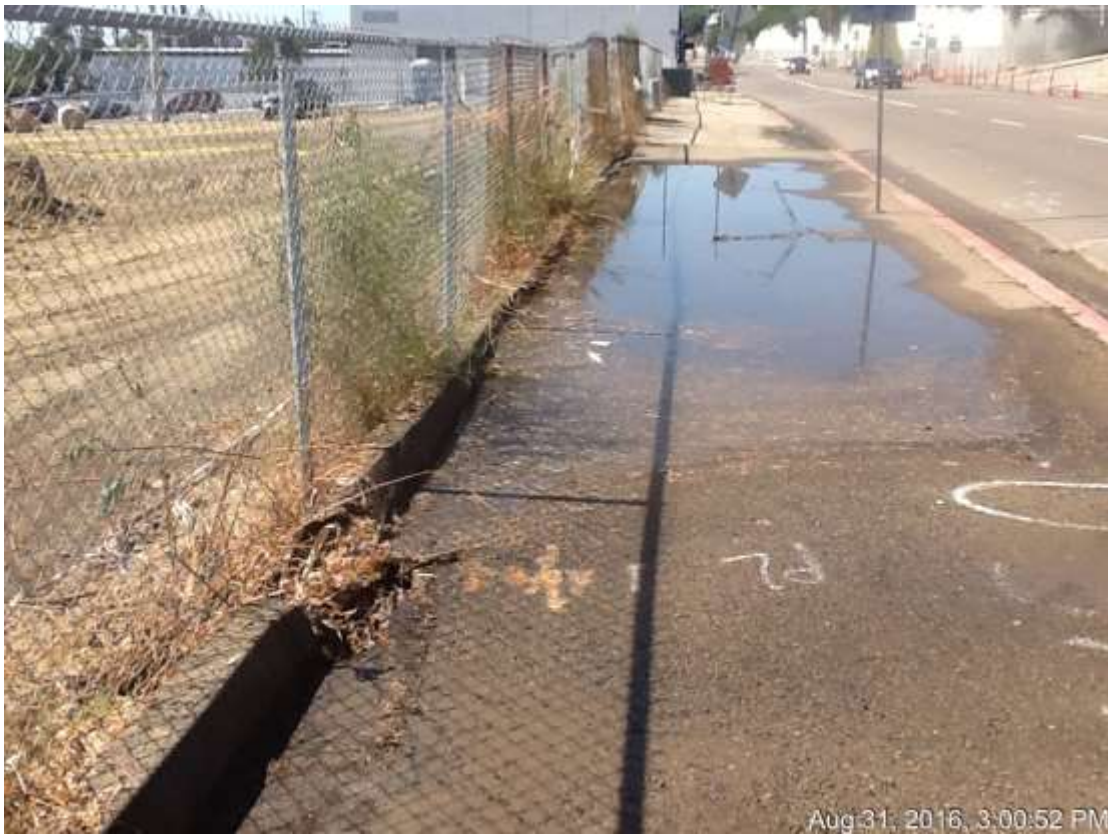
5. Site grading began once the buried foundation removal was completed.
6. On August 31, an accidental release of approximately 100-gallons of hydrant water occurred when the water truck on site drove off while the hose was still connected to a hydrant located immediately outside of the site fence along Kettner Boulevard. The hydrant valve was shut off as soon as personnel could access the hydrant. Some hydrant water pooled along the sidewalk and

shoulder of Kettner Boulevard, and also ran off onto the substation site. Additionally, much of the water had flowed down Kettner Boulevard onto Vine Street, and into a protected storm drain inlet (see Figures 4 and 5).

Figure 4 – Water from an accidental release of hydrant water pooled up along Kettner Boulevard.

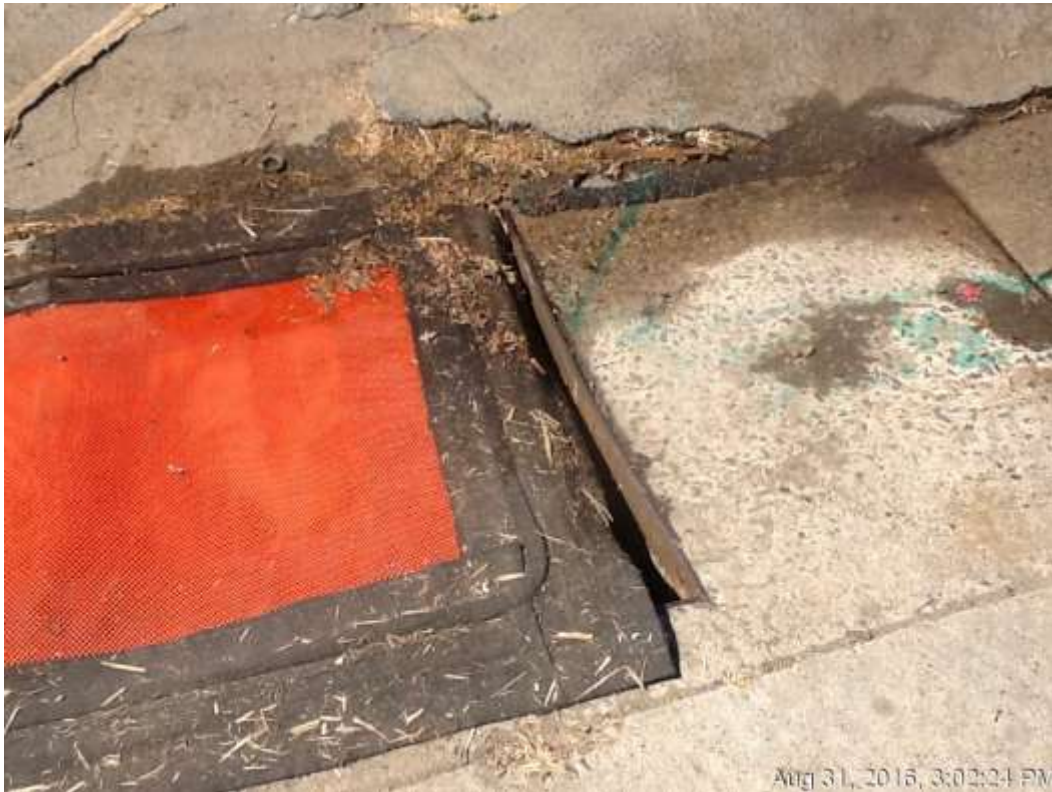
Figure 5 – The hydrant water flowed into a storm drain along Vine Street and also flowed onto the substation site.

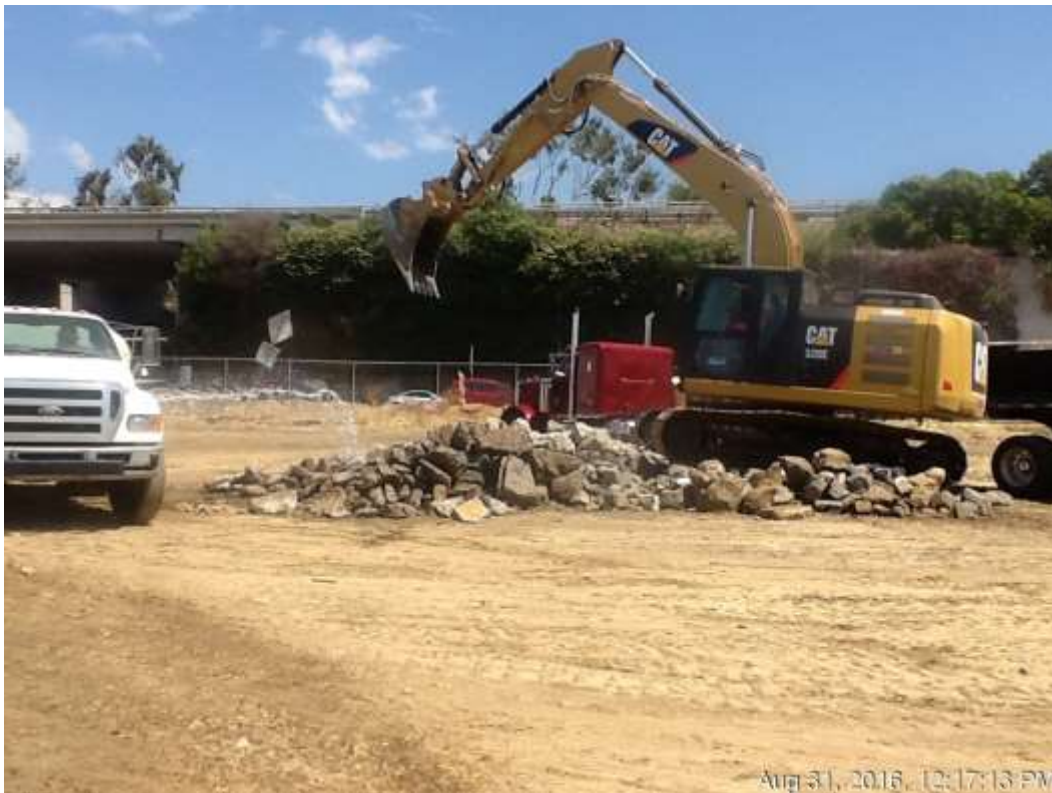
1. **Air Quality AQ-3-** Dust was visible during concrete foundation demolition and loading into haul trucks. This was reported to the site Environmental Inspector (EI) and the crew sprayed down the debris pile to control the dust (see Figure 6).
2. **Air Quality AQ-3-** The CPUC EM observed a haul truck leaving the site without a cover. The EI was notified and the crews were reminded to cover haul loads.
3. **SWPPP WM-9-** The CPUC EM noted that the port-a-potty was staged at the discharge point of the site, approximately 25-feet from a storm drain inlet. Temporary sanitary facilities should be located away from drainage facilities, watercourses, and from traffic circulation. The EI was made aware of the observation and the port-a-potty was moved.

Figure 6 – Water was applied to the debris pile to minimize dust from the demolition and hauling operations.
