PROJECT MEMORANDUM
PG&E WINDSOR SUBSTATION PROJECT

To: Eric Chiang, Project Manager, CPUC
From: Vida Strong, Aspen Project Manager
Date: January 5, 2017
Subject: Monitoring Report #4 – December 19, 2016 to January 1, 2017

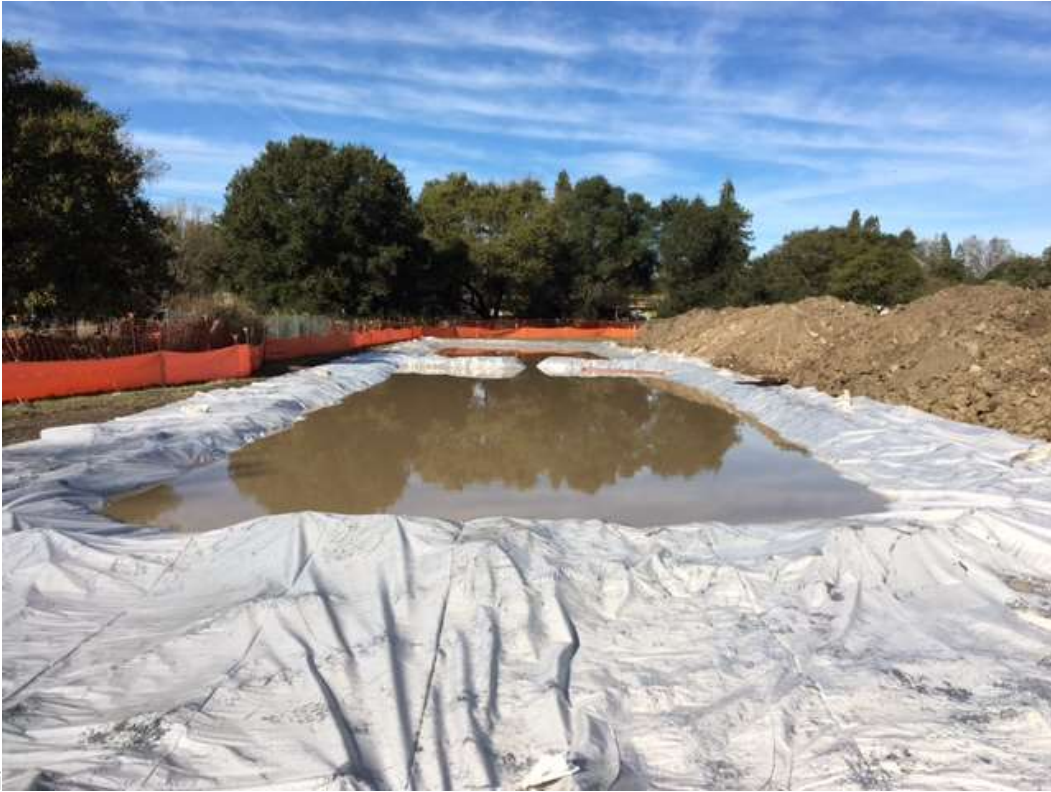
The site continued to be saturated with areas of ponded water. A second storm water retention pond adjacent to the first pond was excavated and lined with plastic (see Figure 1), and a Baker tank with secondary containment was delivered and set up adjacent to the office trailer, on the east perimeter of the substation site. Water was pumped from the central excavation and ponded areas to the storm water ponds, where suspended sediment could settle prior to water being pumped from the ponds to the drain inlet.

Figure 1 – A second storm water retention pond was constructed on the western side of the substation site adjacent to the first pond, December 20, 2016.

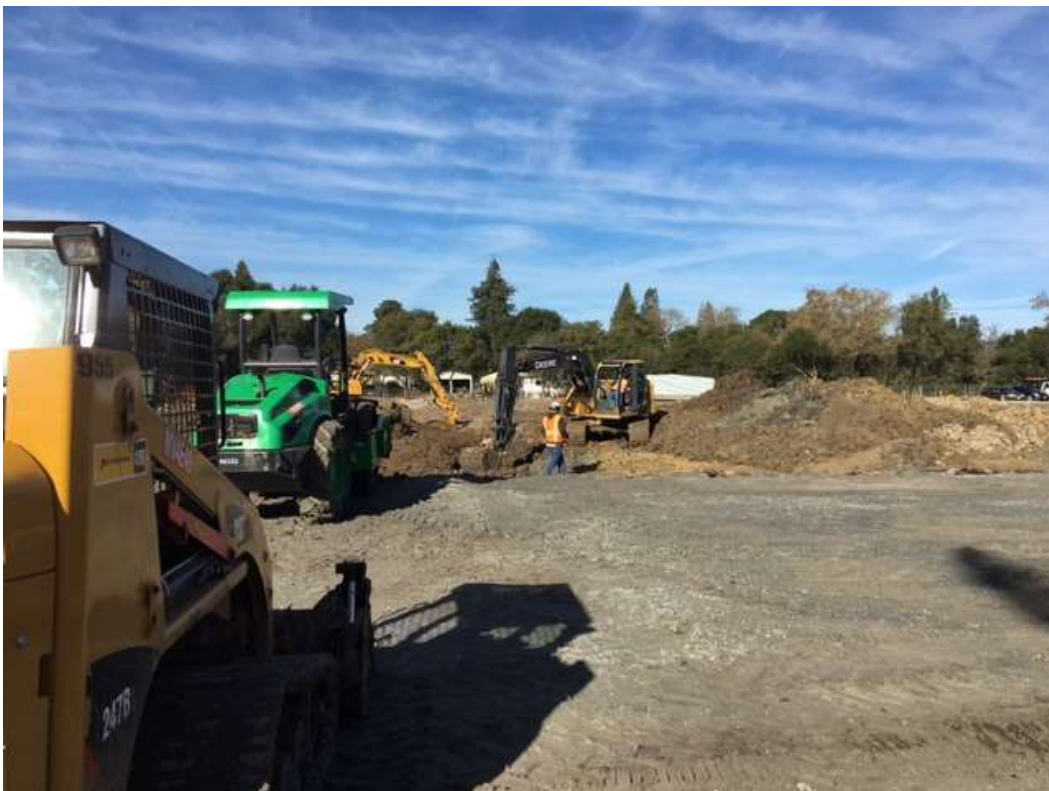
At the time of the CPUC EM's site visit on Tuesday, December 20th, crews were excavating and bulldozing soil from the middle of the site, and laying and compacting engineered rock in the central trench area of the site (see Figure 2). The CPUC EM discussed the recent storm event of December 15th and 16th with Kevin Risley (PG&E Environmental Field Specialist) and Casey Alver (PG&W Water Specialist) and showed them pictures of storm water flow taken during and immediately after the storm event, during which approximately 3 inches of rain was recorded. In general, BMPs were functioning well and the color of offsite flow was similar to that observed by the CPUC EM in a nearby

creek in an undisturbed area. However, there was one location along the northern perimeter where there was only one fiber roll and the offsite flow was visibly more turbid.

Figure 2 – Excavating from the central area of the substation site, December 20, 2016.

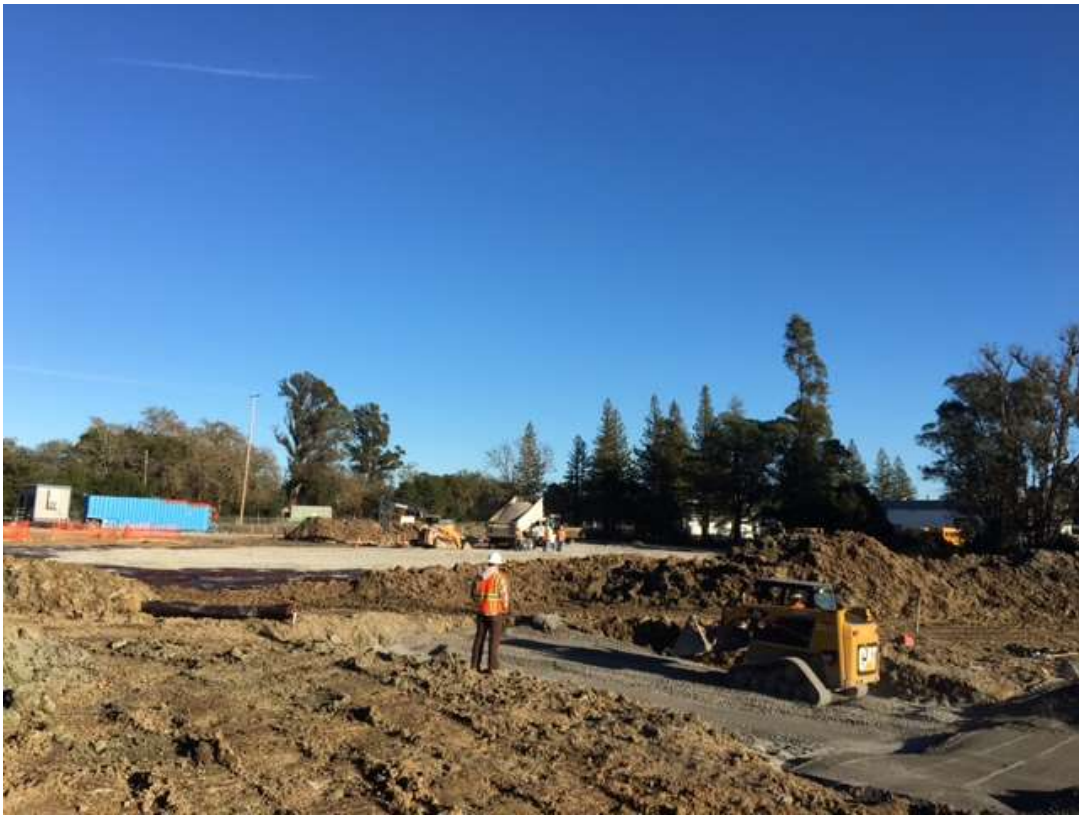
Figure 3 – Rock being delivered and compacted at the substation site, December 22, 2016.

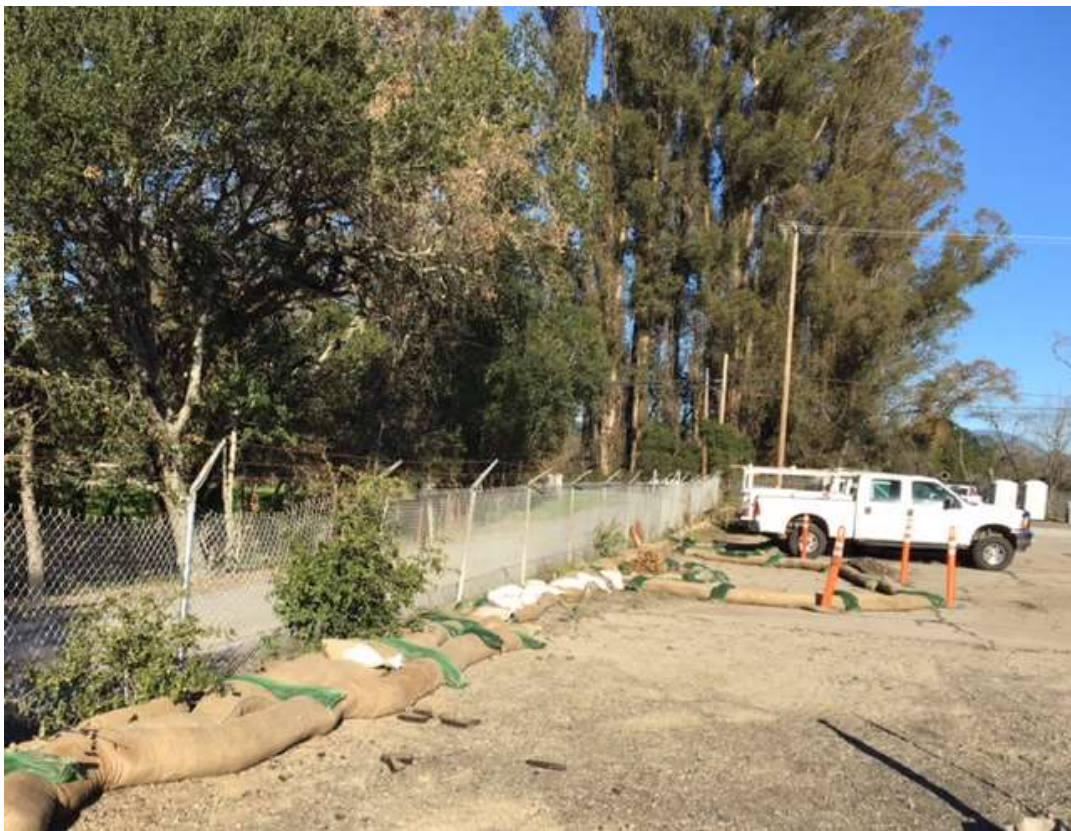
At the time of the CPUC EM's site visit on Thursday, December 22nd, engineered rock was being delivered to the site, and crews were placing and compacting the rock (see Figure 3). Crews were also observed sweeping the rumble plates at the entrance to the site to avoid track-out onto Old Redwood Highway. Additional BMPs had been placed on the northern side of the substation site, where off-site flow had occurred the previous week (see Figure 4).

Figure 4 – Additional BMPs were installed on the northern side of the substation site, December 22, 2016.

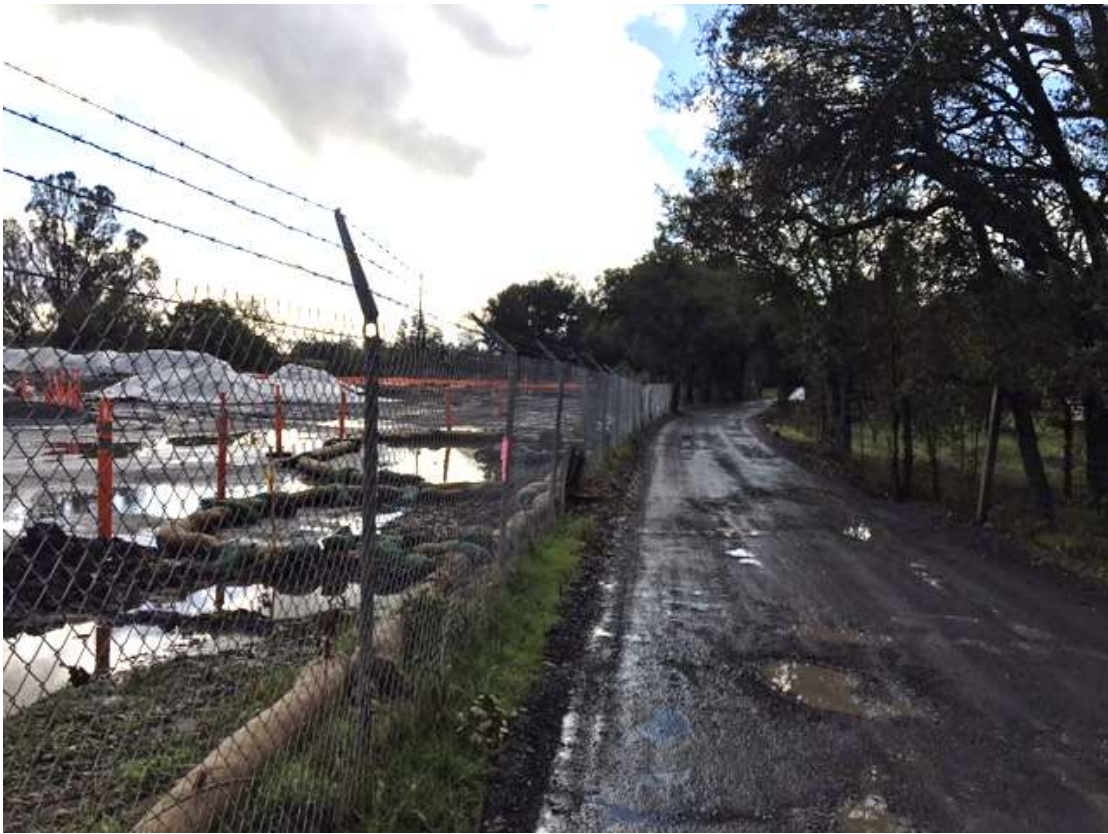
The CPUC EM conducted a site visit of the perimeter of the substation site on Friday, December 23rd, around 2:30 pm after the rain event. Crews did not work that day due to the rain event. The CPUC EM walked along the outside of the fence on the north side of the substation and inspected BMPs and SWPPP measures (see Figure 5). No flowing water was observed going off-site other than what was draining through the drainage inlet into the unnamed ephemeral creek, which was flowing fairly clear.

Figure 5 – Northern perimeter of site after storm event, December 23, 2016.

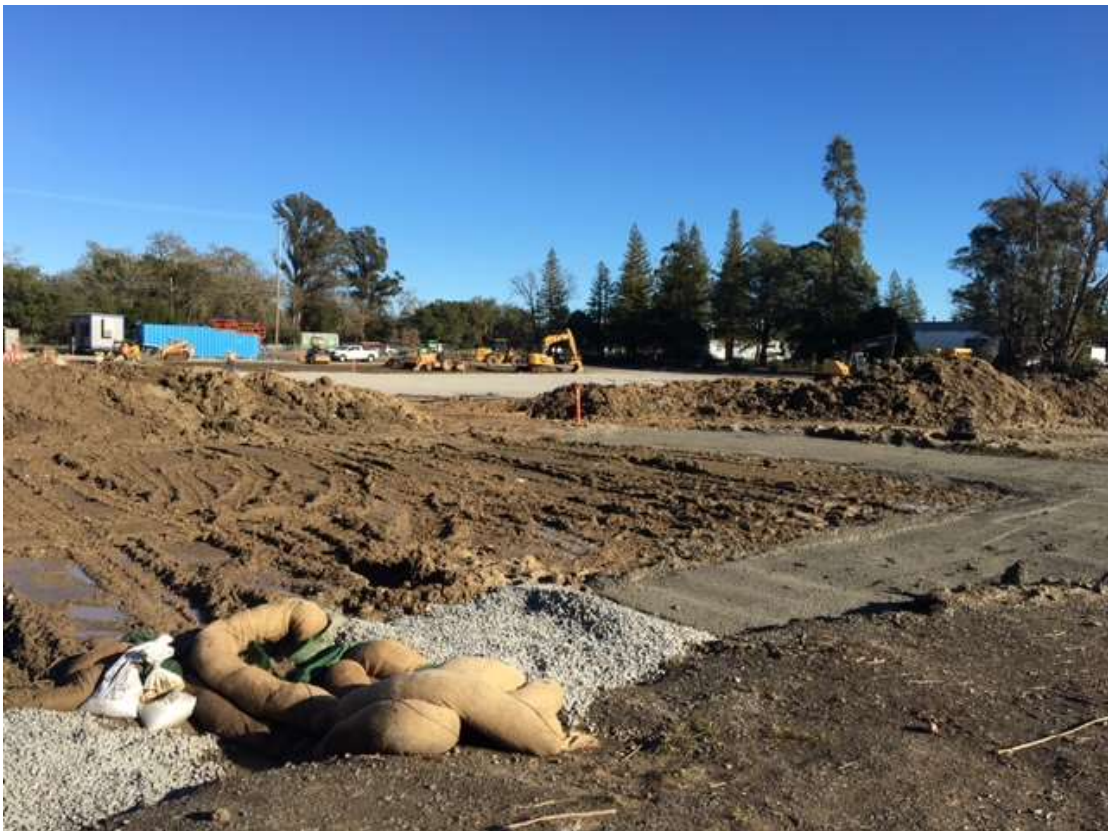
At the time of the CPUC EM site visit on December 28th, base rock was being delivered, and backfilling and compacting of base rock was occurring throughout the substation site (see Figure 6).

Figure 6 – Rock was delivered to substation site and compacted, December 28, 2016.
