<p>California Public Utilities Commission <i>Mitigation Monitoring, Compliance, and Reporting Program</i></p>
	<p>Cleveland National Forest Power Line Replacement Projects</p> <p>Compliance Status Report: 010</p> <p>February 5, 2017</p>

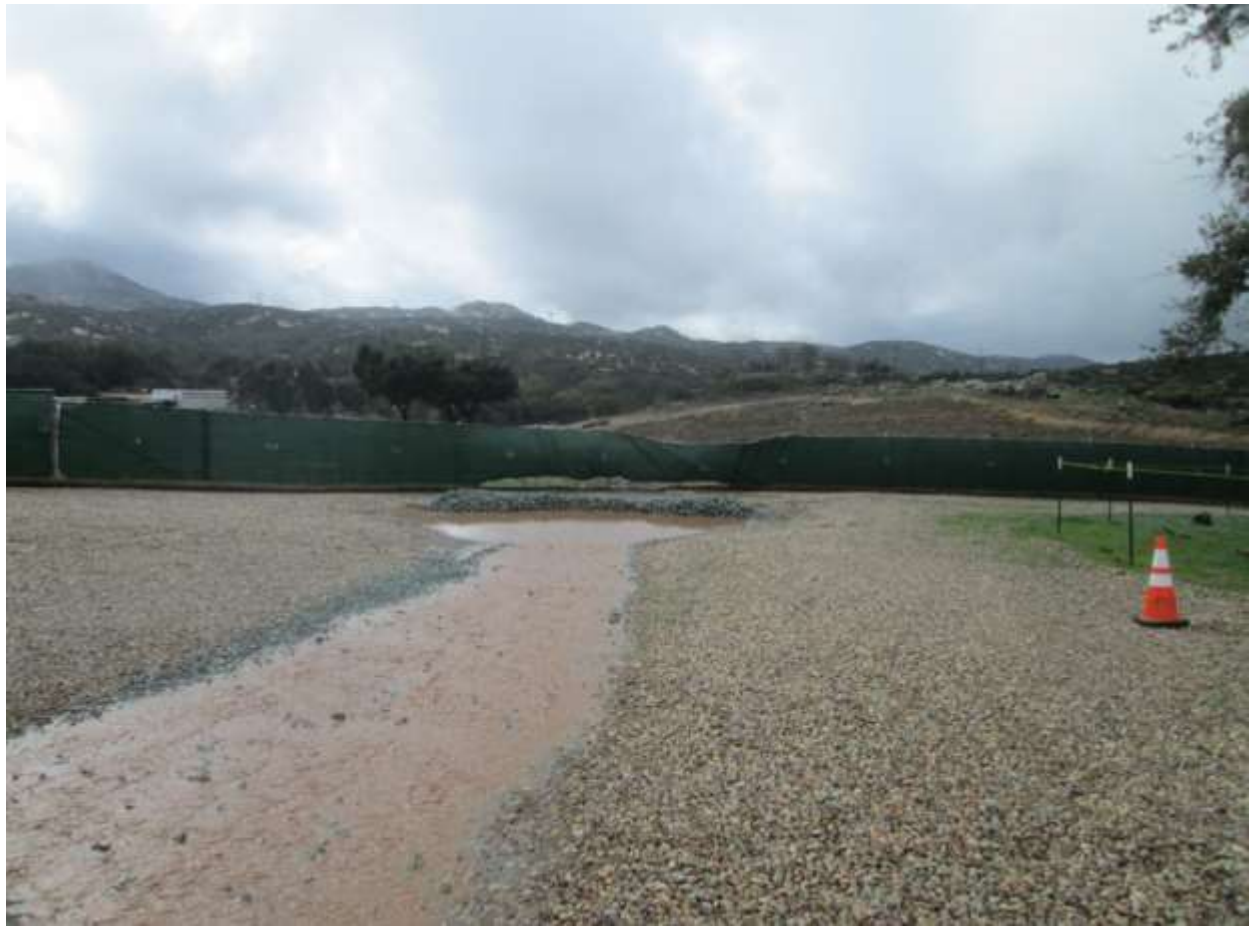
Heavy rain and wind occurred during this reporting period, resulting in extensive BMPs repairs along roads and work spaces within the rights-of-way. At the Japatul Spur Yard, gravel bag berms and velocity dissipaters were used in accordance with the SWPPP to slow the rate of water flow through the yard. Due to the wind and water flow, the visual screening fence installed along the perimeter of the yard was damaged and observed repaired during the reporting period in accordance with APM VIS-02 (See Photo 1—Attachment A).

Photo 1: Due to the rain event that occurred this reporting period, velocity dissipaters and other erosion control BMPs were used to slow the rate of water flow at the Japatul Spur Yard in accordance with the SWPPP (MM HYD-1). Post-rain event, visual screening fence was observed repaired in accordance with APM VIS-02.

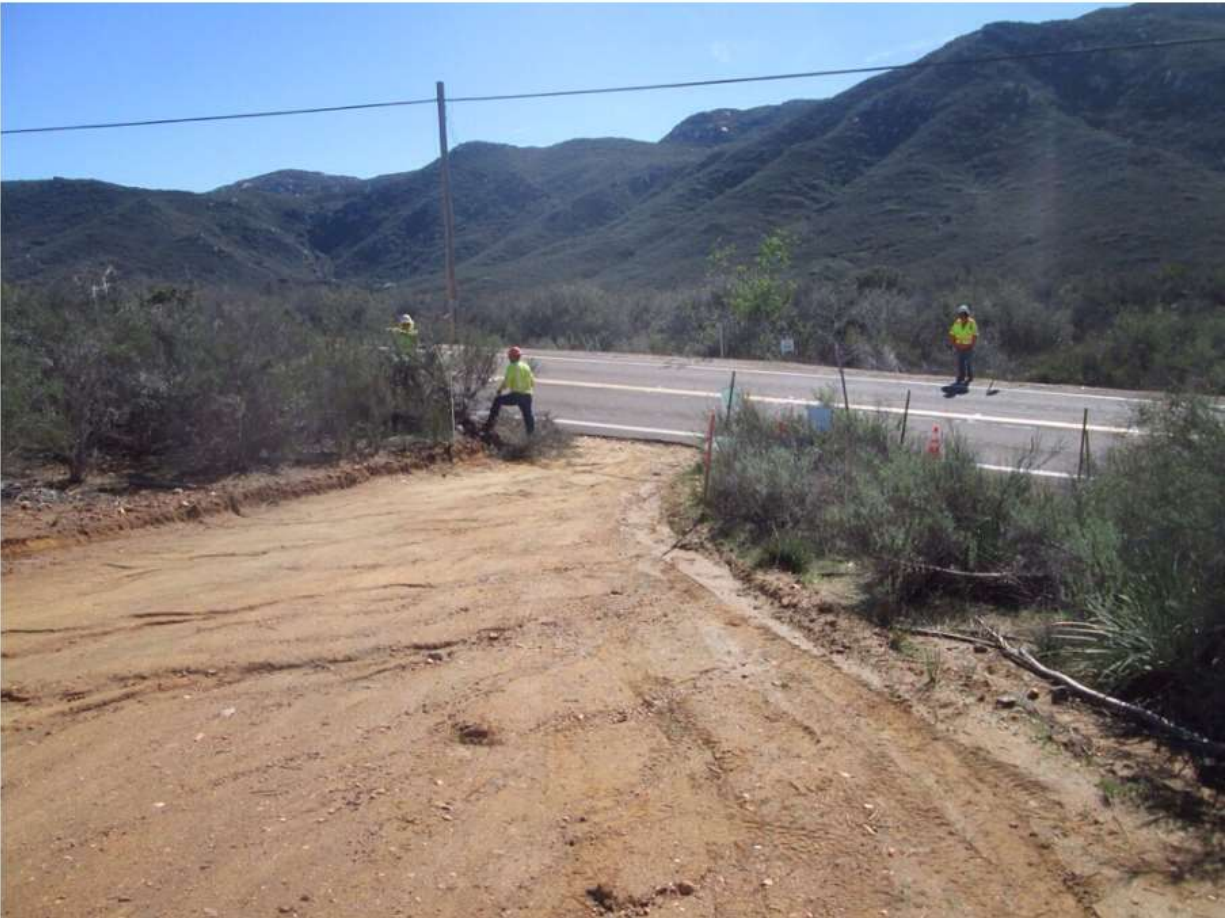
Photo 2: A construction crew was observed clearing vegetation within the approved workspace at Pole Z272870 (TL 625B) in accordance with MM BIO-1. A biological monitor was on site to monitor the activity in accordance with MM BIO-3.

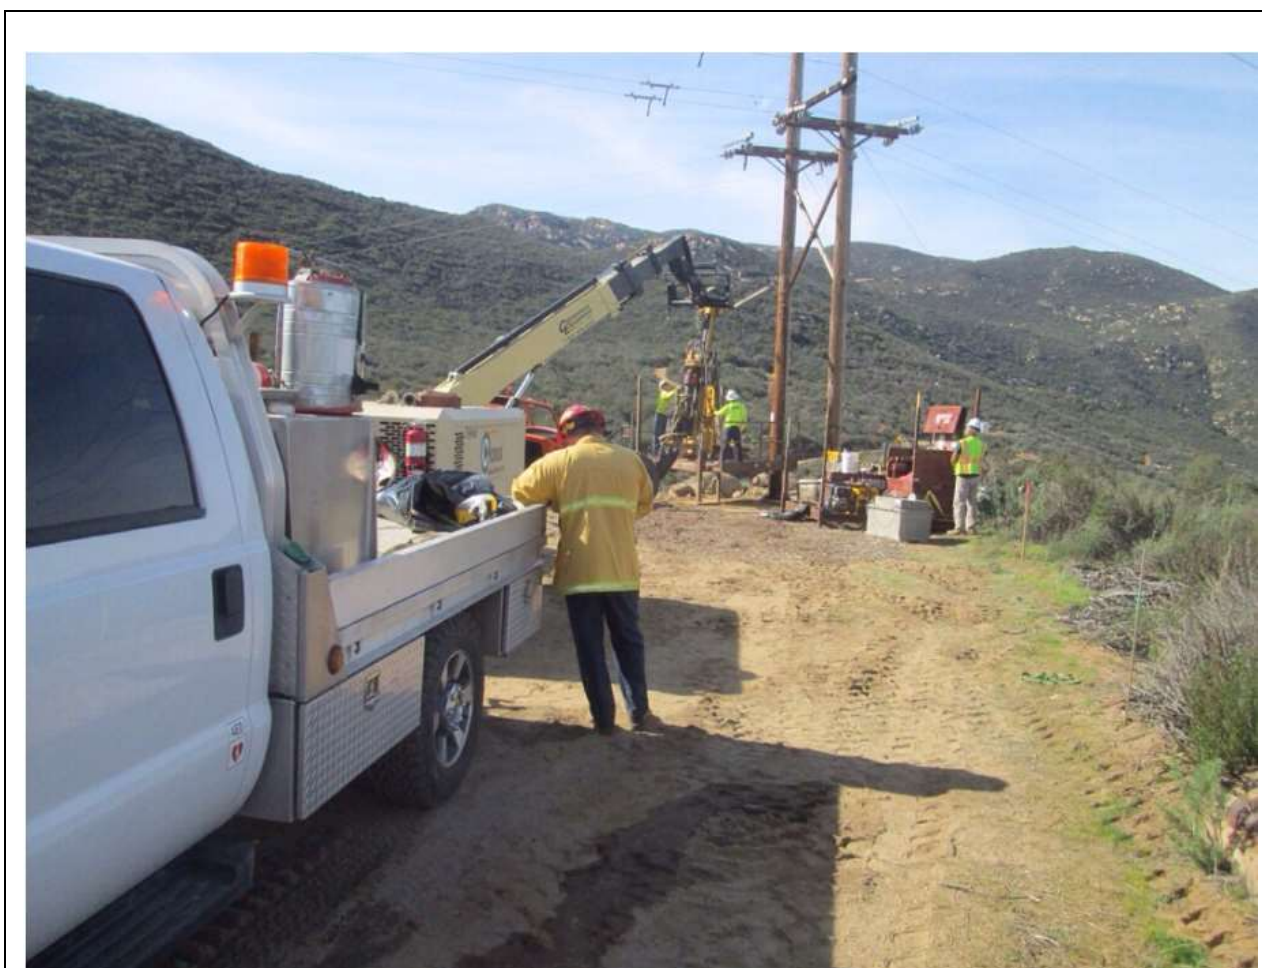
Photo 3: A fire patrol was observed monitoring a crew setting up to drill at Pole Z272879 (TL 625B) in accordance with MM FF-1.

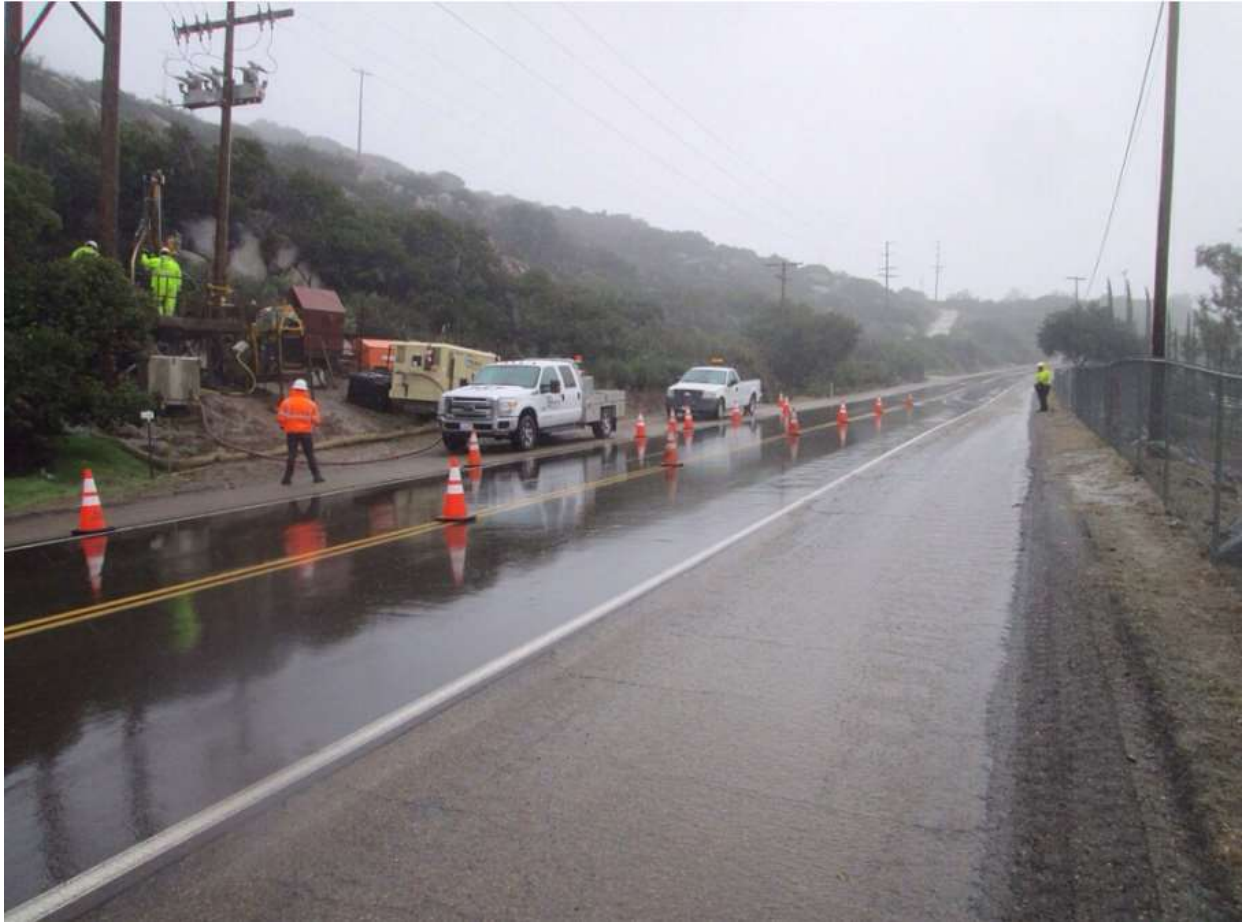
Photo 4: During micropile drilling at Pole Z272901 (TL 625B), a traffic control flagmen and cones were observed in place adjacent to the construction site along Japatul Road in accordance with APM TRANS- 02. Fiber Rolls were observed in place in accordance with the Erosion Control Plan (ECP) and SWPPP (MM HYD-1).

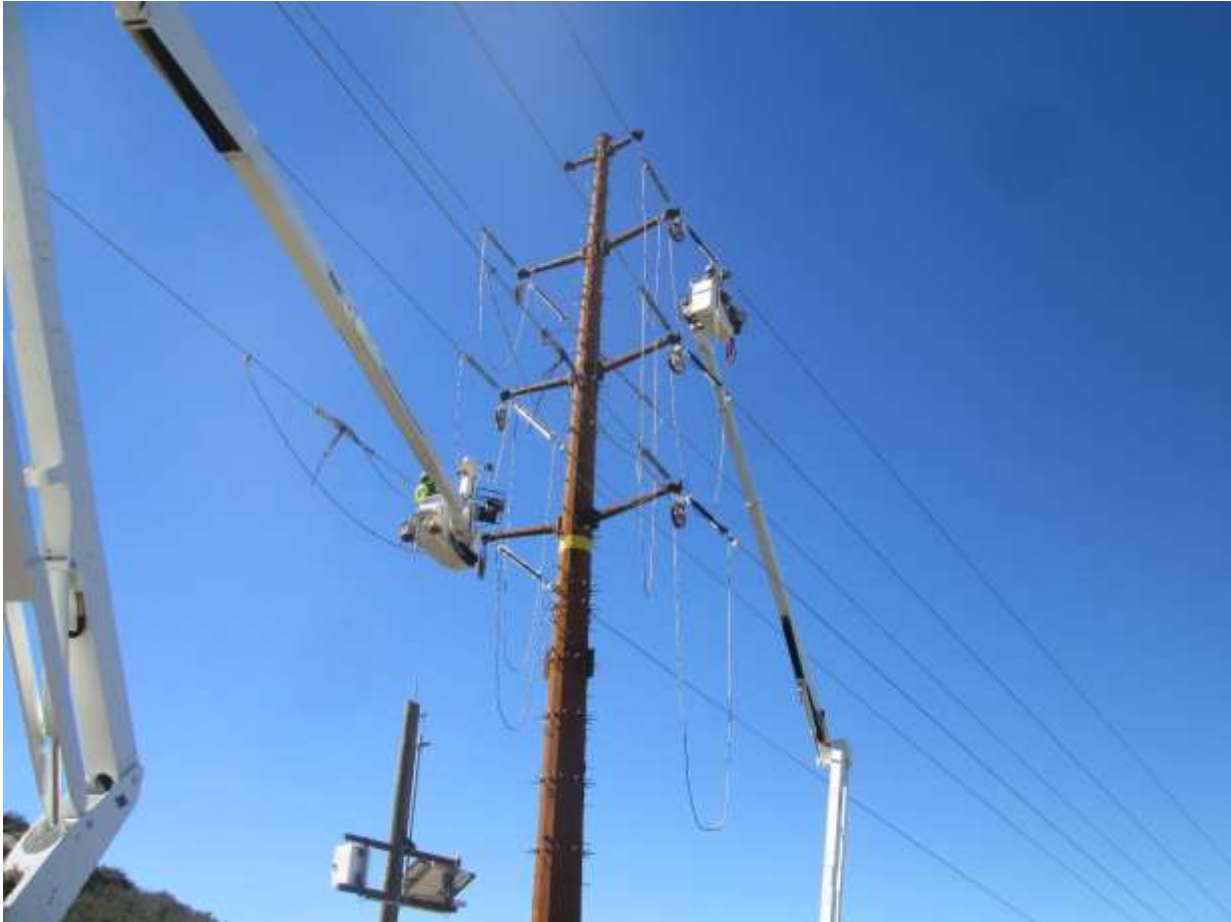
During this reporting period, micropile foundation activity continued, which included drill set up, platform set up, drilling, foundation bar installation, capping, grouting, micropile strength testing, and grounding. Steel replacement poles were staged, assembled, and installed. Wire stringing occurred and included wire pulling, sagging, clipping, stacking, and dead-ending (See Photos 5 and 6—Attachment A).

Photo 5: A line crew was observed dead-ending overhead wire at Pole Z44178 (TL 629E).

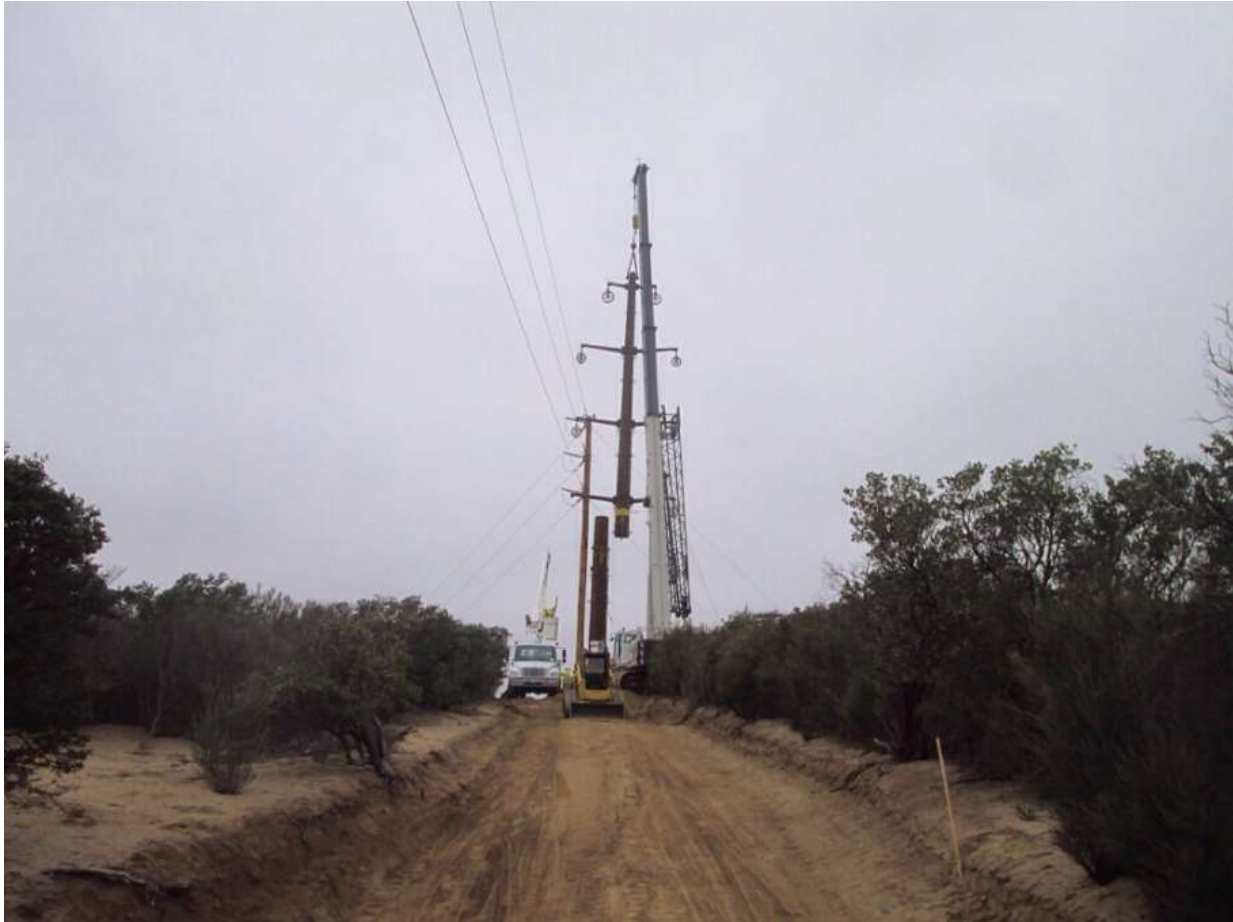
Photo 6: A construction crew was observed installing a steel replacement pole at Pole Z44168 (TL 629E). Vehicles were observed staged within existing access roads.
