**SAN DIEGO GAS & ELECTRIC COMPANY
CLEVELAND NATIONAL FOREST
POWER LINE REPLACEMENT PROJECTS
ACCESS ROAD CONDITION EVALUATION AND
REPAIR DESIGN REPORT**

JUNE 2017

TL682 Access Road Evaluation Summary

TL682 Access Road Improvement Recommendation

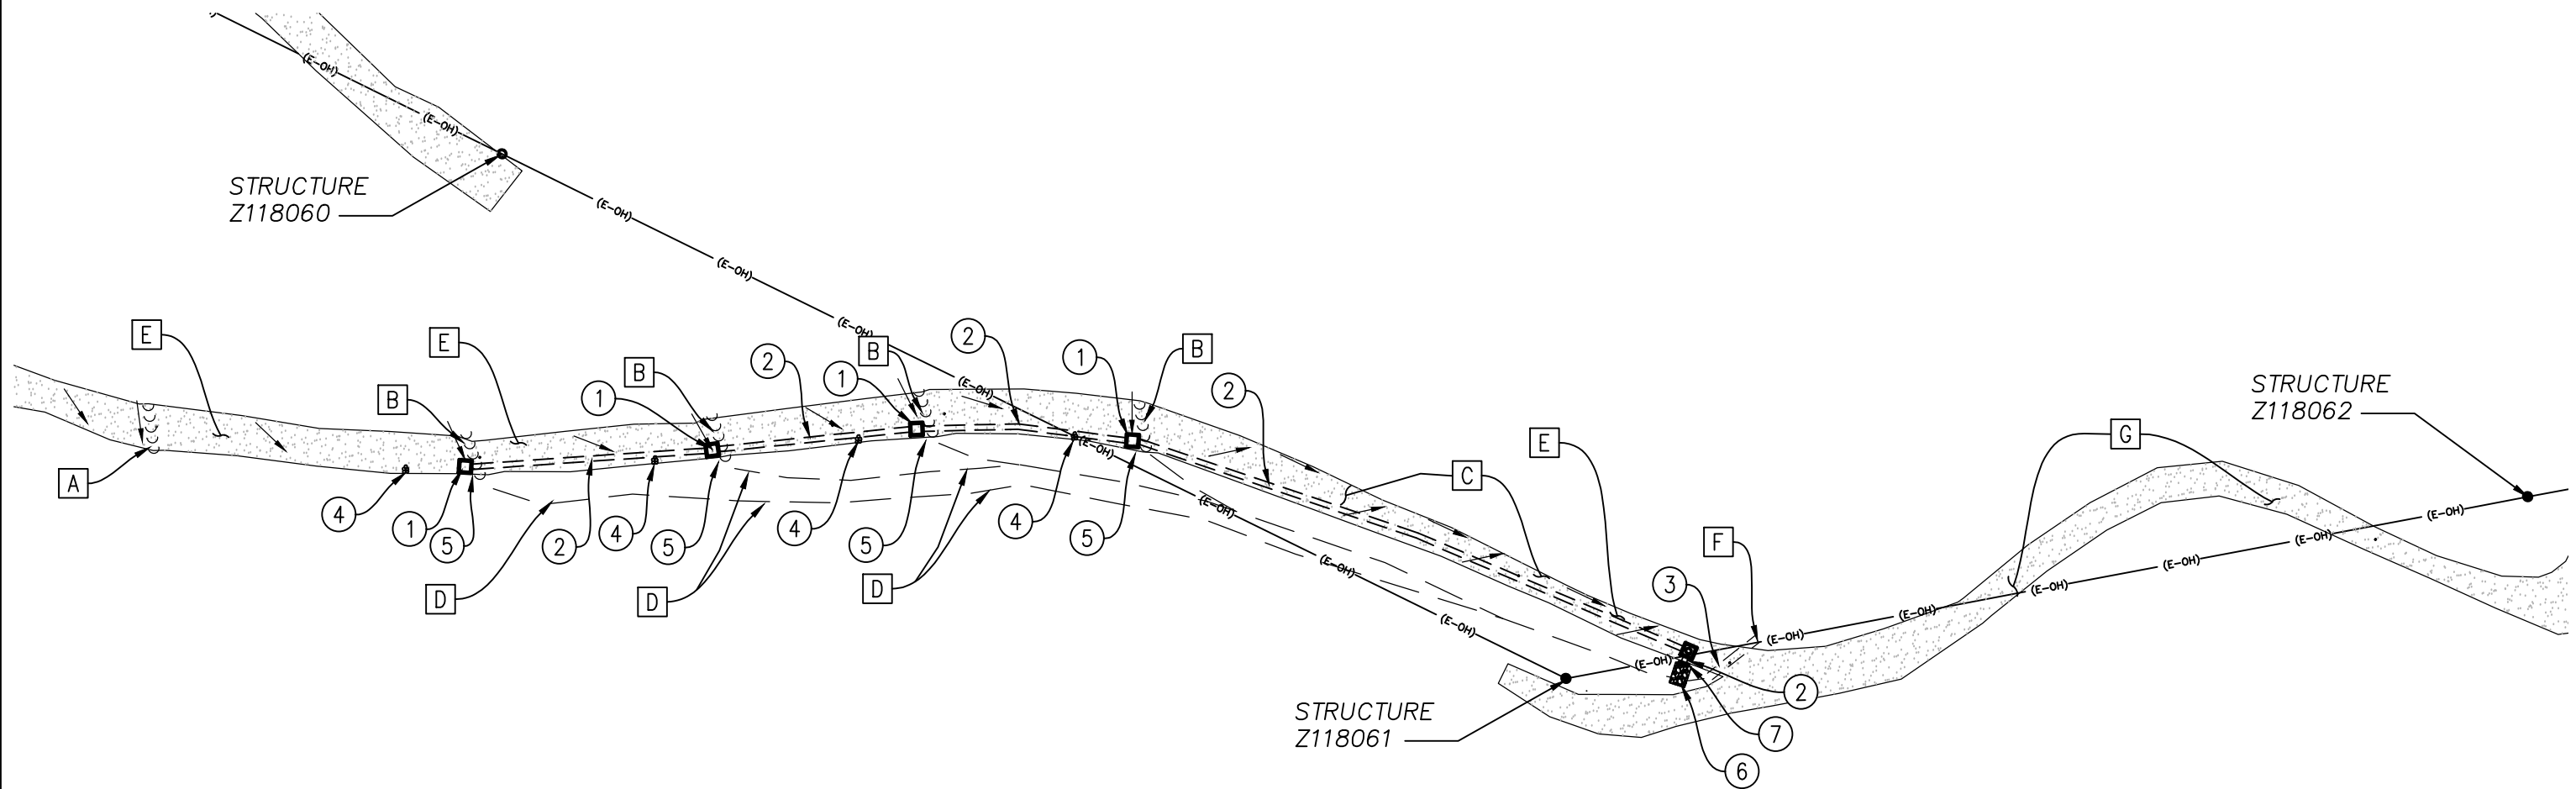
FIGURE 1

Based upon site investigations for TL682 that were performed in accordance with mitigation measure HYD-4, it has been determined that chronic erosion is present outside the road prism along one reach of SDG&E maintained access road between Pole Z118060 and Z118061. Within this reach of access road, chronic erosion was noted observed within the road prism, only outside the road prism within unvegetated areas comprised of erosive soils. Throughout the remaining portions of access road for TL 682 that were evaluated in accordance with mitigation measure HYD-4, chronic erosion was not observed. See Attachment A for additional information.

Figure 1 is provided to illustrate a conceptual repair recommended to collect runoff from the access road and convey it through a storm drain to reduce the amount of runoff within the channels that have formed west of the access road. The existing waterbars will be reconstructed during construction, but instead of discharging through rip rap to the channels, runoff will be directed to Type F catch basins. Runoff collected in the catch basins will be conveyed through an 18" RCP storm drain and discharged through a rip rap energy dissipator near Pole Z118061, where the natural drainage course is well vegetated.

- [A] WATERBAR DISCHARGE TO WELL VEGETATED AREA, NO EROSION NOTED, NO IMPROVEMENT PROPOSED
- [B] WATERBAR DISCHARGE TO SPARSELY VEGETATED AREA, INCISED CHANNEL NOTED, IMPROVEMENT PROPOSED
- [C] RUNOFF DRAINS TO EAST/INBOARD SIDE OF ROAD, NO IMPROVEMENT PROPOSED
- [D] INCISED CHANNELS FORMED WITHIN AREAS OF MINIMAL VEGETATION
- [E] "CHRONIC EROSION" NOT NOTED, NO IMPROVEMENTS PROPOSED ALONG ROADWAY
- [F] EXISTING CULVERT DISCHARGING TO WELL VEGETATED AREA

In addition, to reduce the potential for further incision of the channels that have formed west of the access road, it is recommended that catch basins be added along the westerly side of the road and a new storm drain be installed to convey runoff to a discharge point near Pole Z118061. The installation of these drainage improvements will reduce the flow rate of runoff in the channels to reduce or eliminate further incision and associated transport of sediment to downstream receiving waters. See Attachment B for additional information.

- ① PROPOSED TYPE F CATCH BASIN PER SDRSD D-7
- ② PROPOSED 18" RCP STORM DRAIN, TRENCH PER SDRSD D-60, $Q_{MAX} = 50$ CFS
- ③ PROPOSED TYPE A STORM DRAIN CLEANOUT PER SDRSD D-9
- ④ PROPOSED VELOCITY CHECK DAM PER SDG&E BMP FOR MAINTENANCE ROADS DETAIL 2.2.2
- ⑤ FINE GRADE SPOILS FROM CATCH BASIN TO REMOVE OUTLET FROM WATERBAR
- ⑥ PROPOSED 5'X6' RIP RAP ENERGY DISSIPATOR PER SDRSD D-40
- ⑦ PROPOSED STRAIGHT HEADWALL TYPE B PER SDRSD D-32
